3. LOCATION AND SITE DESCRIPTION

3.1 DEVELOPMENT SITE DESCRIPTION

3.4 SITE HISTORY AND CONDITION

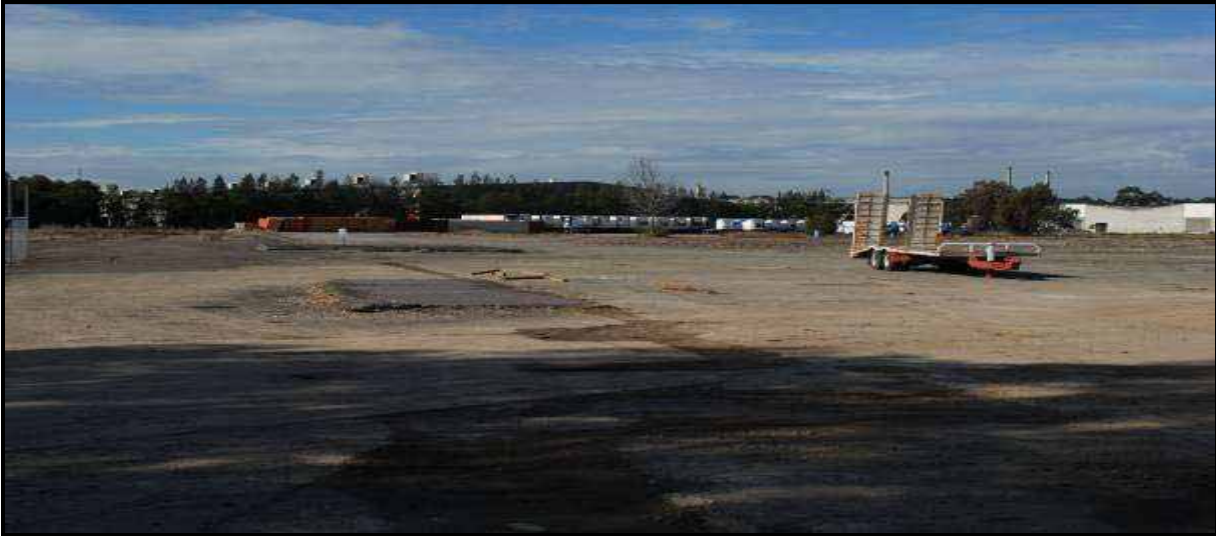
Plate 3.1 View across site facing South East (DSCA 2010)

The site of the proposed RIRP at 1 Grand Avenue, Camellia (refer Figure 1.1) is located within Part Lot 1/DP 226202, Lot 1/DP 579735 and Part Lot 2/DP 579735. The RIRP site consists of an area of approximately 4.5 hectares (ha) and is located within a larger parcel of land (approx 7.4ha) owned by Billbergia. The site has previously been cleared, levelled and capped with “hard” surfaces of concrete and bitumen. The remainder of the Billbergia site is currently used for the storage of shipping containers. REMONDIS will lease the RIRP site from Billbergia. Plates 3.1, 3.2 and 3.3 provide an indication of the existing condition of the site surface and northern boundary adjacent to the Parramatta River.

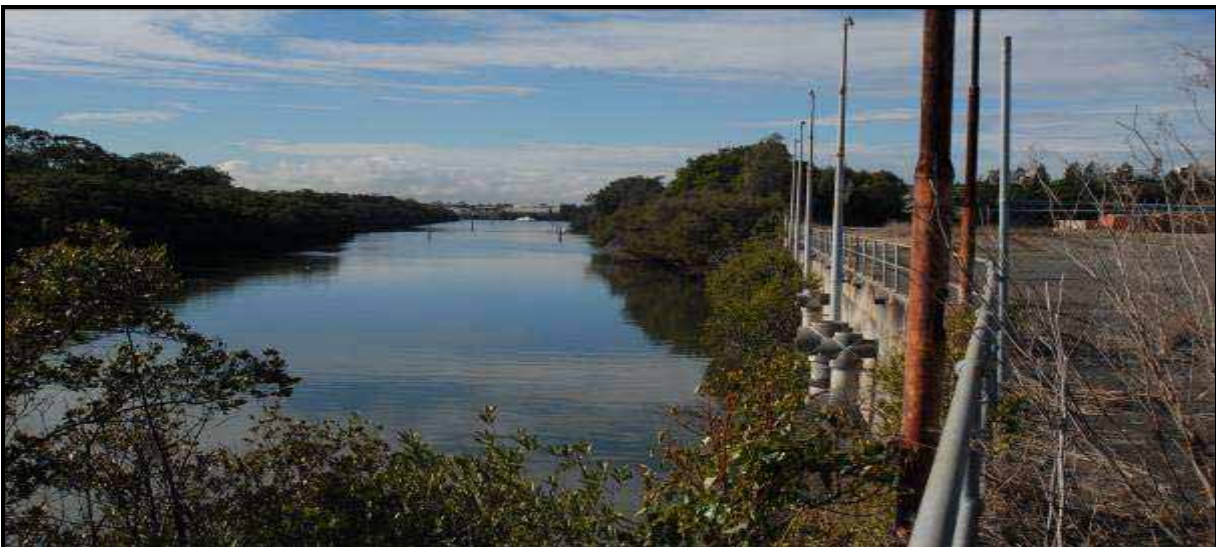
Plate 3.2 A View of the northern boundary of the site adjacent to the Parramatta River facing East (DSCA 2010)

The northern boundary of the site forms part of an Environment Protection Zone adjacent to the Parramatta River. The Environment Protection Zone comprises an approximately 30m wide corridor of land along the bank of the River. The use of this land is subject to the provisions of SREP No 28 and the draft LEP as described in Section 2 of this EA. The Environment Protection Zone within the site is capped with concrete hardstand. There is a concrete retaining wall which runs for the length of the site along the northern site boundary between the site and the River. Narrow patches of Mangrove Forest ranging between one and four metres in width are located along the river foreshore with some Mangroves actively collapsing into the river. Stretches of the foreshore along the site boundary no longer include a vegetated riparian zone with the river being in direct contact with the constructed wall.

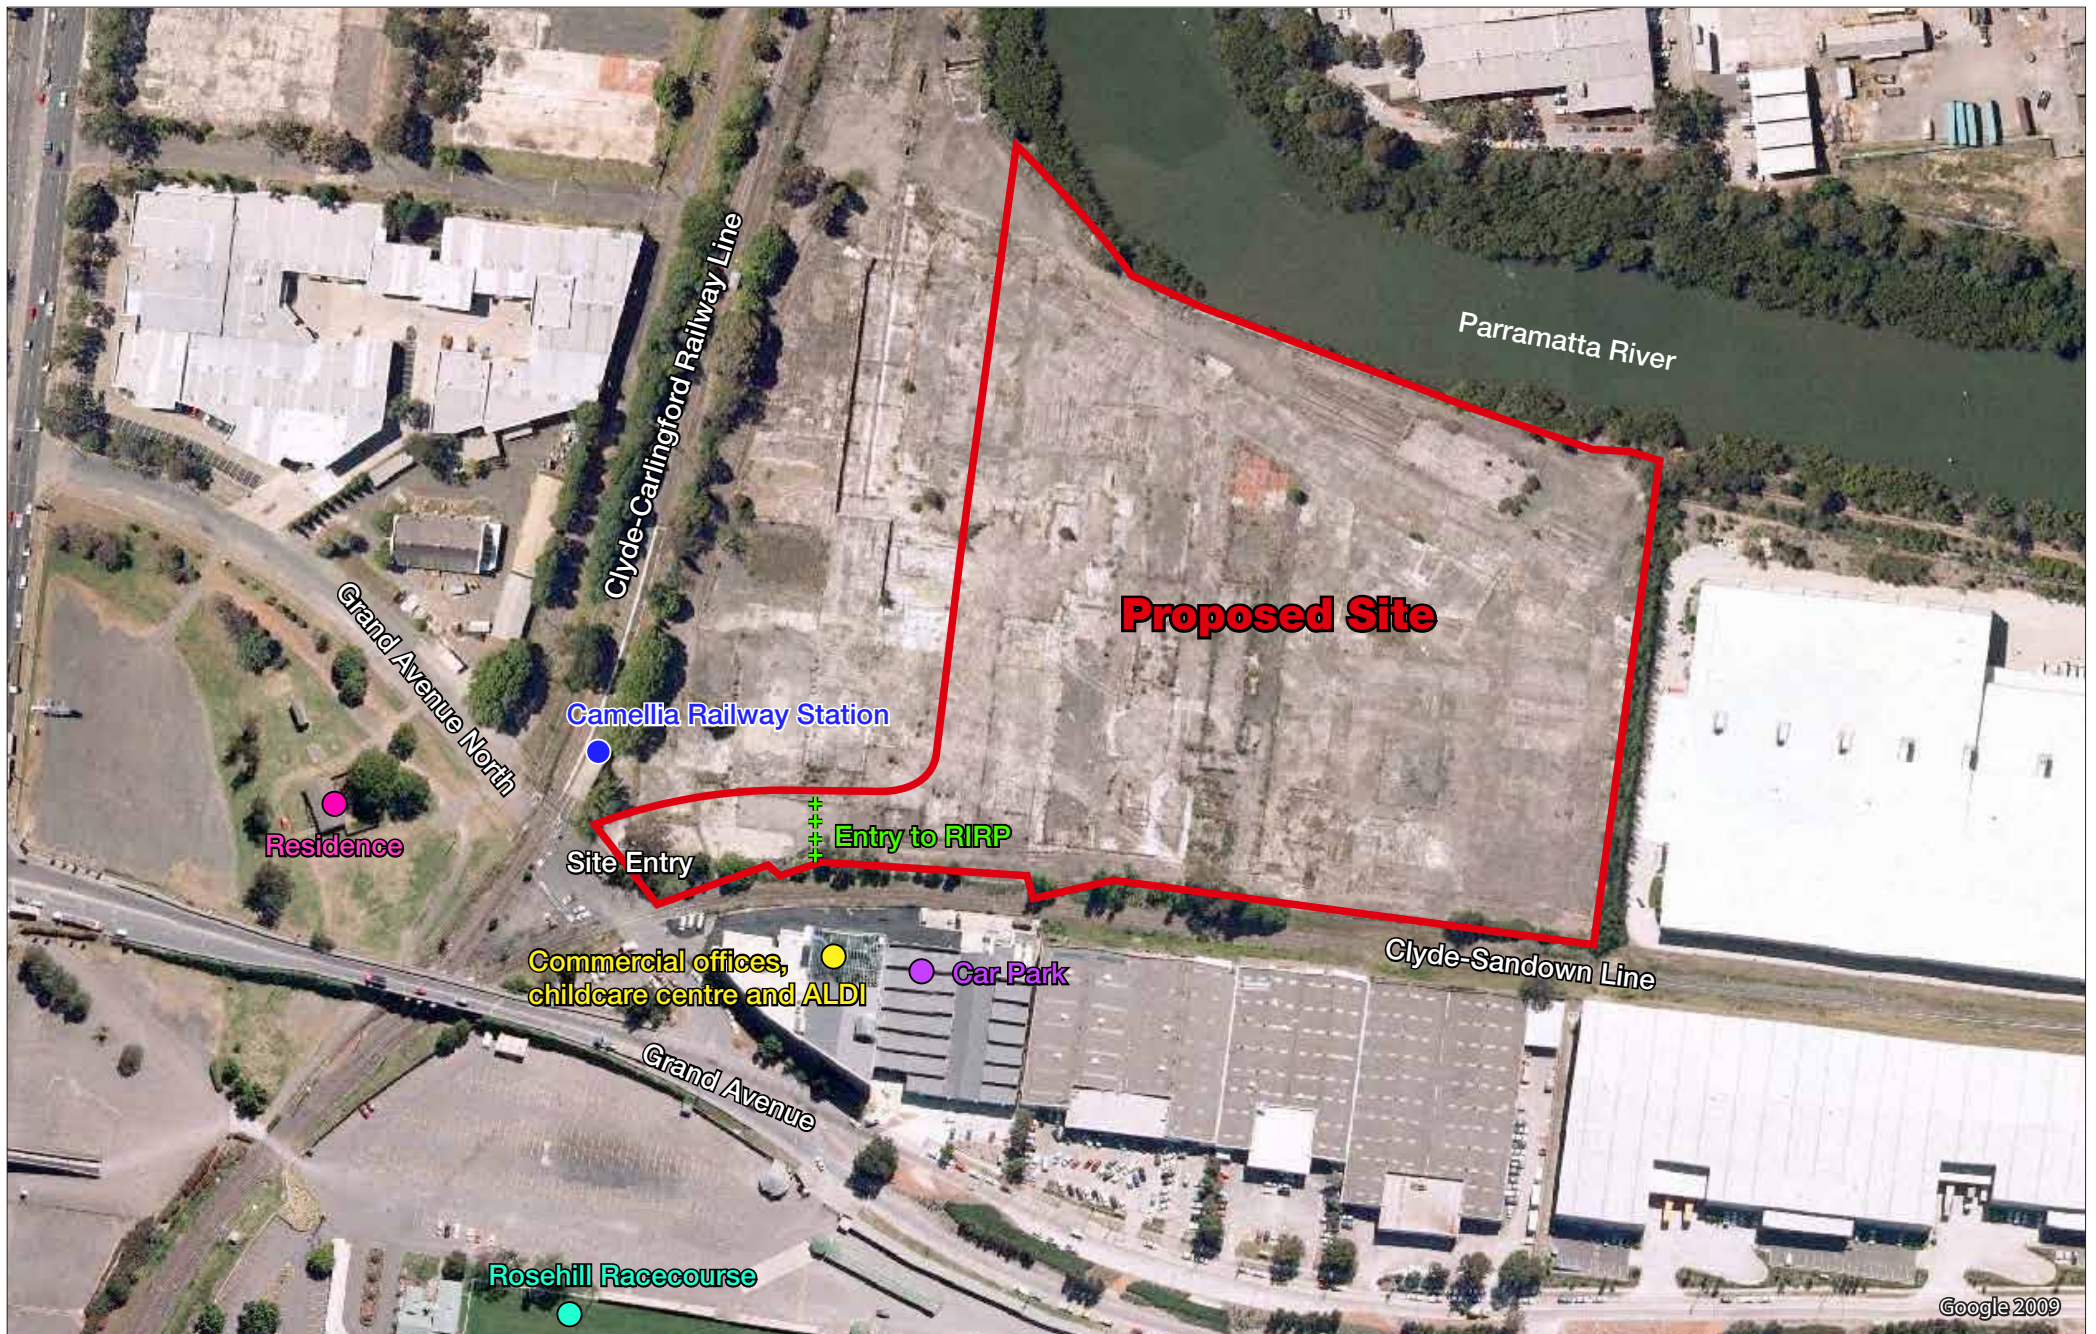
Figure 3.1 Sensitive Receivers

On the southern edge of the site between the goods rail line and Grand Avenue there are recently established commercial premises within the Tilrox/Aldi building occupied by a child care centre, an international college, café and a number of offices (refer Plate 3.4 and Figure 3.1). An Aldi supermarket and car park are located adjacent to this building.

Camellia Railway Station is located adjacent to the site entry (refer Figure 3.1, Plates 3.5 and 3.6).
