HERITAGE IMPACT STATEMENT
FOR PIPE KILN
AT FORMER BRICKWORKS.

SUTHERLAND YARD,
PUNCHBOWL BRICK & TILE CO. LTD,
PRINCES HIGHWAY, OAK ROAD
& FLORA STREET,
KIRRAWEE, N.S.W.

For
Henroth Investments Pty Ltd.

Draft	September 2010
Final	September 2010

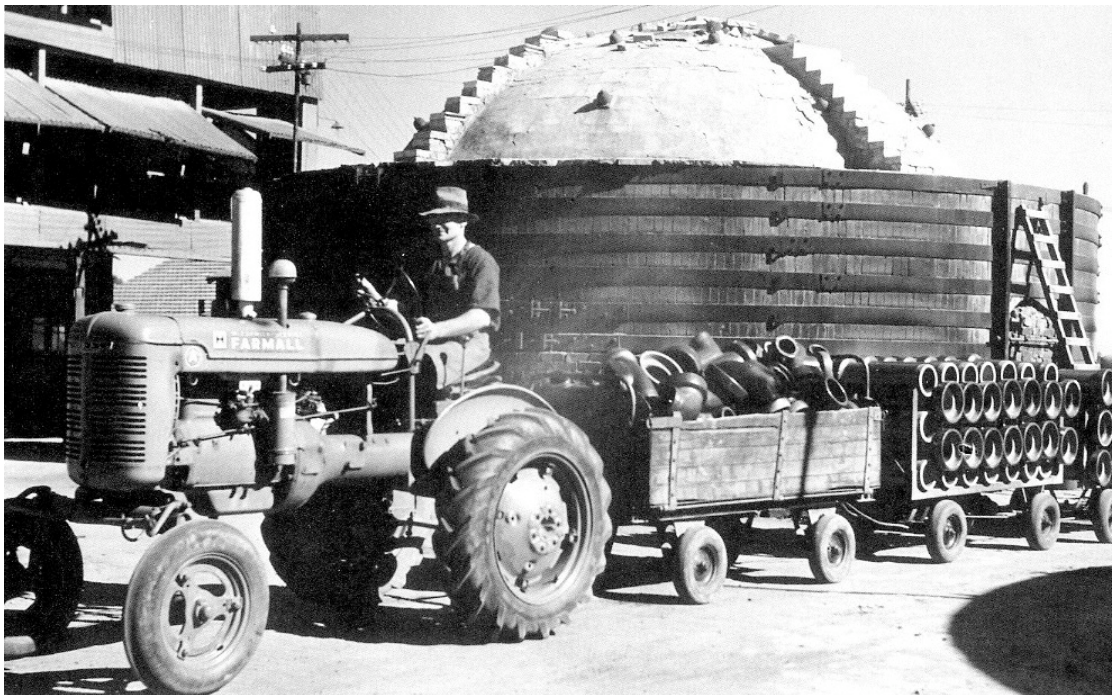
Figure 2.15. The fired pipes being transferred from the pipe kilns, c.1959. Source. Ron Ringer, *The Brickmasters 1788-2008*, Dry Press Publishing, Sydney, Horsley Park, 2008, p 281.

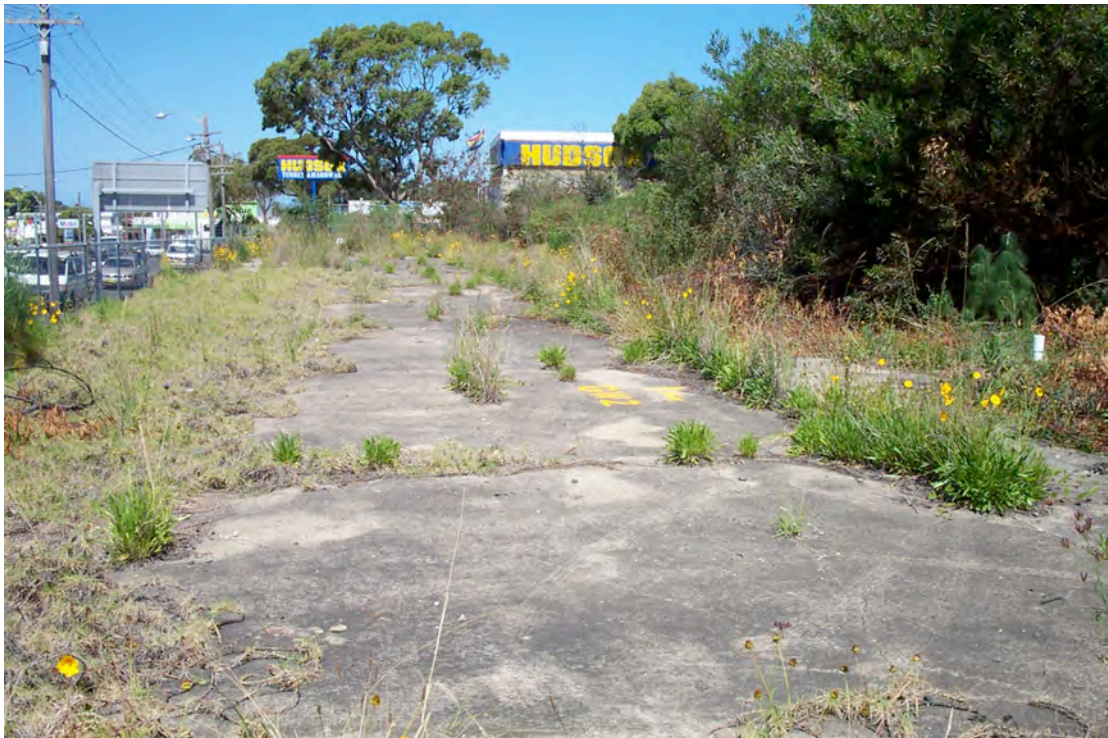
Plate 3.2. Concrete slab on the site of the tunnel kiln, looking east.

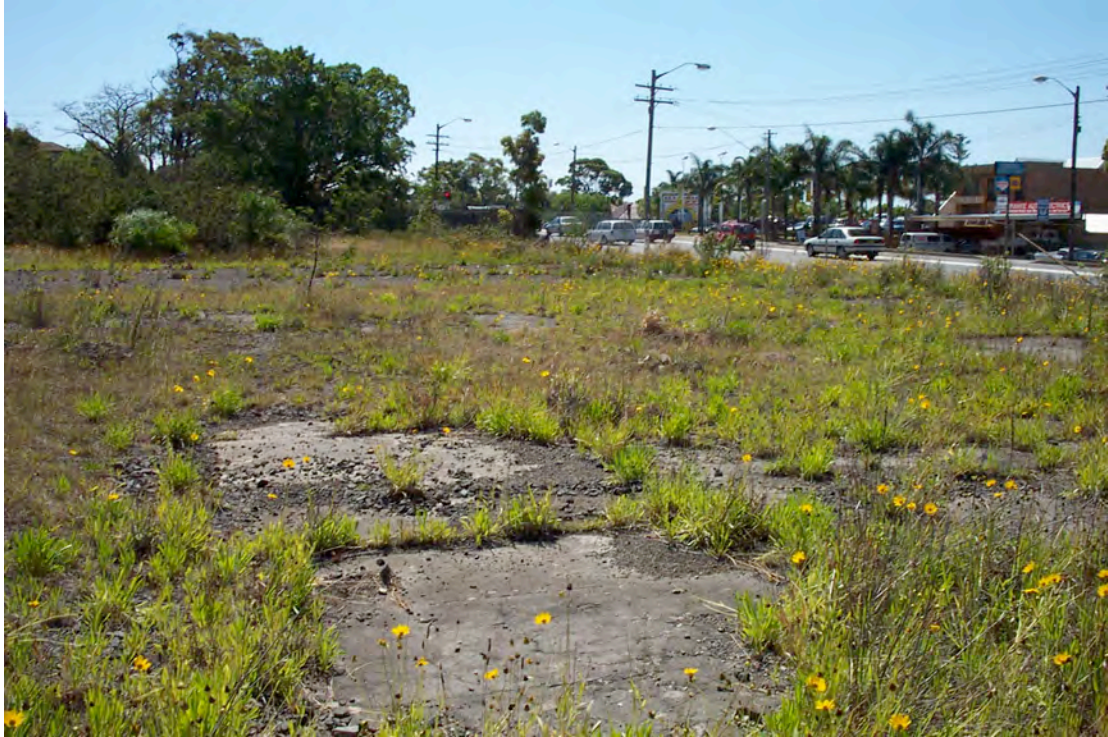
Plate 3.3. Concrete slab floor of former brickmaking workshops.

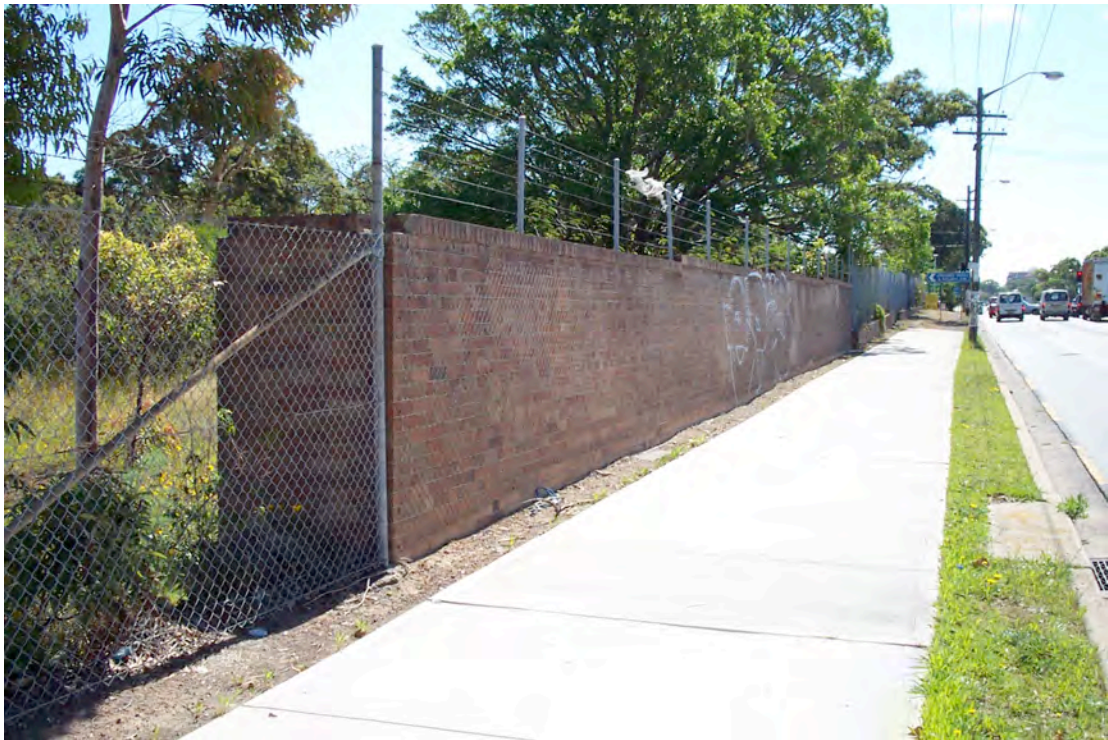
Plate 3.4. Boundary wall on Princes Highway frontage at north-western corner of the site.

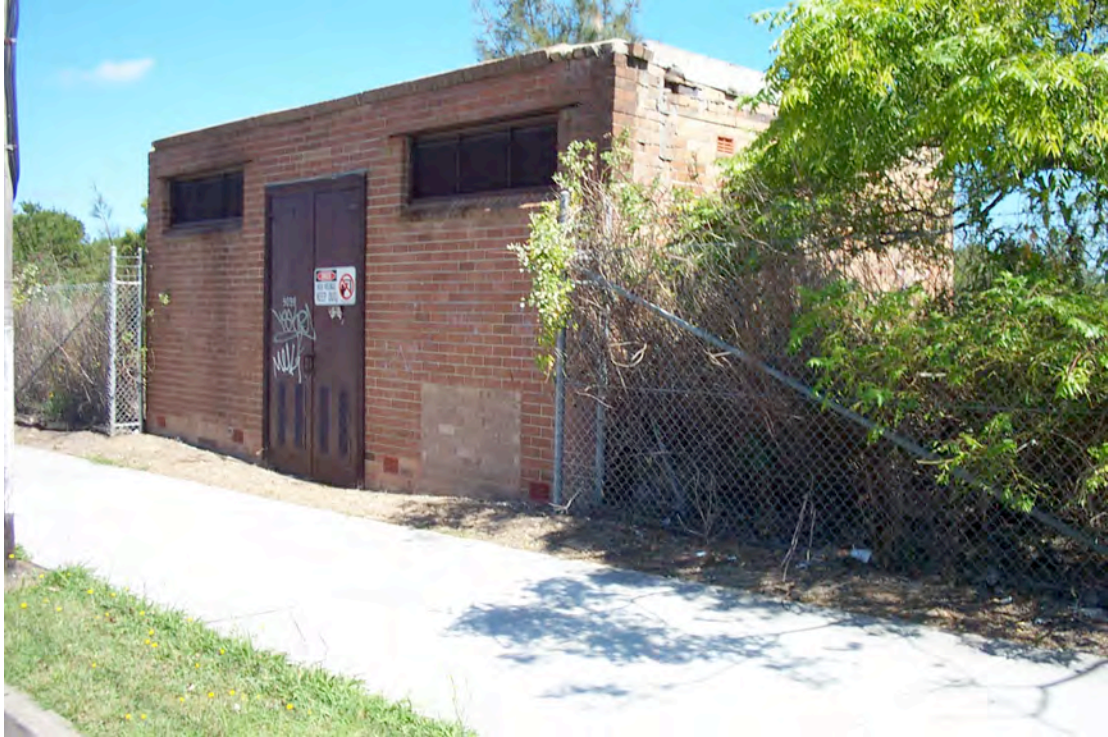
Plate 3.7. Electrical Substation, Princes Highway frontage.
