GEOTECHNICAL ASSESSMENT
(In Accordance with Pittwater Council Risk Management Policy)

PROPOSED RESIDENTIAL DEVELOPMENT

CNR MACPHERSON STREET & BOONDAH STREET WARRIEWOOD, NSW

Ref: 21359Zrpt2

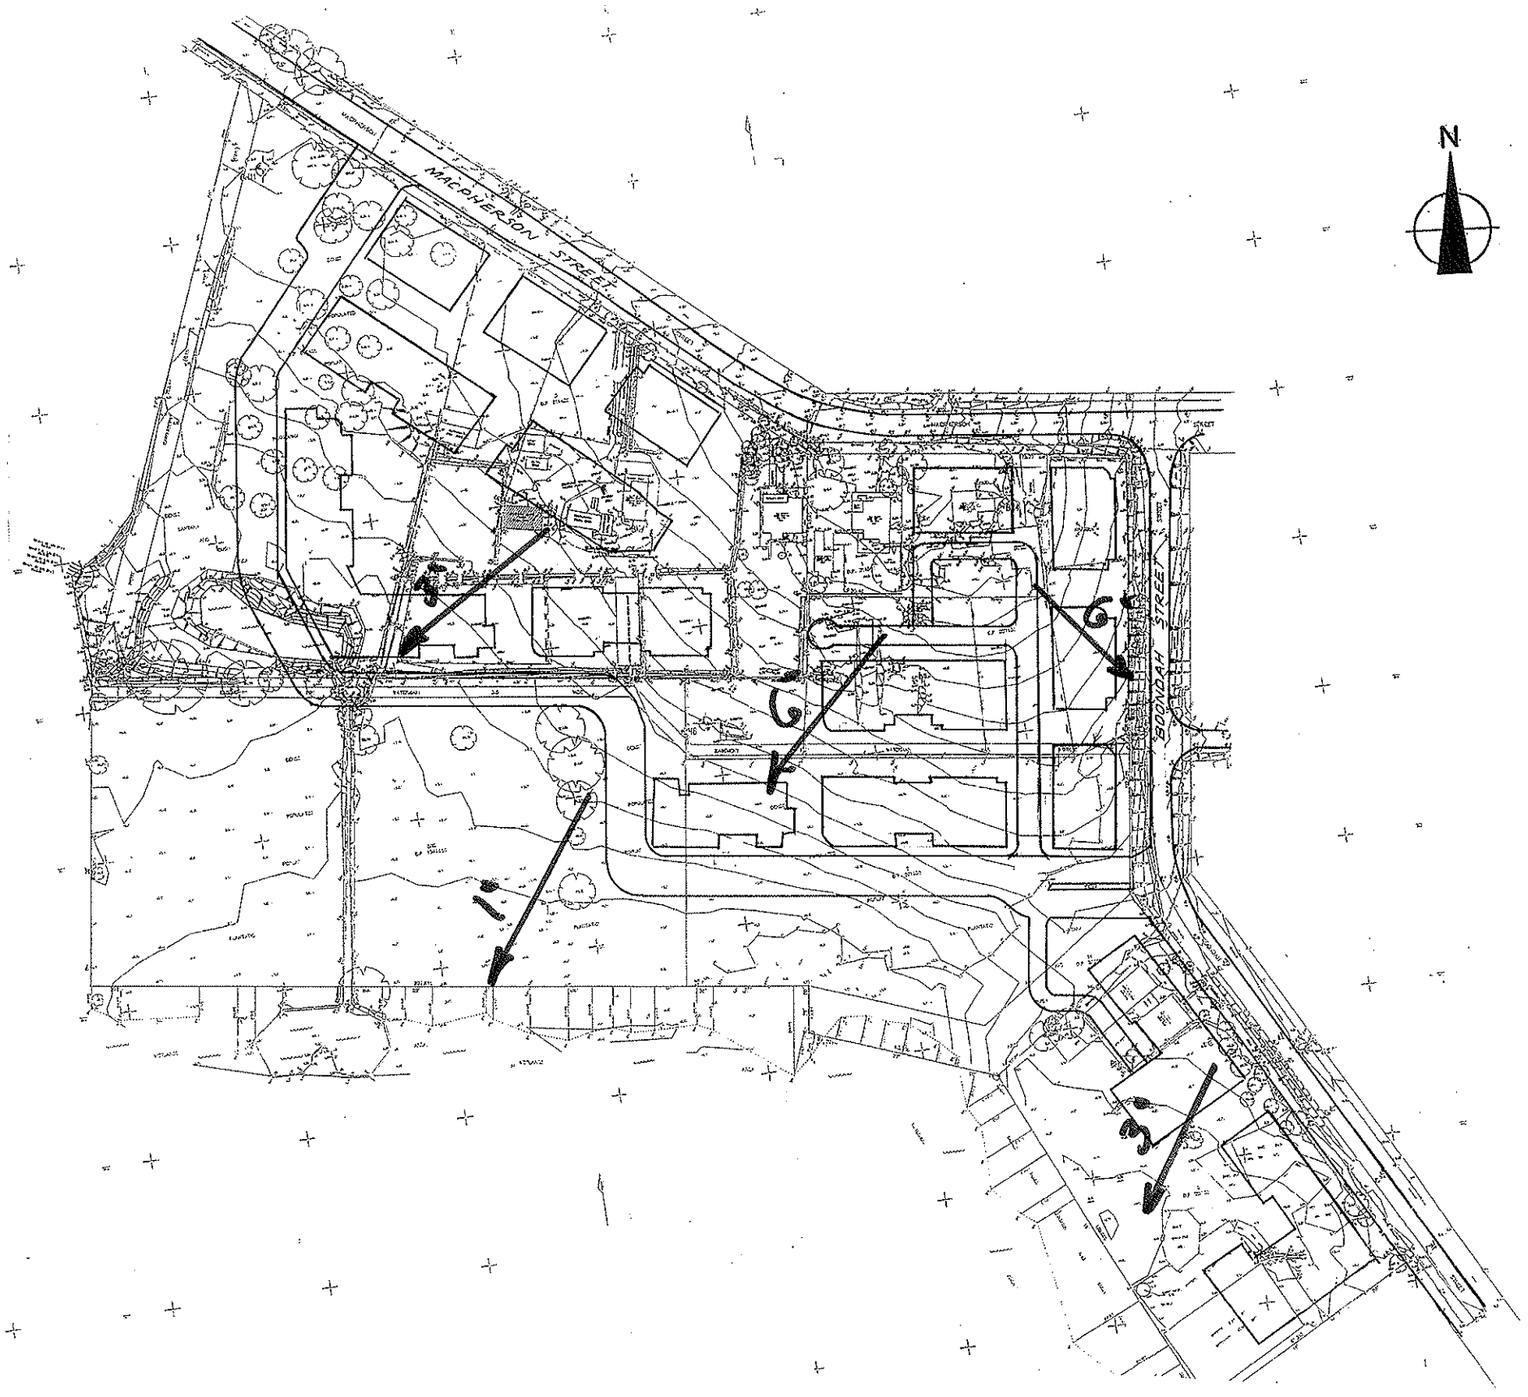
GEOTECHNICAL SKETCH PLAN

The attached Figure 1 presents a geotechnical sketch plan showing the principal geotechnical features present at the site. The ground contours indicated on Figure 1 are based on a site plan (Drawing No 100, Revision A) prepared by Meriton Apartments. Additional features on Figure 1 have been measured by hand held inclinometer and hence are only approximate. Should any of the features be critical to the proposed development, we recommend they be located more accurately using instrument survey techniques.

We recommend that the summary of observations which follows be read in conjunction with the attached Figure 1.
