## St Vincent's Hospital, Caritas Site Ancillary Report

- Perimeter Walls and Fencing
- Rear Ablutions and Storage Block
- Old Kitchen Facility

299 Forbes Street, Darlinghurst

Considerations on Particular Heritage Items:  
To be read in context with Heritage Impact  
Statement for the same Site

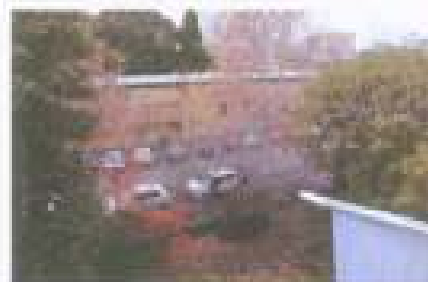
Figure 1  
View from top floor of Main House towards Forbes Street, showing the oldest portion of the external perimeter fence  
(Source: Graham Brooks & Associates, July 2008)

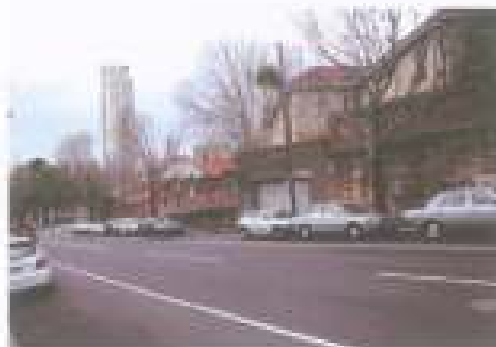
Figure 18:  
View looking south down Bourke Street showing brick wall and stone foundation retaining wall. The wall in the foreground and to the right is the perimeter wall of the former Darlinghurst Police Station.  
(Source: Graham Brooks & Associates, July 2008)

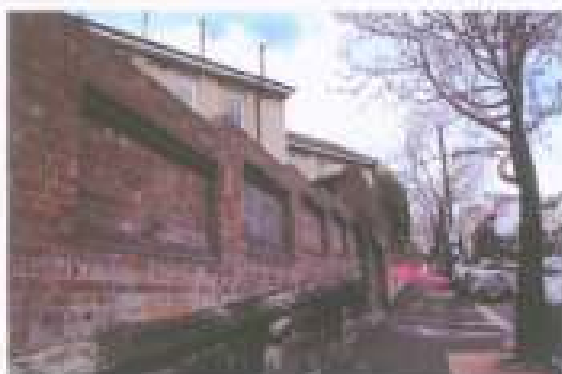
Figure 12:  
The original stone retaining walls, capped to brick, having probably existed in the 1820s. It seems to have already been in place when the interventions were made for the garage and driveways along this side.  
(Source: Graham Brooks & Associates, July 2008)

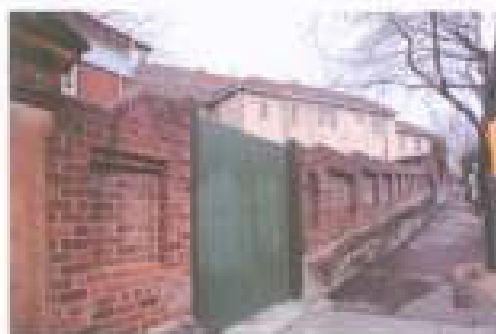
Figure 12:  
View looking south up Bourke Street showing brick wall and stone foundation retaining wall. The brick wall is probably 1820s and was already in place when the 1870 plans were drawn up.  
(Source: Graham Brooks & Associates, July 2008)

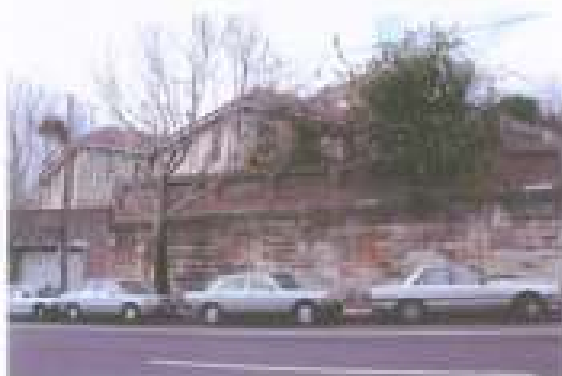
Figure 16:  
The point at which three different walls meet along Bourke. The left stone retaining wall with its brick wall above is the precursor of the former Darlinghurst Police Station. The garage with its surrounding wall to the left is the Curtis property and this portion was positioned in the 1930s plans.  
(Source: Graham Brooks & Associates, July 2008)

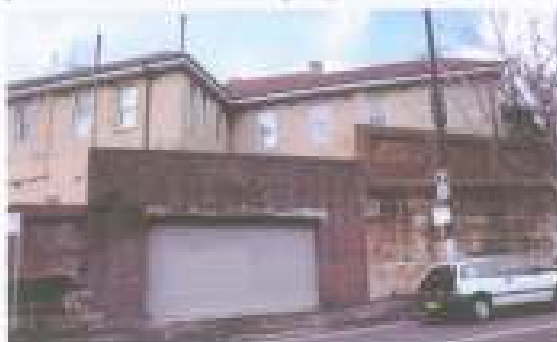
Figure 16:  
Intersection of two walls along Bourke Street: the upper and lower of the Police land, the upper and lower of the Carfax land and the Carfax garage wall intervention.  
(Source: Graham Brooks & Associates, July 2006)

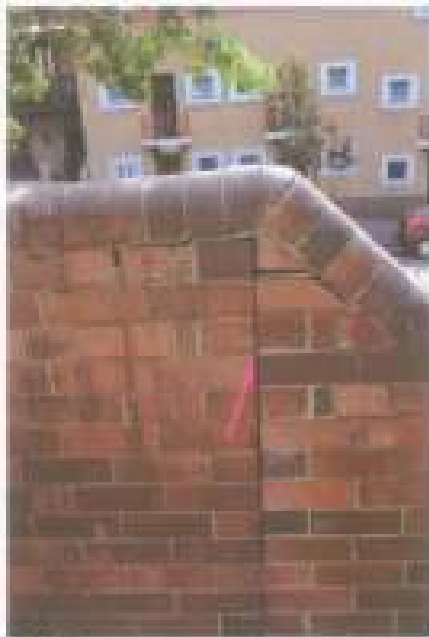
Figure 22:  
Detail showing joint along the Bourke Street wall  
(Source: Graham Brooks & Associates, July 2008)

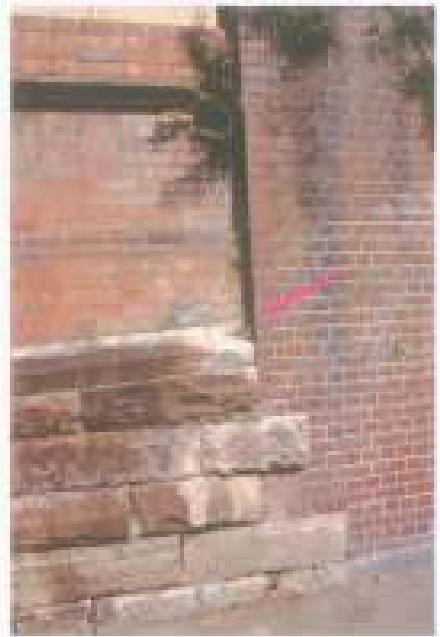
Figure 23:  
Detail of the meeting between a number of wall arrangements on the Clontarf property at the place where the intervention for the garage was created following upon the 1935 plan  
(Source: Graham Brooks & Associates, July 2008)

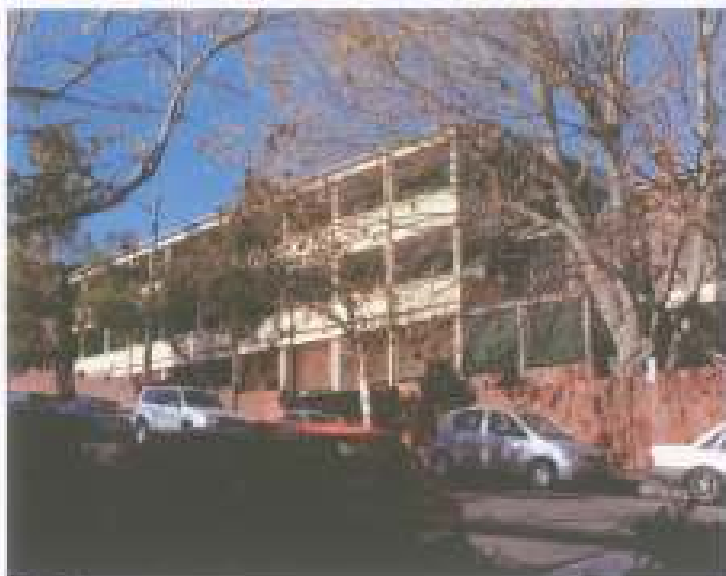
Figure 26:  
View of the 1980s building, and showing a perimeter fencing/wall arrangement which seems consistent with that era. It is not clear what complicates the foundation for this wall.  
(Source: Graham Brooks & Associates, July 2008)

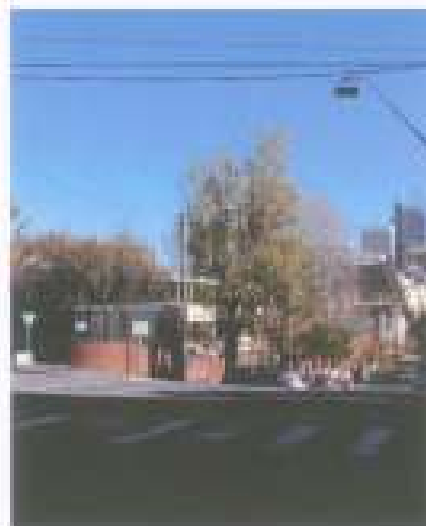
Figure 29:  
View looking west down Burton Street with the CarMa complex on the left and showing what seems to be a 1990s fencing/wall arrangement.  
(Source: Graham Brooks & Associates, July 2008)

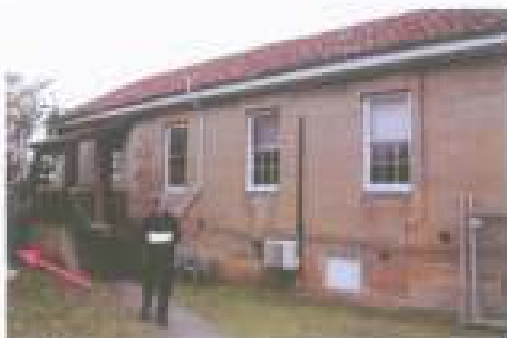
Figure 38  
View outside the later 1900s additions at the south side of the property adjacent to the Pullen lane. The ground is elevated at this point but falls away steeply to the rear, at the right of the image.  
(Source: Graham Brooks & Associates, July 2008)

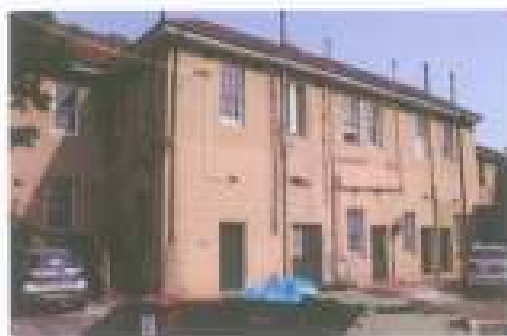
Figure 40  
View of the 1930s additions along the west facade. The ground level is flat and concrete paved but falls away steeply towards the rear (pictured next).  
(Source: Graham Brooks & Associates, July 2008)

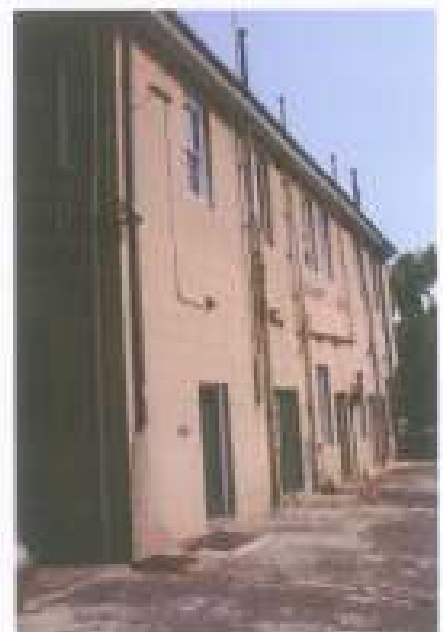
Figure 41  
The later 1900s additions at the west side (rear) of the property  
(Source: Graham Brooks & Associates, July 2008)

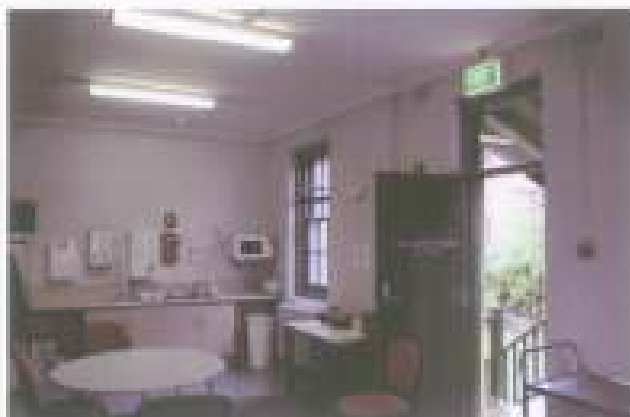
Figure 43  
Interior of the later 1930s unit at the south side, showing the opposite of recent disposal  
which are typical of much of the interior of the building  
(Source: Graham Brooks & Associates, July 2008)

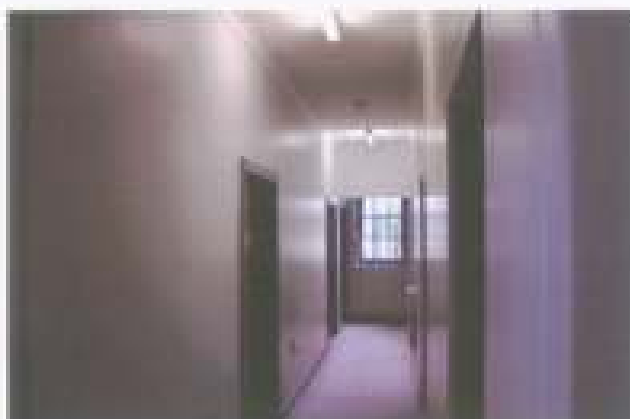
Figure 44  
Interior view of the later 1930s unit where older single rooms have been reconfigured as  
office space  
(Source: Graham Brooks & Associates, July 2008)

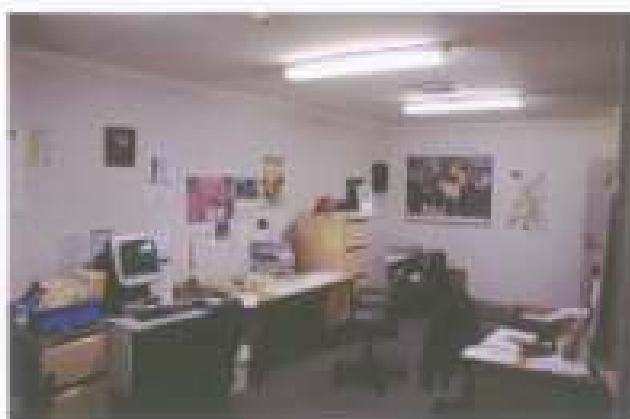
Figure 45  
Conversion of basement space into storage rooms and office space  
(Source: Graham Brooks & Associates, July 2008)

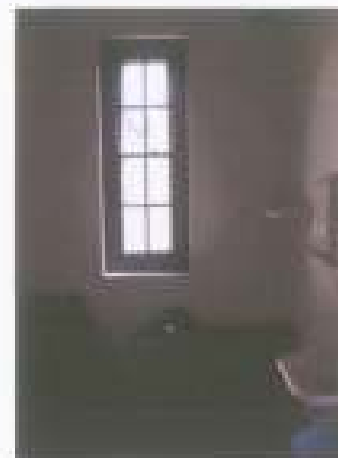
Figure 46  
The washroom facilities, which in their original location and take up a considerable portion of the interior space  
(Source: Graham Brooks & Associates, July 2008)

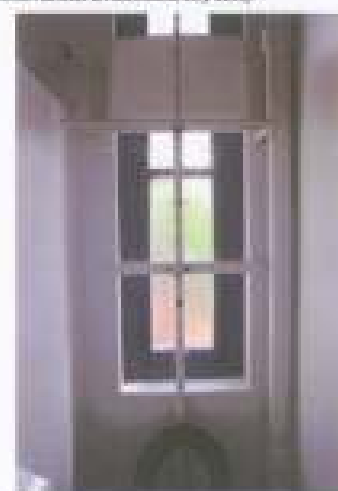
Figure 47  
Interior of the washroom facilities  
(Source: Graham Brooks & Associates, July 2008)

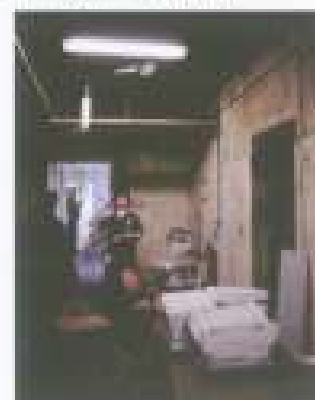
Figure 48  
A portion of the disused basement area with various equipment and plumbing, such as water fittings, toilets etc.  
(Source: Graham Brooks & Associates, July 2008)

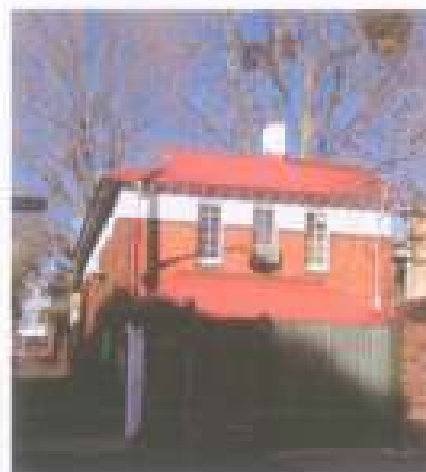
Figure 99.  
View of the north-west corner of the site with the old kitchen facility and entrance gate  
(Source: Graham Brooks & Associates, July 2008)

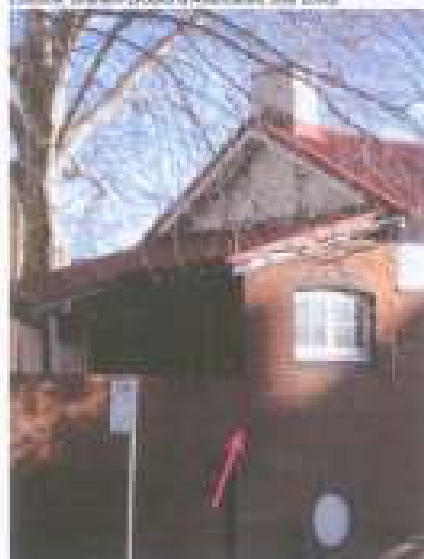
Figure 100.  
Detail view of the north side of the old kitchen facility taken from Burton Street and showing intersection with brick wall  
(Source: Graham Brooks & Associates, July 2008)

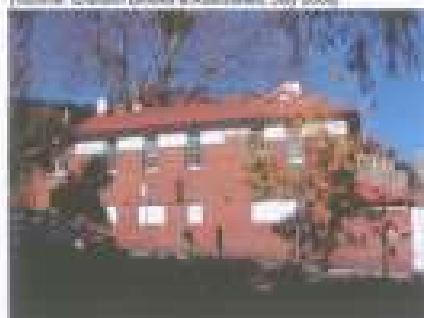
Figure 101.  
Side of the old kitchen facility as it presents along Burton Street (north facade)  
(Source: Graham Brooks & Associates, July 2008)

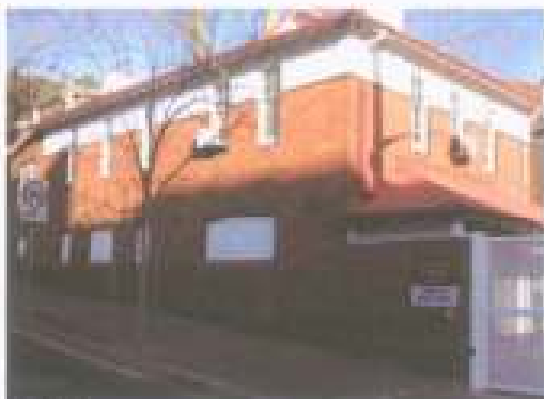
Figure 52:  
View of the southwest corner, old kitchen facility, adjacent to security entrance gate  
(Source: Graham Brooks & Associates, July 2006)

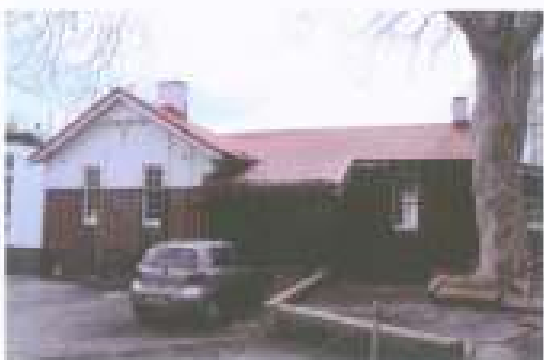
Figure 54:  
The level of the ground at the top of the ramp and at the first floor level of the old kitchen facility, which served as a flat for individual tenement for some time.  
(Source: Graham Brooks & Associates, July 2006)

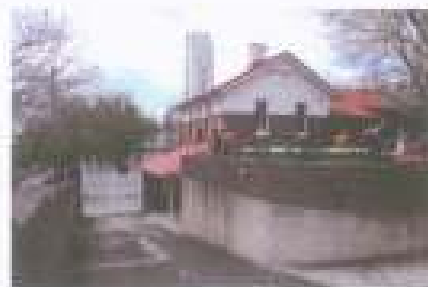
Figure 55:  
View down the ramp to Burton Street  
(Source: Graham Brooks & Associates, July 2006)

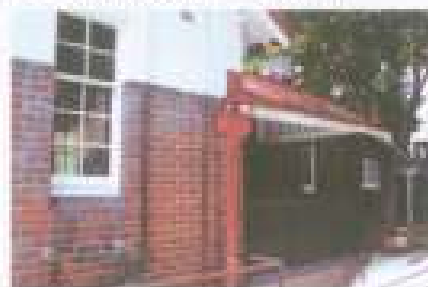
Figure 56:  
Detail of the south face of the building showing the small lower wall, with face brick and stone combinations.  
(Source: Graham Brooks & Associates, July 2006)

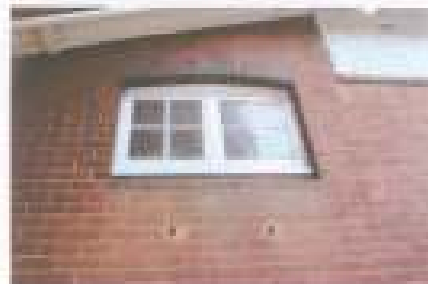
Figure 57:  
Window along the Burton Street (north) side  
(Source: Graham Brooks & Associates, July 2006)

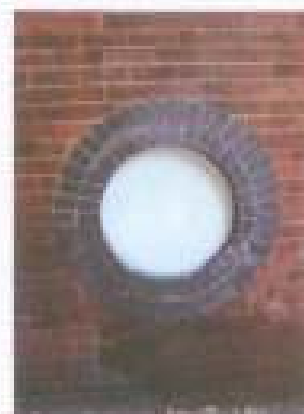
Figure 58:  
Former window along the Burton Street (north) side  
(Source: Graham Brooks & Associates, July 2006)

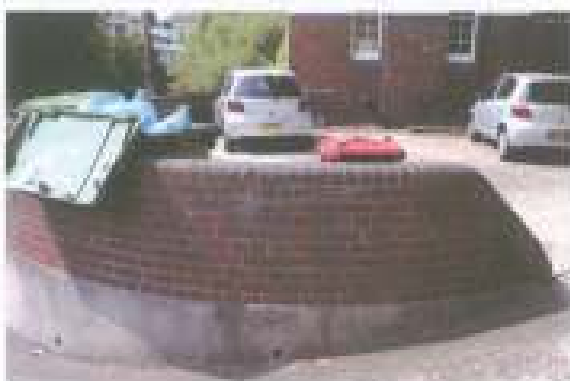
**Figure 62**  
The curved retaining wall counting wheel up from Butler Street  
(Source: Graham Brooks & Associates, July 2006)

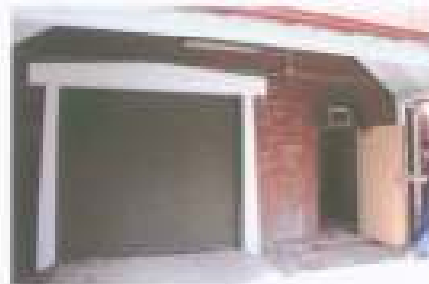
**Figure 63**  
Lower level of the old kitchen facility showing the connection to garage  
(Source: Graham Brooks & Associates, July 2006)

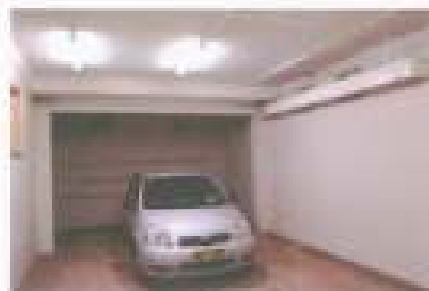
**Figure 64**  
Interior view of the lower level, near a car garage  
(Source: Graham Brooks & Associates, July 2006)

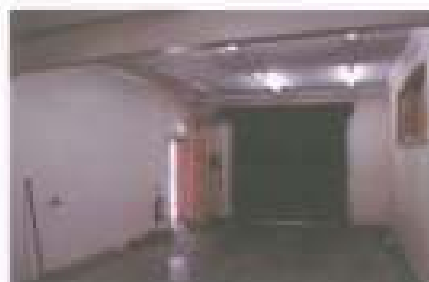
**Figure 65**  
Interior lower level garage space. Nothing appears to connect from former area  
(Source: Graham Brooks & Associates, July 2006)
