***MINE SUBSIDENCE RISK ASSESSMENT***

***PROPOSED RESIDENTIAL DEVELOPMENT***

***MINMI AND LINK ROAD***

***Project 39663D***

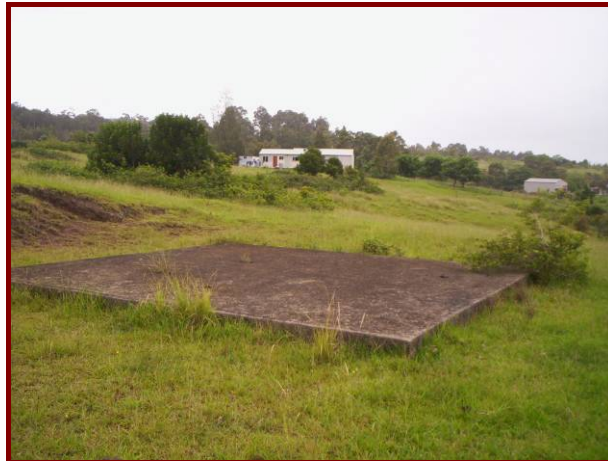
**Shaft No 40**

Name	General Location	Easting	Northing	Visual Assessment 2008
C	South of Railway St in paddock	<b>370071</b>	<b>6360749</b>	Capped
Dam	NE of corner of Link Road and Woodford Street, near masonry dam.	370030	6359462	Capped
WS	West of Woodford Street, South of old school	369824	6360046	Capped
4	Gully near transmission line	<b>370554</b>	<b>6360069</b>	Not Found
6	Gully near transmission line	<b>370461</b>	<b>6360080</b>	Concrete capping observed
12	Link Road North	<b>371169.55</b>	<b>6358944.53</b>	Capped and Filled
14	Link Road North	<b>371651.34</b>	<b>6359088.97</b>	Capped
40	West side of Gully in Minmi West	<b>369871</b>	<b>6360646</b>	Capped
