3.2 Bank Stability and Erosion Potential

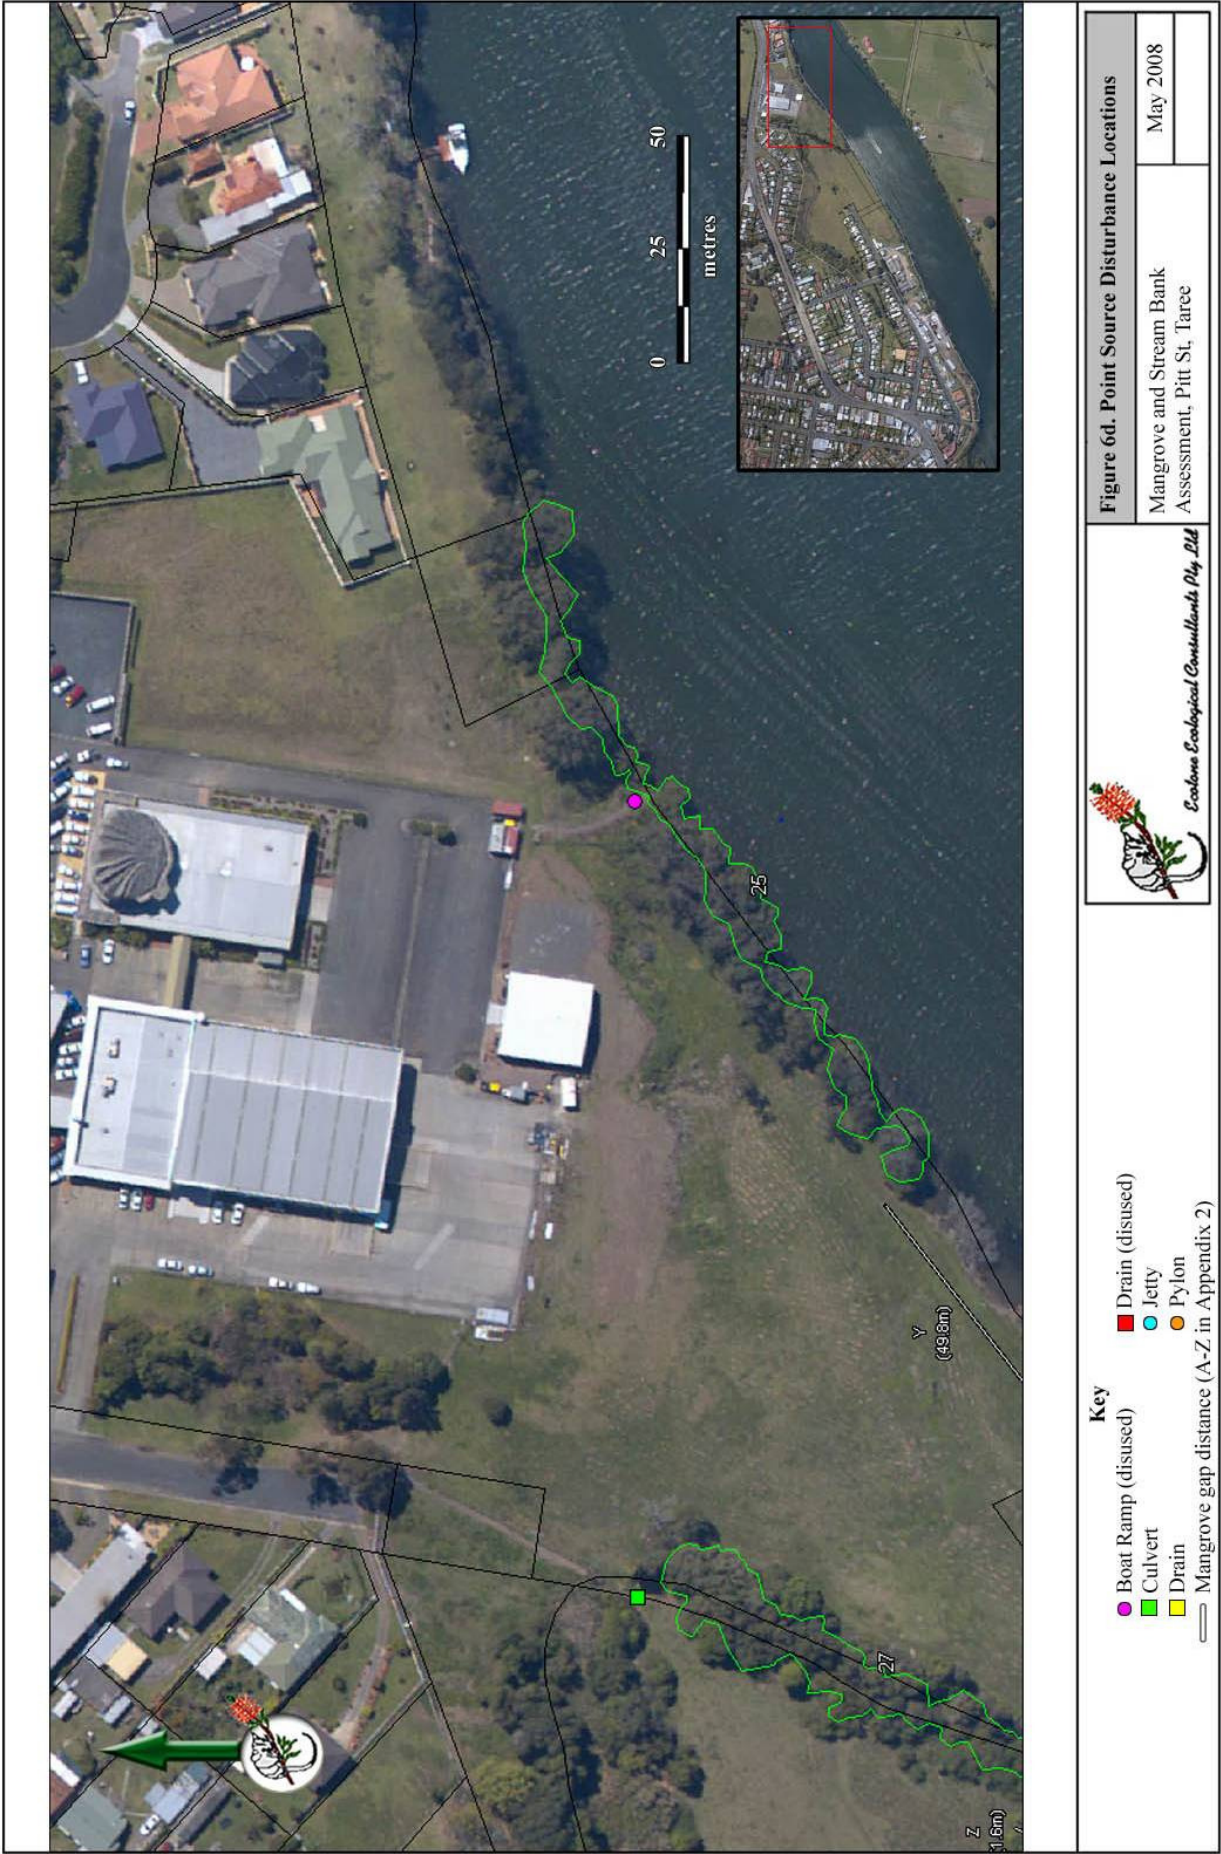
Figures 7a to 7d provide a visual representation of the overall state of bank stability in linear sections along the Manning River and the unnamed tributary. Details of the bank condition along each section are included in **Appendix 4**.

Other areas of poor bank stability occurred in more limited areas along the shoreline, and were usually related to access by horses, often combined with wave action due to passing power boats along the main river. Poor stability also occurred where a section of mangroves had died.

The most stable sections of bank occurred mainly at the eastern end along the Manning River, plus stretches in the central area where mangroves were dense and the bank was heavily vegetated. The sections of bank where the bank height was lower and less steep were also generally more stable. One section directly behind the concrete plant had been artificially stabilised by the pouring of large quantities of concrete on and at the base of the bank. This section had a higher stability rating for this reason plus the high level of plant cover. Many parts of the unnamed tributary also had a high stability rating where vegetation cover was high and access by horses too difficult.
