**GREATER TAREE CITY COUNCIL
REZONING OF PITT ST WATERFRONT
CHATHAM**

Acid Sulphate Soil and Contamination Assessment
and Review

GEOTTUNC01736AA-AD
7 November 2007

**RE: Acid Sulphate Soils and Contamination Assessment
Pitt Street Waterfront, Chatham (Taree)**

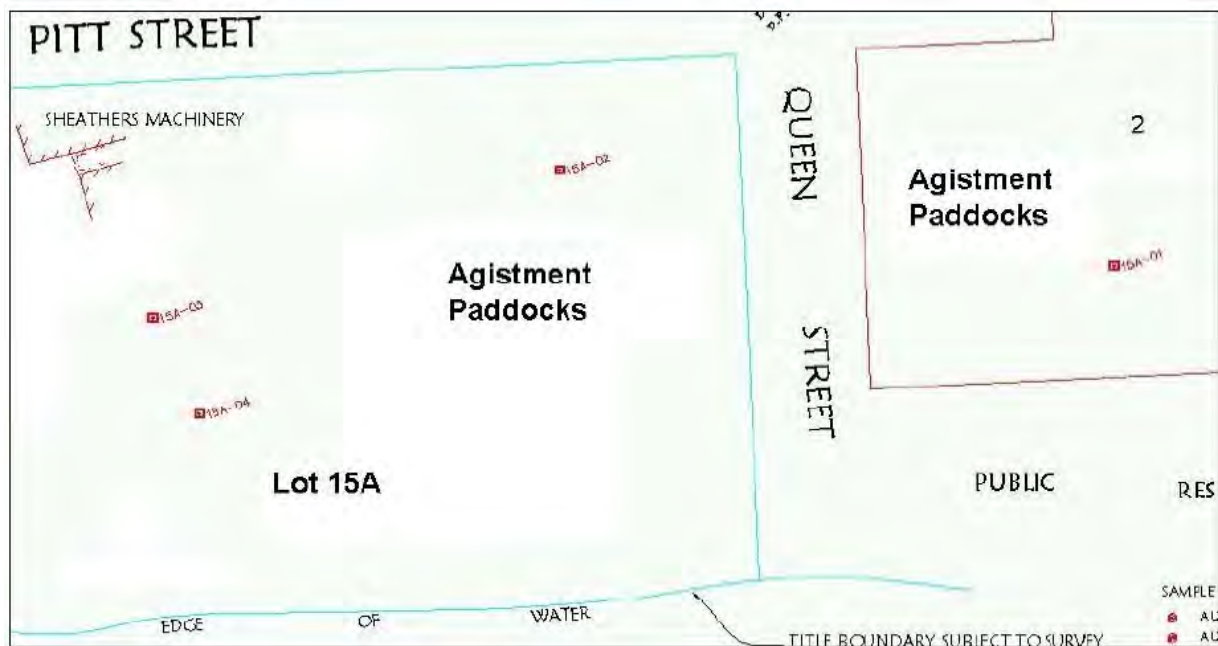
Figure 6: Extract from EnviroSAFE 2004 report showing sample locations in the agistment paddocks at the eastern end of Pitt Street.

Samples were obtained from the agistment paddocks due to the presence of fill from unknown sources and the potential for the use of pesticide for rural application. The sample locations are shown on Figure 6. Samples were analysed for petroleum hydrocarbons, heavy metals, organochlorine pesticides, organophosphorus pesticides, and asbestos. No concentrations exceeding guideline values for residential development were detected.

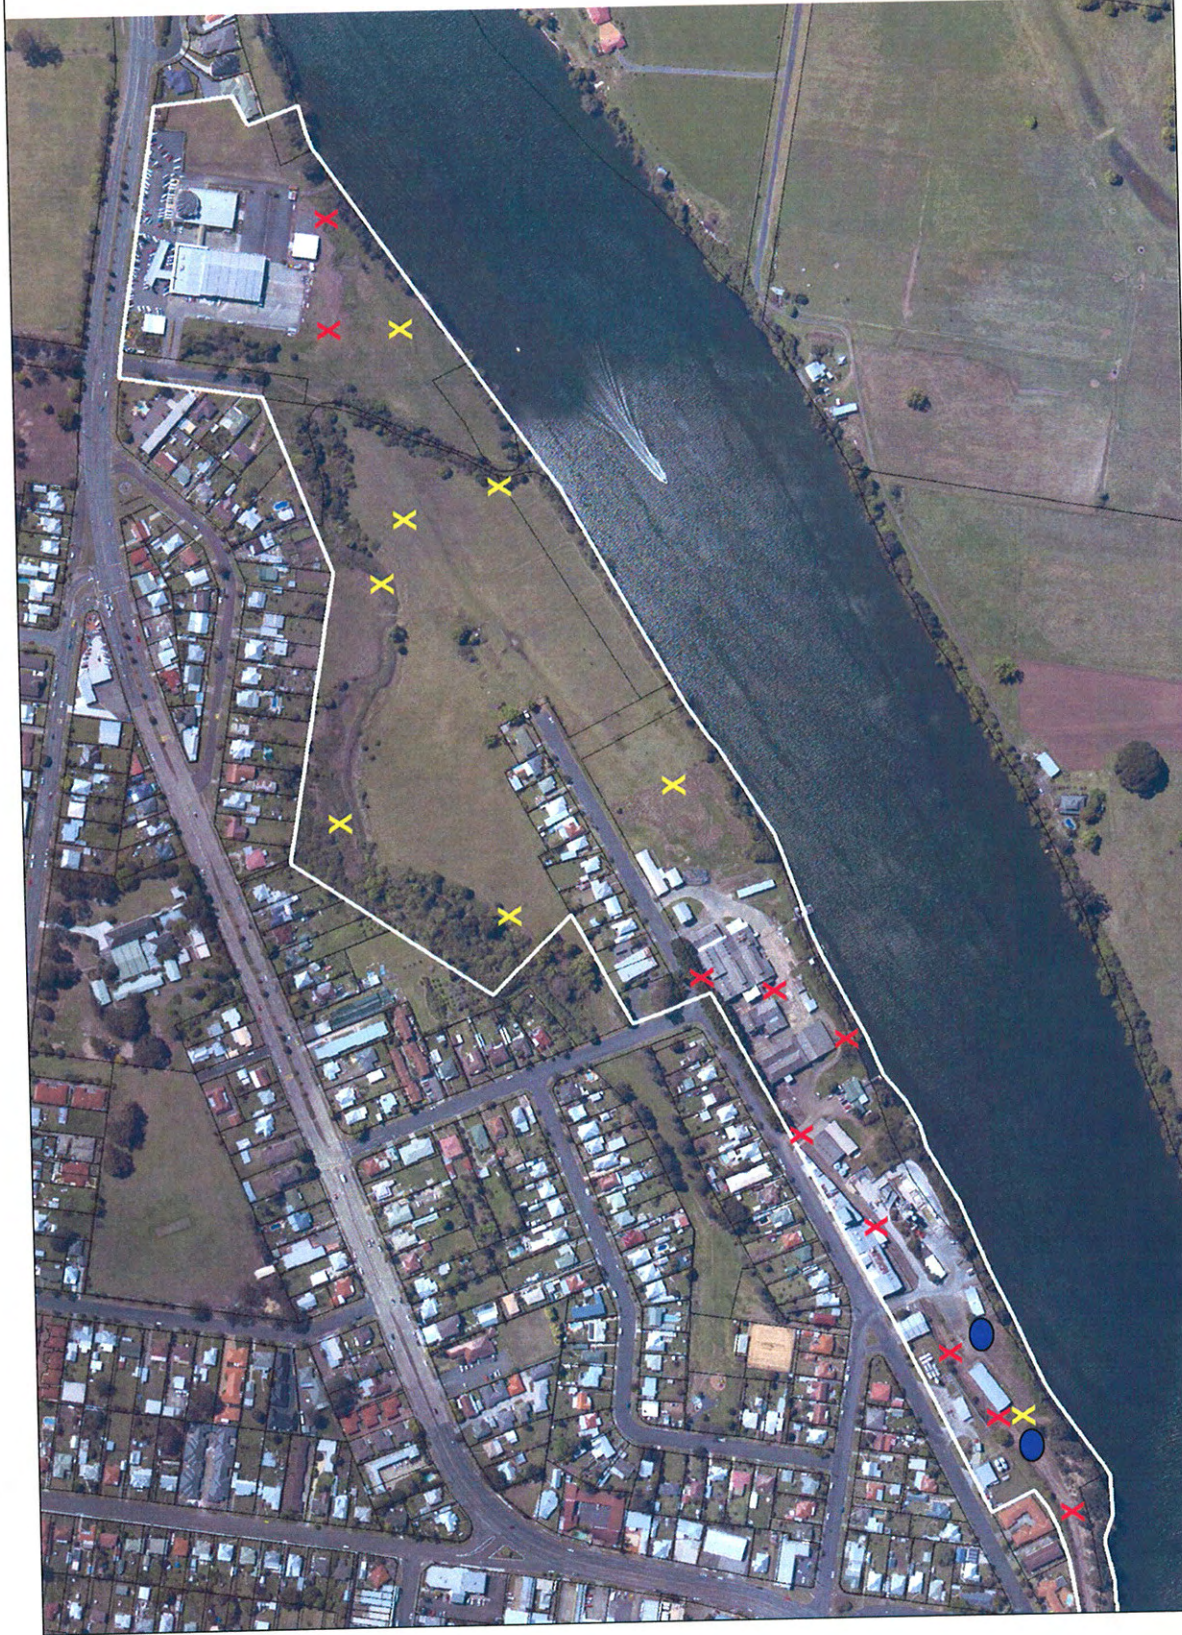
client: GREATER TAREE CITY COUNCIL		  SPECIALISTS MANAGING THE EARTH			
project: PITT STREET MARINA PRECINCT TAREE		drawn		SRM	
title: SAMPLE LOCATIONS		approved		14/9/07	
project no: GEOTTUNC01736AA-AD		date		nts	
figure no: FIGURE 10		scale		A4	
		original size

Near surface soil samples were then taken from the remainder of the locations marked on Figure 10. These samples were obtained using a stainless steel trowel and were placed in laboratory supplied sample jars and placed on ice in cooler boxes on site for transport to the testing laboratory under Chain of Custody conditions.

Eight locations were sampled to the depths of up to 4.5m in the locations shown on Figure 10 attached.

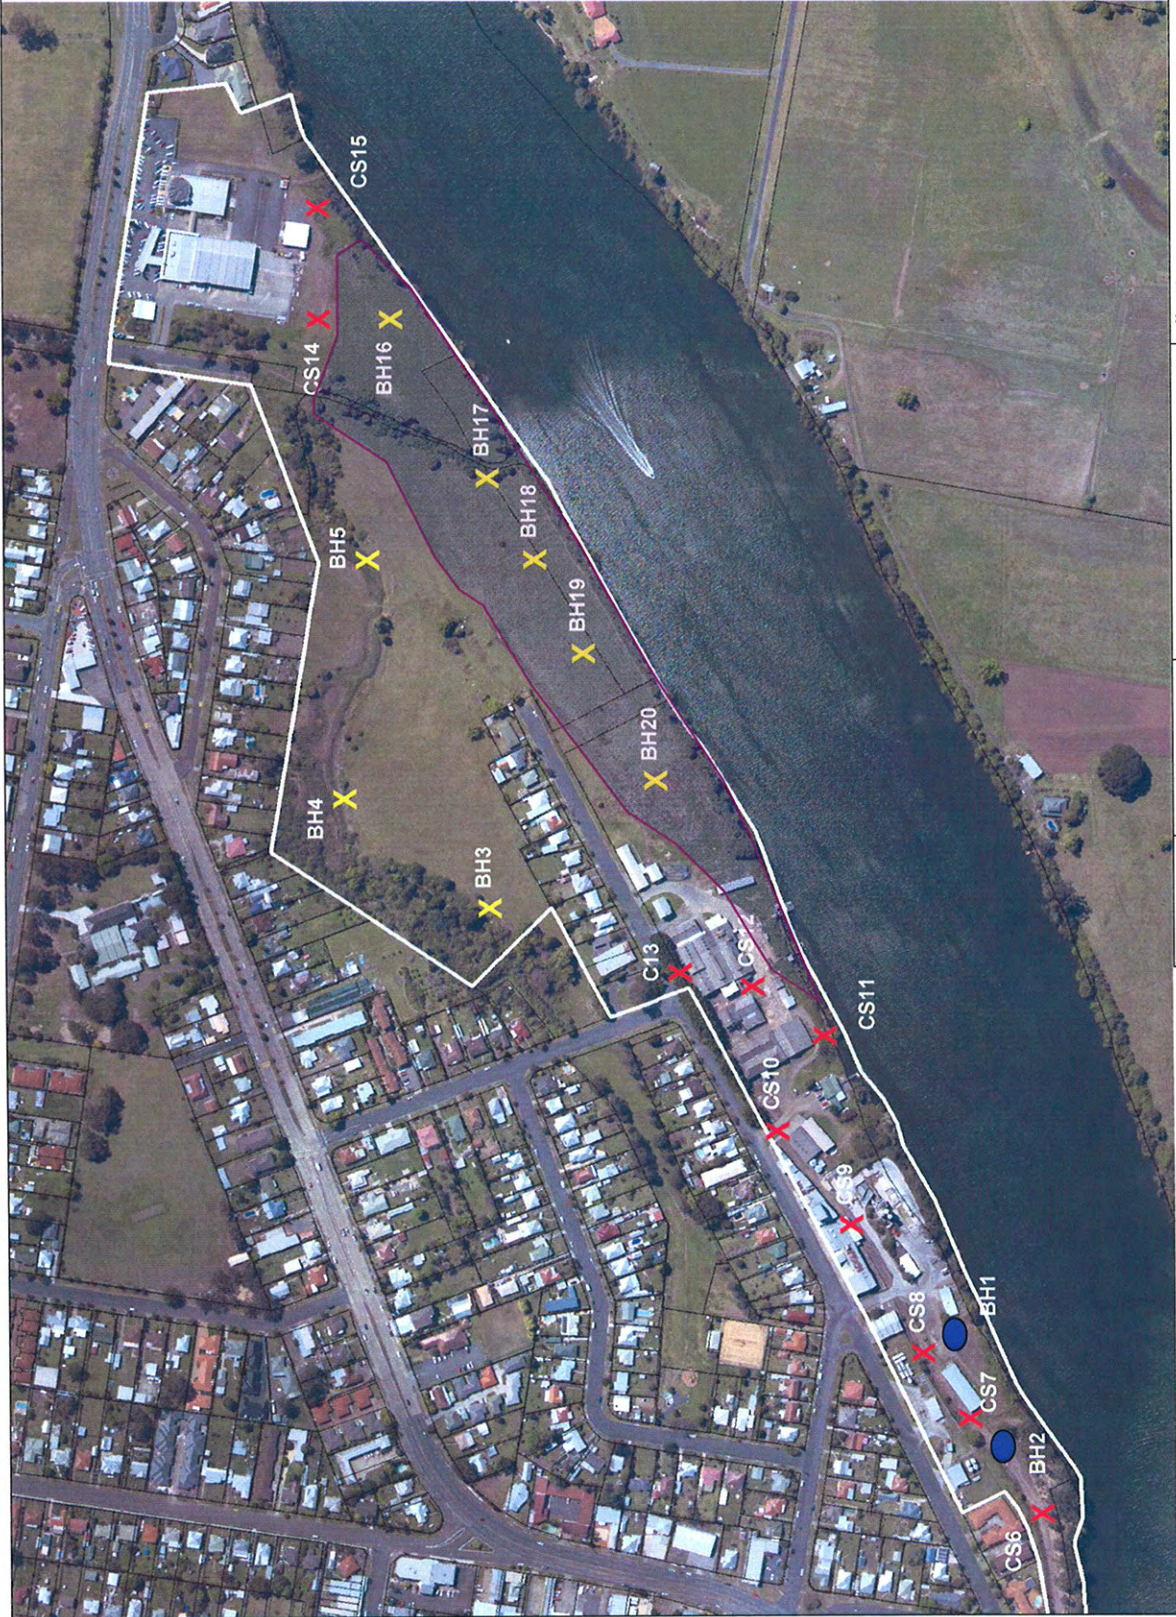
It is understood some possible development proposals include dredging a marina in the low lying eastern part of the site adjacent to the Manning River. Testing indicates potential ASS in this area as estimated on Figure 10. There is therefore a high likelihood that these excavations, and other detailed excavations for service trenches etc will expose ASS.
