Hazardous Building Materials Survey

HAZARDOUS BUILDING MATERIALS SURVEY CARDINAL FREEMAN RETIREMENT VILLAGE, VICTORIA STREET, ASHFIELD, NSW 2131

REFERENCE NO. S5738A FINAL REV 1

JUNE 2009

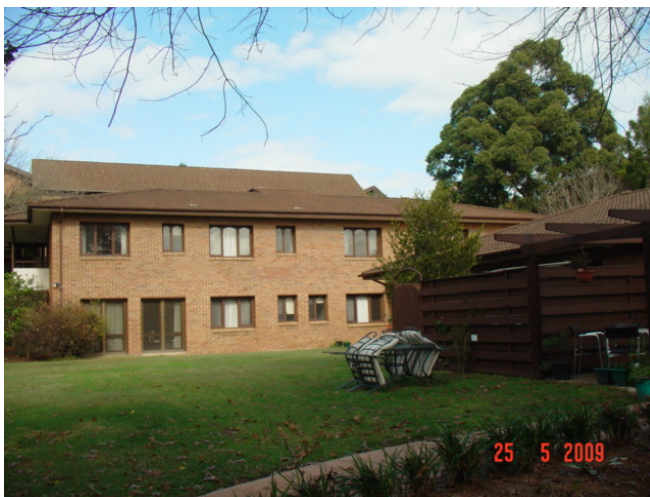
Photograph 2

Convent and Village Café – View of northern side of Convent.

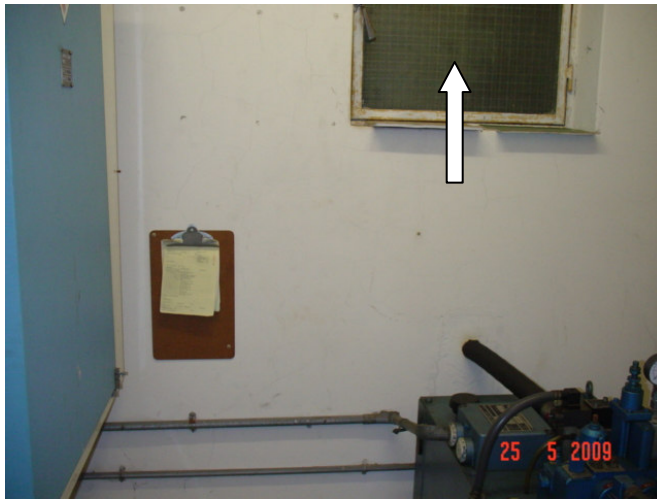
Photograph 4

Convent, lift motor room – arrow points to lift shaft behind the glass window.

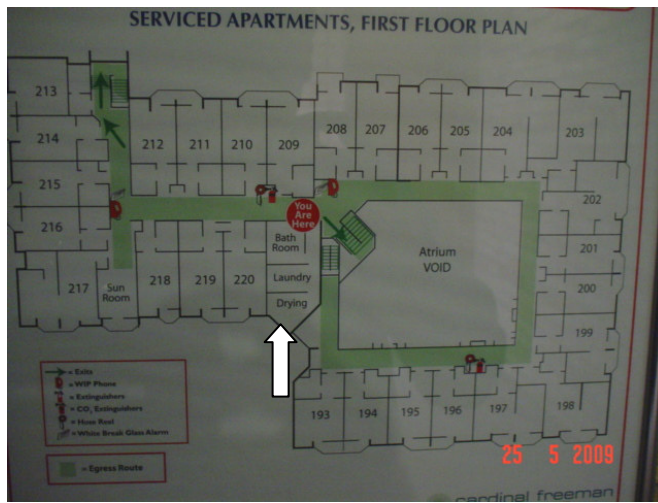
The nominated areas for inspection in this large building include the laundry areas and switch room, refer Photographs 9 and 10 in Appendix 3. Photograph 9 shows the first floor layout (fire evacuation plan) and Photograph 10 shows the switch room access door and the laundry area above.

Serviced Apartments, First floor plan – Arrow points to drying (balcony) and laundry room behind that is nominated for inspection. The laundry room below on the ground floor is included as well.

The remaining areas are not included in the inspection.

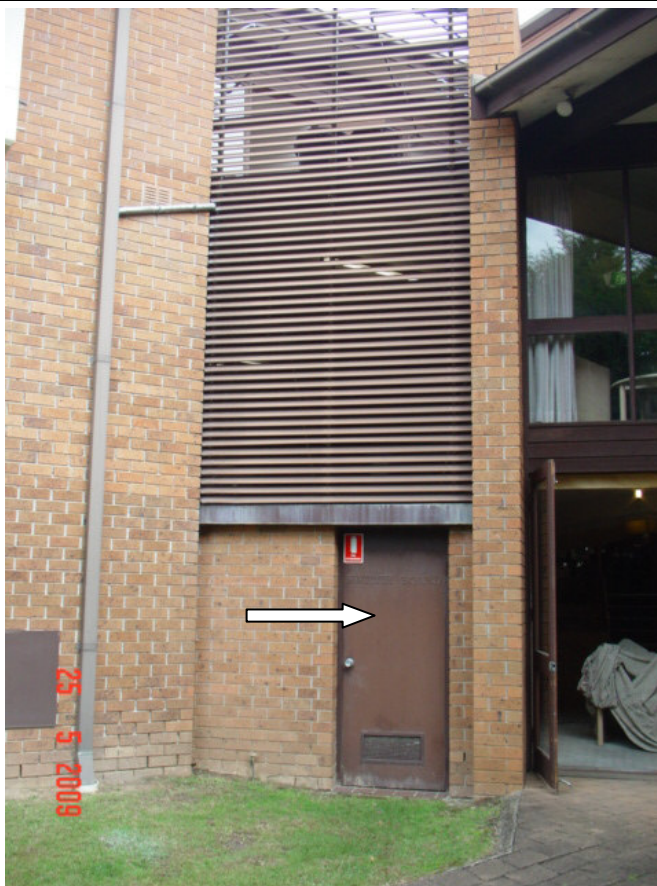
Photograph 10

Switch room beneath the laundry on the ground and first floors.

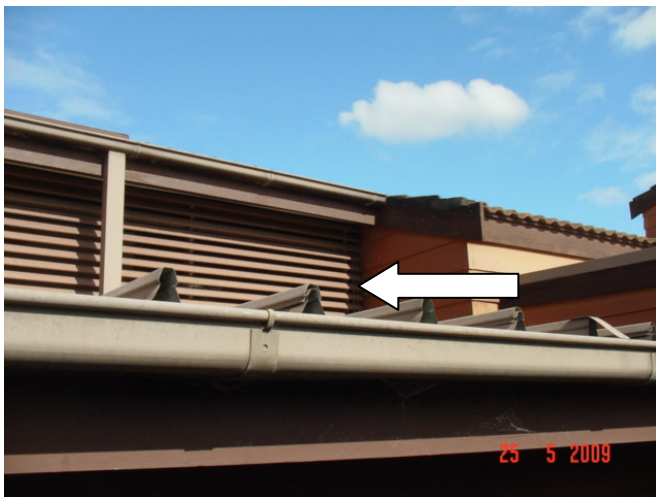
- (i) Laundry, First floor - The fibre cement cladding on the eastern side of the laundry balcony did not contain asbestos. Refer to Sample S5738A/04 in Appendix 1 and Photographs 11 and 12 in Appendix 3.
- (ii) Laundry, First floor - The fibre cement eaves in the laundry balcony did not contain asbestos. Refer to Sample S5738A/05 in Appendix 1.
- (iii) Laundry, First floor – The ceiling is set plasterboard. No access is available to the ceiling / roof cavity. Refer to Photograph 13 in Appendix 3.

Serviced Apartments, Roof area above Laundry room – These areas were not accessed.

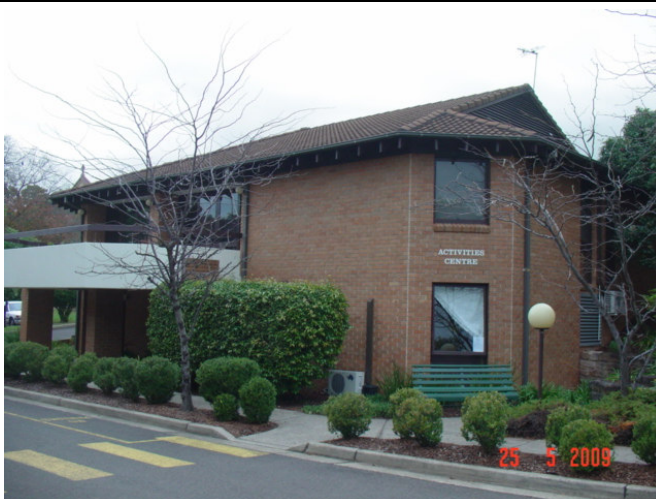
Refer to Photograph 16 of the building in Appendix 3.

Activities building.

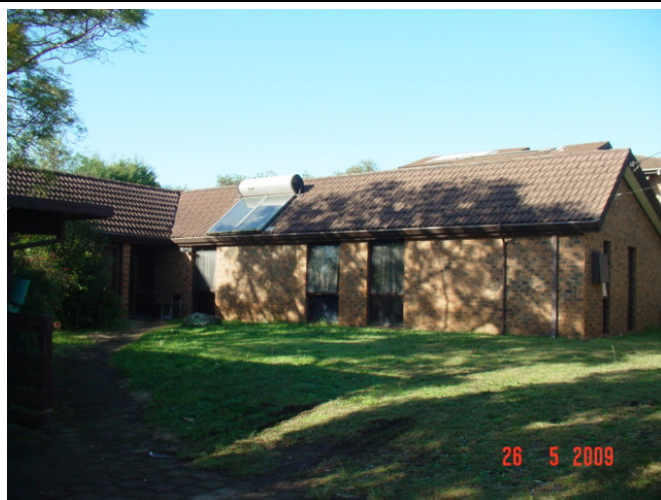
The two single-storey residential buildings are L-shaped and are similar in floor layout. 102 Queen Street was occupied and only limited access was available at the time of the inspection. Refer to Photograph 17 in Appendix 3.

102 Queen Street, Clissold Street.

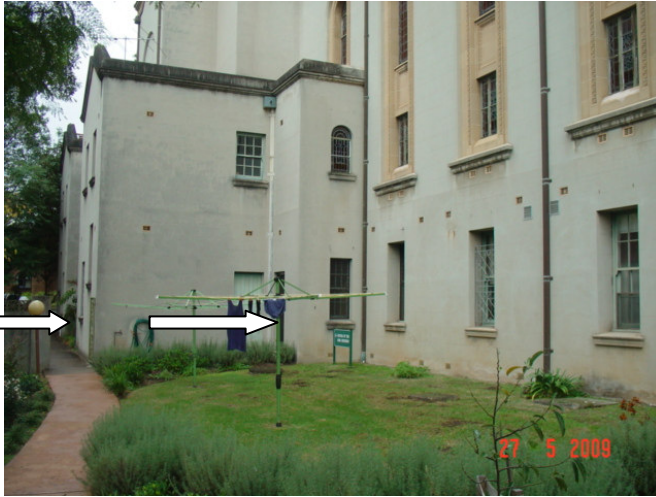
The area that was inspected comprises of the maintenance workshop, archives (store room) and the passage behind where the two stairs to the Chapel are located. Refer to Photograph 26 in Appendix 3 that show part of the exterior of the Chapel.

The area that was inspected comprises of an open plan office area, two office rooms, a toilet / shower room and a kitchen / lunch room. The ceiling throughout is set plasterboard. Refer to Photograph 26 in Appendix 3 that show part of the Chapel.

Chapel

Left arrow points to 'Passage' that connects to Archives and Workshop.

Right arrow points to Sister's Office (ground level only).

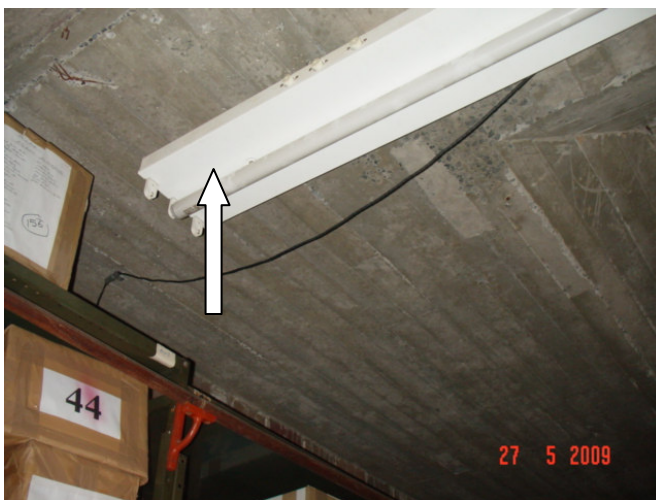
This type of capacitor does not contain PCBs. Refer to Photograph 27 in Appendix 3.
- (ii) No other fluorescent light fittings which house metal-cased capacitors were identified during the inspection.

Chapel – Archives adjacent Workshop
Tri-tube fluorescent light fitting.

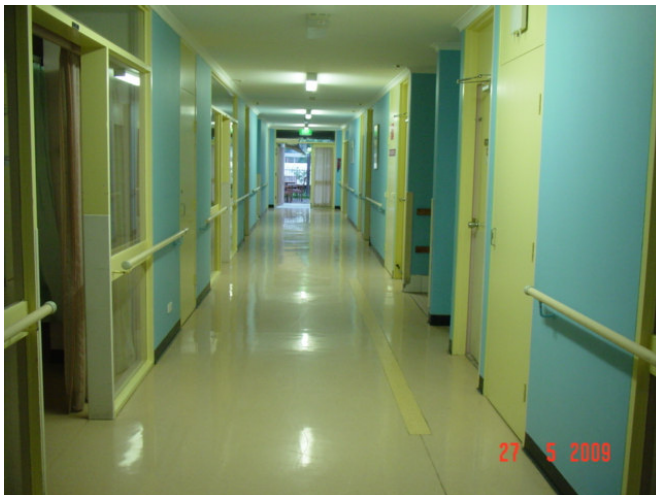
The two level building comprises of the nursing home level and the basement car park level. The wards identified as 1-14 and adjacent areas which are located along the southern corridor and the western corridor form part of the older section of the building. Refer to Photograph 28 in Appendix 3. The wards identified as 15-26 along the northern corridor and adjacent areas is the newer section of the building.

Nursing Home - South Corridor and
'Wards' on either side.
