Report No: MA/ME/AARTPS/C

ARBORICULTURAL ASSESSMENT REPORT & TREE PROTECTION SPECIFICATION

Marrickville Metro

23rd May 2010

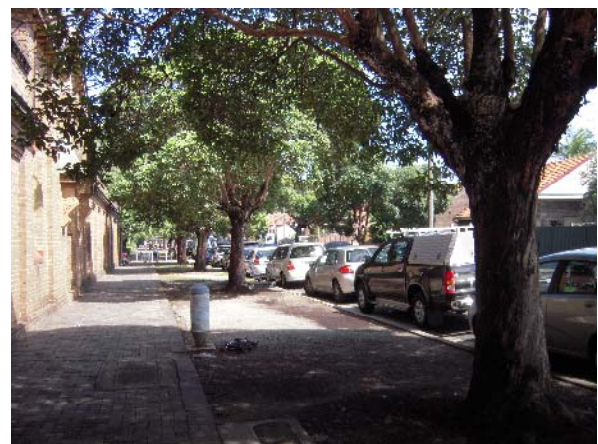
3.4.2 Tree 20 *Ficus macrophylla* (Moreton Bay Fig)

Tree 20 has been identified as *Ficus macrophylla* (Moreton Bay Fig). This tree has been assessed as being in fair health due to the canopy being comprised predominately of epicormic growth and the presence of small and large diameter deadwood throughout its canopy. The structure of this tree has also been assessed as being poor evidenced by the wounds with possible decay on the main stem and first order branches. Mechanical damage likely the result of lawn mower equipment was also noted on several surface roots.

Figure 9: Showing damage to exposed roots of Tree 20

This tree has high Landscape Significance, a Remaining Life Expectancy Range of 5-15 years and has been allocated a Retention Value of *Consider for Retention*. It is understood that this is a heritage-listed tree. If this tree is to be retained, internal diagnostic testing should be undertaken to determine the presence and extent of decay (refer to Section 3.3.4).
