SITE CONDITION REPORT
FOR
14-18 BOONDAH ROAD
WARRIEWOOD VALLEY NSW

Prepared for: Tracy Davey, Meriton Apartments
Murray Donaldson, Architectus Sydney

Report No: 110148_Rep_Rev1
August 2010
(Released: 24 August 2010)

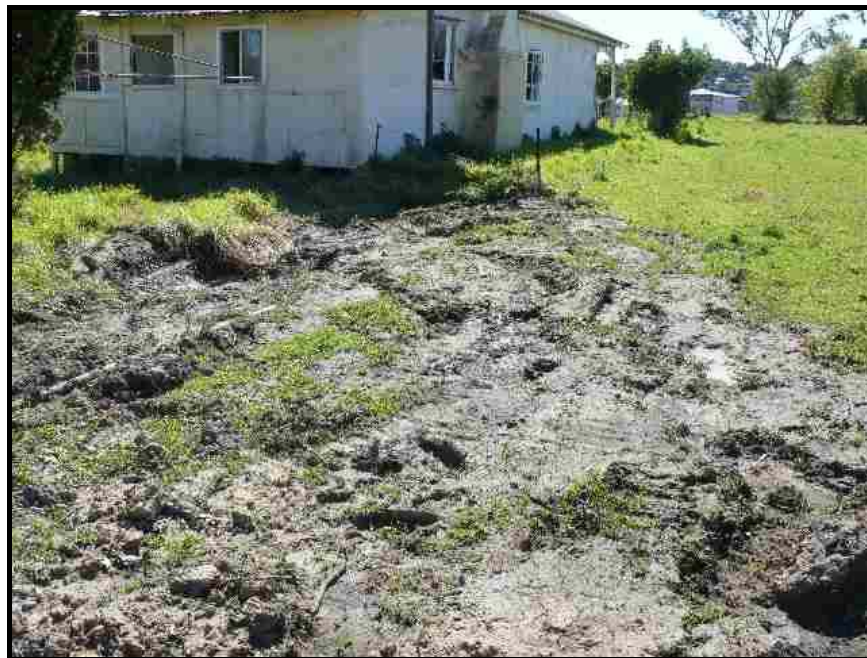
Photograph 4B:

Photograph 4A: From the south east corner of this residence and approximately 20m away the soil/grass has recently been disturbed and evidence of the tyre marks of a light truck are present. The reason needs to be known and when construction equipment is on site pits excavated to ensure no waste materials have been buried.

An examination of aerial photographs did not reveal any activity or shed at this location. When construction equipment is on site an inspection of this area is warranted by digging pits to establish if any material has been buried.

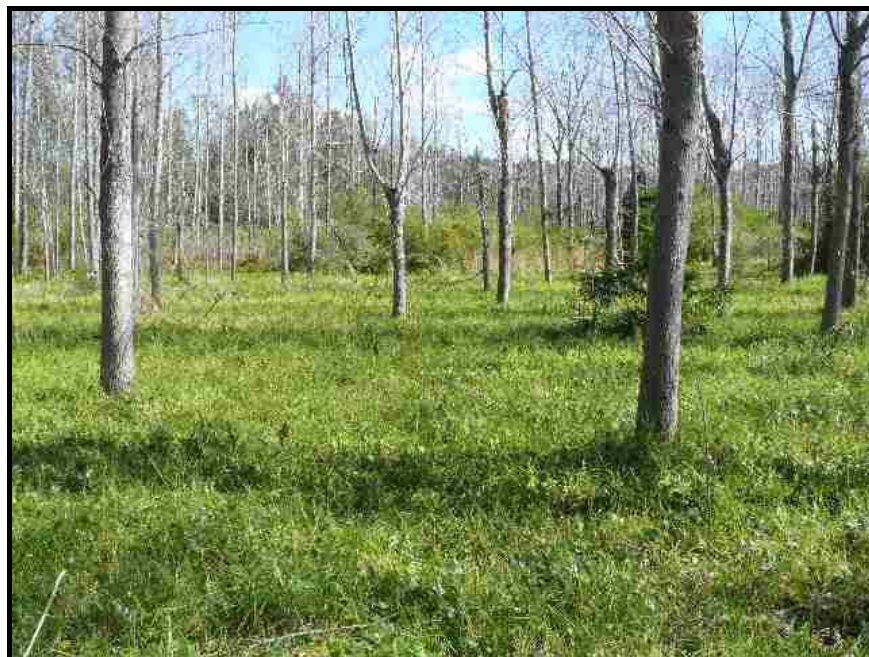
Photograph 8B:

Photograph 8A: The wooded land was inspected and no visual evidence of soil being disturbed or waste materials being dumped were evident.
