**MINE SUBSIDENCE RISK ASSESSMENT**

**PROPOSED RESIDENTIAL DEVELOPMENT**

**MINMI AND LINK ROAD**

**Project 39663.07**

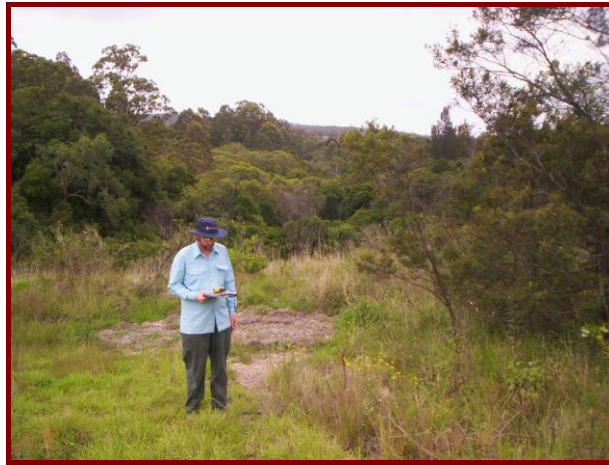
**Approximate Location of Browns No 4 Tunnel Entry (B4)**

- Tailings were pumped into the Borehole Seam workings;
- Most shafts on site has been filled and capped, however some could not be found as follows:
  - No 4 Entry (B4 on Drawing 3) was never found and assumed to have been filled over;
  - No 2 entry (B4) and the nearby unlabelled entry (B10) were removed by open cut operations;
  - The Purple Hill shaft and ABC entry were never found;

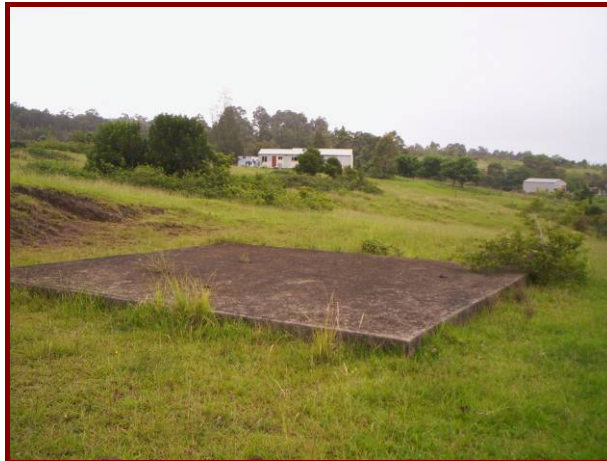
**Shaft No 40**

<b>Name</b>	<b>General Location</b>	<b>Easting</b>	<b>Northing</b>	<b>Visual Assessment 2008</b>
C	South of Railway St in paddock	<b>370071</b>	<b>6360749</b>	Capped
Dam	NE of corner of Link Road and Woodford Street, near masonry dam.	370030	6359462	Capped
WS	West of Woodford Street, South of old school	369824	6360046	Capped
4	Gully near transmission line	<b>370554</b>	<b>6360069</b>	Not Found
6	Gully near transmission line	<b>370461</b>	<b>6360080</b>	Concrete capping observed
12	Link Road North	<b>371169.55</b>	<b>6358944.53</b>	Capped and Filled
14	Link Road North	<b>371651.34</b>	<b>6359088.97</b>	Capped
40	West side of Gully in Minmi West	<b>369871</b>	<b>6360646</b>	Capped
