Site Audit Report 1 Grand Avenue, Camellia

Billbergia Pty Ltd

ENVIRON Australia Pty Ltd

April 2011

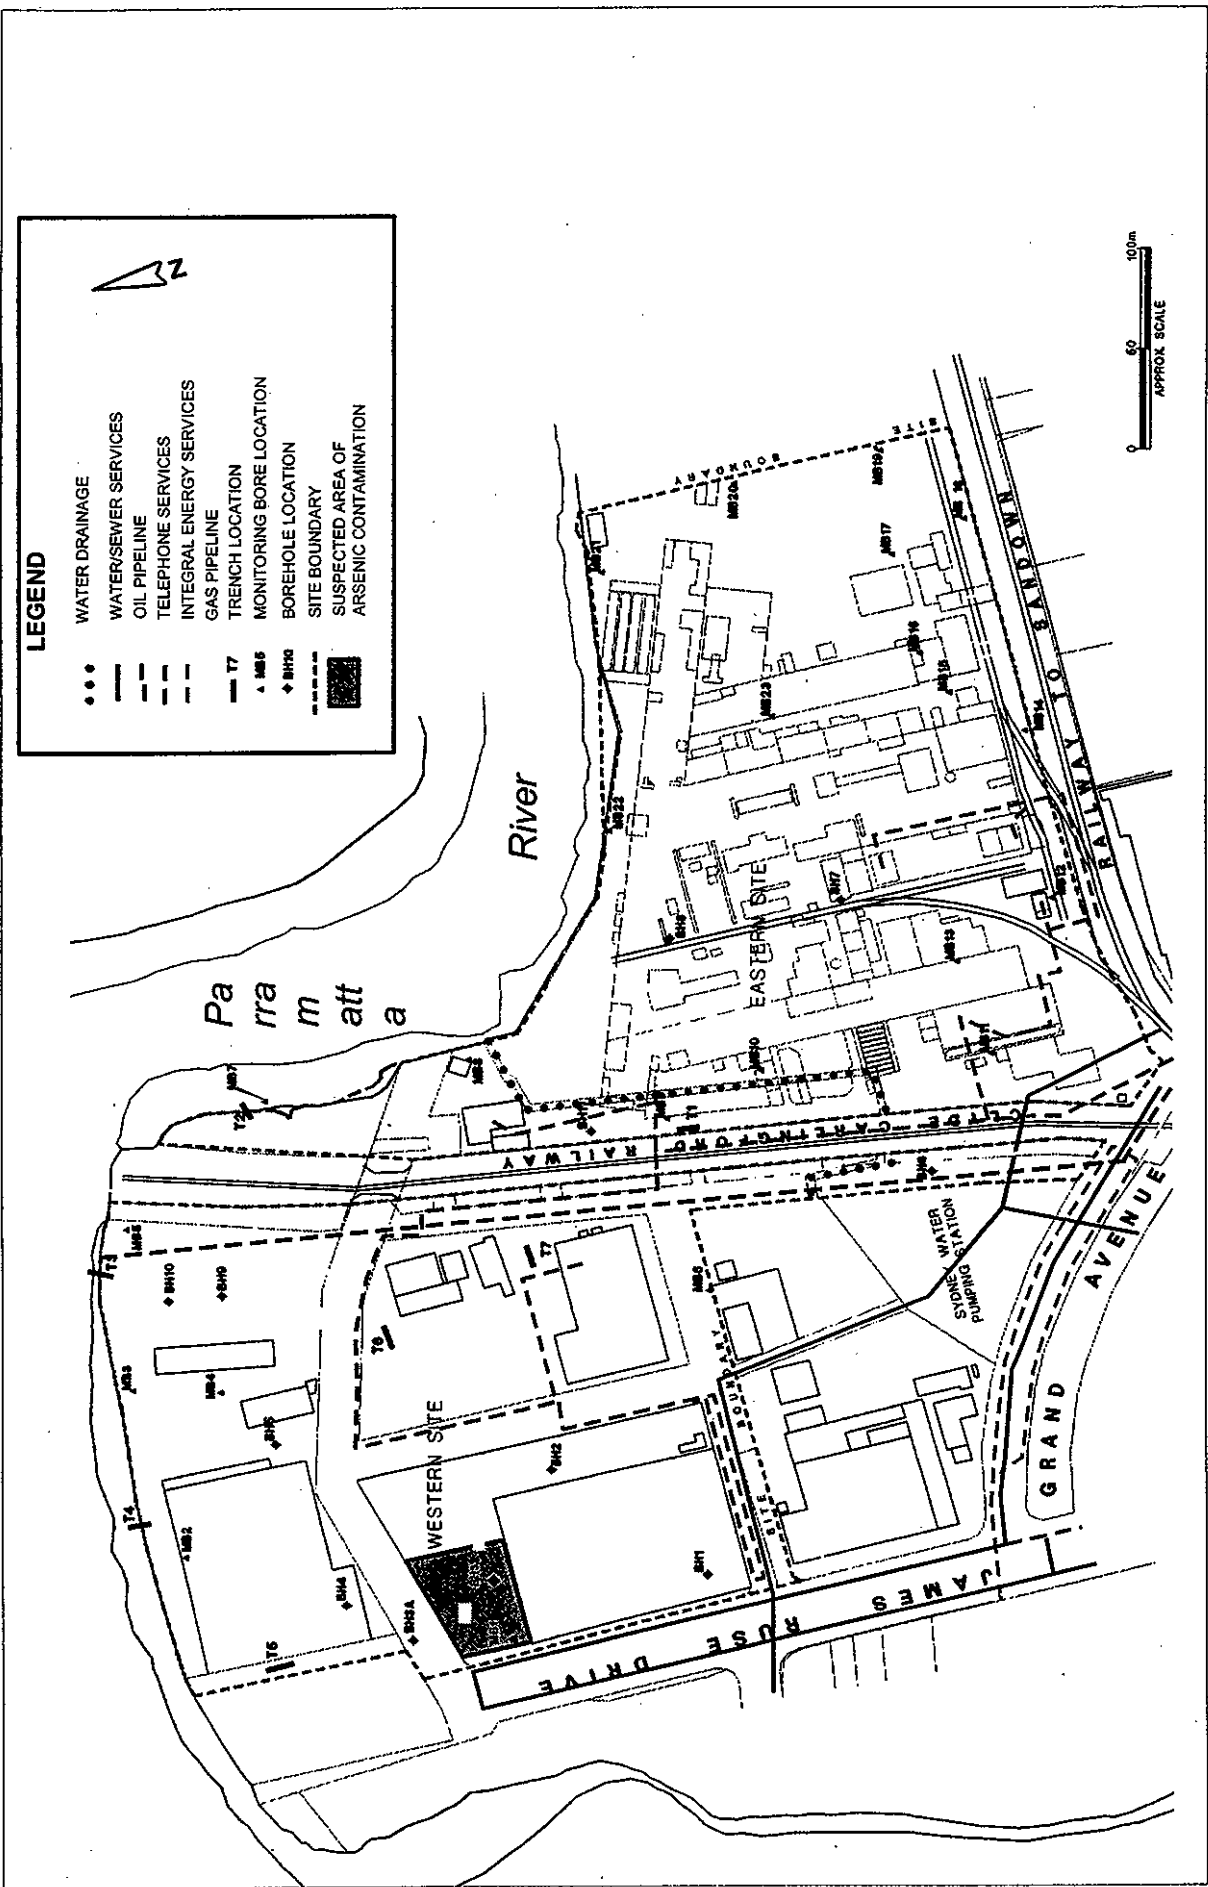
Figure 2. Service Location Plan, Eastern and Western Portions of former James Hardie site, Camellia.

The only known underground service lines are a water drainage easement parallel to the Carlingford rail line (Fig.3), and telephone lines (Fig.2). Decommissioned subsidiary water, sewerage and power lines to the various former buildings are presumed to be present and may be located in or underneath a layer of potentially contaminated fill. It must be noted that the plans obtained from the various service organisations do not include all levels of service lines. A new easement for access along the rail line is being implemented with the Rail Infrastructure Corporation.
