CPP Project 6029

Subject: Wind Engineering – Barangaroo South Concept Plan (Mod 6)

Please find herein comments regarding the impact of the architectural changes to the Barangaroo South development on the pedestrian level wind conditions. The drawings prepared for this S75W application have been reviewed and assessed from an environmental wind perspective at ground level. The only relevant geometric changes are the re-orientation of Globe Street, with the corresponding change in plan form of Buildings R11, R2, R3, C1, C3, and C8, Figure 1, and the removal of mid-rise building C7, Figure 2. The heights of the amended buildings are assumed to be similar.

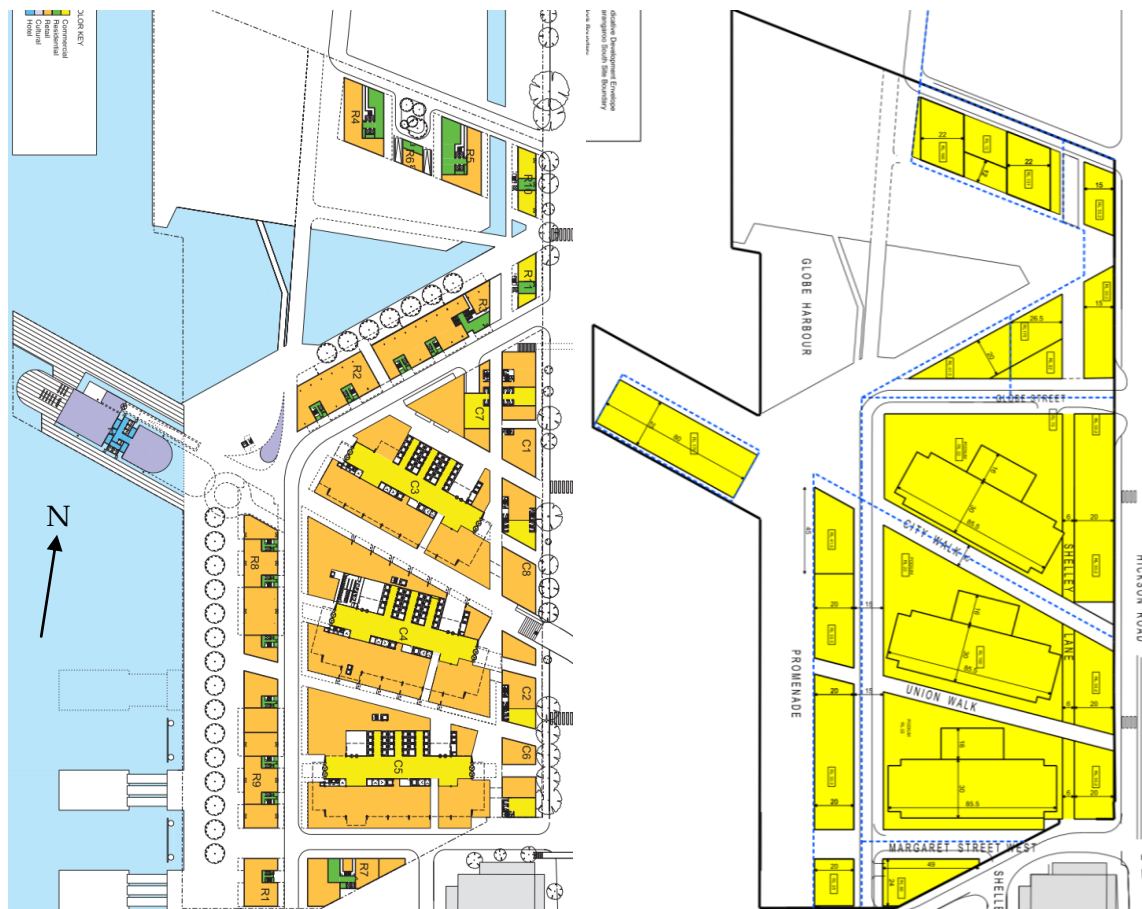
Figure 1: Ground plan of existing Mod 4 (L) and proposed Mod 6 (R) configurations

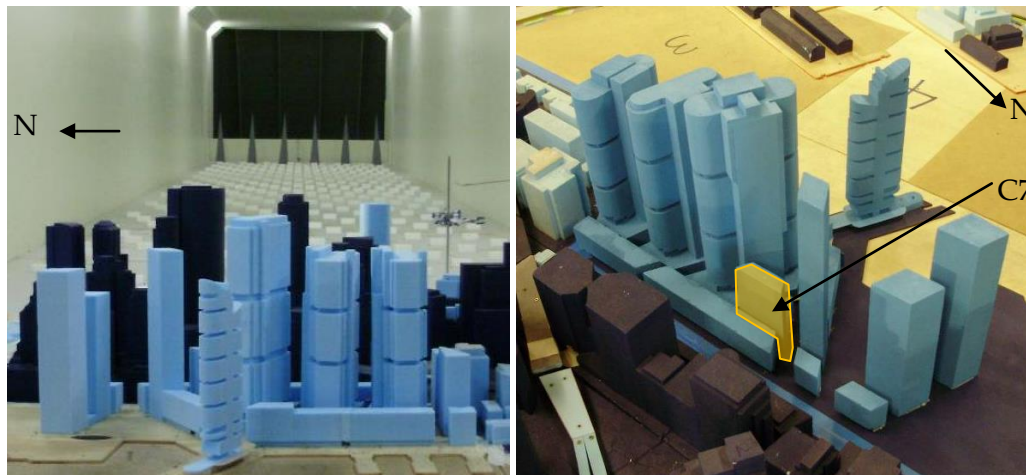
Figure 2: Photograph of the existing Mod 4 configuration (L) and existing Mod 4 configuration with revised tower geometry (R) wind tunnel models

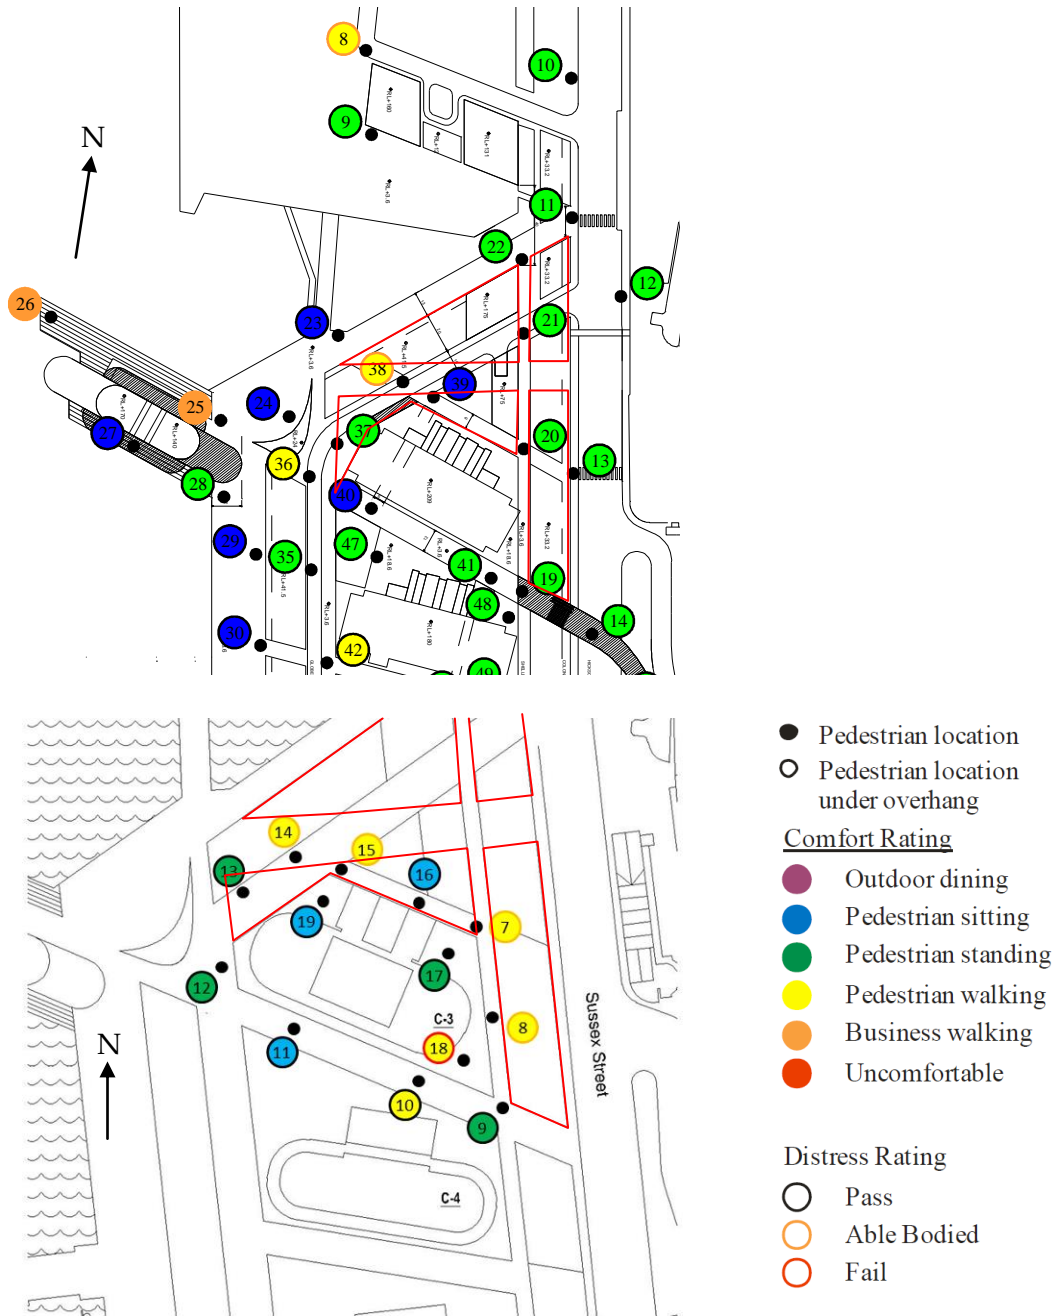
Figure 3: Wind climate results for the Mod 4 configuration (T) and curved towers and realignment of Globe Street(B)

The directional wind flow pattern around the site is complex. The classification of wind conditions at various locations around the site in the Mod 4 configuration is summarised in Figure 3, with directional results presented in Figure 4 and Figure 5. Classification of the comfort and distress criteria is determined by the integration of the measured wind speed with the local wind climate. The wind conditions between the two wind tunnel tested Mod 4 configurations are generally slight with any differences due to the precise measurement location, the proximity of the results to a step in the criterion level as well as the change in geometry of the towers.

From a comfort criterion perspective the wind conditions around the site all met the pedestrian walking criterion, Figure 3, except around the base of the hotel protruding into the harbour. From a pedestrian level wind comfort perspective, the most important change from the Mod 4 to Mod 6 geometry is the increase in size of the Building C3 podium, marked in red in Figure 3. This increase in size is expected to improve wind conditions to the north of Building C3 and along Shelley Lane and Globe Street, by redirecting downwash from reaching ground level. The forming of a regular street grid pattern, particularly opening Globe Street to the west, will increase the ground level wind speed and the channelling of wind. Winds from the west will be channelled along Globe Street to the north of Building C3 causing windy conditions across Hickson Road. The rising topography to the east of the site and the lack of a continuation of the flow path across Hickson Road will ameliorate this condition and wind conditions are expected to remain suitable for pedestrian walking hence acceptable for the intended use of the space.

From a pedestrian distress perspective, apart from in the vicinity of the exposed hotel, there were five locations around the site that were classified as acceptable for 'able-bodied' pedestrians only; to the north-west of Building 4 (Location 8, Figure 3(T)), on Globe Street to the north of Building C3 (Location 38, Figure 3(T), and Locations 14 and 15, Figure 3(B)), and on Shelley Lane to the east of Building C3 (Locations 7 and 8, Figure 3(B)). Exceedances were marginal, with a twice per annum mean wind speed about 15.5 m/s compared with the criterion level of 15 m/s, Figure 5, except Locations 8

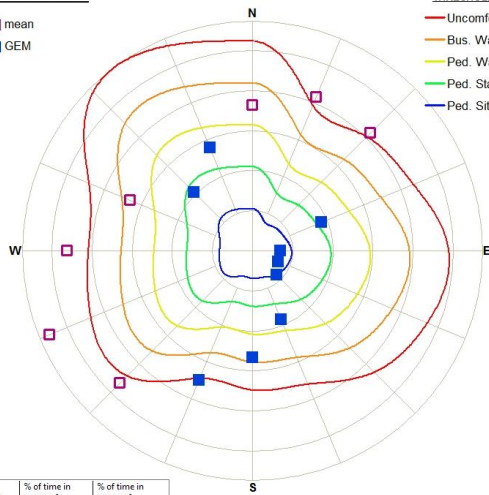
LOCATION 8

Wind Speed (m/s)	% of time in excess of Mean	% of time in excess of GEM
2.0	52.0	55.1
4.0	27.7	29.5
6.0	14.9	13.8
8.0	7.5	5.0
10.0	3.0	1.4
8.9	5.0	Bus Walking
18.4	0.022	Able Body
7.9	Ped Walking	5.0
15.5	Able Body	0.022

Figure 4: Directional results in the Mod 4 configuration with sharp-edged tower

It is evident from Figure 4 that the locations are impacted by winds from the south-west and to a lesser extent from the north-east. The wind conditions at Location 8 are governed by downwash from Building R4 and the proposed changes to the buildings to the south will have negligible impact on the wind climate in this area being governed by the geometry and orientation of Building R4. Winds conditions at Location 38 are expected to improve with the increase in Building C3 podium size by redirecting

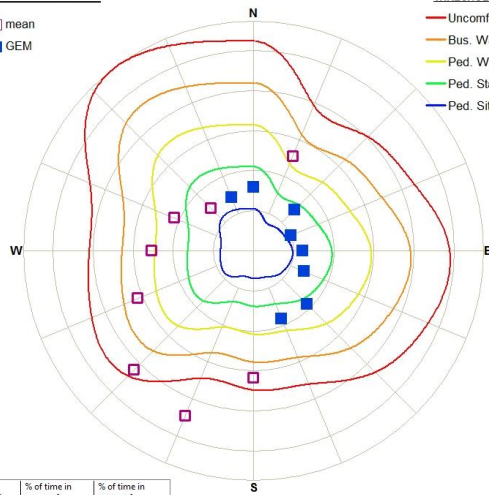
LOCATION 38

Wind Speed (m/s)	% of time in excess of Mean	% of time in excess of GEM
2.0	42.6	44.6
4.0	19.9	18.7
6.0	9.3	7.1
8.0	3.6	2.0
10.0	1.3	0.5
7.2	5.0	Ped Walking
18.0	0.022	Able Body
6.5	Ped Walking	5.0
14.6	Pass	0.022

downwash away from reaching ground level for critical winds from the south-south-west.

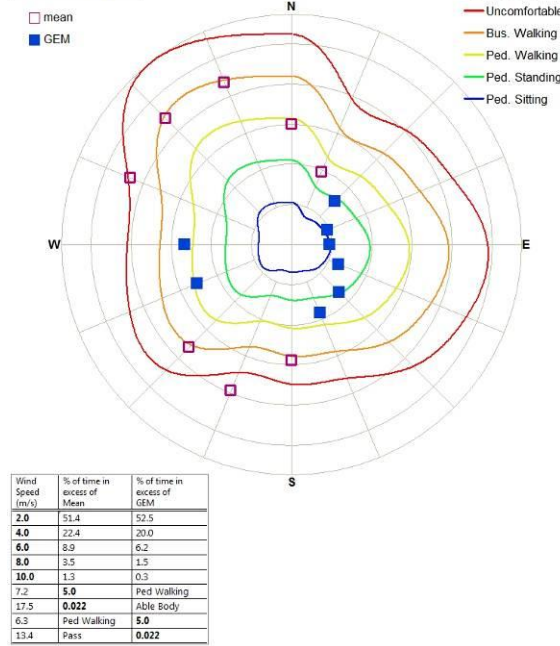
LOCATION 7.2

Figure 5: Directional results in the Mod 4 configuration with curved towers

It is evident from Figure 5 that Location 7, on Shelley Lane, was impacted by winds from the south-west and north-west quadrants. Both these wind directions induce downwash from Building C3 at this location. Winds from the south-west are channelled between Buildings C3, C4, and the hotel on the peninsula and brought to ground level by the massing of the tall buildings. Winds from the north-west are brought to ground level by the massing of Building C3. With the increase in podium size to the north of Building C3, a portion of this downwash will be redirected away from reaching ground level and will pass over the roofs of Building C1/C8. The re-direction of flow is expected to improve the wind conditions in this area.

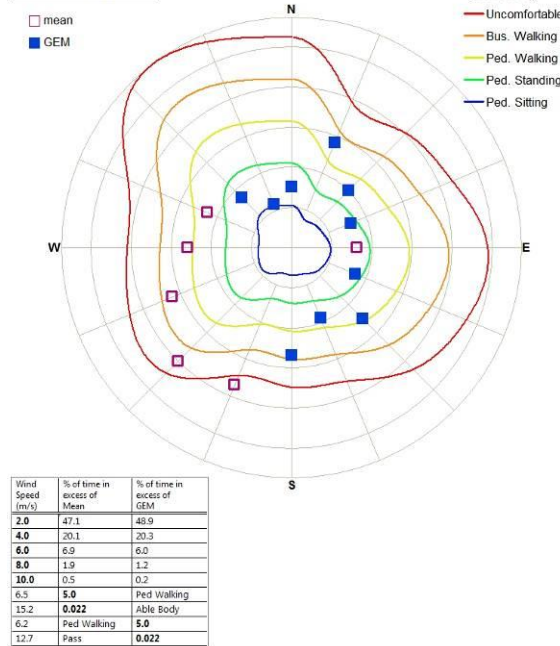
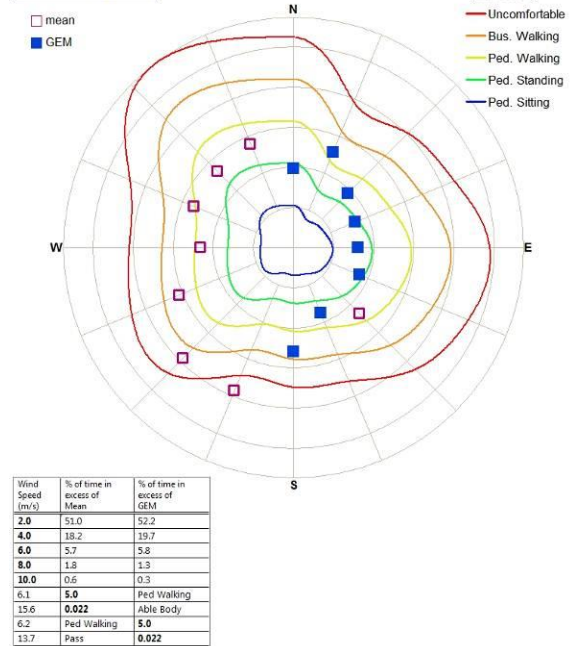
LOCATION 14.2

LOCATION 15.2

Locations 14 and 15 marginally exceed the distress criterion and are classified as suitable for 'able bodied' pedestrians. The conditions are caused by strong winds from the south-south-west, Figure 5. These conditions are calmer than Location 38 in Figure 4 caused to a large extent by the curved ends of the towers, but the flow is still accelerated between the hotel and the Building C3 and C4. The increase in size of podium to the north-west of Building C3 and to the south of R3, is expected to improve the wind conditions in this area.
