Project 72138.00  
31 January 2011  
GRB:III

**Waste Classification of In-situ Material  
110-114 Herring Road, Macquarie Park**

This letter report by Douglas Partners Pty Ltd (DP) provides details of the methodology and findings of a preliminary waste classification assessment of *in situ* materials undertaken by Douglas Partners Pty Ltd (DP) at 110 – 114 Herring Road, Macquarie Park. The work was undertaken at the request of the Stamford Property Services Pty Ltd for the off-site disposal of excavated material.

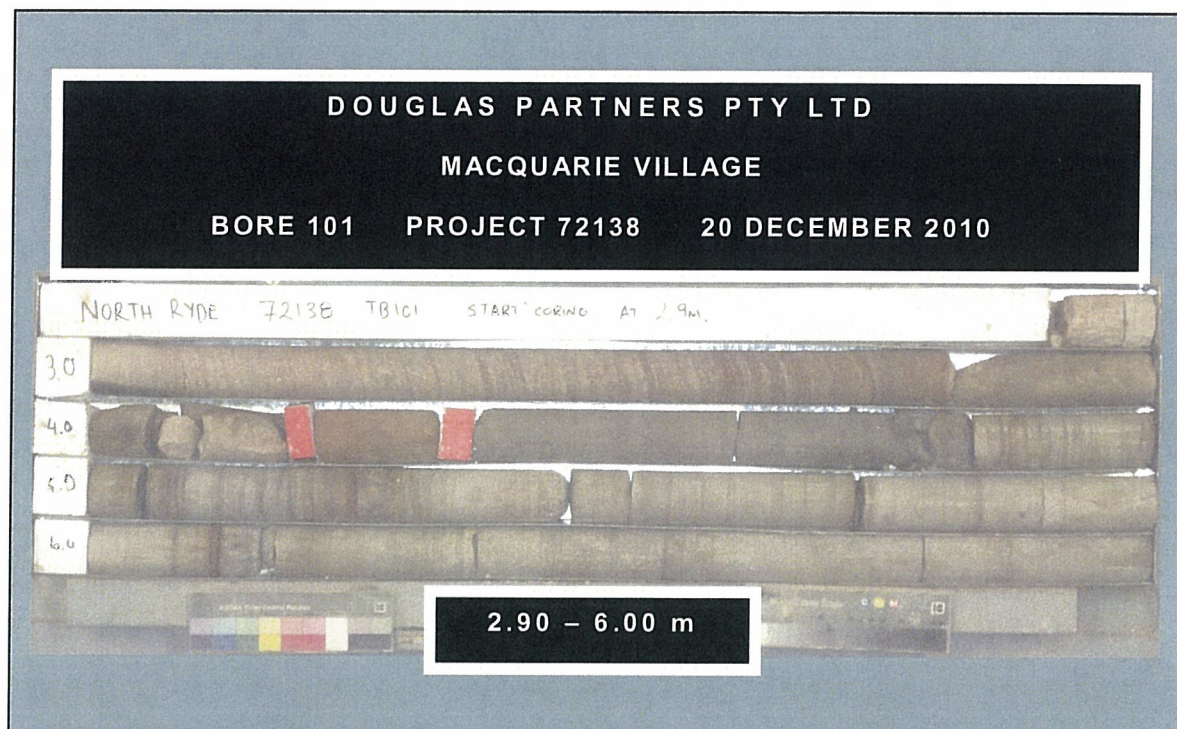
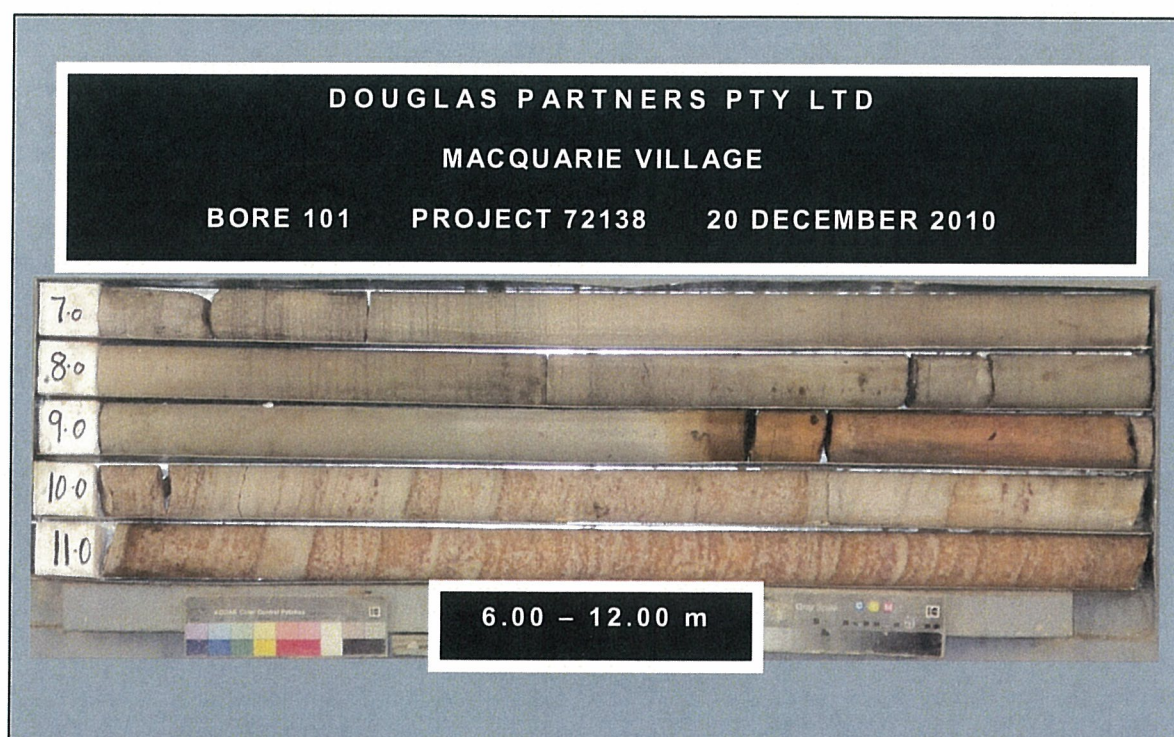
# BOREHOLE LOG

**CLIENT:** Stamford Property Services Pty Ltd  
**PROJECT:** Macquarie Village  
**LOCATION:** 110-114 Herring Road, Macquarie Park
