**TCG PLANNING**  
**PROPOSED LIFE CITY WOLLONGONG**  
**WARWICK STREET BERKELEY**  
**GEOTECHNICAL INVESTIGATION**  
**REPORT G09/1100-Ar      JANUARY 2014**

**Re: Proposed Life City Wollongong, Warwick Street, Berkeley**

This report presents the results of a geotechnical investigation carried out for the above project.

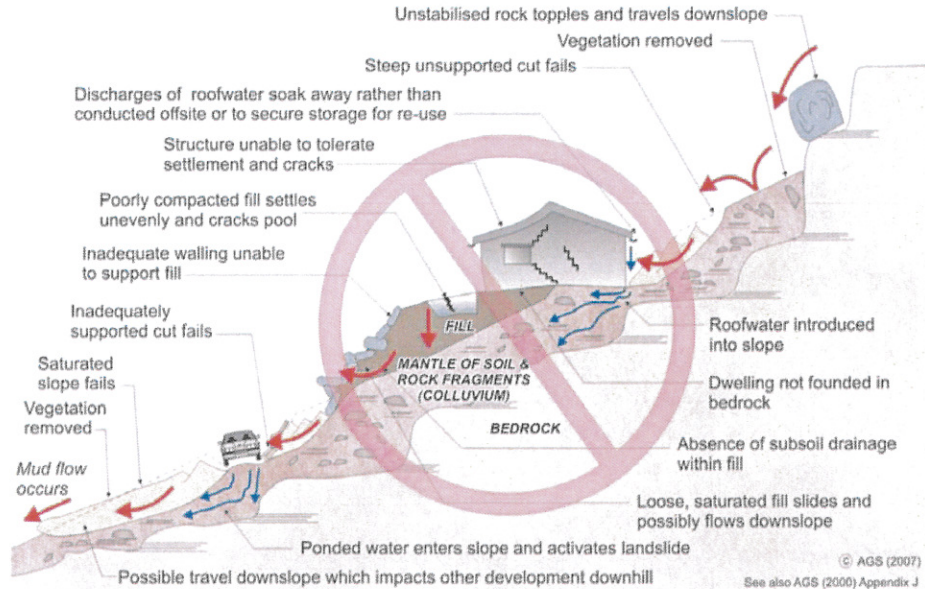
### EXAMPLES OF **POOR** HILLSIDE CONSTRUCTION PRACTICE

**Roadways and parking areas** - are unsurfaced and lack proper table drains (gutters) causing surface water to pond and soak into the ground.

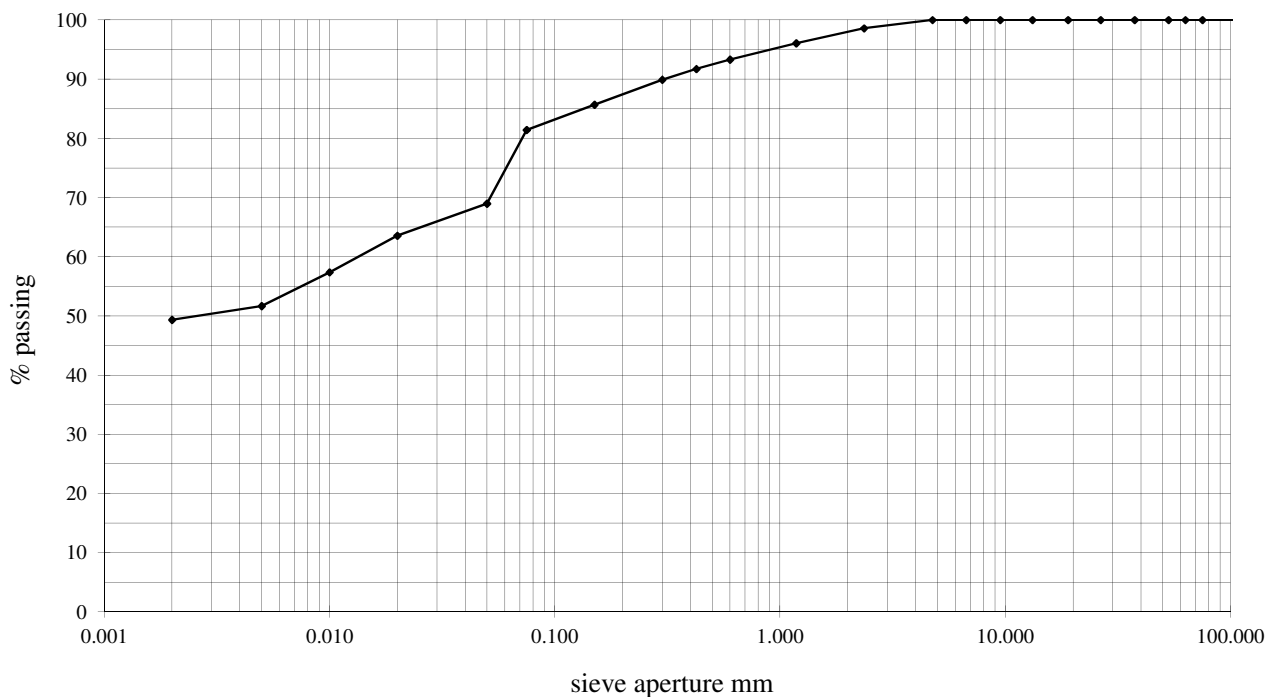
**Client:** Network Geotechnics Pty Ltd  
**Address:** Unit 129-15 Gundah Road Mt Kuring Gai NSW 2080  
**Project:** Proposed Life City Wollongong (G09/1100 A)  
**Location:**  
**Test Method:** AS 1289 3.6.1 / 3  
**Job Number:** 13-32-745  
**Sample Source:** BH2 0.70-0.95m  
**Sampled By:** Client

Clay	Silt	Sand	Gravel
------	------	------	--------

Sample Description: SILTY CLAY: brown

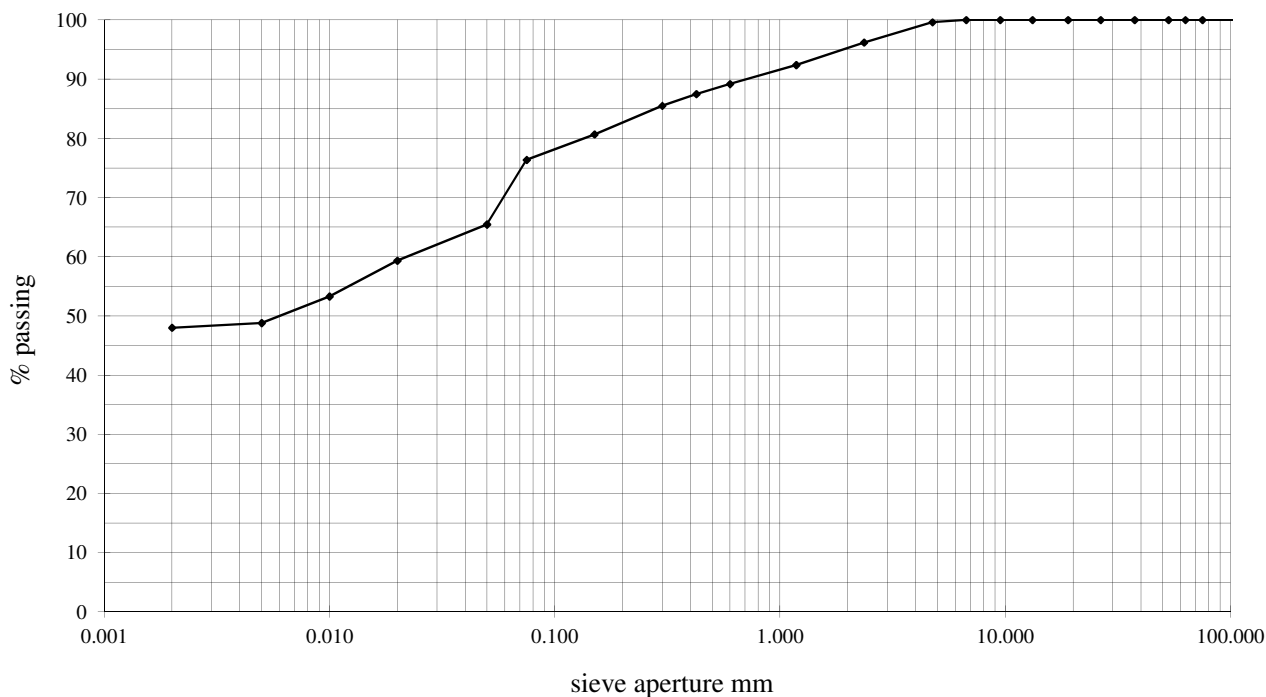
**Client:** Network Geotechnics Pty Ltd  
**Address:** Unit 129-15 Gundah Road Mt Kuring Gai NSW 2080  
**Project:** Proposed Life City Wollongong (G09/1100 A)  
**Location:**  
**Test Method:** AS 1289 3.6.1 / 3  
**Job Number:** 13-32-745  
**Sample Source:** BH2 0.70-0.95m  
**Sampled By:** Client

Clay	Silt	Sand	Gravel
------	------	------	--------

Sample Description: SILTY CLAY: brown

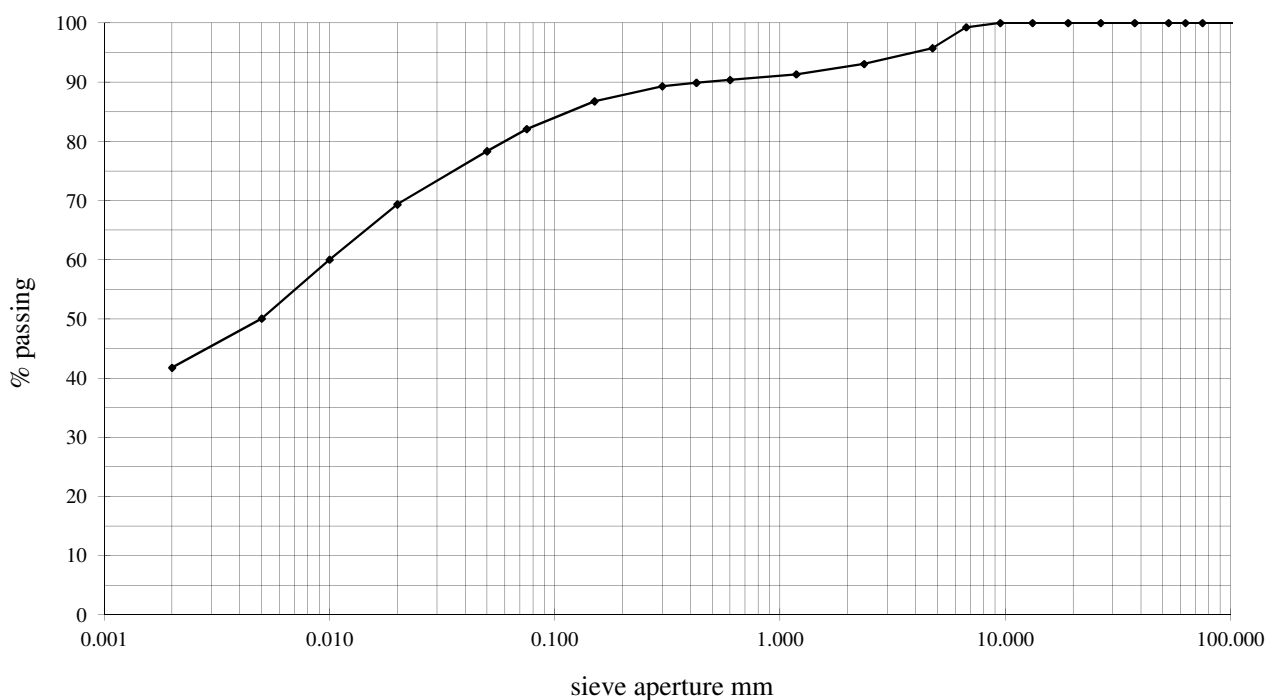
**Client:** Network Geotechnics Pty Ltd  
**Address:** Unit 129-15 Gundah Road Mt Kuring Gai NSW 2080  
**Project:** Proposed Life City Wollongong (G09/1100 A)  
**Location:**  
**Test Method:** AS 1289 3.6.1 / 3  
**Job Number:** 13-32-745  
**Sample Source:** BH5 1.50-1.95m  
**Sampled By:** Client

Clay	Silt	Sand	Gravel
------	------	------	--------

Sample Description: SILTY CLAY: brown

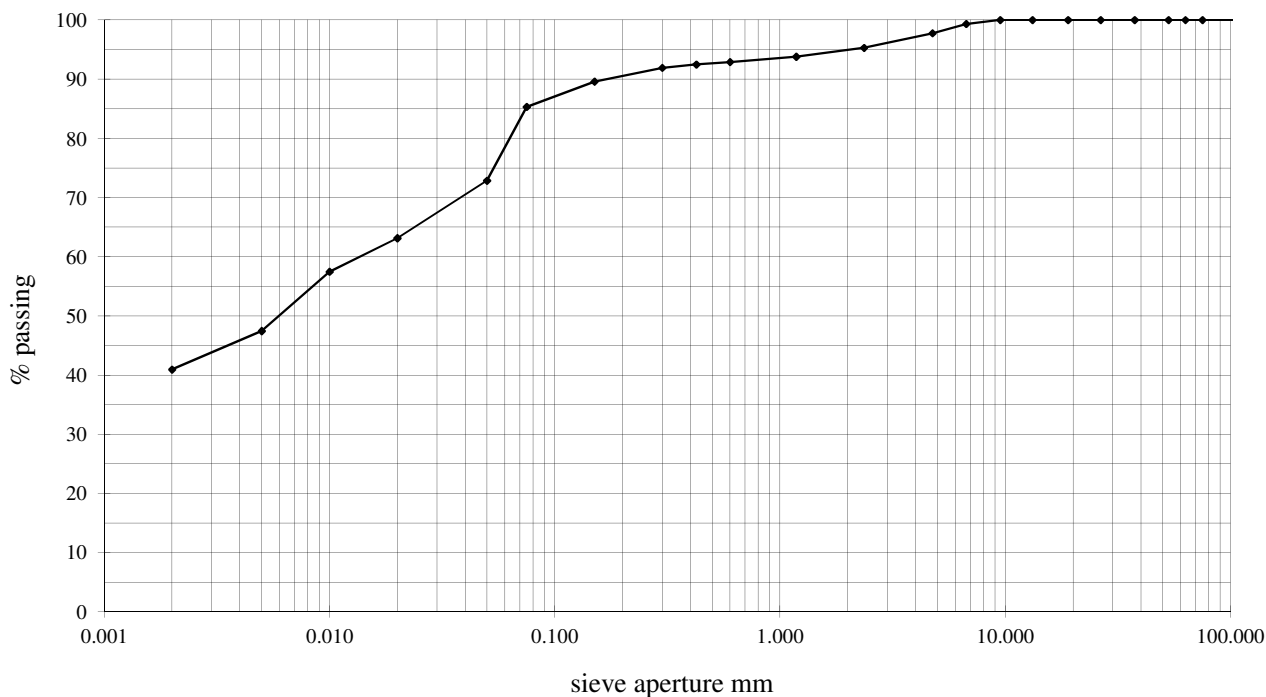
**Client:** Network Geotechnics Pty Ltd  
**Address:** Unit 129-15 Gundah Road Mt Kuring Gai NSW 2080  
**Project:** Proposed Life City Wollongong (G09/1100 A)  
**Location:**  
**Test Method:** AS 1289 3.6.1 / 3  
**Job Number:** 13-32-745  
**Sample Source:** BH5 1.50-1.95m  
**Sampled By:** Client

Clay	Silt	Sand	Gravel
------	------	------	--------

Sample Description: SILTY CLAY: brown

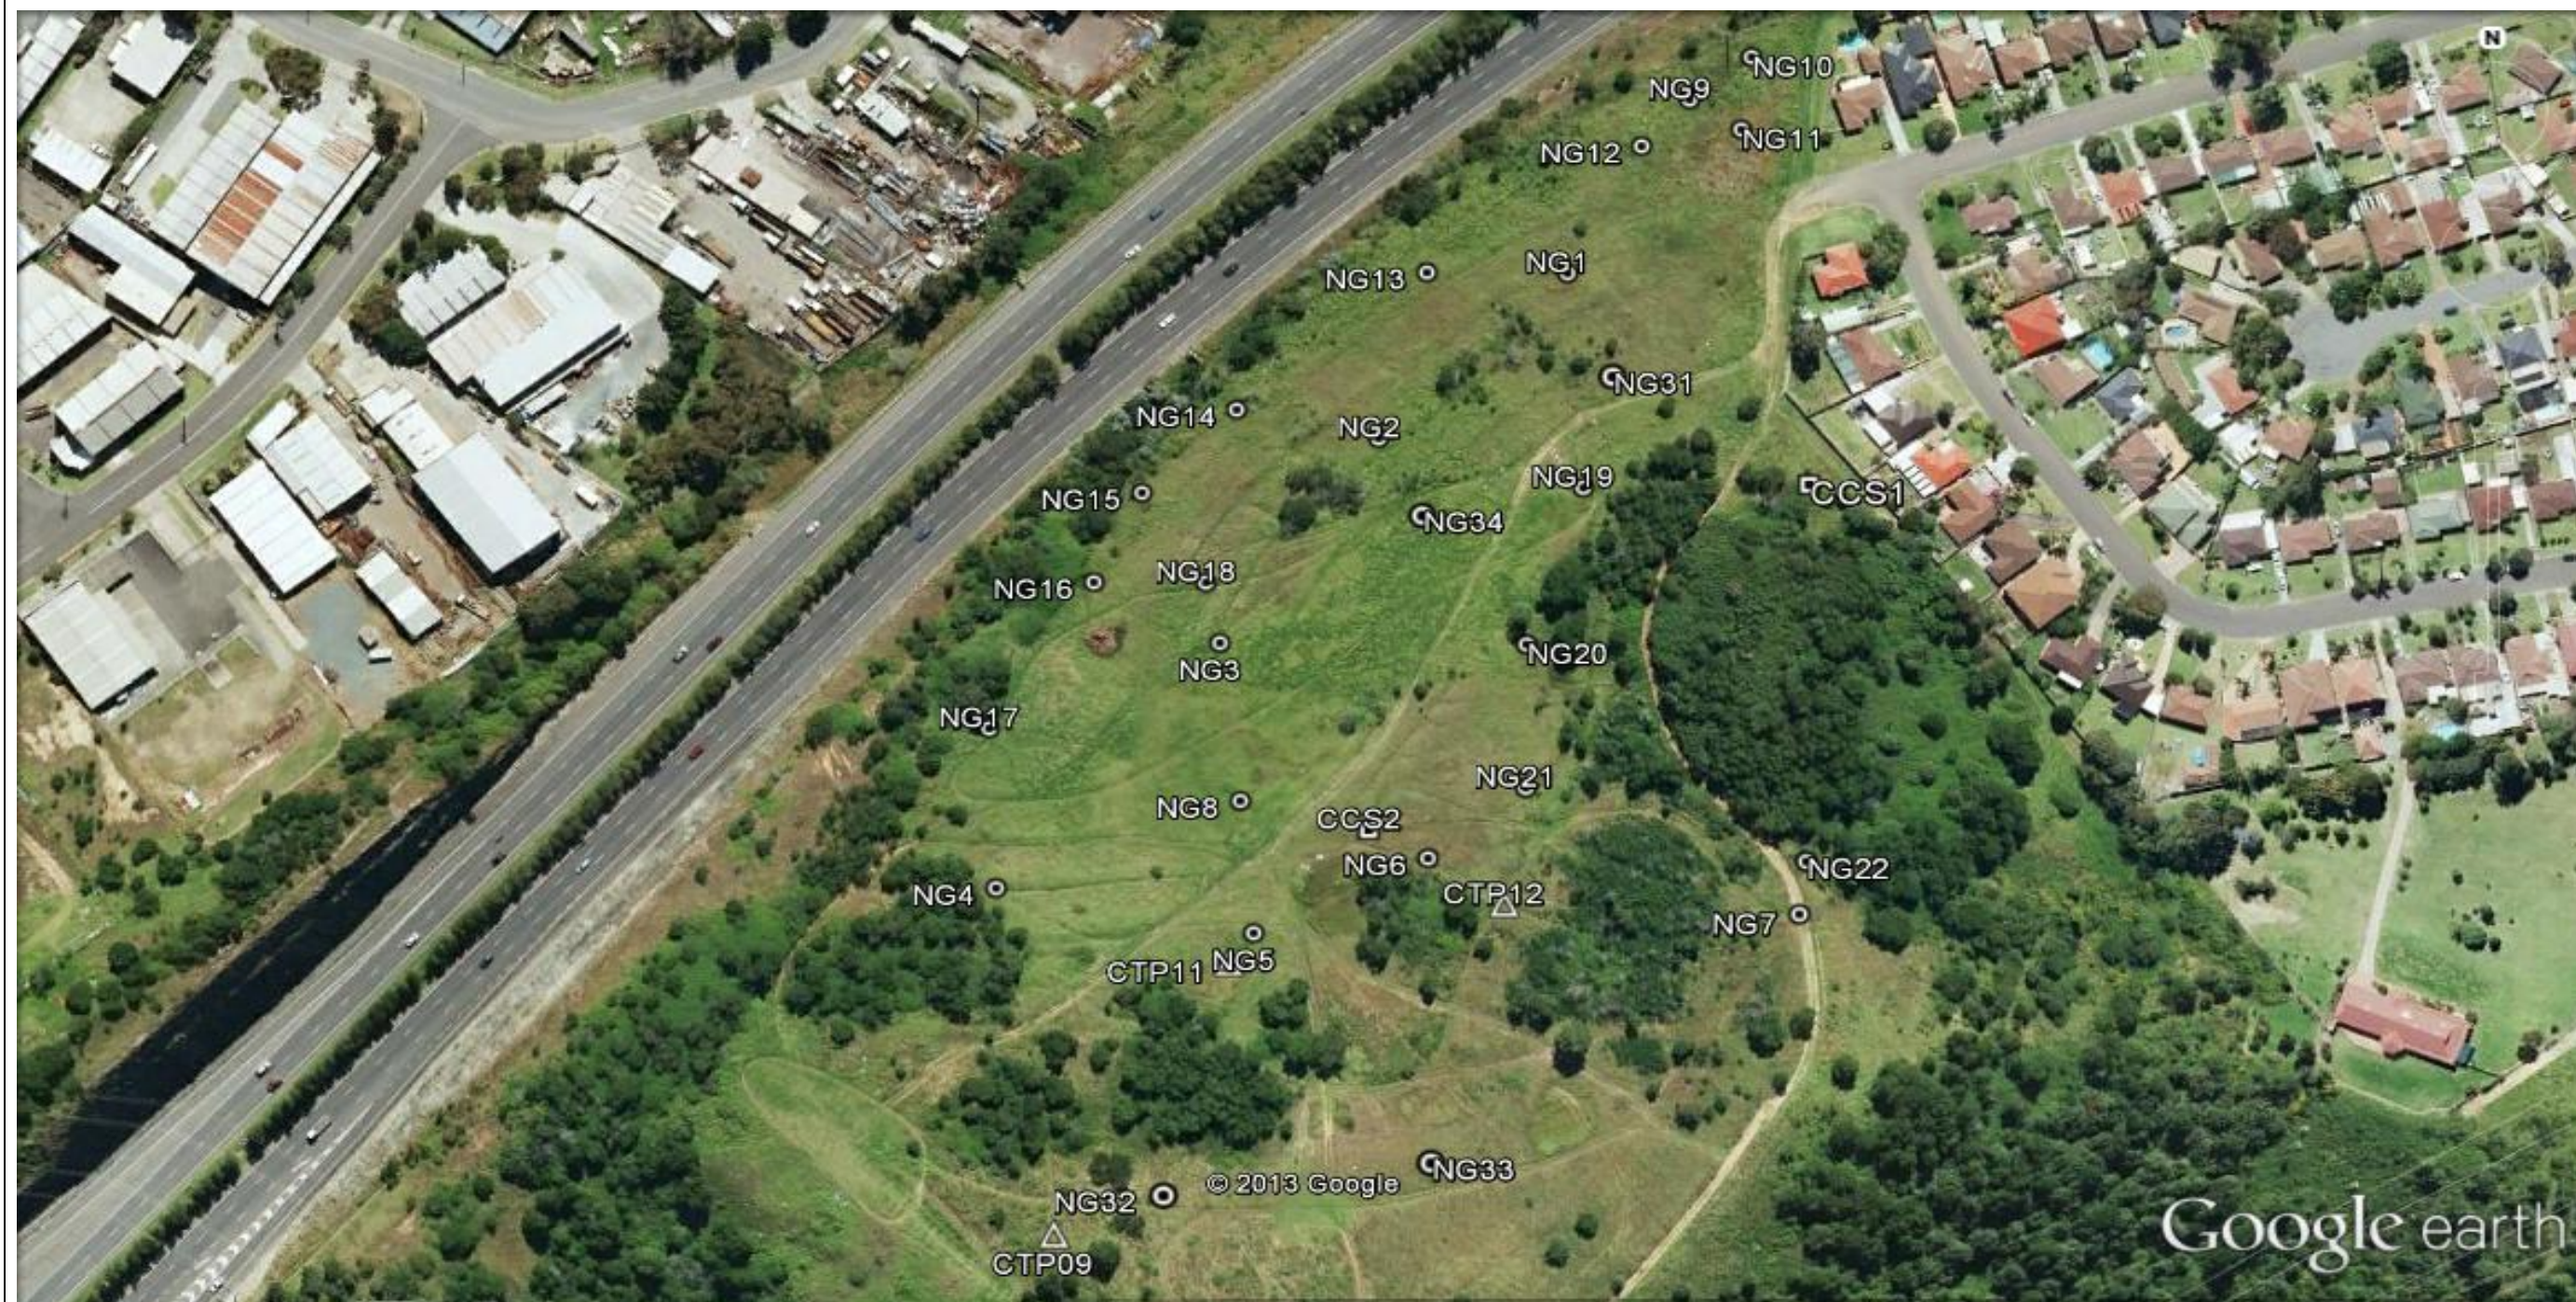
○ NETWORK GEOTECHNICS (NG) BOREHOLE 2013
