# DEWATERING AND GROUNDWATER MANAGEMENT PLAN

**Former Kirrawee  
Brick Works  
564-594 Princess Highway  
Kirrawee NSW**

**DL3060\_S001357**

**February 2014**

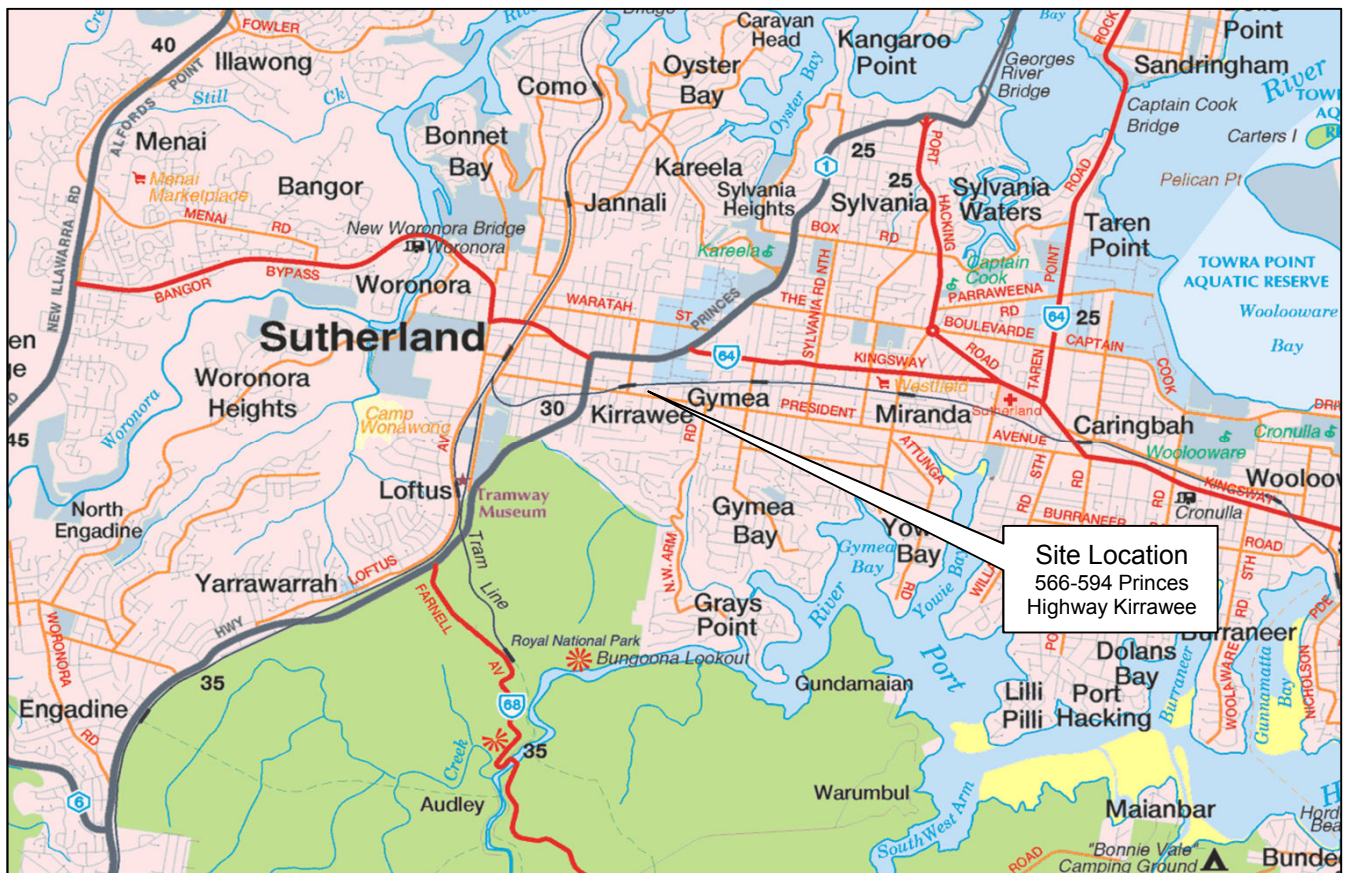
Site Location

| DESIGNED:<br>DLA | SITE LOCATION | | |

Refer to **Figure 1 -Site Location** and **Figure 2 – Site Survey**.
