**TCG PLANNING**  
**PROPOSED LIFE CITY WOLLONGONG**  
**WARWICK STREET BERKELEY**  
**GEOTECHNICAL INVESTIGATION**  
**REPORT G09/1100-Arr      FEBRUARY 2014**

**Re: Proposed Life City Wollongong, Warwick Street, Berkeley**

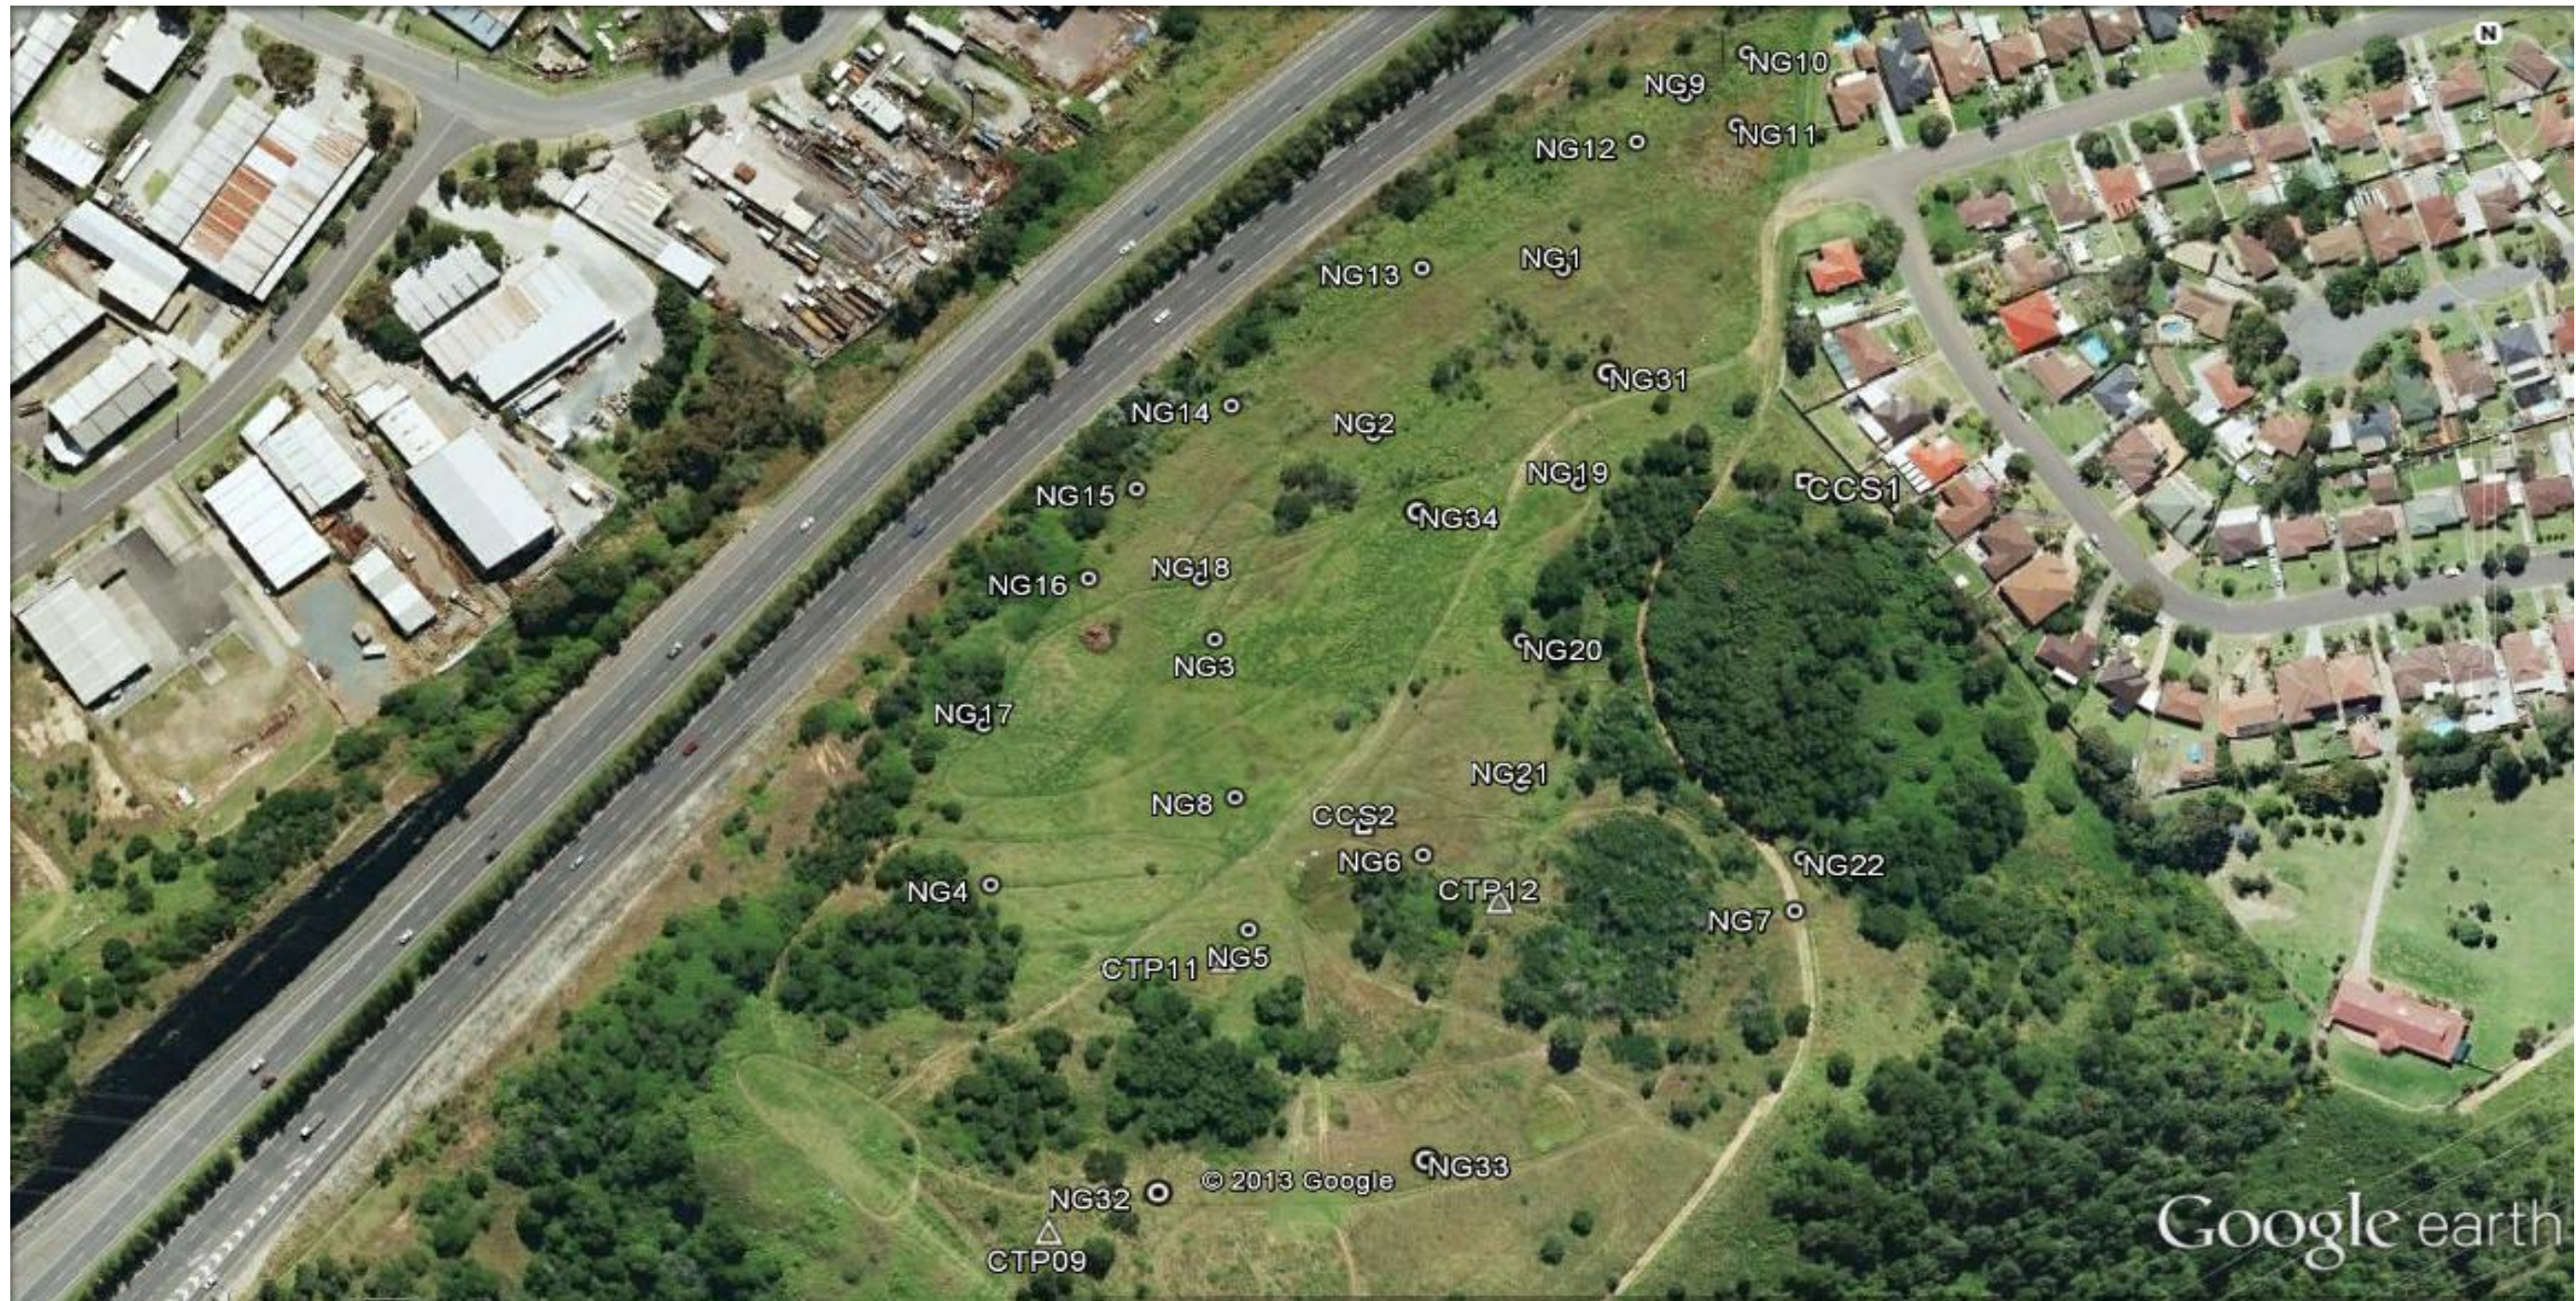
○ NETWORK GEOTECHNICS (NG) BOREHOLE 2013
