Trinity Mixed Use Development & Marina Project

Modification 5

Commercial Residential and Marina
Development, Trinity Point Lake
Macquarie

CGS2221

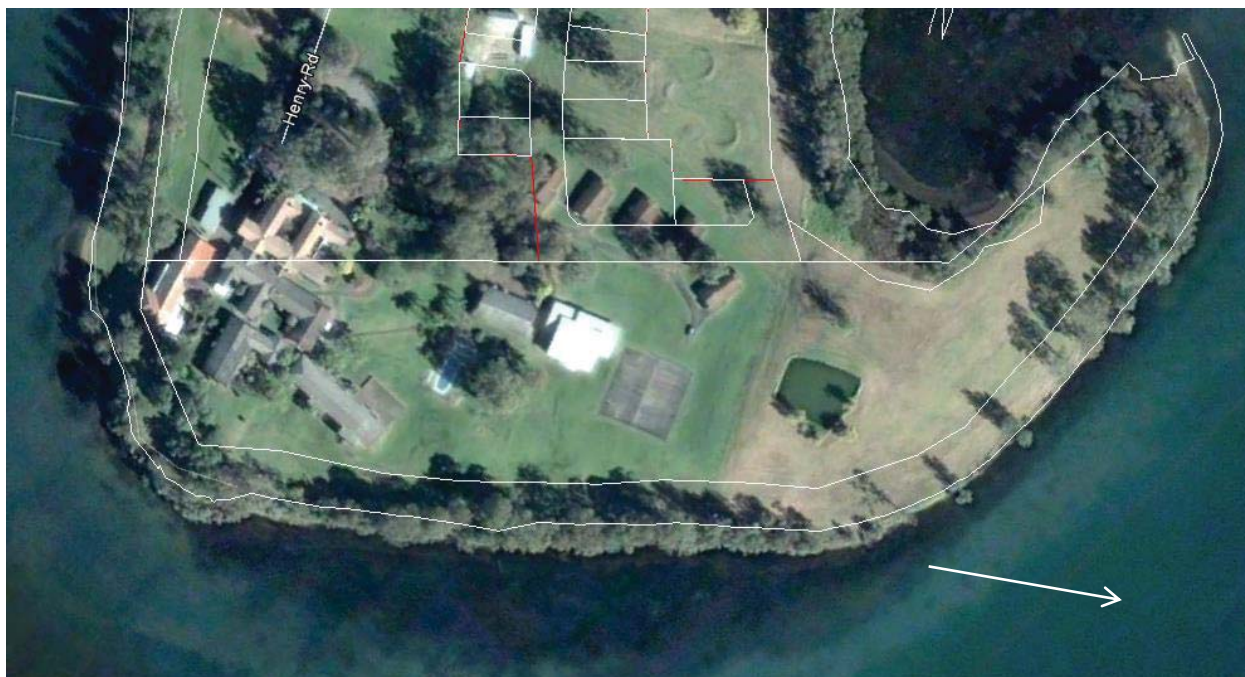
Figure 2: Google Earth® image circa 2005 illustrating historical site conditions. Approximate north is indicated. Not to Scale.

Historical Google Earth® imagery from 2005 (Figure 2) indicates that the site formerly contained several buildings, a pool and a small dam. The buildings have been demolished; however remnants of slabs and footings along with a garden wall and a survey benchmark remain at the crest of the bluff at Bluff Point. The pool and dam have been infilled. Current conditions are illustrated in Figure 3.

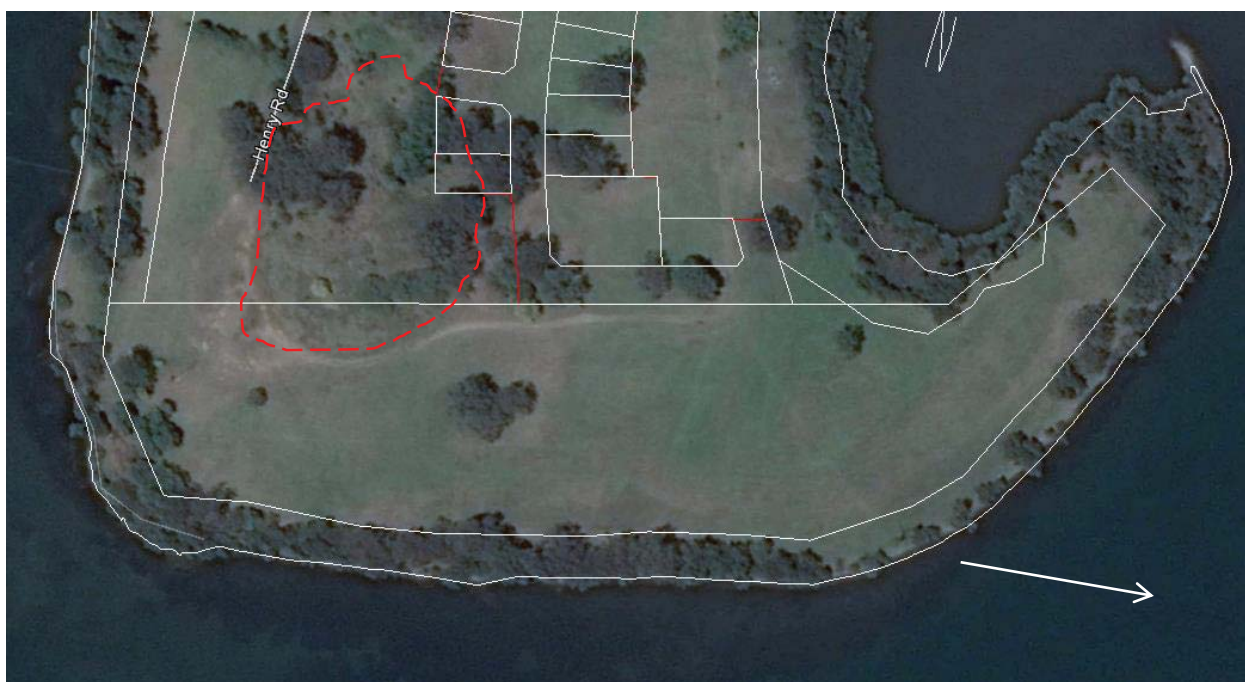
Figure 3: Google Earth® image circa 2013 illustrating current site conditions. A stockpile of uncontrolled fill including some construction debris is located in the highlighted area. Not to Scale.

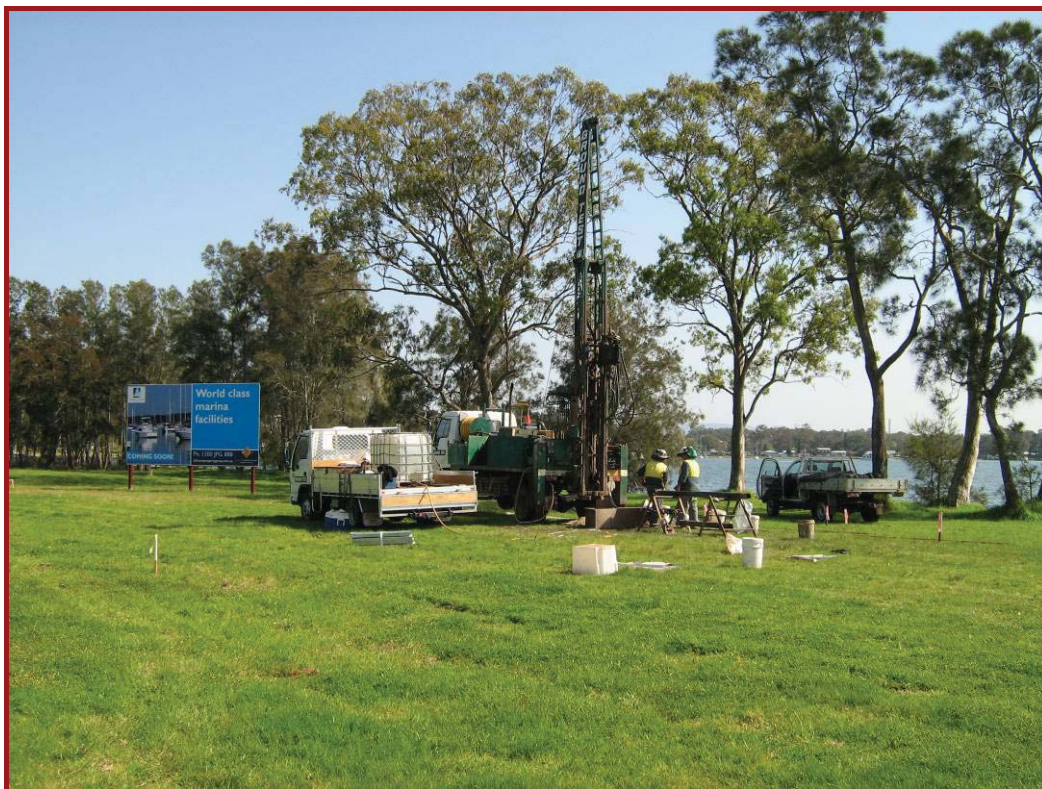
Photo 1 – set up on Bore 101, in the area of the proposed marina

Photo 1 – set up on Bore 101, in the area of the proposed marina village

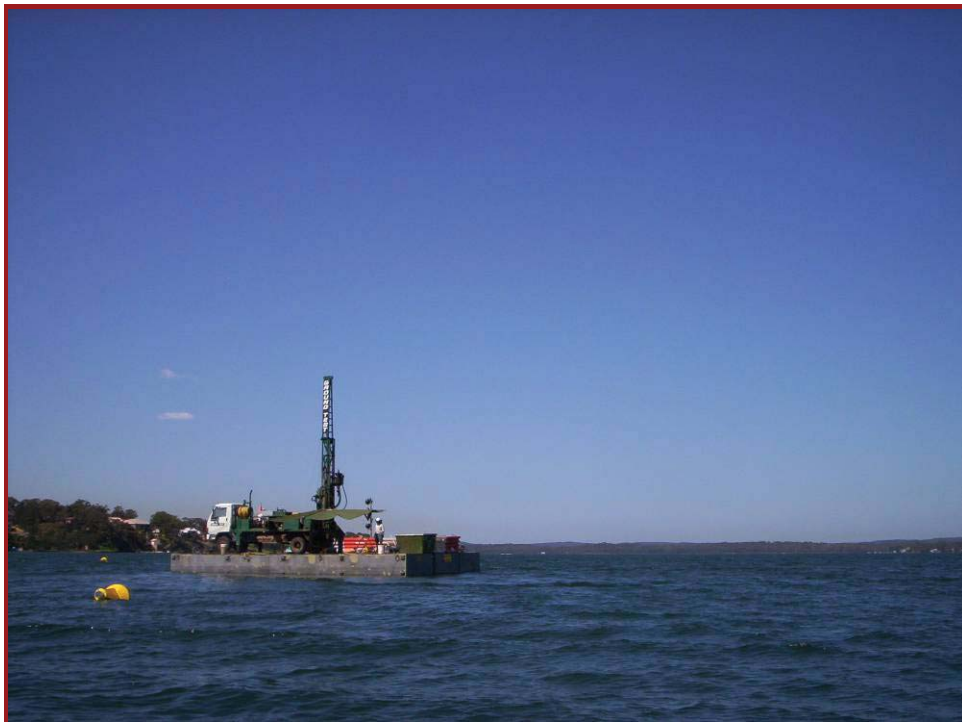
Photo 4 – drill rig set up on modular barge, in proposed marina area

The over-water bores were also drilled using a truck mounted drilling rig, set up on a modular barge (refer Photo 4). The target depth for the over-water bores was 3 m into rock, however this was not able to be achieved at all locations. Bore 201 had to be abandoned early due to strong winds and unsafe working conditions.

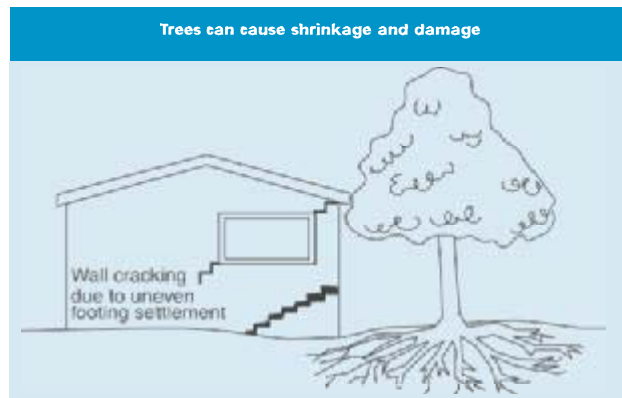
As the moisture absorption process completes its journey to the innermost areas of the building, the internal footings will rise. If the spread of moisture is roughly even, it may be that the symptoms will temporarily disappear, but it is more likely that swelling will be uneven, creating a difference rather than a disappearance in symptoms. In buildings with timber flooring supported by bearers and joists, the isolated piers will rise more easily than the strip footings or piers under walls, creating noticeable doming of flooring.

As the weather pattern changes and the soil begins to dry out, the external footings will be first affected, beginning with the locations where the sun's effect is strongest. This has the effect of lowering the external footings. The doming is accentuated and cracking reduces or disappears where it occurred because of dishing, but other cracks open up. The roof lines may become convex.

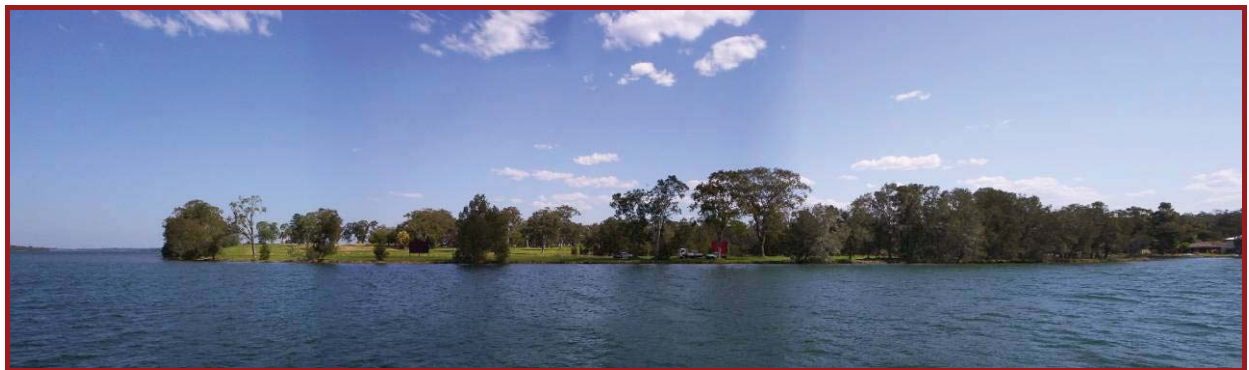
Photo 2 – view of site from the Lake

Photo 2 – view of site from the Lake

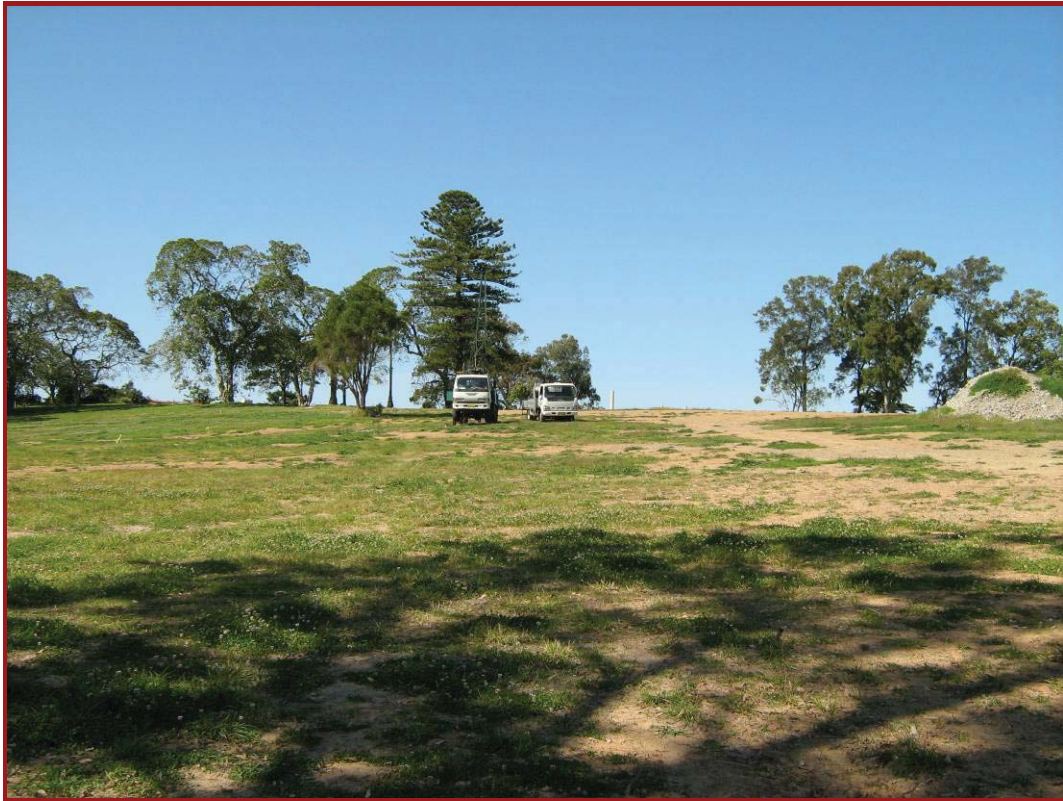
Photo 3 – looking south towards the crest of Bluff Point, from the area of the proposed tourist village

Photo 3 – looking south towards the crest of Bluff Point, in the area of the proposed tourist village
