Subject: Moruya East Village – Groundwater Issues

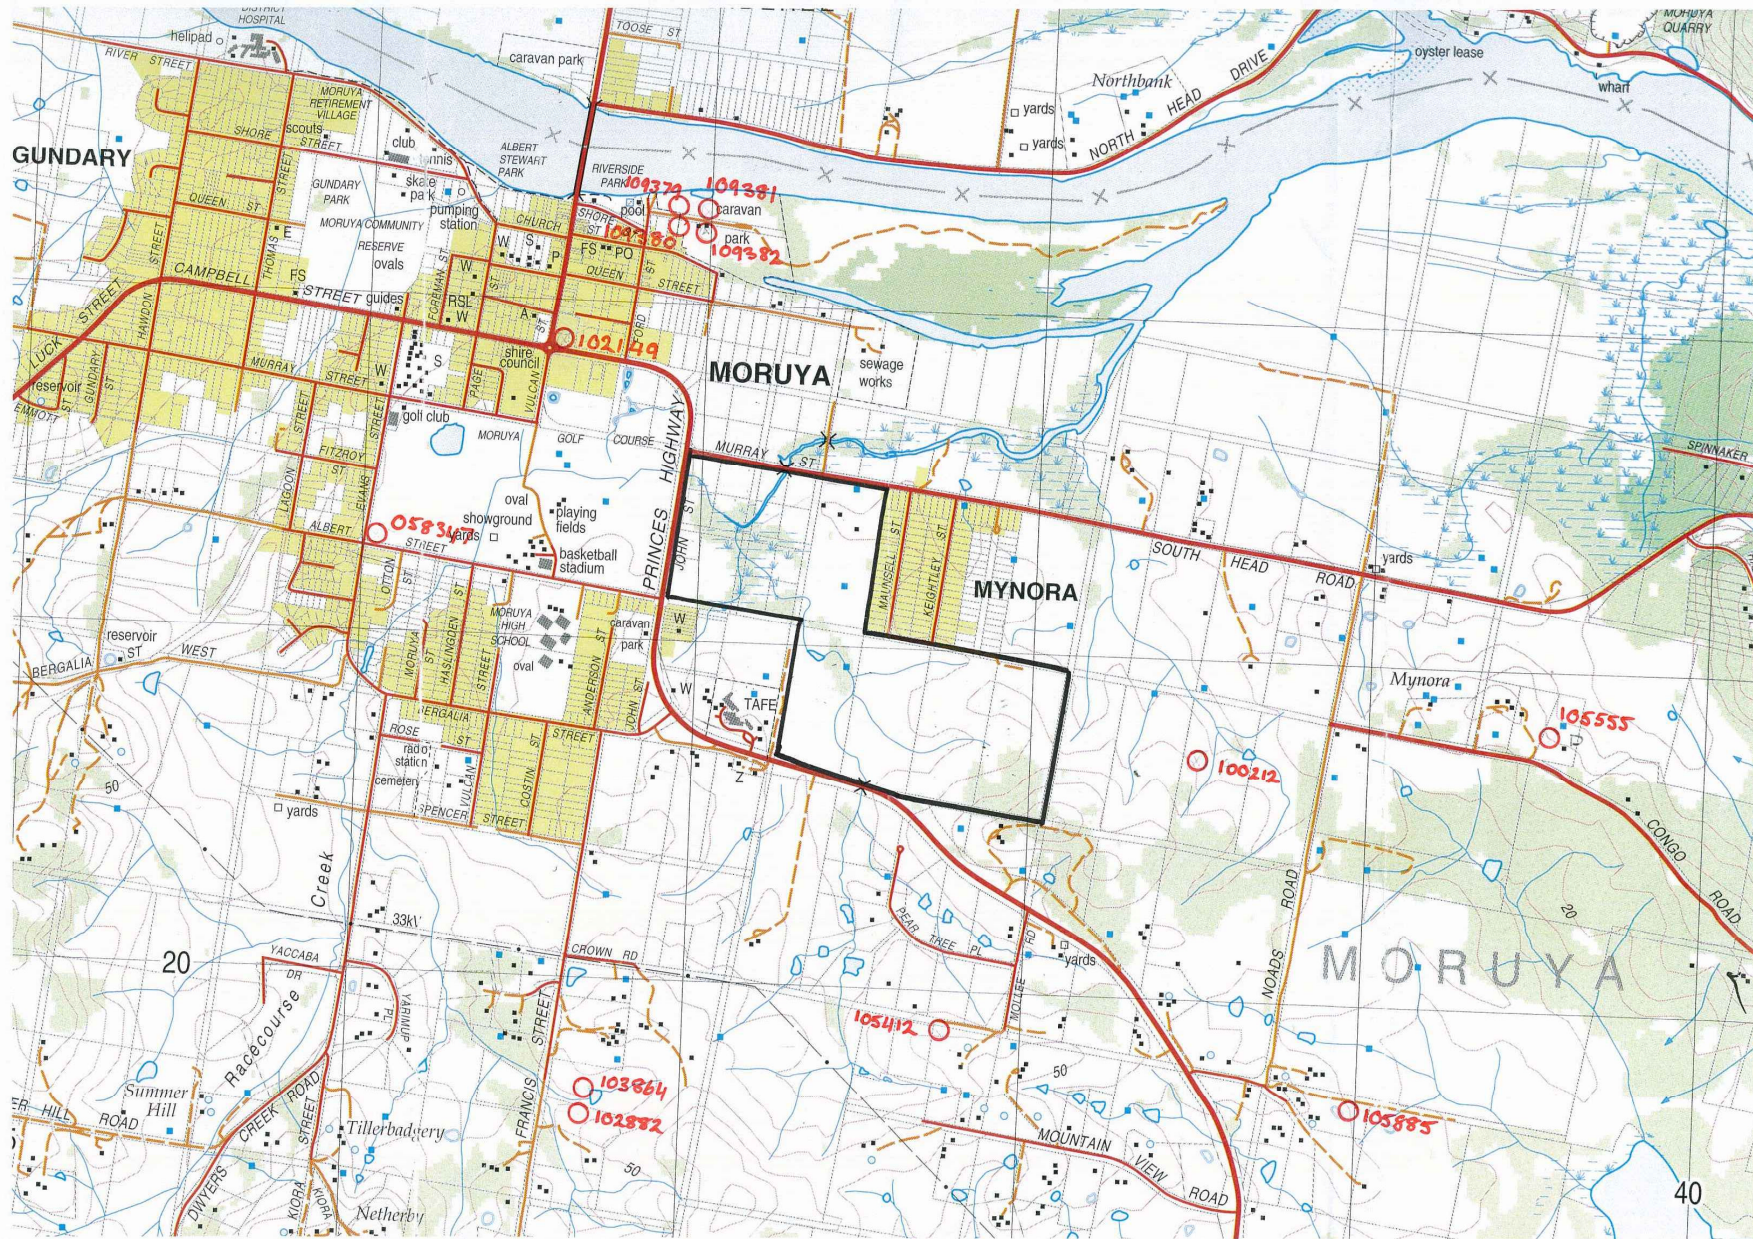
Figure 1: Locations of Groundwater Bores

In order to assess the hydrogeology of the locality and the use of groundwater, a search of the DWE groundwater bore database has been undertaken. The location of the identified bores (shown in red) in relation to the site (outlined in black) are shown on Figure 1 attached at the end of this letter. Relevant details of the identified bores are contained in Tables 1 and 2 (also attached at

As shown on Figure 1 and the tables, the bores within 1 km of the boundaries of the site come from three different landscape units reflecting their position in the landscape and the underlying geology:
