MANGROVE AND BANK STABILITY ASSESSMENT

PITT STREET PRECINCT, TAREE

Prepared for
SKM Pty Ltd & Greater Taree City Council

EEC PROJECT No. 0619GT

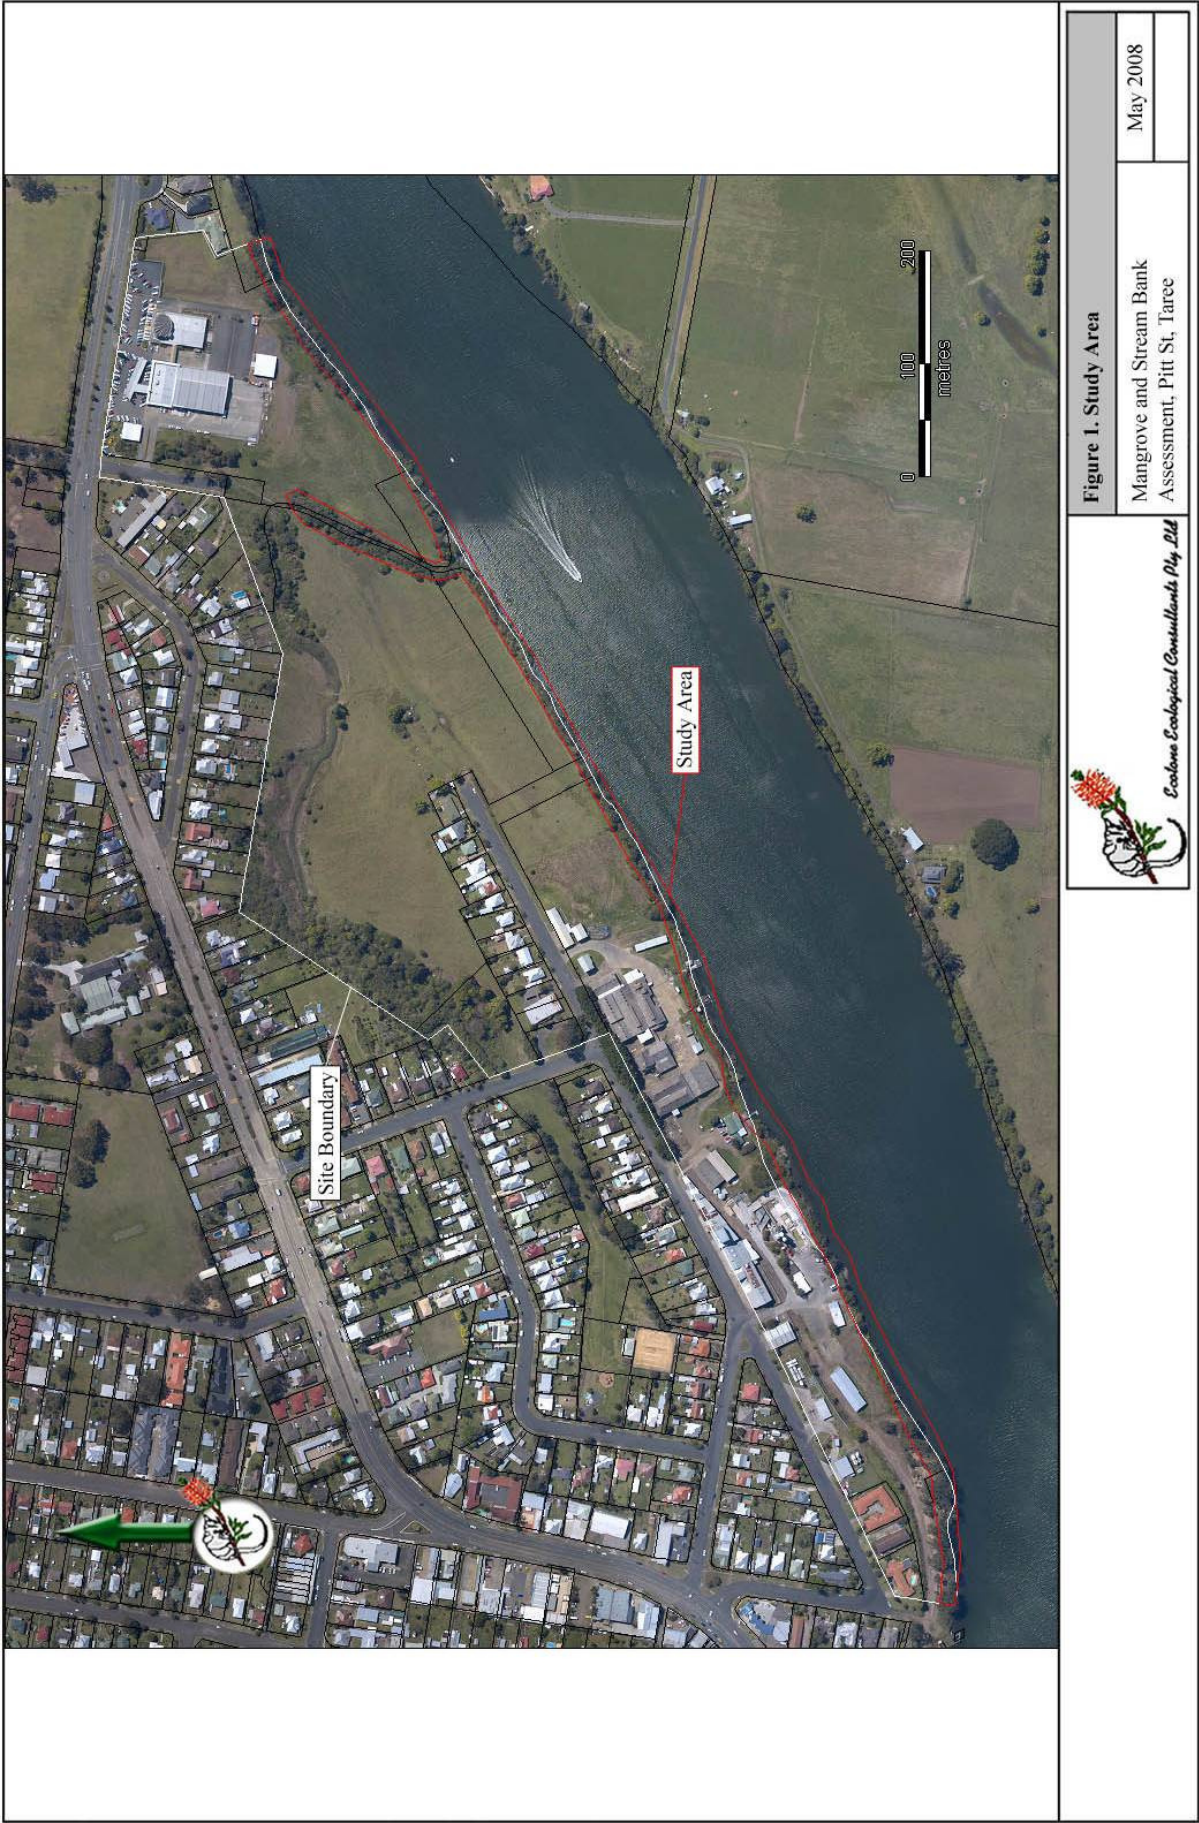
This report details the results of field investigations and provides a brief assessment of potential impacts on mangrove assemblages and bank stability within the study area based on the current version of the Concept Masterplan. The study area is shown on **Figure 1** and comprises the Manning River riparian zone and the unnamed tributary. The current version of the Concept Masterplan is included as **Figure 2**.
