BARANGAROO STAGE 1

BARANGAROO CONCEPT PLAN AMENDMENT (MP06_0162 MOD4) - MARINE ECOLOGY, WATER QUALITY AND CONTAMINATED SEDIMENT IMPACT ASSESSMENT

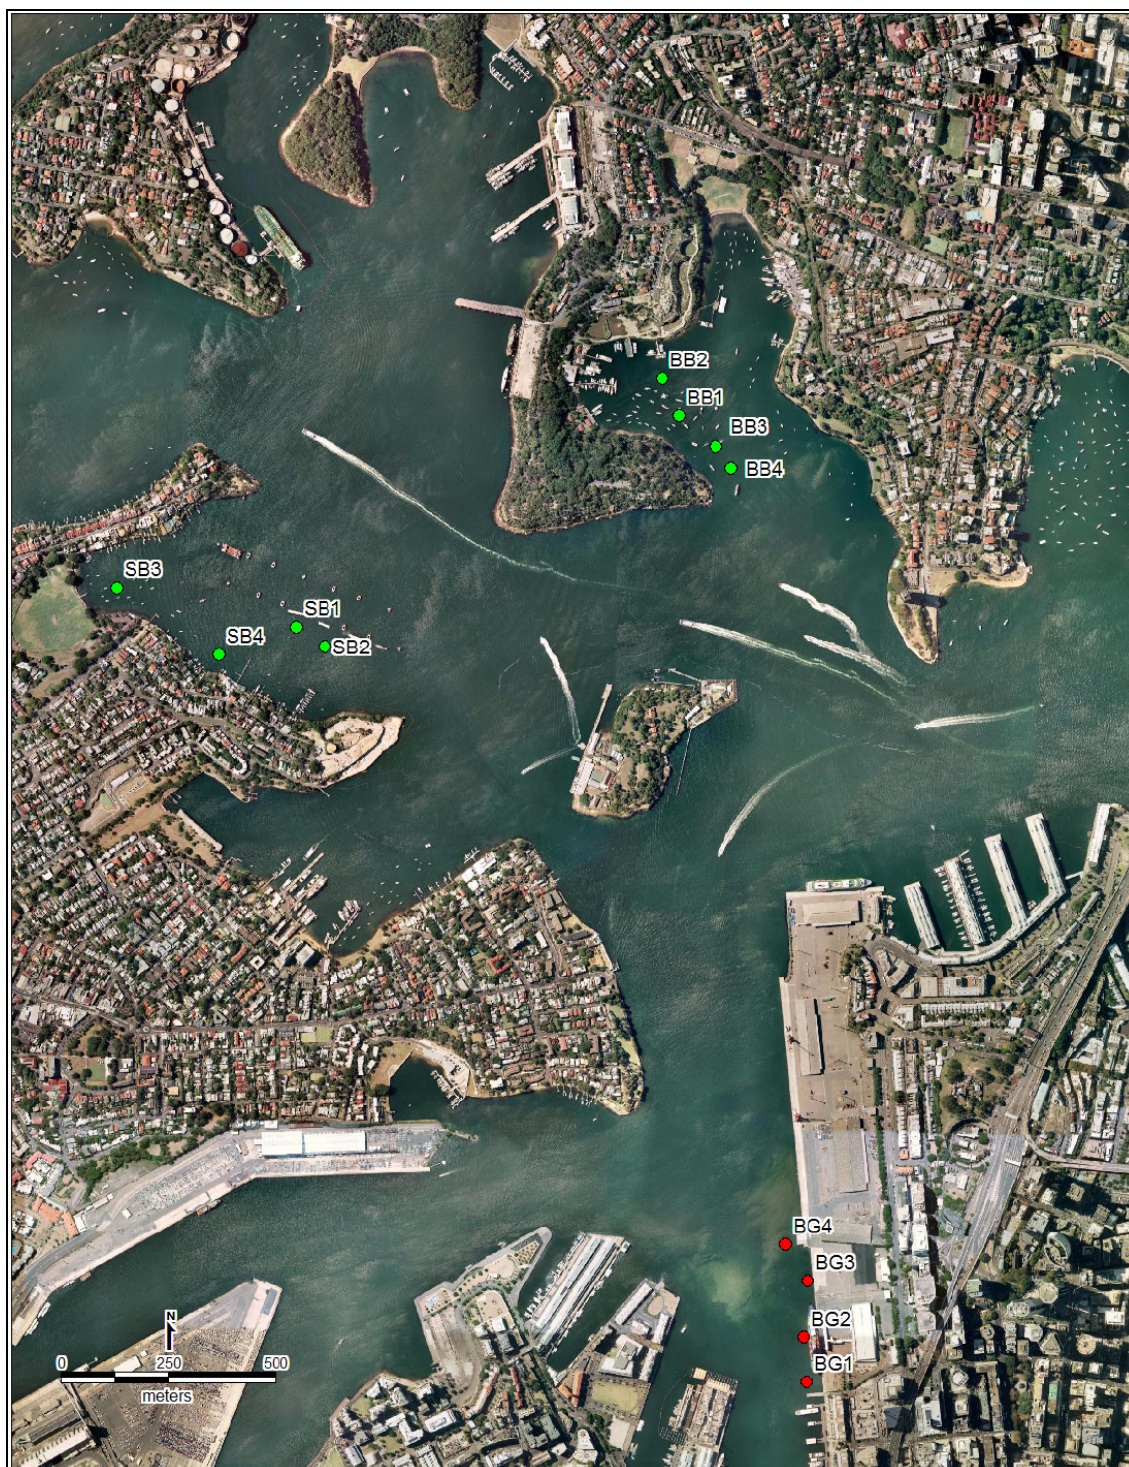
Figure 5.1 Location of sampling locations and sites; ● reference sites, ● impact sites.

Detailed inspection of the seafloor was undertaken within the footprint of the proposed Lend Lease development and at two reference locations (**Figure 5.1**). A total of four spot dives (sites) were undertaken by commercially qualified scientific divers at each location, to ascertain the seabed conditions and to determine the presence and extent of any sub-aquatic vegetation. Spatial data for each site was recorded using a Garmin GPS 60CSx. Maximum depths at each site were recorded by divers using dive computers.
