## **PROPOSED SALAMANDER SHORES HOTEL REDEVELOPMENT**

GEOTWARA20848AA-AB  
24 March 2009

**RE: PROPOSED SALAMANDER SHORES HOTEL REDEVELOPMENT  
SOLDIERS POINT ROAD, SOLDIERS POINT  
GEOTECHNICAL ASSESSMENT**

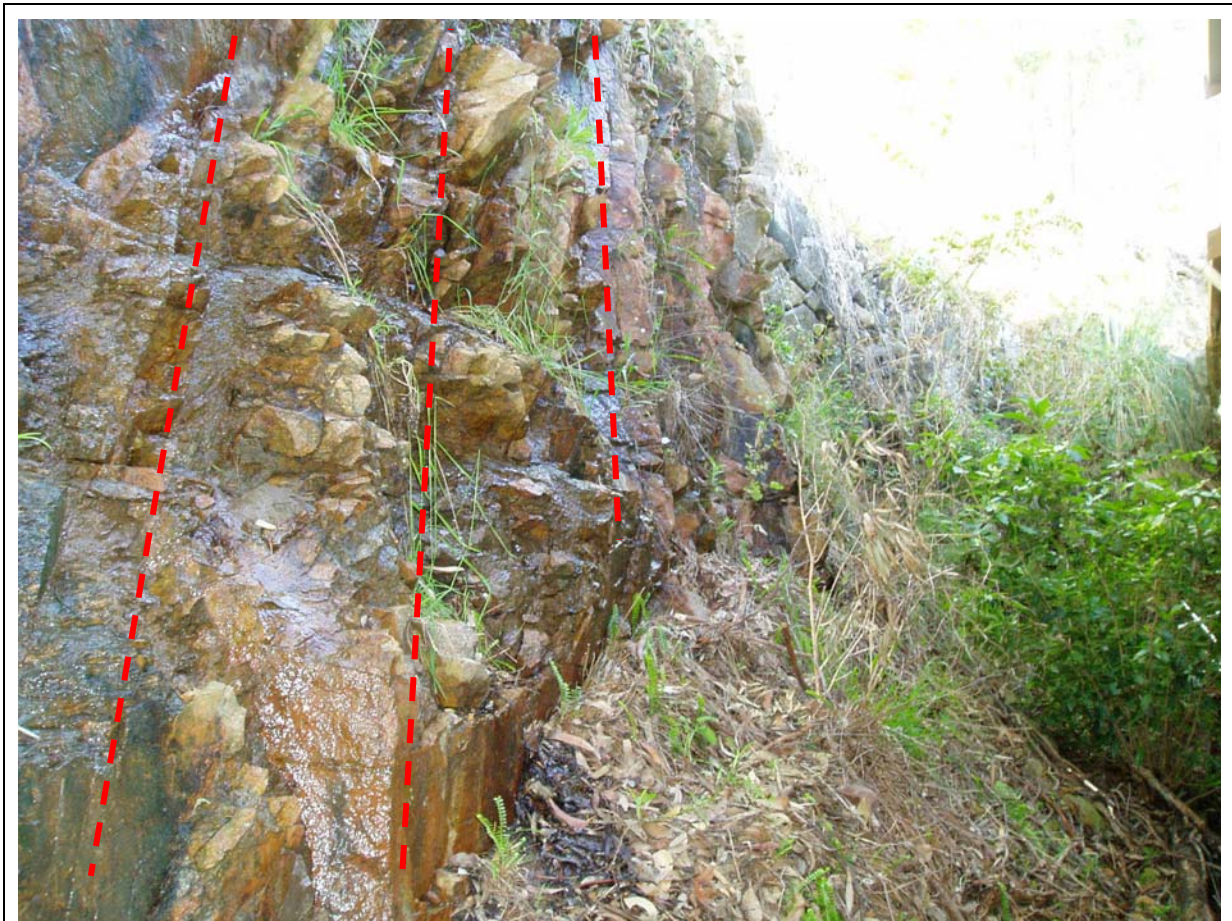
A photograph of the rock cutting behind the Sailing and Aquatic Club, located to the east of the site shows the typical jointing structure of the exposed rhyodacite.

**Photograph 1** – Cutting behind the Sailing and Aquatic Club to the east of the site, red dashed line annotates the predominant columnar structure of the rhyodacite rock.

Defects throughout the rock mass comprise mainly of moderately dipping joints with clean or slightly ironstained joint faces. Some weathered clay seams occur throughout the rockmass representing weathering zones of secondary hydrothermal mineralisation and alteration. Defect spacing within the rock mass generally increases with depth, with the general defect spacing in Unit 2B in the order of 100m to 300m increasing in Unit 2C to 300mm to 1000mm. Local outcropping and previous experience with rhyodacite materials in the area suggest the defects within the rock mass form a predominately columnar jointing structure. Areas of localised intense random jointing may be apparent along previous cooling margins and hydrothermal intrusion within the rock mass.

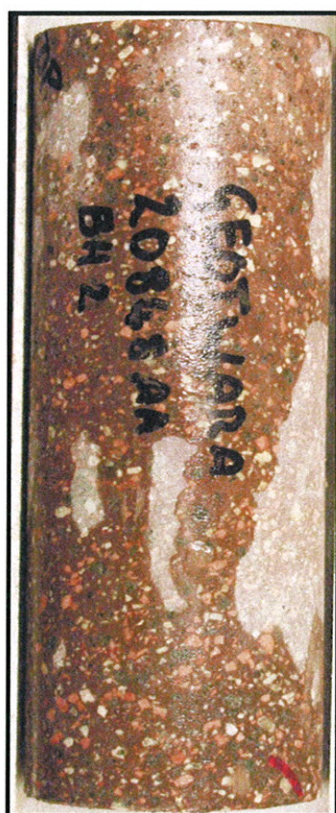
**Before**

| QESTLAB work order ID | depth | date tested | height<br>average diameter | uniaxial<br>compressive<br>strength | wet density<br>moisture<br>content | sample description<br>bedding/foliation | comments<br>failure mechanism |
|---|---|---|---|---|---|---|---|
| GLEN09W-00146<br>BH 2 2.83 to 2.98 m<br>GLEN09S-00515 | | 2 Mar 09<br>8.60 min | 148 mm<br>51.8 mm<br>2.85:1 | 223 | 2.6 t/m <sup>3</sup><br>0.9 % | rhyodacite | disintegrated |
