TITLE: INTERPRETED GEOLOGICAL SECTION B - B'

Proposed Macquarie Village

110 - 114 Herring Road, Macquarie Park

PROJECT No:	72138
DRAWING No:	3
REVISION:	0

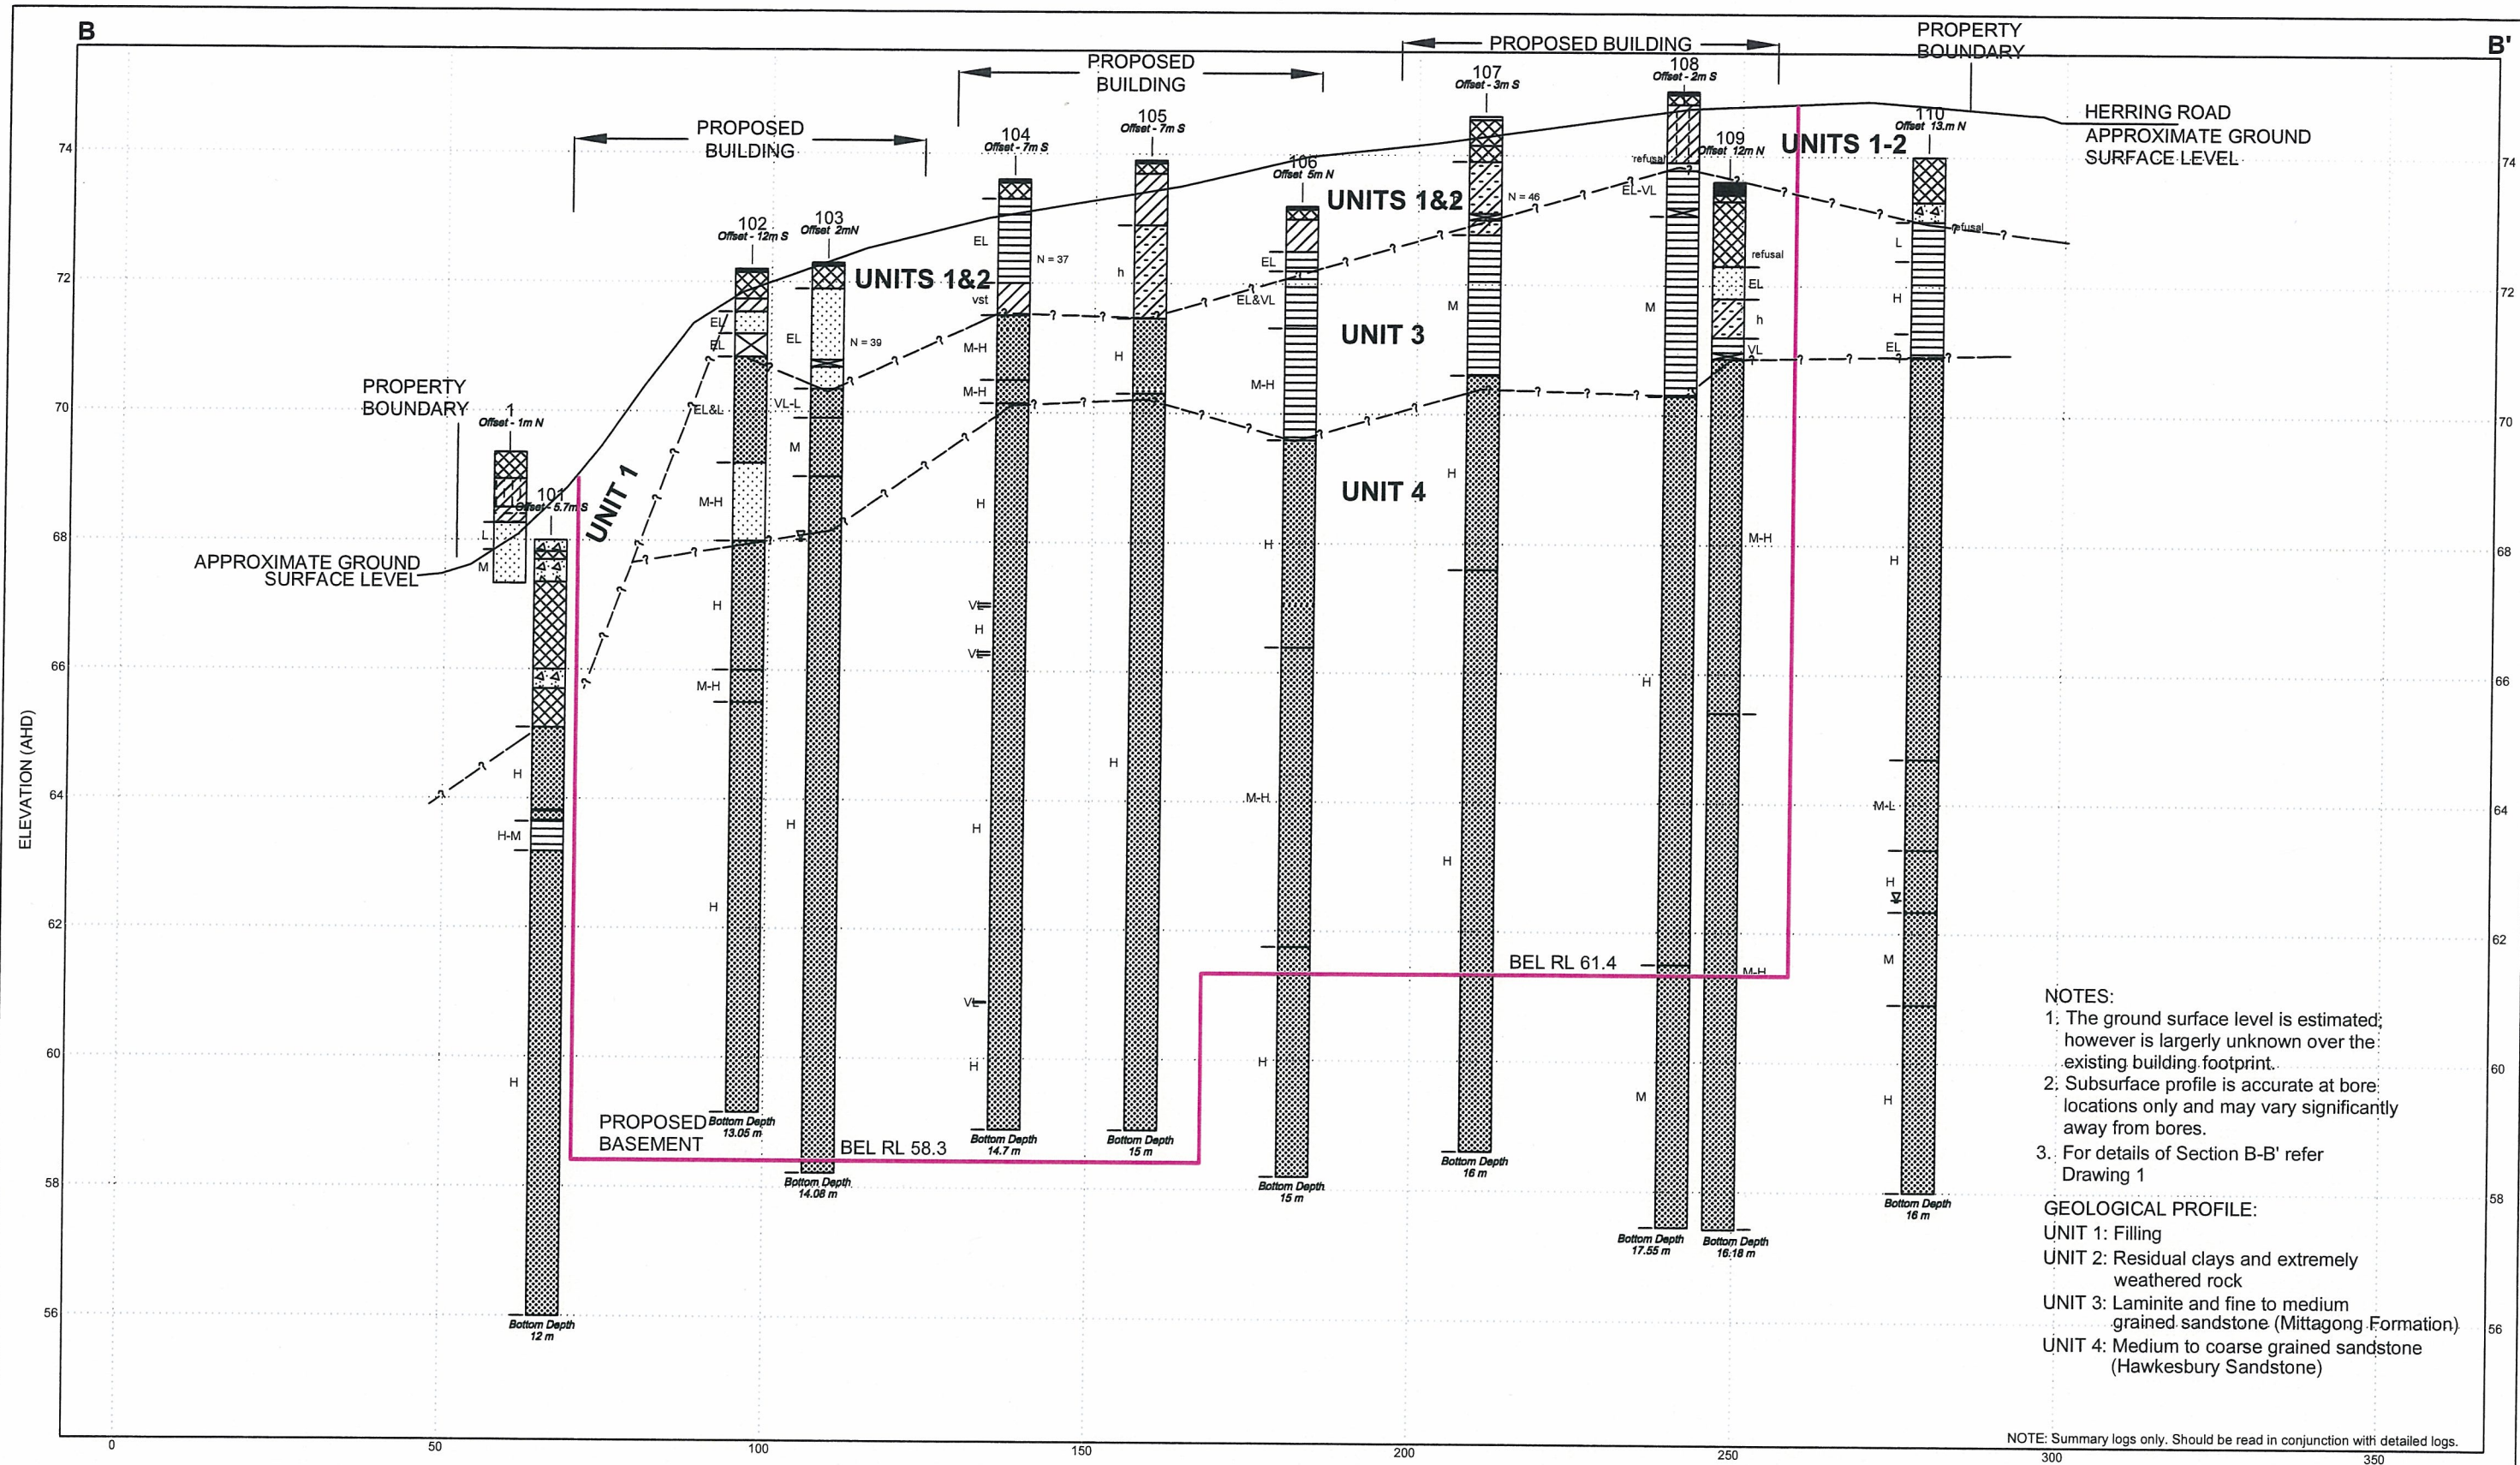
- 1: The ground surface level is estimated; however is largely unknown over the existing building footprint.
- 2: Subsurface profile is accurate at bore locations only and may vary significantly away from bores.
- 3: For details of Section B-B' refer Drawing 1

GEOLOGICAL PROFILE:

UNIT 1: Filling

UNIT 2: Residual clays and extremely weathered rock

UNIT 3: Laminite and fine to medium grained sandstone (Mittagong Formation)

UNIT 4: Medium to coarse grained sandstone (Hawkesbury Sandstone)
