3.4 The House Complex

3.4.2 The House

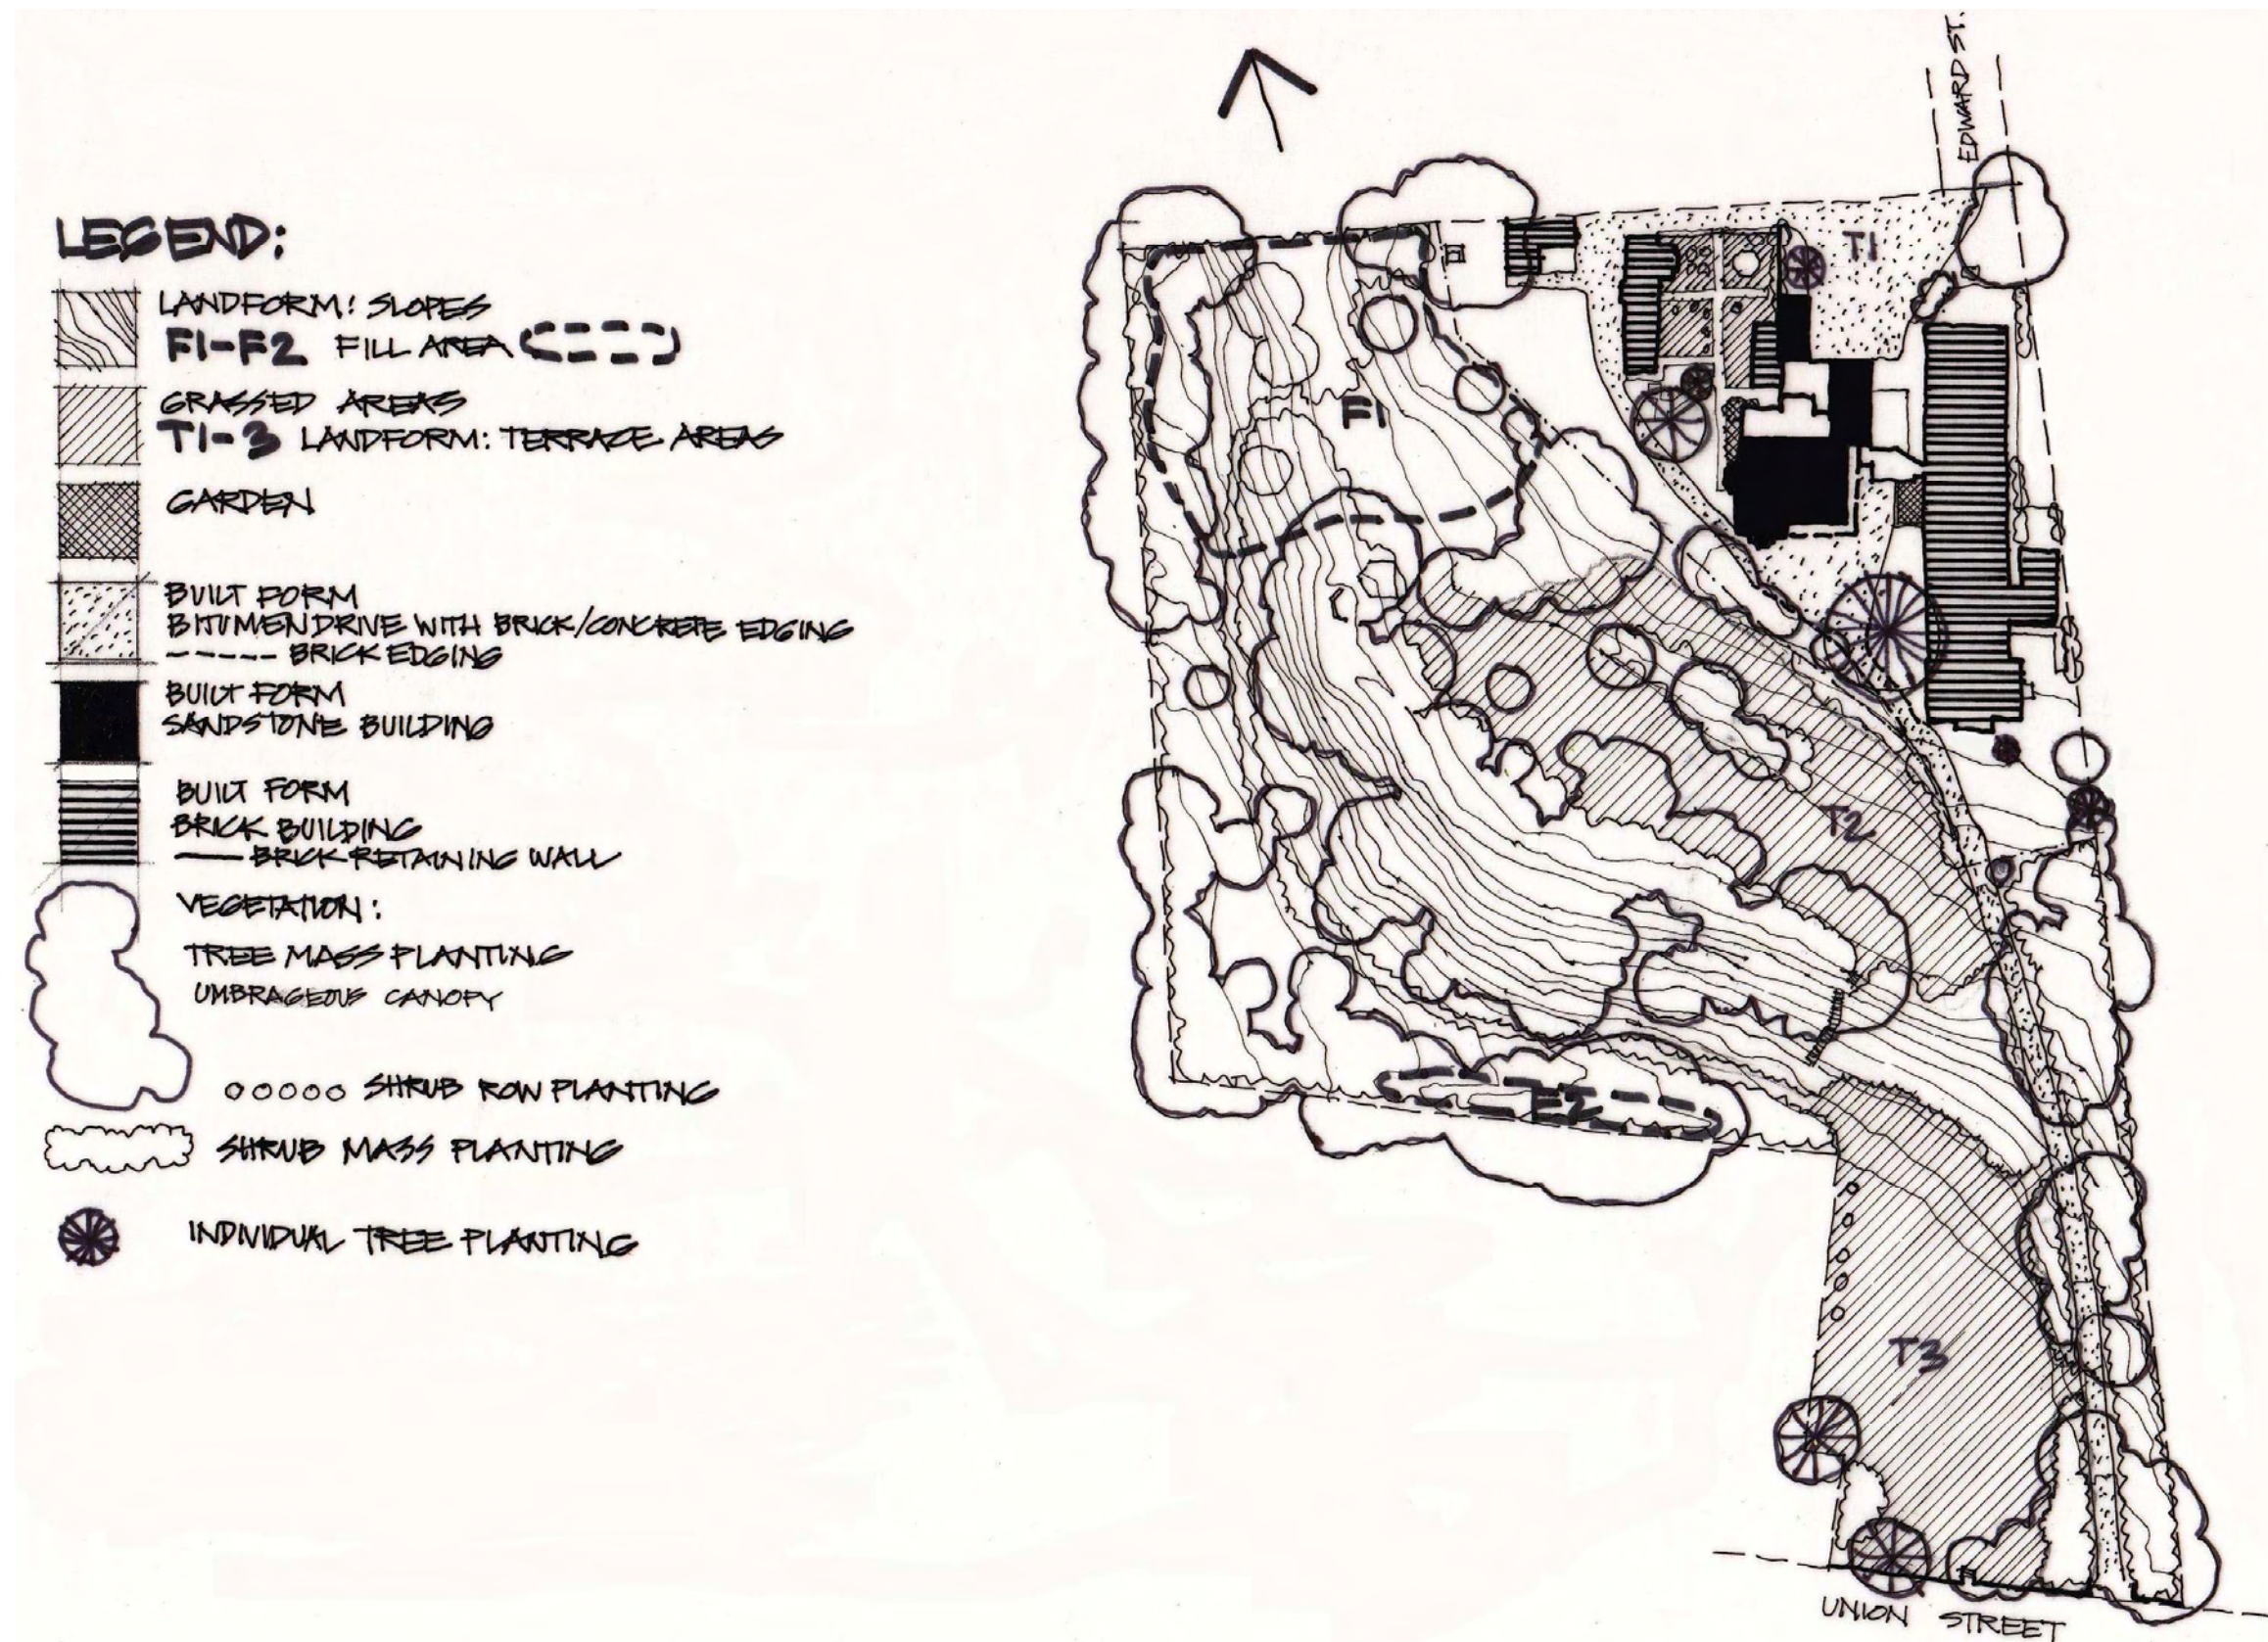
Figure 3.19 The key elements of the cultural landscape for Graythwaite.
Source: CAB Consulting, 2010.

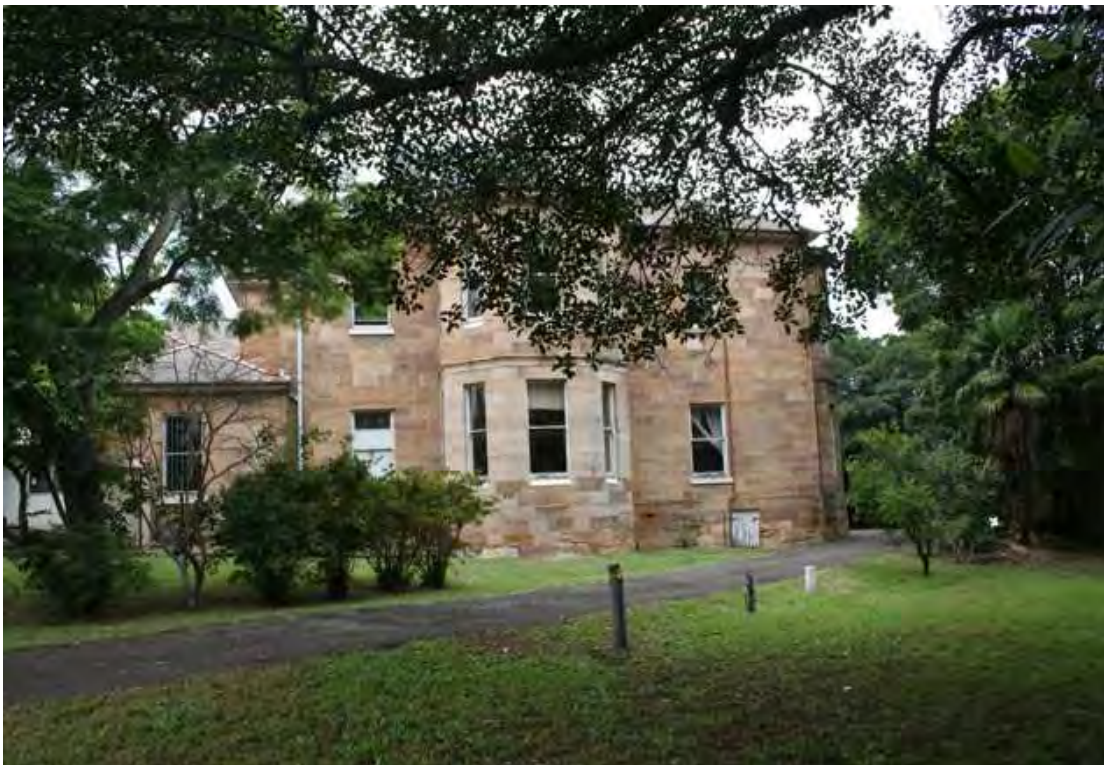
Figure 3.21 The west elevation of Euroka Villa (Graythwaite) today showing the 1870s remodelling by George Dibbs including the removal of the upper level balcony and the construction of the bay windows.
Source: Tanner Architects 2010.

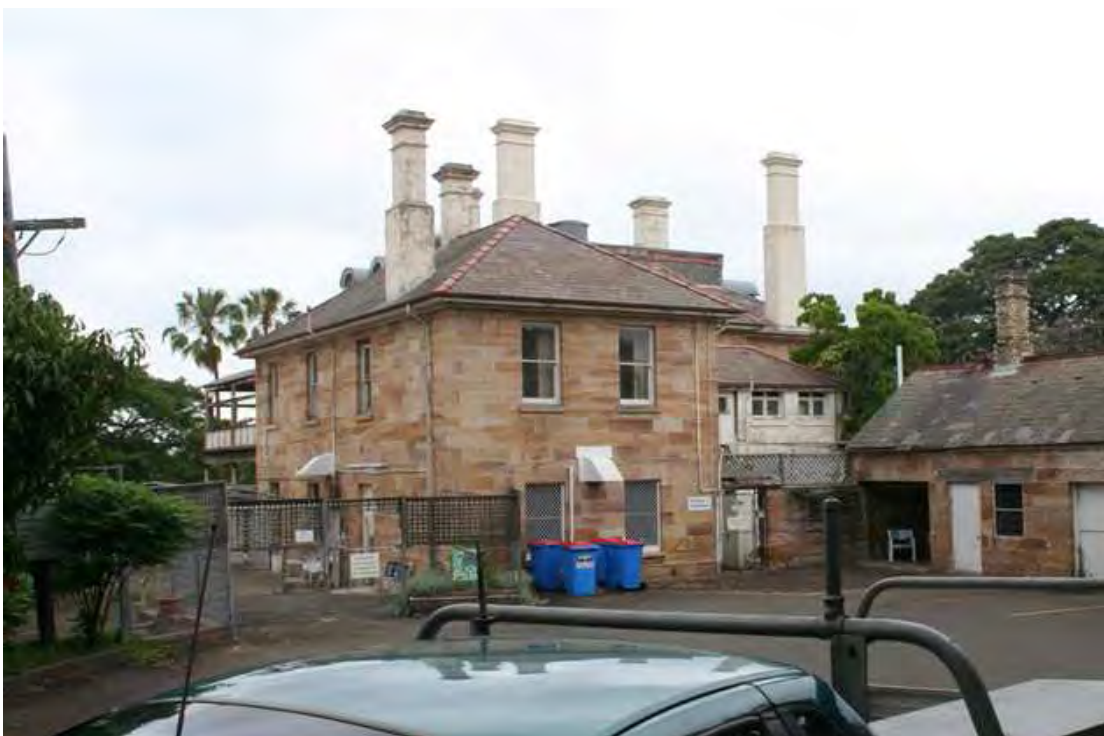
Figure 3.23 The same view today. A noticeable change is the lavatory/bathroom block attached to the rear of the House c1916 and the removal of the iron railing to the roof observatory. The garden setting has also been removed.
Source: Tanner Architects 2010.

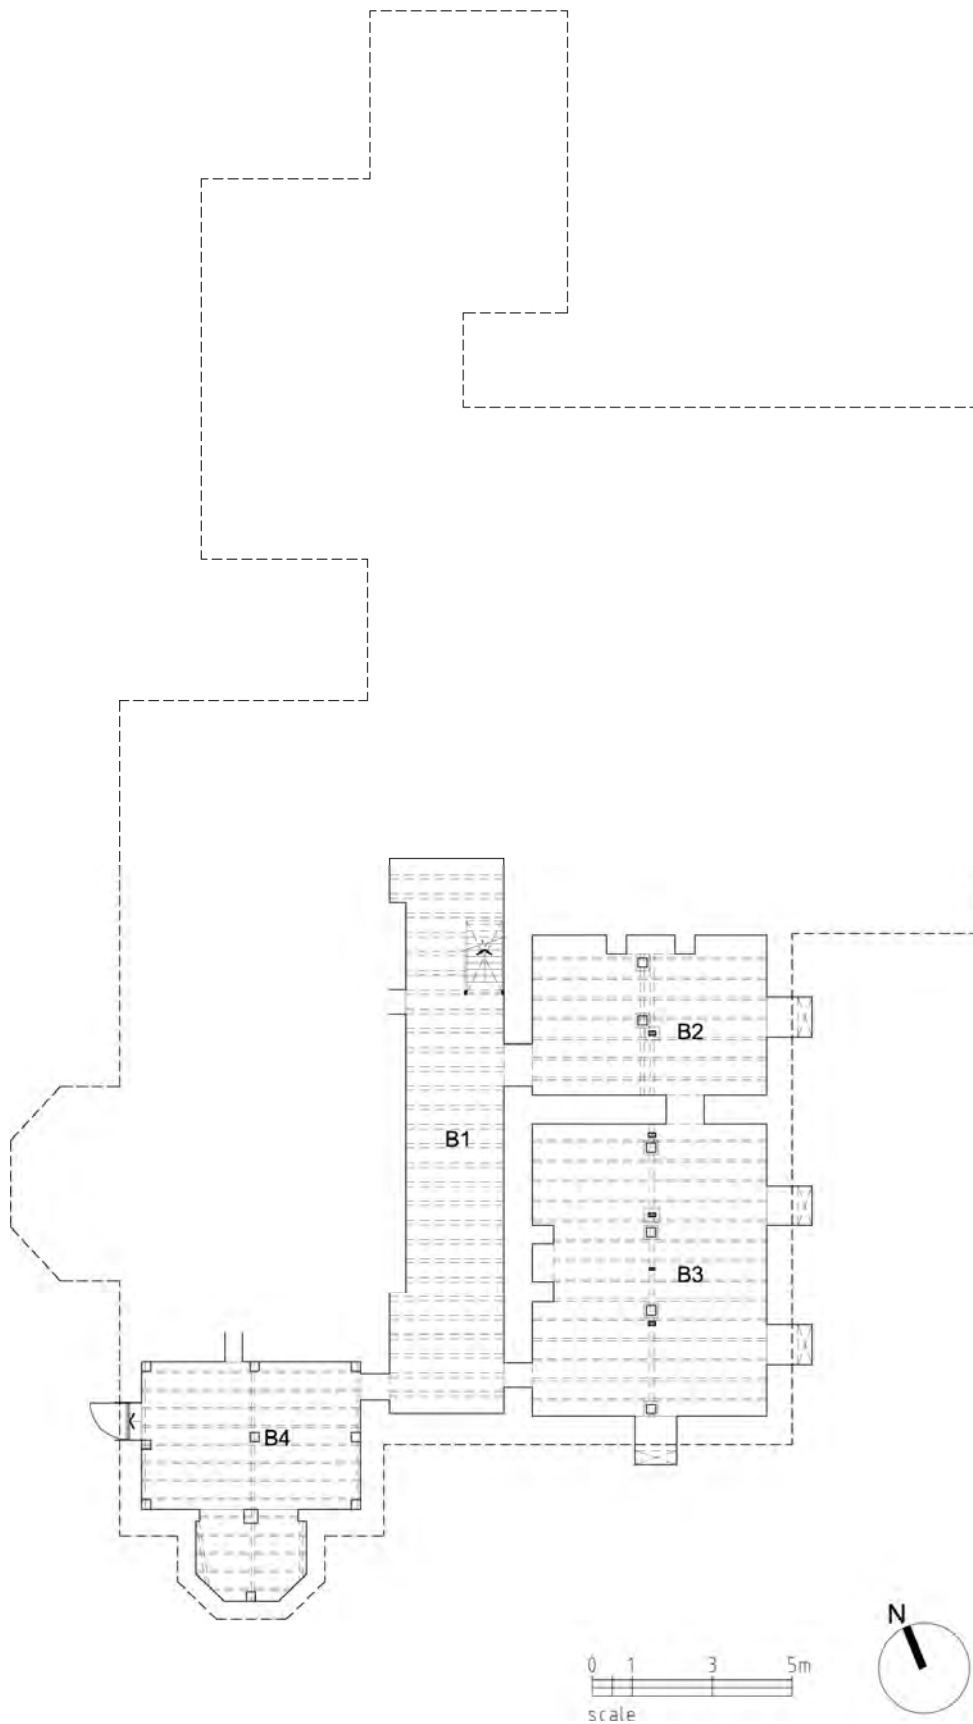
Figure 3.28 Basement floor plan of the House, existing conditions, not to scale.
Source: Tanner Architects 2010.

The basement comprises four interconnected spaces under the entrance hall (B1), the former drawing room (B2 and B3) and the southern part of G1 (B4) (see Figure 3.28). Access to the basement is by a timber-framed stair under the main stair (Stair 1) or by a doorway on the western wall of the House in B4. The floor to ceiling height is quite low and it is hard to envision the basement being used for anything other than rudimentary storage (see Figure 3.32).

The sandstone walls generally support the walls of the house above although there is a substantial cross wall under the reception room (G6), which does not appear to provide any structural support. The fireplaces in the reception room are supported by sandstone walls in B2 and B3. The width of the walls in spaces B1, B2 and B3 are greater than the walls in B4, providing evidence of the different phases of construction between the west wing (c1859) and the main part of the house (c1874). It is possible that the stone used in B1-B3 were salvaged from the c1833 Euroka Cottage. The width of the sandstone wall on the west side of B1 (and in the entrance hall (G5) above) varies, suggesting that the wider section may in fact form part of the western wall of the c1833 Euroka Cottage. The timber ceiling/floor joists in B1 are adzed, suggesting that they may be remnants of Euroka Cottage or may have been salvaged and re-used in c1874 to support the tessellated floor in the entrance hall. The soil floor of the basement may conceal stone flagging although none is currently evident. There is a later (c1980s) secondary system of structural support provided by brick piers supporting the ceiling/floor joists throughout B2, B3 and B4 (see Figure 3.33).

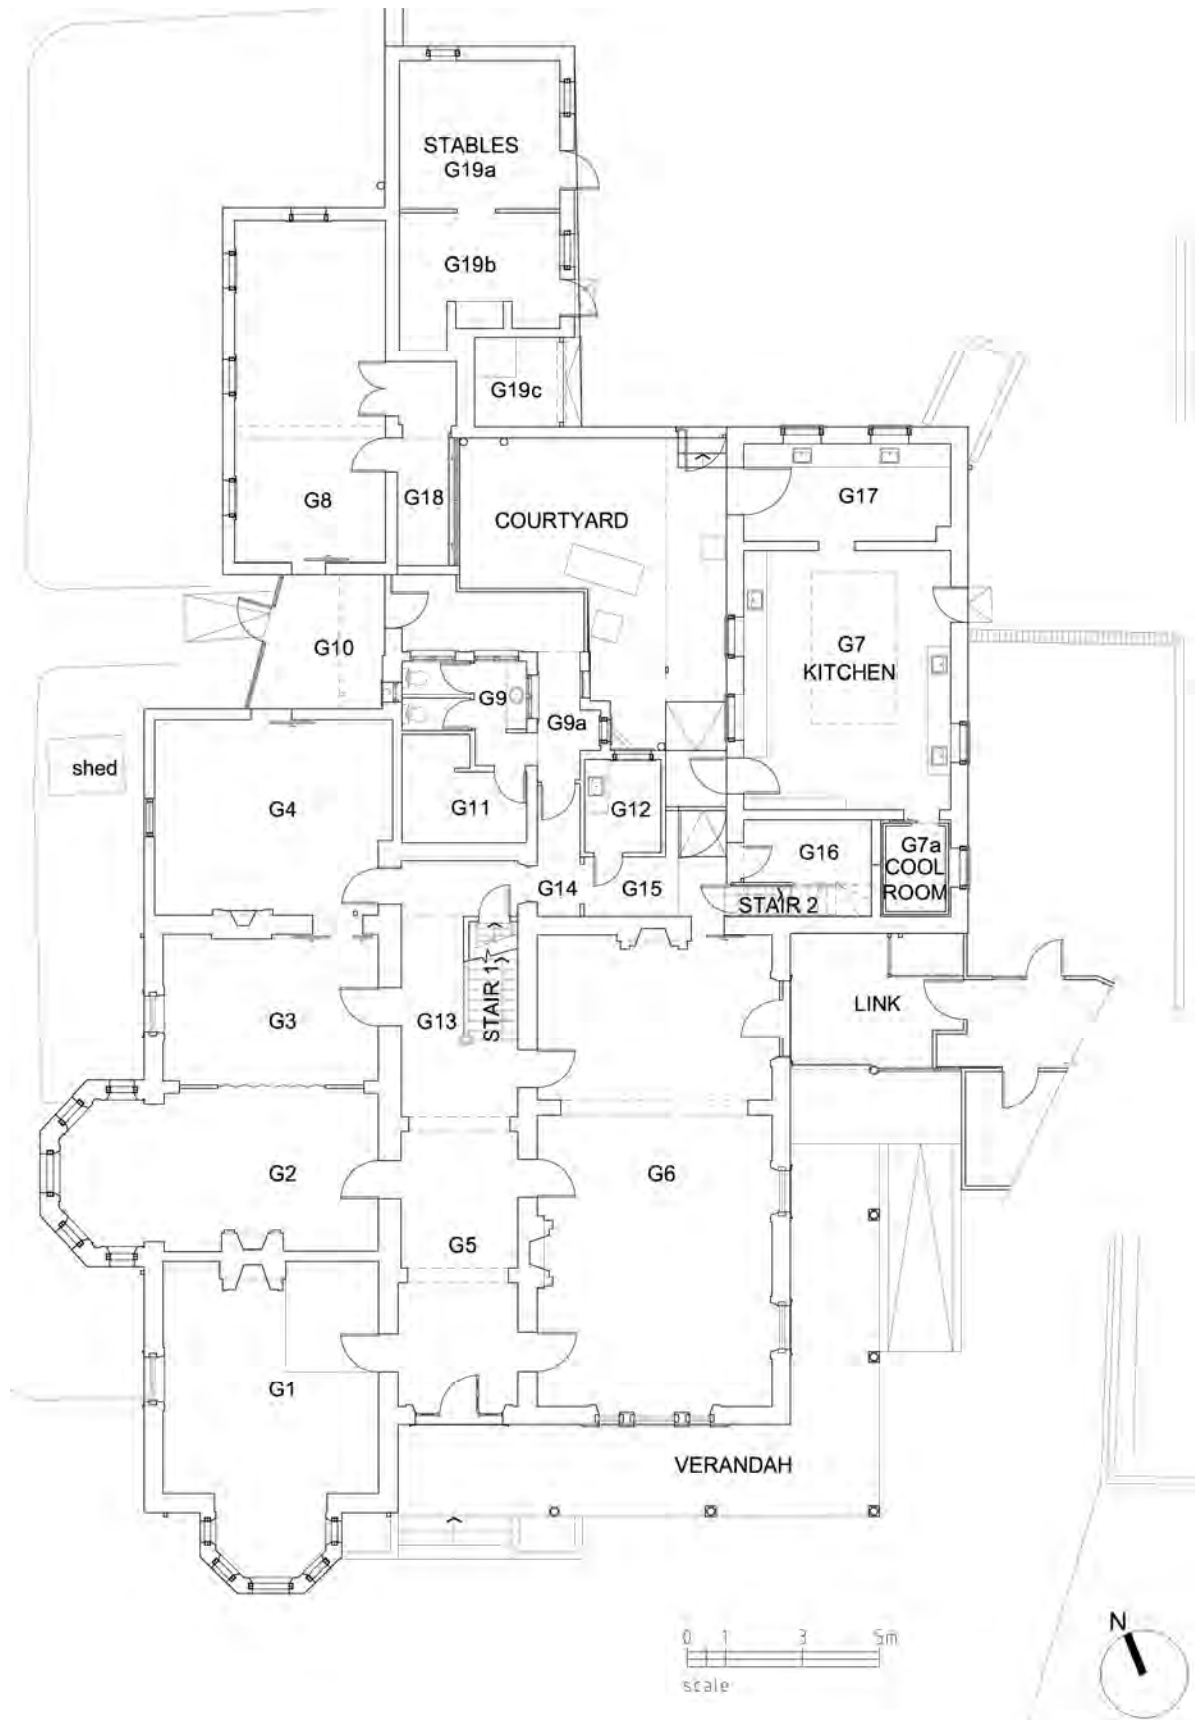
Figure 3.29 Ground floor plan of the House, existing conditions, not to scale.
Source: Tanner Architects 2010.

The ground floor of the house comprises large, formal living spaces divided by a wide central entrance hall (see Figure 3.29). The eastern half of the House dates from c1874 and is essentially two rooms—the entrance hall (G5/G13) and the large reception room used as a drawing room and ballroom (G6) during the Dibbs phase (1874-1915) and as a dining room during the Red Cross phase (1916-1980). The western half of the ground floor comprises three rooms (G1, G2 and G3) that form part of the two-storey wing constructed by Edwin Sayers c1859 (as modified by Dibbs c1874) and a fourth room (G4) added to the rear of the House by Dibbs in 1891.

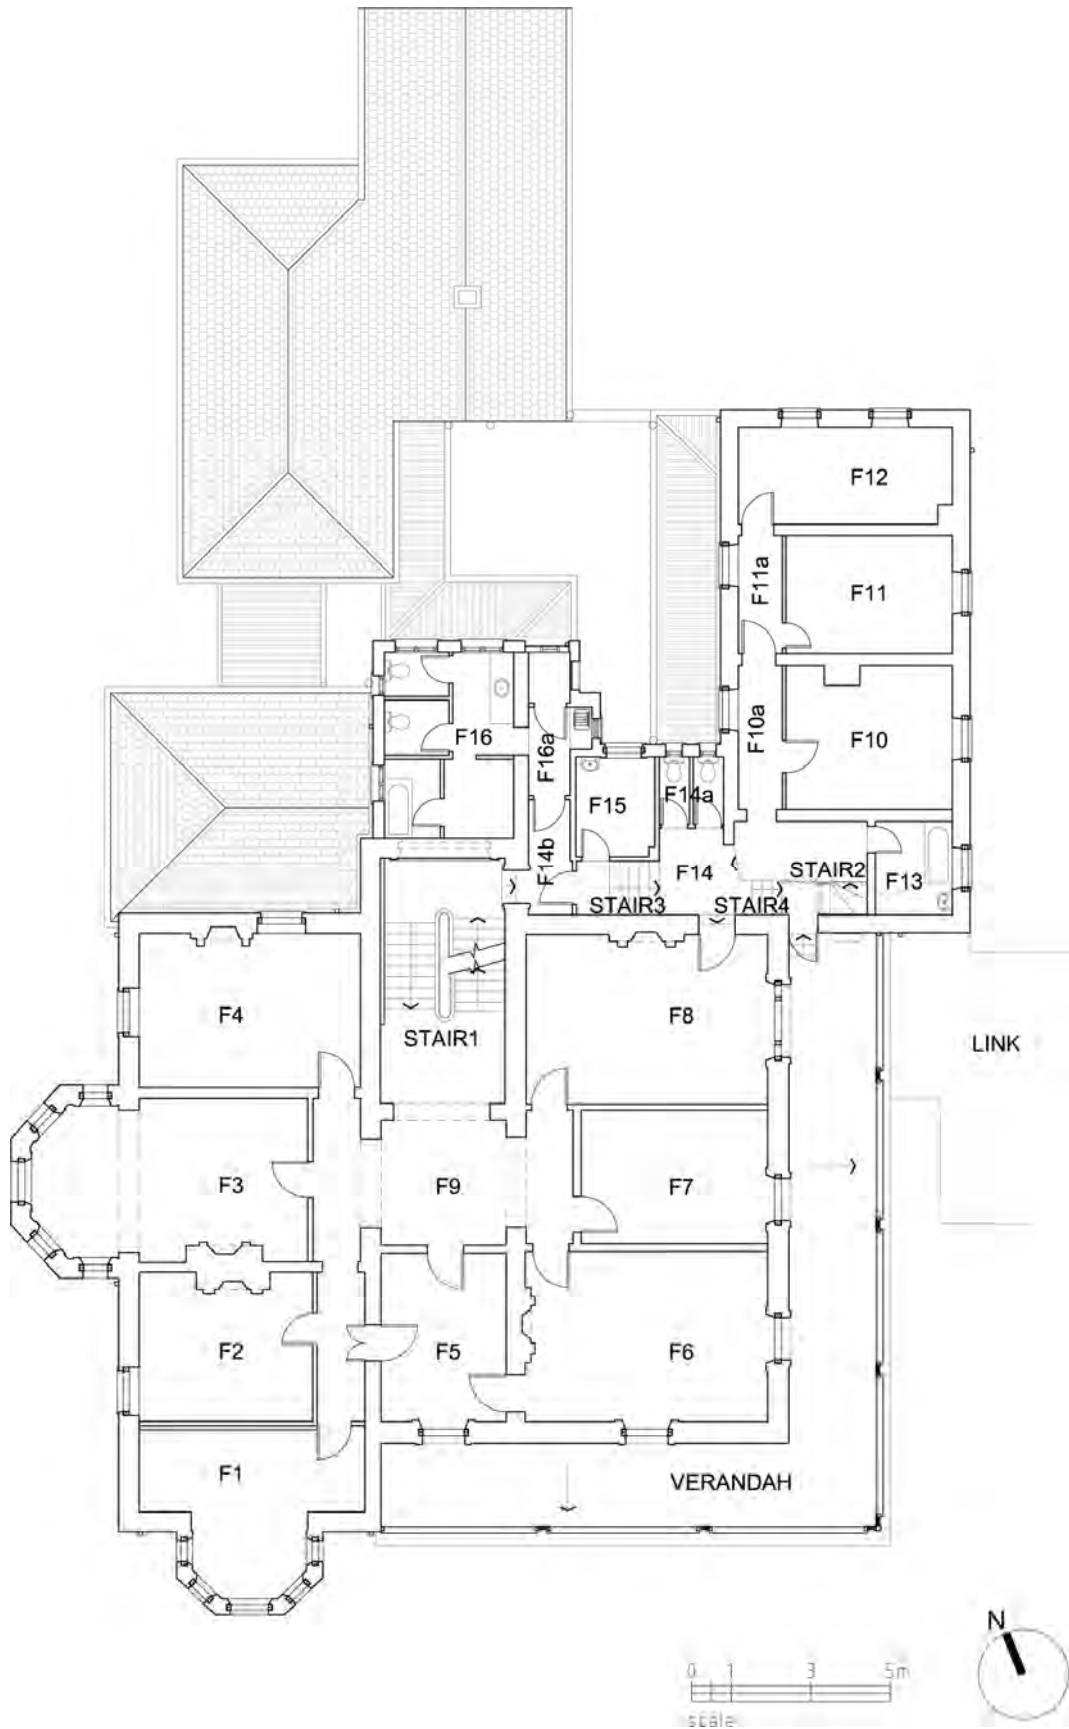
Figure 3.30 Graythwaite first floor plan of the House, existing conditions, not to scale.
Source: Tanner Architects 2010.

The planning of the first floor consists of an upper flight of the staircase (Stair 1) that leads to a central hall (F9) flanked by narrow cross halls to the former bedrooms (F1/2, F3, F4 and F6), possible dressing room (F7), and possible bathroom (F5). The arrangement of the rooms is essentially symmetrical when taking into account the different buildings phases—Rooms F1/F2, F3 and F4 and the access hall forms part of the west wing constructed by Sayers c1859, while the remainder is associated with the construction of the main part of the house by Dibbs c1874. An unusual aspect of the planning is the second door (DF8.2) in room F8 that leading directly to the service wing suggesting that this room was originally the nursery.

The plan form of the rooms is largely intact to the Dibbs phase apart from the partitioning of one of the bedrooms (F1/F2) during the Red Cross phase. Rooms F1 and F3 have bay windows constructed by Dibbs c1874. The rooms are mostly intact in regard to fittings such as flooring, skirting boards, architraves, windows and doors, fireplaces, cornice and ceiling to the Dibbs era. As with the first floor verandah facing rooms, W1.F5-F8 are French windows, and W1F8 has side lights. The painted wall and ceiling treatments of the Dibbs phase are probably recoverable upon investigation.

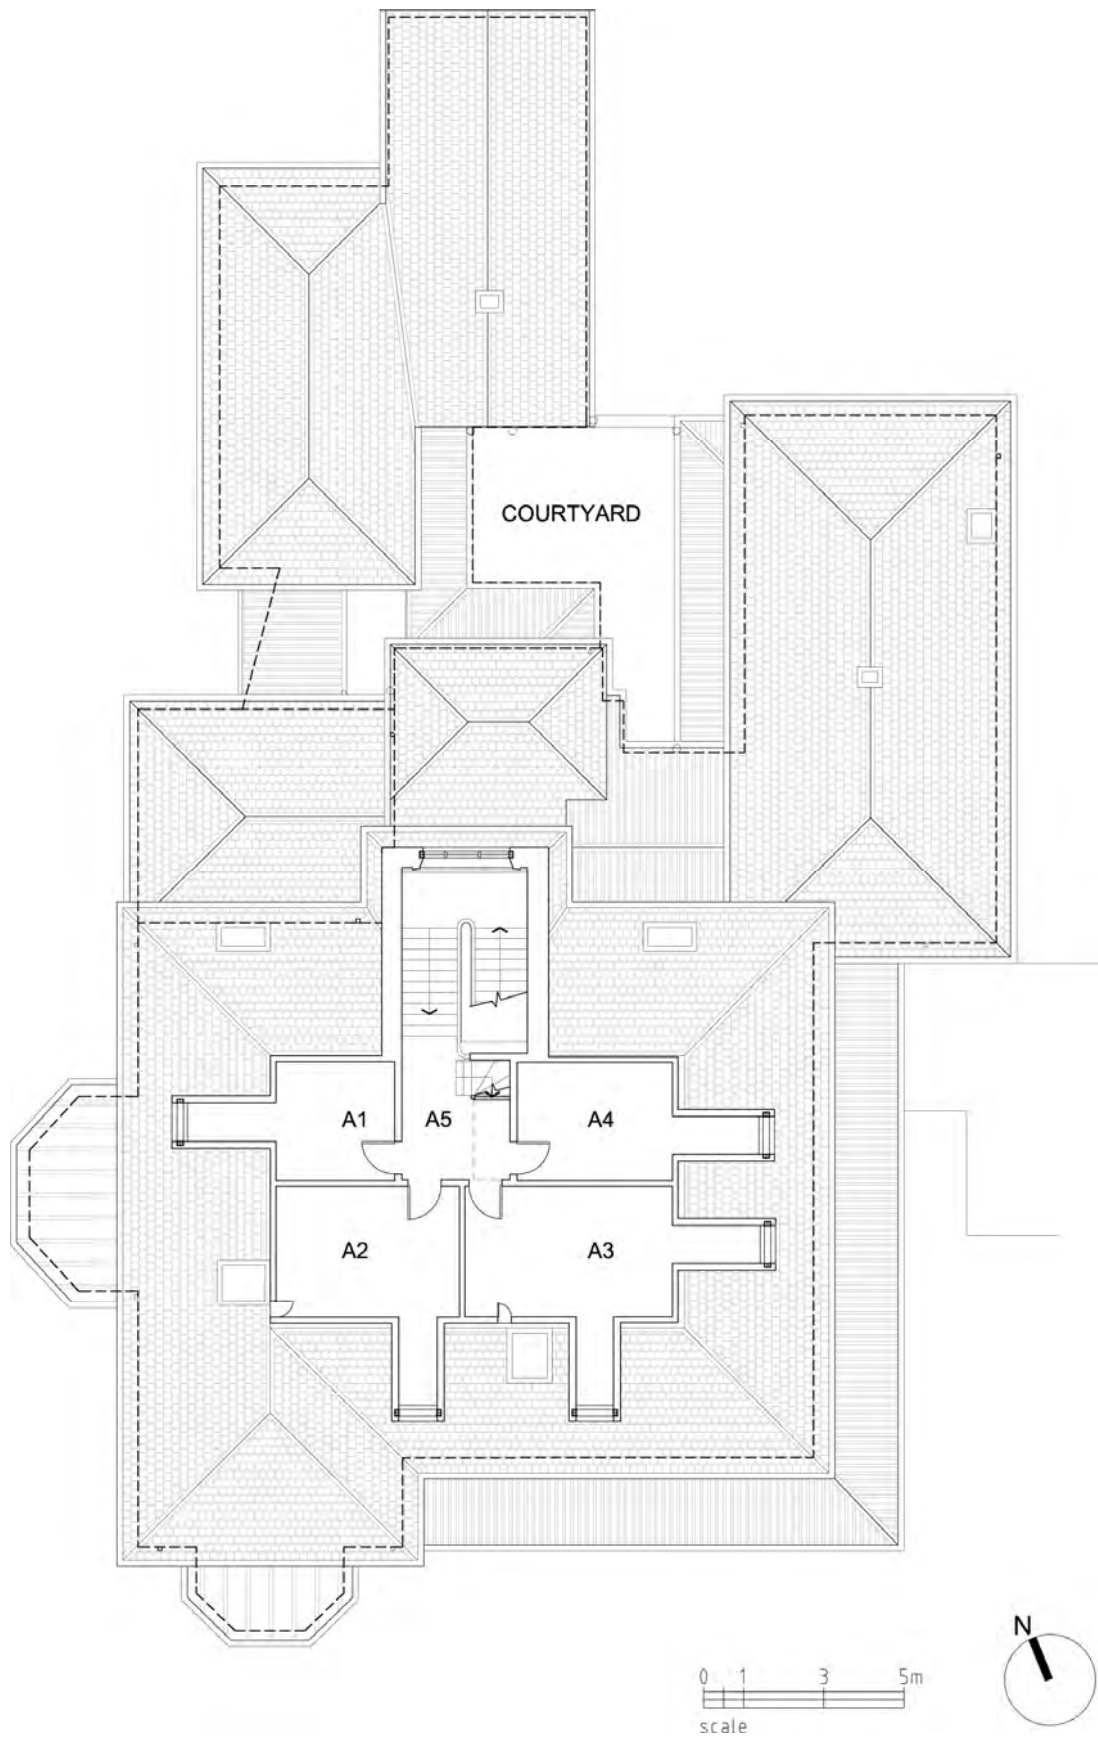
Figure 3.31 Attic plan of the House, existing conditions, not to scale.
Source: Tanner Architects 2010.

The planning of the attic floor level consists of the last flight of the main stair (Stair 1) that leads to a hall (A5) that provides access to former bedrooms (A1-A4). The hall features a smaller stair that leads to the roof observatory (or widow's walk). The Attic floor level was constructed by Dibbs as part of the c1874 construction of the main part of the house.

Each bedroom is features a dormer window set within a narrow space distinct from the room proper. The windows are double hung sashes with the upper sash having a rounded head. The rooms are mostly intact in regard to fittings such as flooring, skirting boards, architraves, windows and doors and ceiling to the Dibbs phase. Room A2 has a set of cedar fitted cupboards, which date from the Dibbs phase. A discernible later alteration is the addition of highlights above the doors facing onto the hall, which appear to date from the 1950s. There are no fireplaces on this level.

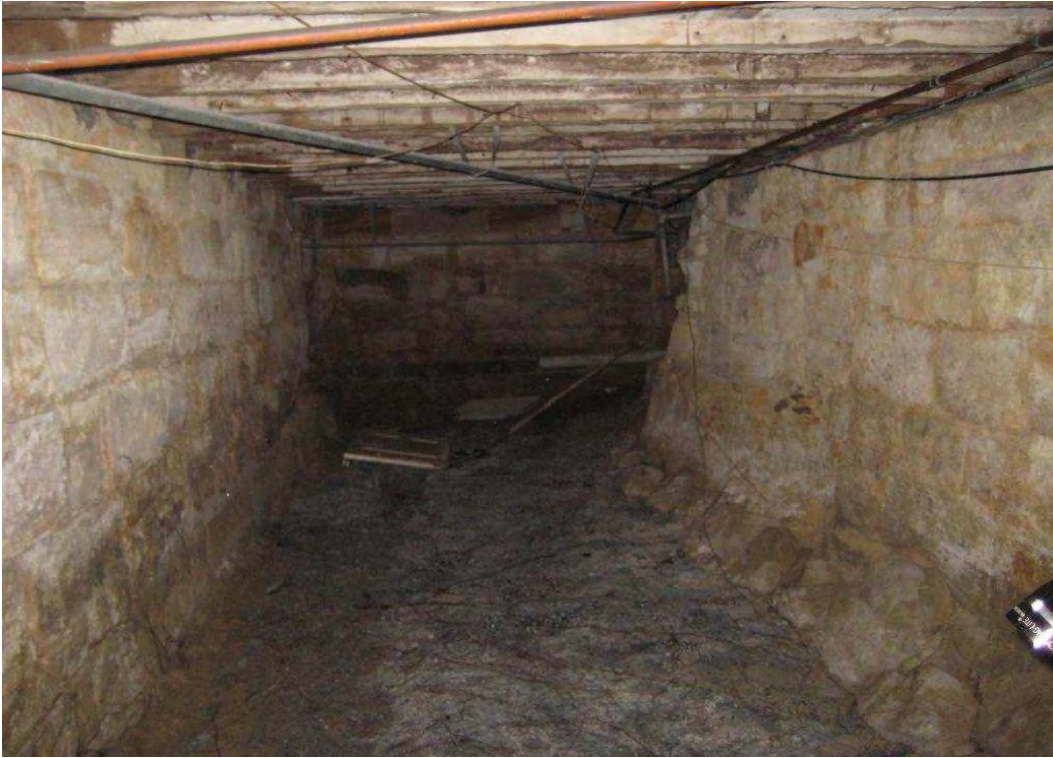
Figure 3.32 looking south in basement room B1 (under the entrance hall).
Source: Tanner Architects 2010.

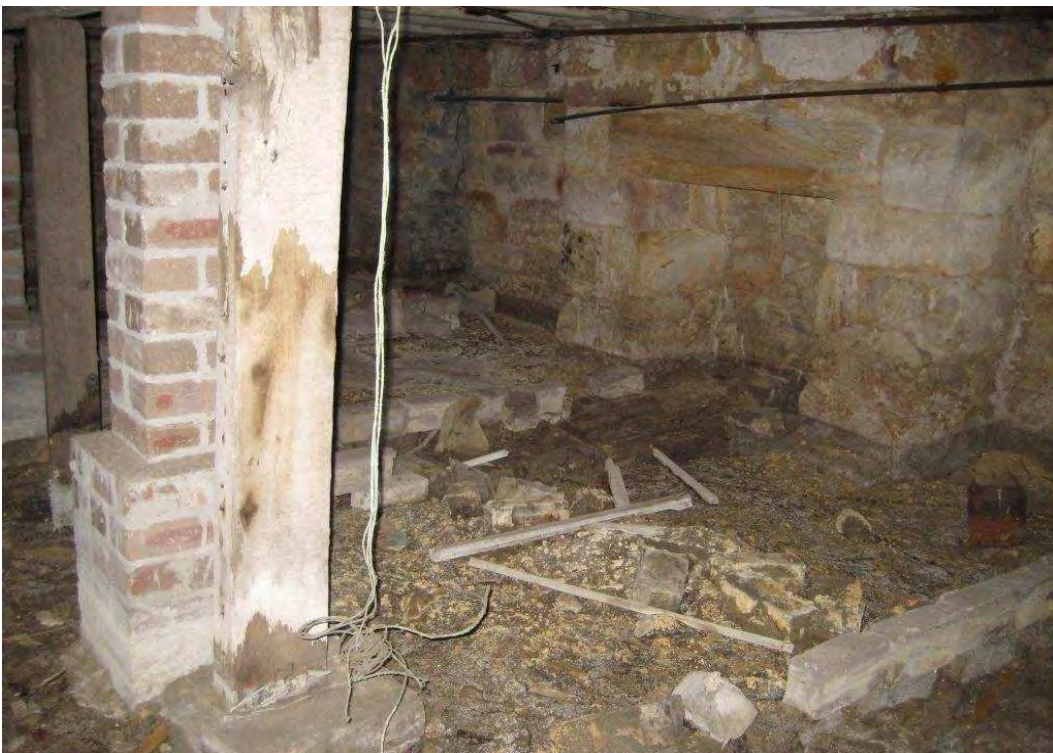
Figure 3.33 Basement room B3, showing masonry support for fireplace and additional brick pier and timber post supports.
Source: Tanner Architects 2010.

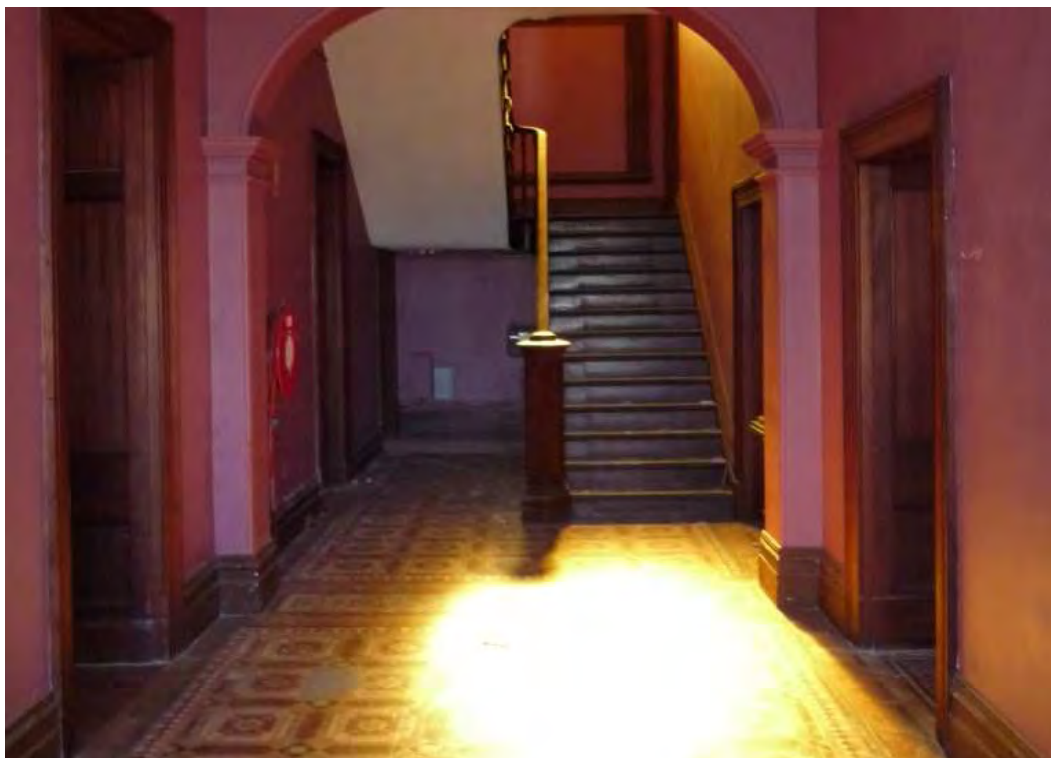
Figure 3.35 The entrance hall today. Note the tessellated tiles have been retained, while the wall brackets (on each wall nib) have also been salvaged and stored elsewhere in the building.
Source: Tanner Architects 2010.

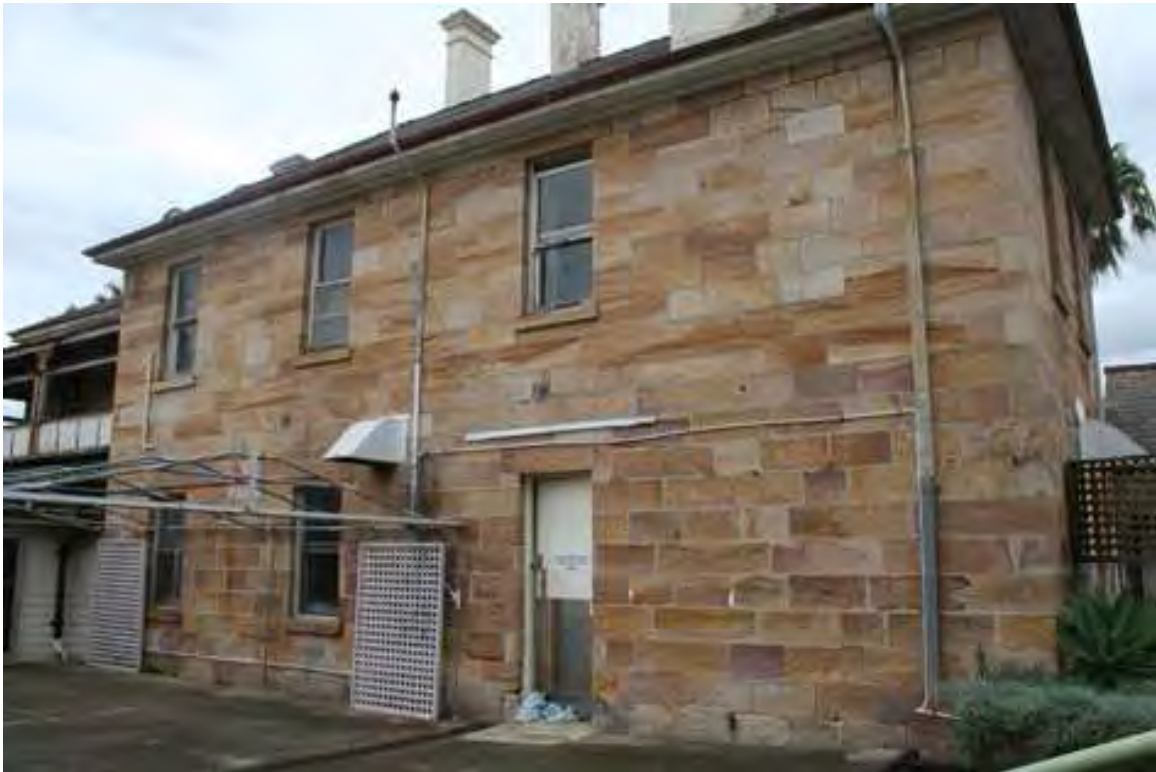
Figure 3.40 The east (garden facing) elevation of the kitchen wing.
Source: Tanner Architects 2010.

The building seen today was evidently designed to present a formal front to the east garden while the west, courtyard facing, elevation is more utilitarian. The windows on the east, north and upper west elevations are single paned sashes while the lower west elevation has multiple-paned sashed windows and suggest an earlier date of construction (probably 1850s). A verandah or covered way with a coved roof runs the length of the west elevation and fronts a courtyard.

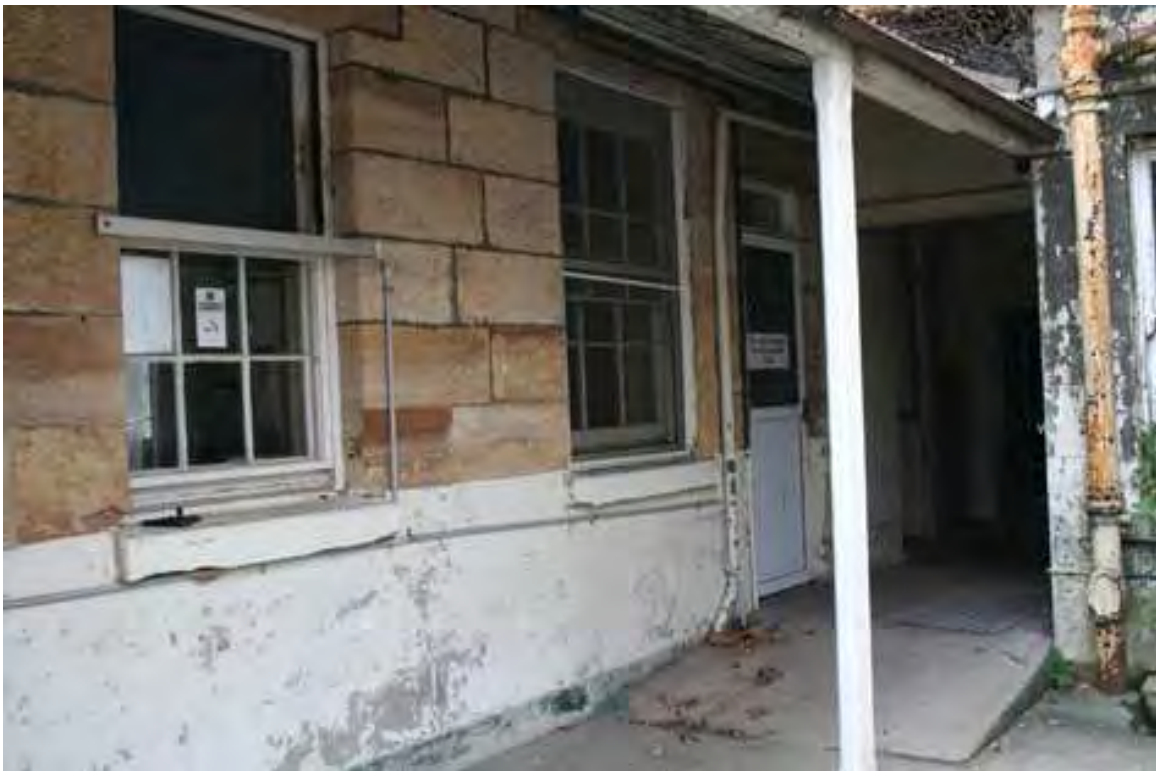
Figure 3.41 The west (courtyard facing) elevation of the kitchen wing.
Source: Tanner Architects 2010.

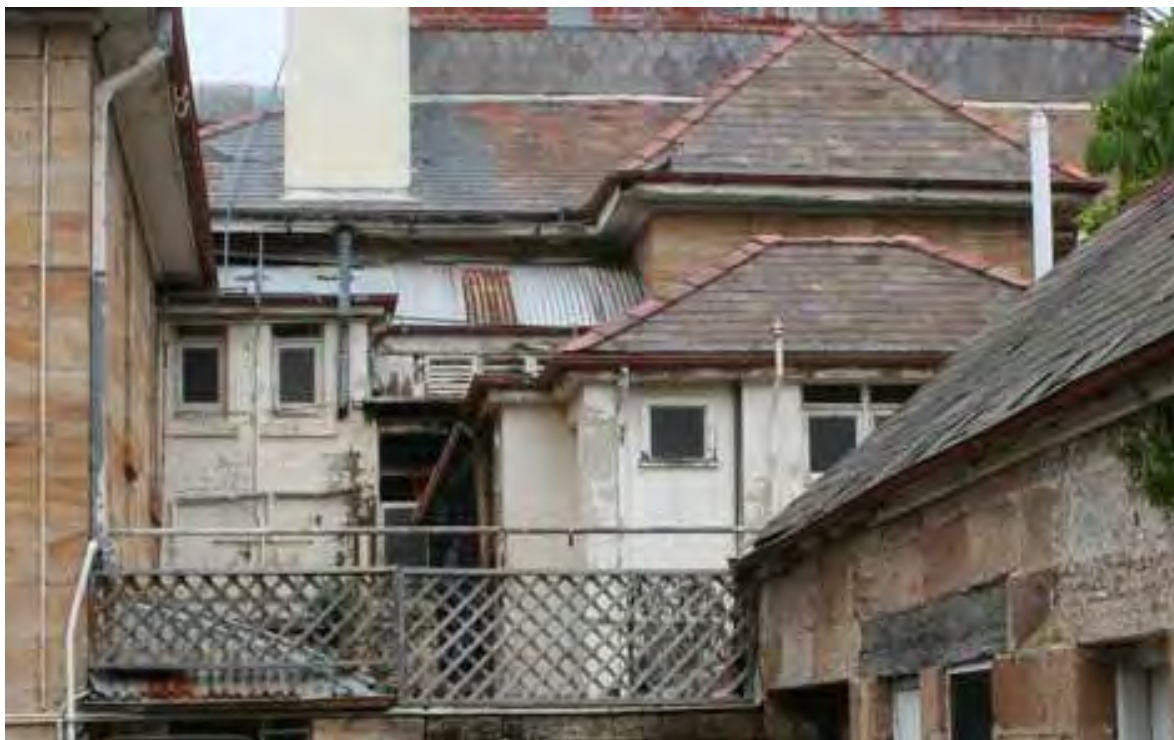
Figure 3.44 The exterior of the first floor of the bathroom and lavatory block addition. Note the form of the c1874 part of the House (beyond) and Kitchen Wing (at left).
Source: Tanner Architects 2010.

The bathroom and lavatory block was one of the major developments of the 1915/1916 conversion of Graythwaite from a residence into a convalescent home. The bathroom and lavatory block is a two storey brick building with coursed rendered external walls. The roof is in two parts, the main body of the structure having a hipped element with slate tiles, the other being a skillion. The windows are casements and double hung sashes. The addition is built up to the rear elevation of the c1874 section of the House and in part incorporates the earlier covered way or verandah (Stair 3 and G15) with a coved roof.

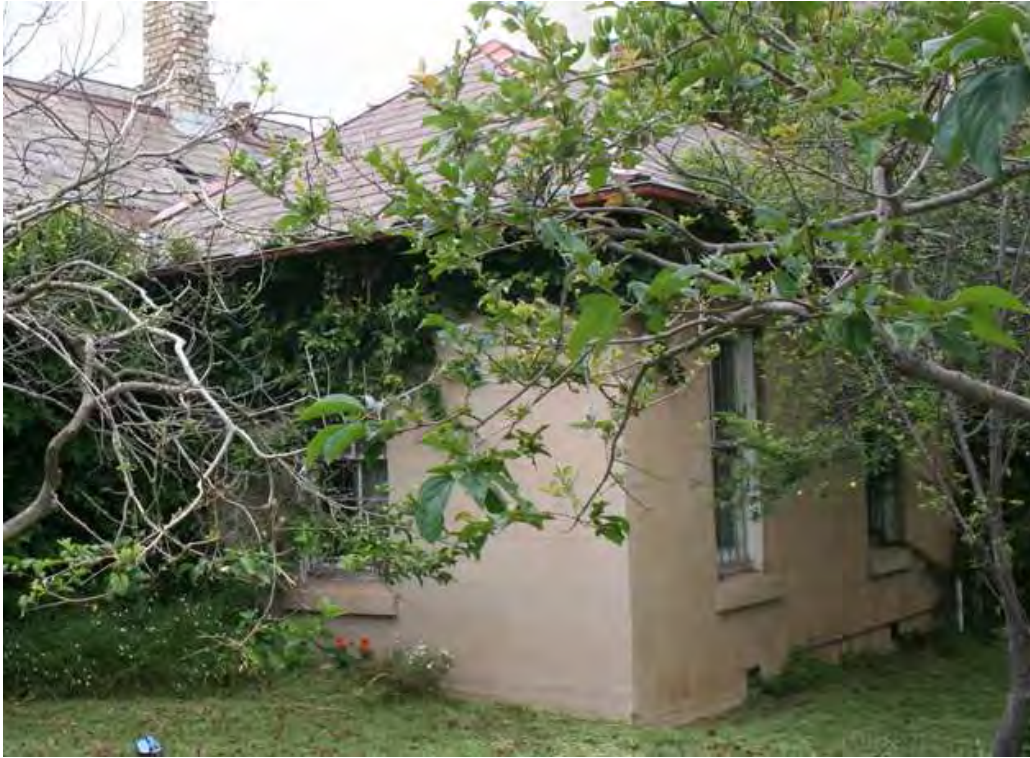
Figure 3.46 The exterior of the former Massage Room/Doctor's Room.
Source: Tanner Architects 2010.

The building is a single storey brick building rendered with ashlar coursing and with a hipped roof clad in slate tiles and partly abuts the former stables building. An unpainted section of the wall finish visible in the link with the house (G10) indicates the cement mix was coloured to give a sandstone-like appearance. The east wall is formed in part by the sandstone wall of the stables building. Internally, the walls are plastered with timber picture rails and skirting boards, the ceiling in the lower section is pitched, and the doors are four panelled. The floor is timber under vinyl. The interior is well-lit by a number of double sash windows.

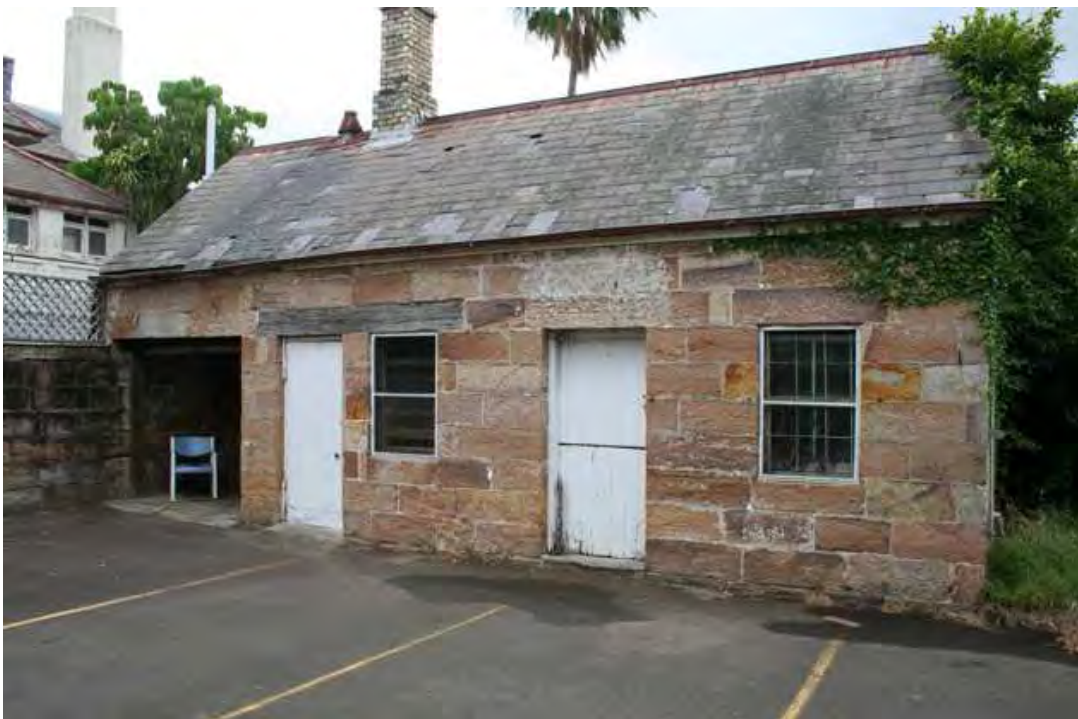
Figure 3.49 The east elevation of the former Stables Building today.
Source: Tanner Architects 2010.

The east elevation of the building has two large openings on the south side (one since infilled and now formed by door DG19.1 and window W1.G19, and original door (DG19.2) and window (W2.G19) openings. The southernmost opening is shown in a drawing of 1916 as the boiler room and this use seems to have continued well after the Second World War (the service has been removed but the ceiling housing for the flue remains as does the flue, although not insitu). The original boiler could have been installed in 1883 as part of the Raleigh Patent hot water service Thomas Dibbs had fitted.¹ The room today serves as storage and there is a roller door. Another 1880s alteration is the addition of the brick chimney and fireplace in room G19b, and the overall refurbishment of the flooring. The changes were probably made when the Coach House was constructed c1888.

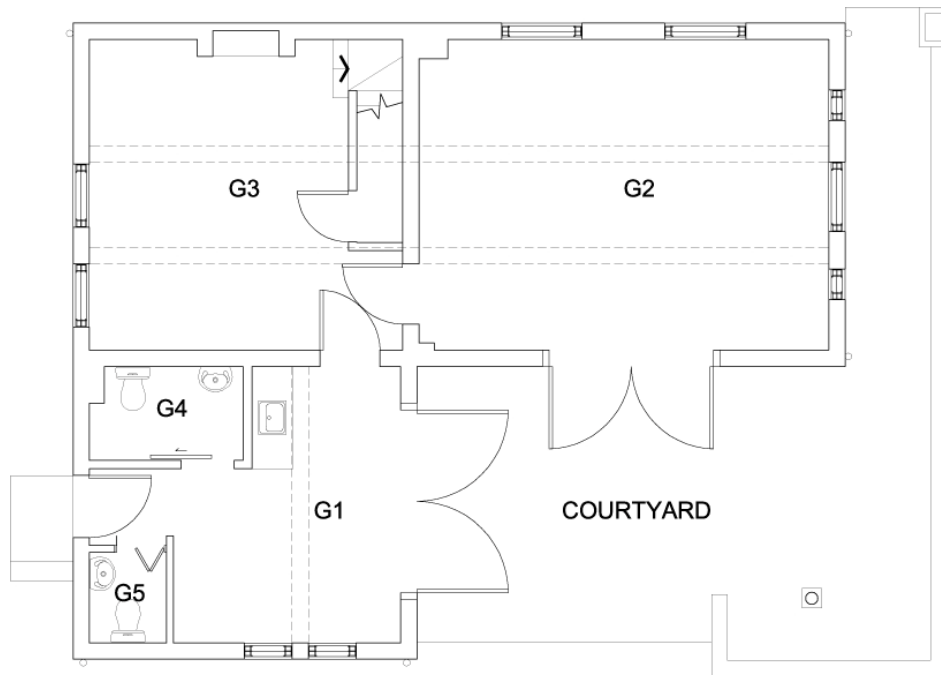
Figure 3.53 The ground floor plan of the coach house, not to scale.
Source: Tanner Architects 2010.

Internally, the ground floor comprises three large rooms that closely approximate the original planning as demonstrated by a survey floor undertaken in 1943; in this survey Space G1/G4/G5 was a garage, G3 was storage, and the use of G2 was unknown. One of the large spaces (G1/G4/G5) was subdivided in the mid-1980s. The walls are painted brick and the ceiling is the framing and boarding of the floor above. The double hung sash windows have a simple boarded architrave with applied edge beading. Space G3 has a plain brick fireplace and stair. Four panelled doors lead to the former coach house (perhaps G2 given the number of windows) and stable (G1). The flooring is covered in each space. The joinery fabric requires further examination to determine date as some elements may have been replaced in the 1980s renovation. Overall this level has a high level of integrity of plan form and probably also fabric. Removal of the floor lining may reveal physical evidence to determine the former uses of G1/G4/G5 and G2.
