3.4 The House Complex

3.4.2 The House

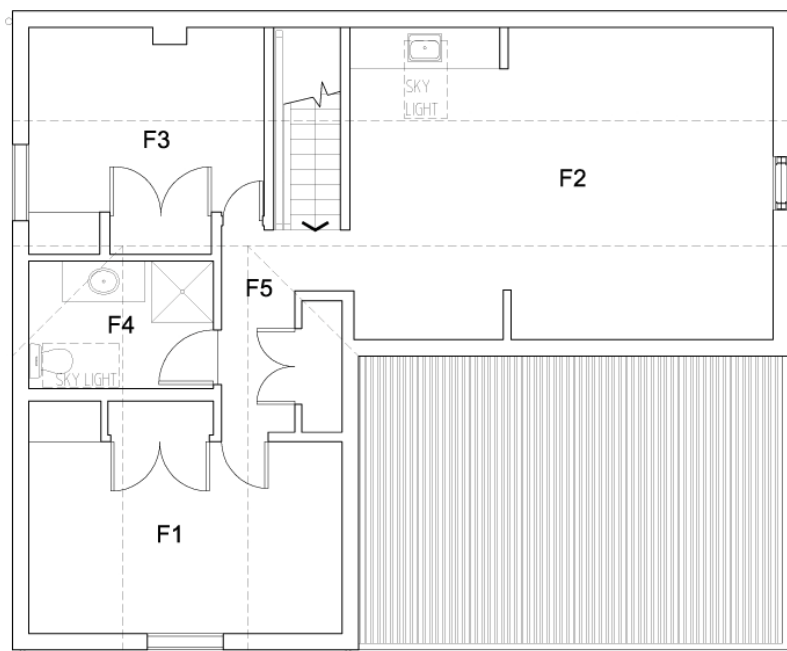
Figure 3.54 The first floor plan of the coach house, not to scale.
Source: Tanner Architects 2010.

The loft prior to the mid-1980s comprised a large space at the eastern end with a timber staircase. An early survey of this floor undertaken in 1943 shows an open space then being used for male staff sleeping quarters. The current floor configuration dates entirely from the mid-1980s and provides small rooms evidently for medical staff uses (F1, F3, F4) and a larger communal room (F2). The walls have been sheeted in plasterboard and the ceiling lined in beaded tongue and groove boards, all dating from the 1980s renovation. The bathroom space (F4) has a modern tiled wall and modern fittings. The flooring is covered in each space but is timber boarded. Access to this floor is by the steeply pitched timber framed stair off F5. The dog-leg form staircase has a simple timber handrail and newel posts and is without balustrading. The location of the staircase is original, but the fabric may not be. Overall this level has a low level of integrity of plan form and fabric, although removal of the linings may reveal earlier, more significant fabric. The exceptions are the original window openings and staircase that are of a higher level of significance.

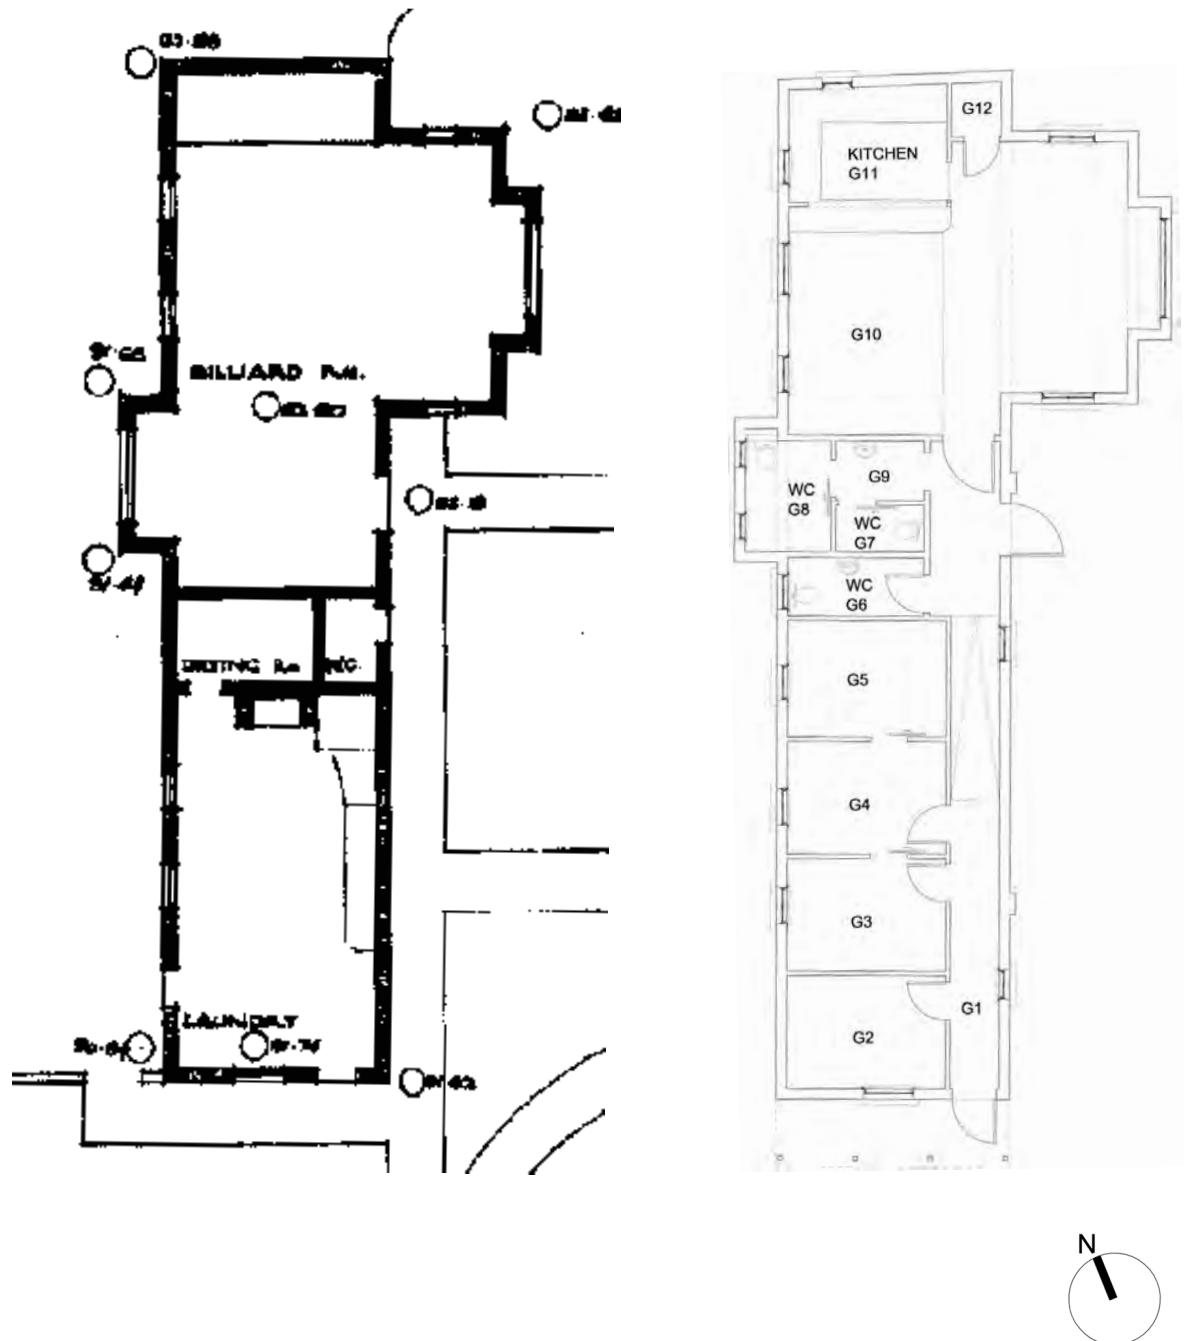
Figure 3.55 The ground floor plan of the former Tom O'Neill Centre in 1943 (LHS) and existing conditions, not to scale.
Source: NSW Public Works Department Drawing PH84_4 and Tanner Architects 2010.

The current internal room configuration dates from alterations undertaken in 1953 to provide modern male staff quarters (Figure 3.55). It includes an upper level at the north end and a lower level at the south end. The two levels are connected internally by a long ramp that extends down an east corridor. The upper level contains a large space—the former billiard room, kitchen and toilets. The lower level has been subdivided into four rooms of similar proportions—three of which are interconnected. These rooms show evidence of being used for a kitchen and accommodation/office space. Most of the internal fabric has been modified since the 1950s, although some evidence of early details still remain in the main open space on the upper level.

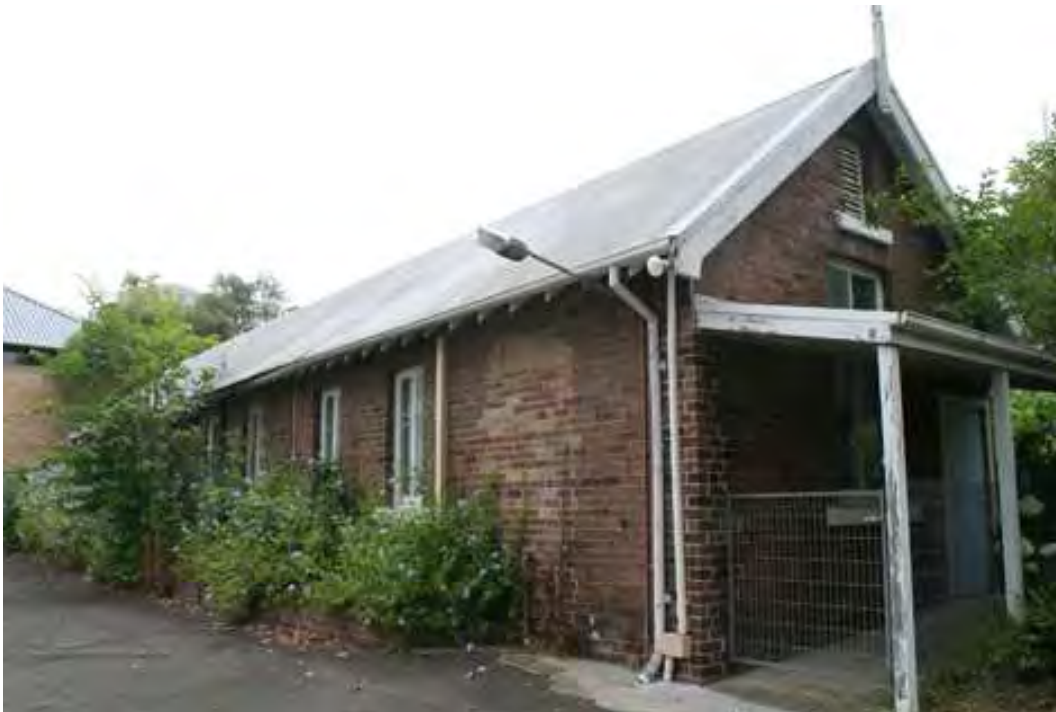
Figure 3.57 The west and south elevations of the former Laundry and Billiard Room (now known as the Tom O'Neill Centre).
Source: Tanner Architects 2010.

Known in recent years as the Tom O'Neill Centre, the building's original date of construction is unconfirmed. It may have been developed by Thomas Dibbs as it is similar in detail to another (now demolished) building located to its east known to have been constructed in 1891. While no documentary evidence for its construction in this period has been found, the location of the building relative to the formal paved garden suggests an earlier date of construction. In 1916 the building was the co-joined laundry and billiard room, which was used by the returned soldiers. As there is no documentary evidence to support a c1915/16 date of construction, the billiard room is likely to date from the Thomas Dibbs era. Most houses of this social standing had a billiard room and there is no evidence in the main house for such use. The billiard room was well lit by an east-facing window which had an outlook onto the neighbouring formal garden.

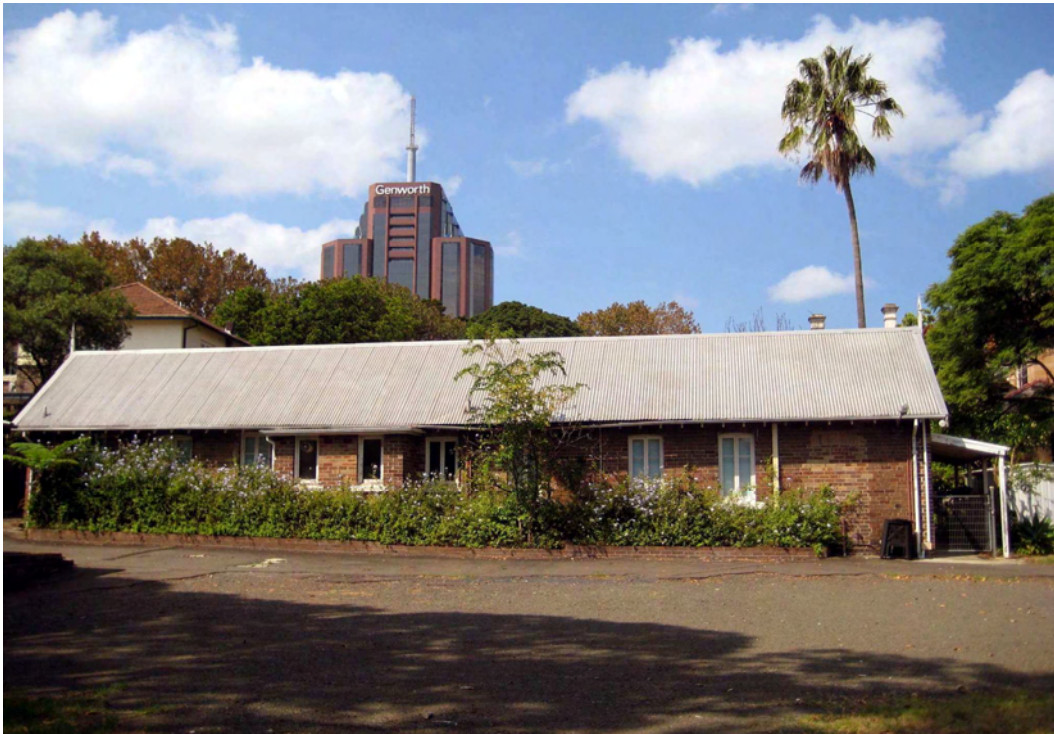
Figure 3.58 The east elevation of the former Laundry and Billiard Room (now known as the Tom O'Neill Centre). The projecting wing housed the billiard room.
Source: Tanner Architects 2010.

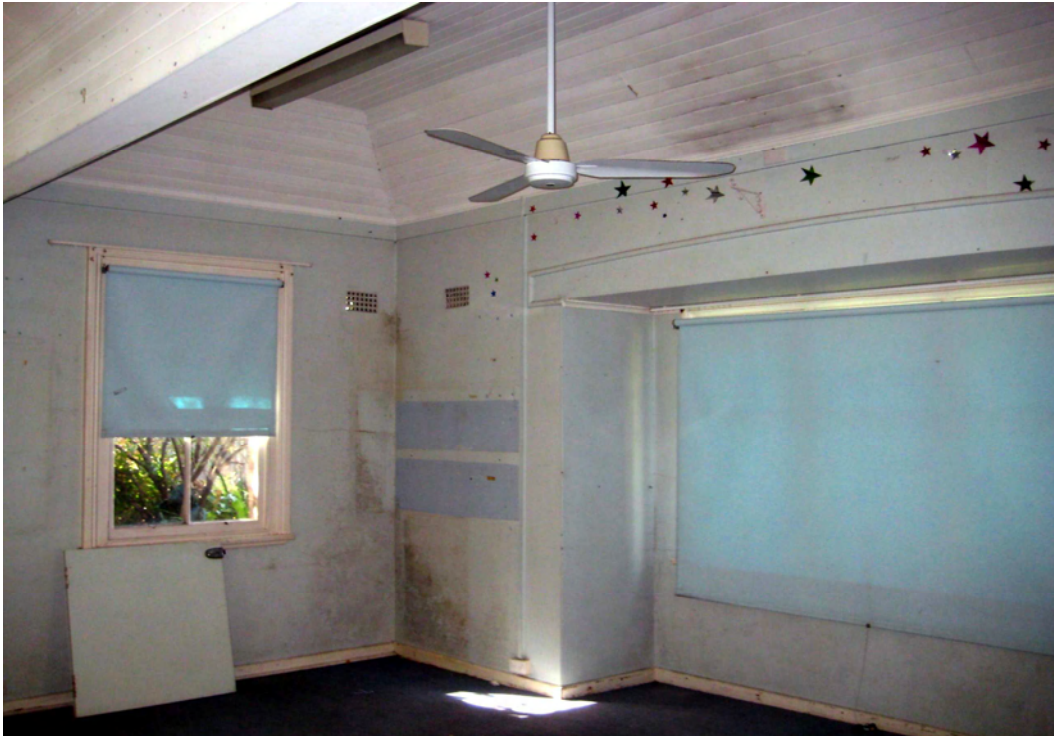
Figure 3.59 The interior of the former billiard room, within what is now known as the Tom O'Neill Centre.
Source: Tanner Architects 2010.

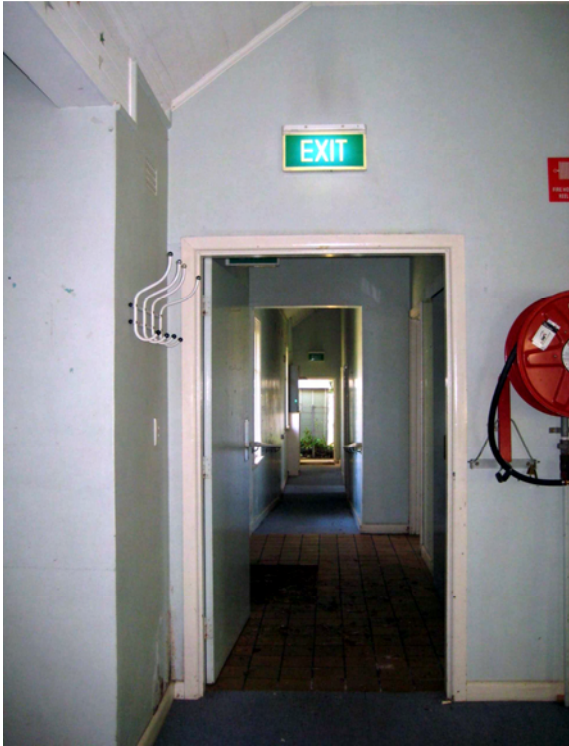
Figure 3.60 Looking south down the corridor of the former Tom O'Neill Centre.
Source: Tanner Architects 2010.

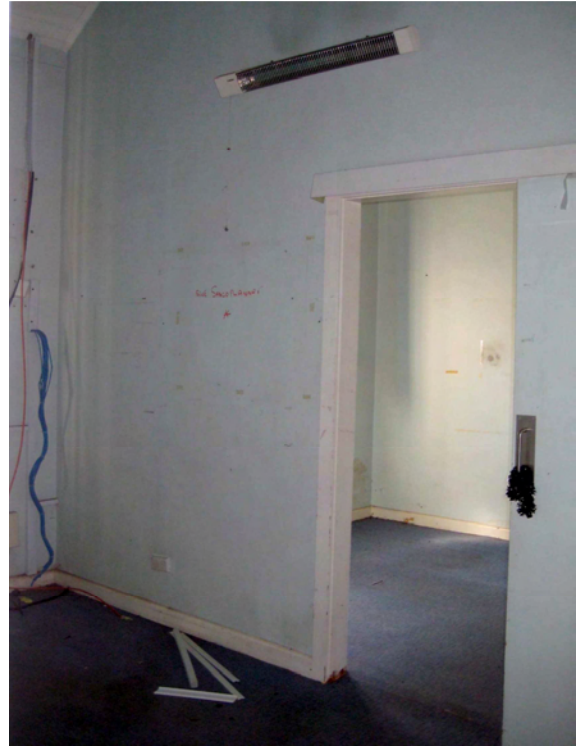
Figure 3.61 Two of the separate rooms to the west of the main corridor.
Source: Tanner Architects 2010.

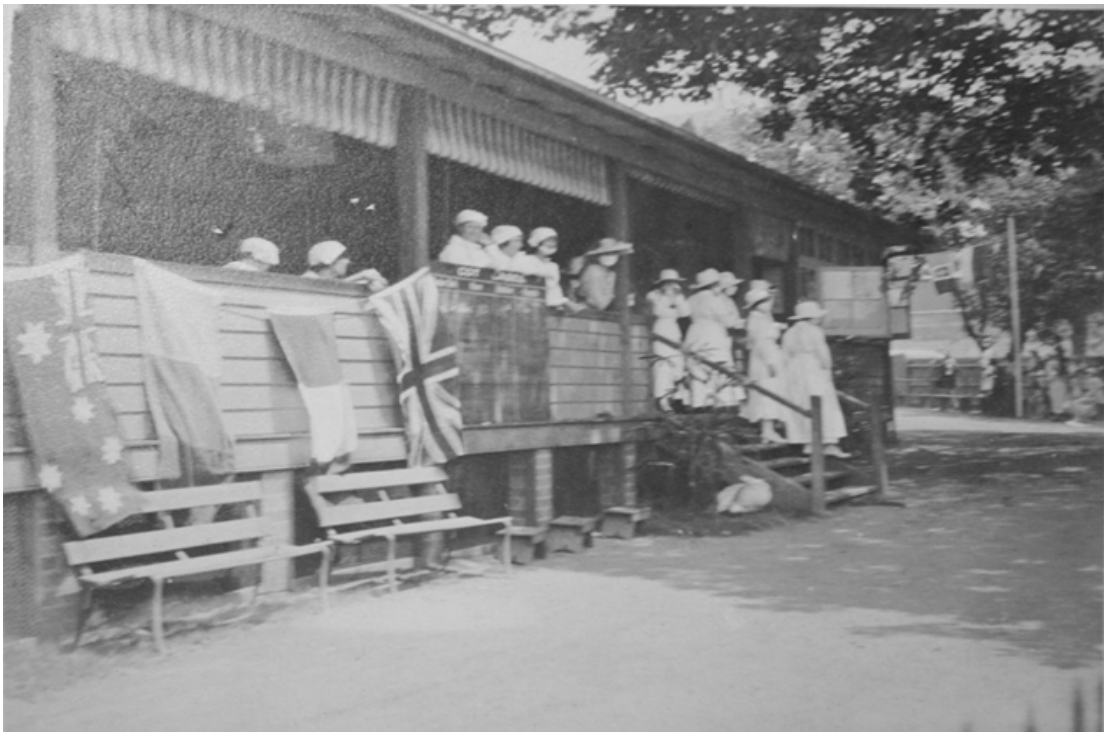
Figure 3.62 The east elevation of the Ward Building on ANZAC Day in 1919.
Source: Red Cross Archives (Sydney).
