# tanner Architects

GRAYTHWAITE 20 EDWARD STREET, NORTH SYDNEY

OUTLINE SCHEDULE OF CONSERVATION REPAIR WORKS

November 2010 Issue P1

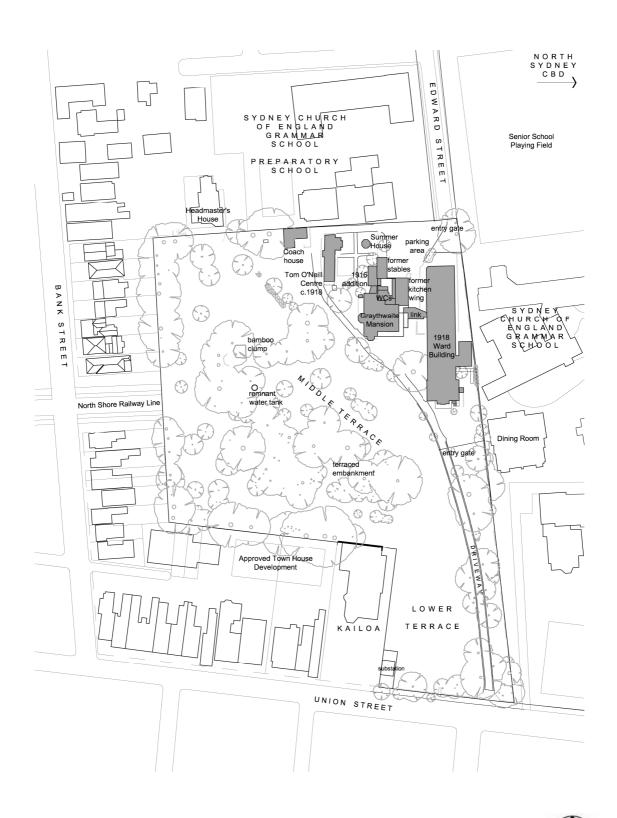
Figure 1 Site plan, not to scale.

Located at Union Street, North Sydney (Figure 1), the 2.678 hectare property is bounded on the east and north by Shore School, on the south by Union Street and private residential properties fronting Union Street, and on the west by private residential properties fronting Bank Street. The current street address is 20 Edward Street, although a Union Street address was used throughout the nineteenth century and greater part of the twentieth century.

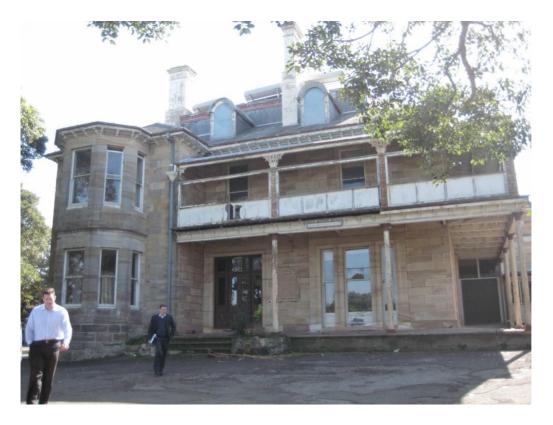
Figure 2 Graythwaite House, south elevation.

Graythwaite House is a two-storey building of load-bearing sandstone construction with a basement and attic level. The hipped and gabled roofs are slated, with a steeply-pitched mansard rising from the centre of the main part of the house. A cast iron and timber verandah and balcony returns around the south and east elevations, and has a corrugated galvanised steel roof. To the north-east is two-storey sandstone wing, originally comprising the kitchen and staff accommodation, and to the north-west is the single-storey 1830s sandstone stables building, both with slate roofs (Figure 3). Original floor and roof structures are timber-framed, with later concrete slab floors in some of the rear ground floor rooms. Windows are timber-framed, double-hung sashes.

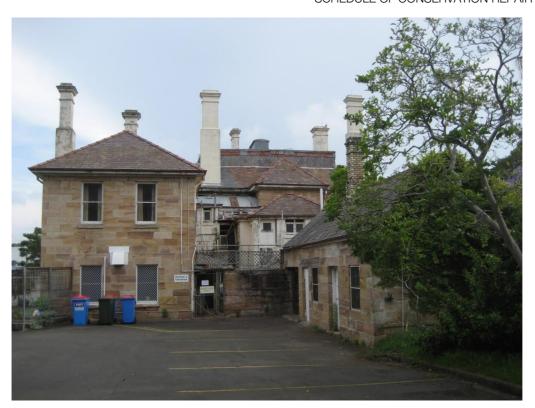
Figure 3 Graythwaite House, north elevation.

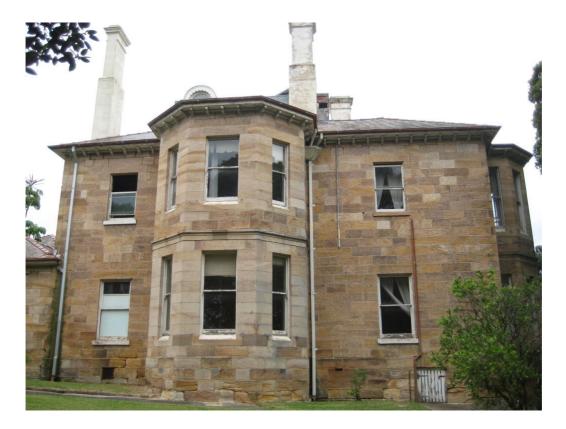
Figure 4 Graythwaite House, west elevation.

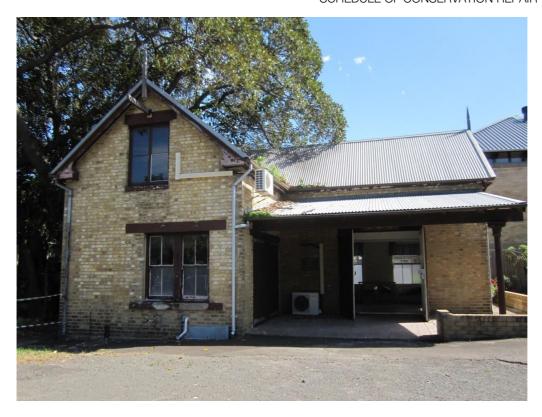
Figure 5 The Coach House, from the south.

Constructed in the 1890s, the Coach House is a small building of blond brick construction with timber-framed floor and roof structures (Figure 5). L-shaped in plan, the building is single-storey with an attic level, and has gabled roofs clad in corrugated galvanised steel. Windows are timber-framed double-hung sashes, and there are two large, timber ledged and braced barn doors at ground floor. A verandah, not original, extends across part of the south elevation.

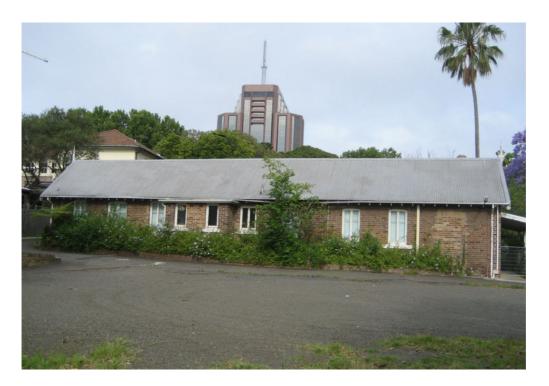
Figure 6 The former Tom O'Neill Centre, west elevation.

The Tom O'Neill Centre was constructed in 1918, shortly after the site's acquisition by the State for use as a convalescent home. The single storey brick building has a gabled roof clad in corrugated galvanised steel (Figure 6), and concrete and timber-framed floors.
