3 ANALYSIS OF PHYSICAL EVIDENCE

3.1 Introduction

This section of the CMP describes the surrounding context and cultural landscape of Graythwaite. The analysis of the cultural landscape and key elements is based on surveys undertaken in April-June 2010. An inventory for each of the key built elements has been included at Appendix D of this CMP.

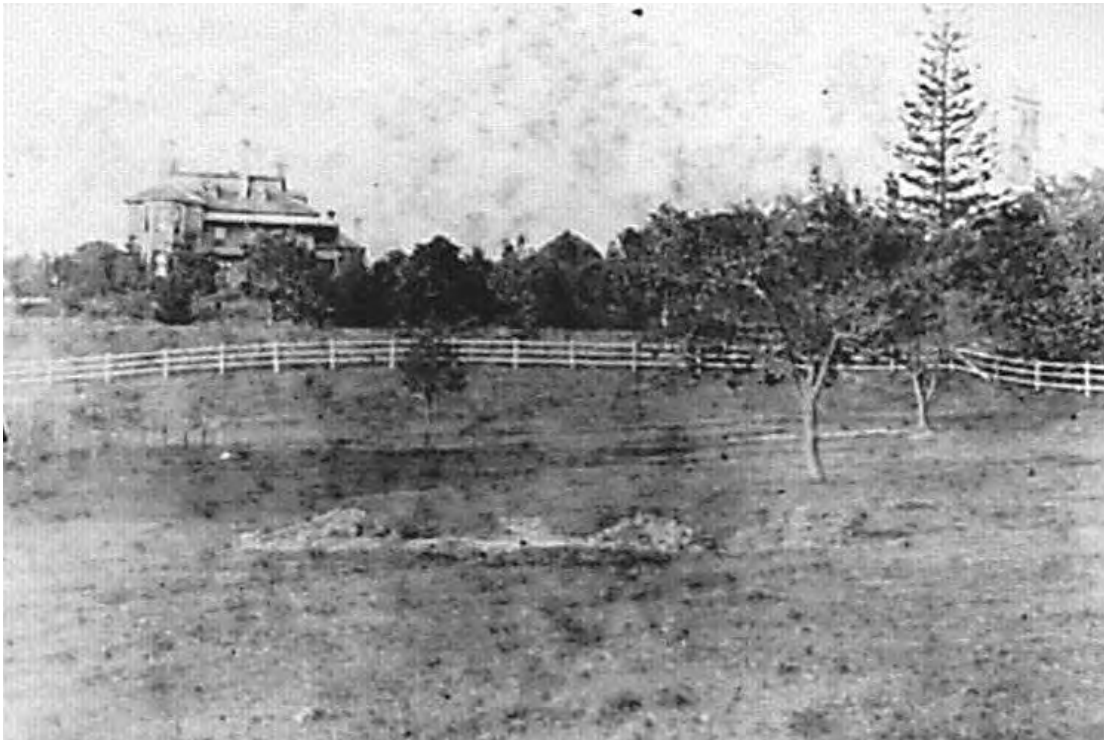
Figure 3.3 The house complex c1900 from Union Street with the lower terrace (former orchard) and lower embankment (former vineyard) in the foreground.
Source: State Library of NSW.

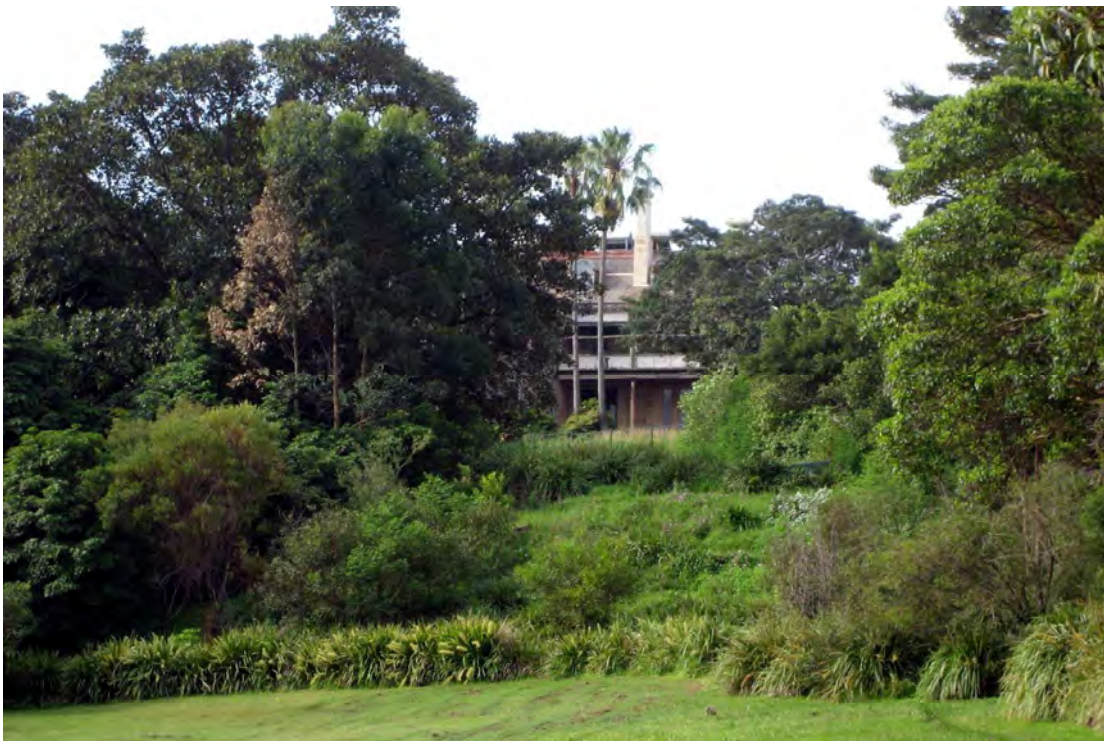
Figure 3.4 The house complex from the central terrace (former tennis court area). The mature vegetation on the upper (and lower) embankment now largely obscures the house from view.
Source: Tanner Architects 2010.

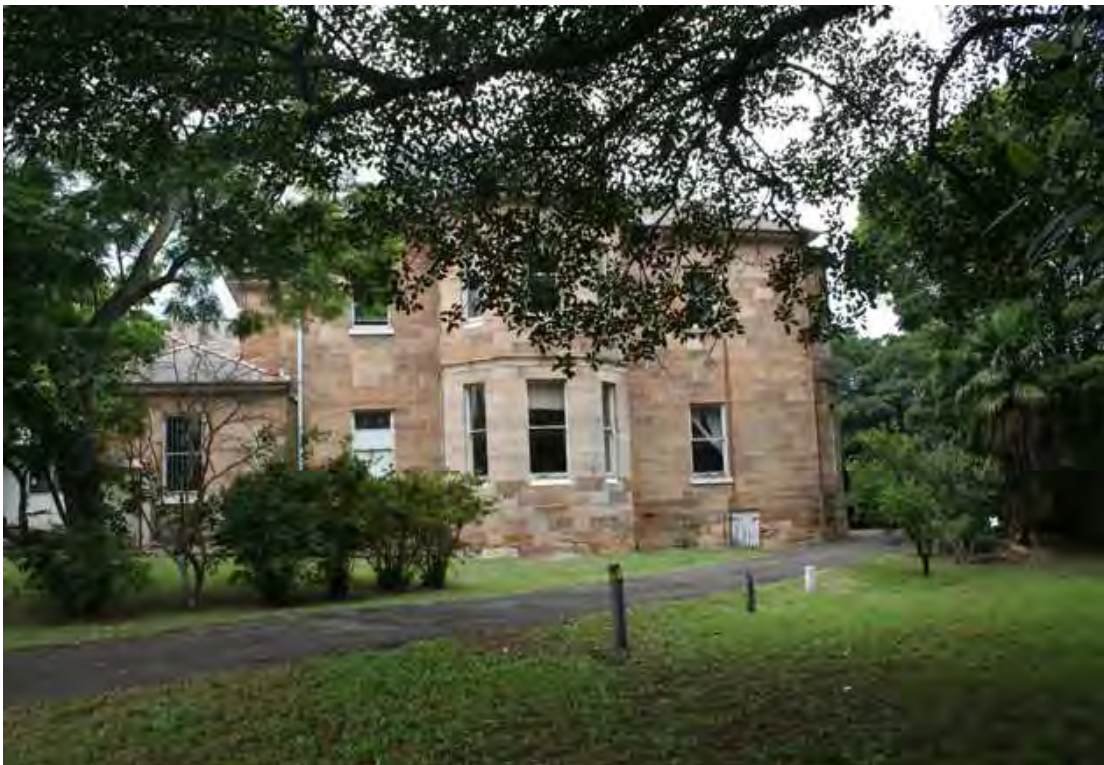
Figure 3.7 The west elevation of Euroka Villa (Graythwaite) today showing the 1870s remodelling by George Dibbs including the removal of the upper level balcony and the construction of the bay windows.
Source: Tanner Architects 2010.

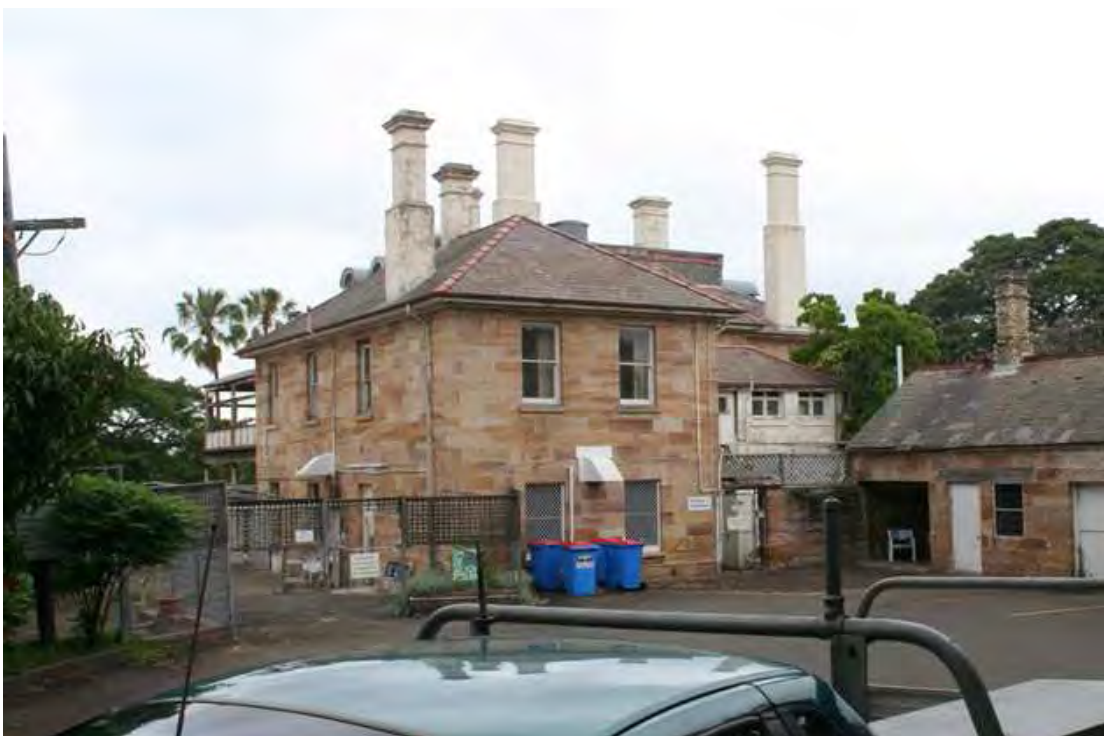
Figure 3.9 The same view today. A noticeable change is the lavatory/bathroom block attached to the rear of the House c1916 and the removal of the iron railing to the roof observatory. The garden setting has also been removed.
Source: Tanner Architects 2010.

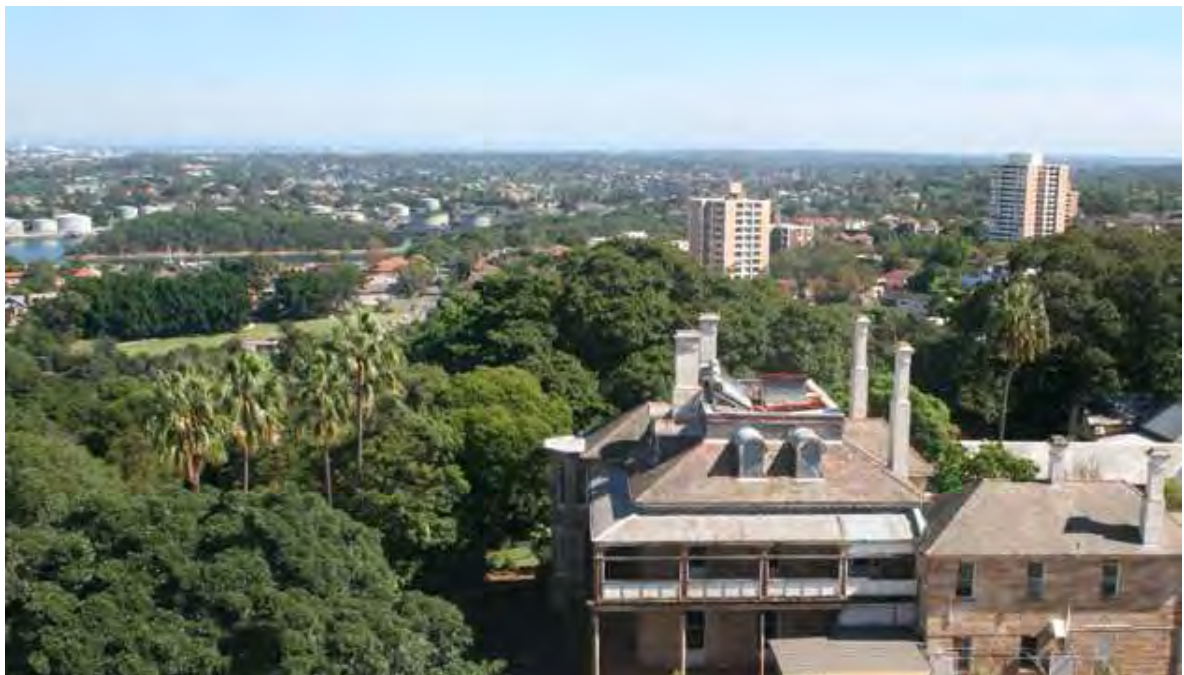
Figure 3.11 The same view today taken from the tower on the adjacent Shore School site. The most noticeable change is the maturing of the garden setting. The house itself has changed little.
Source: Tanner Architects 2010.

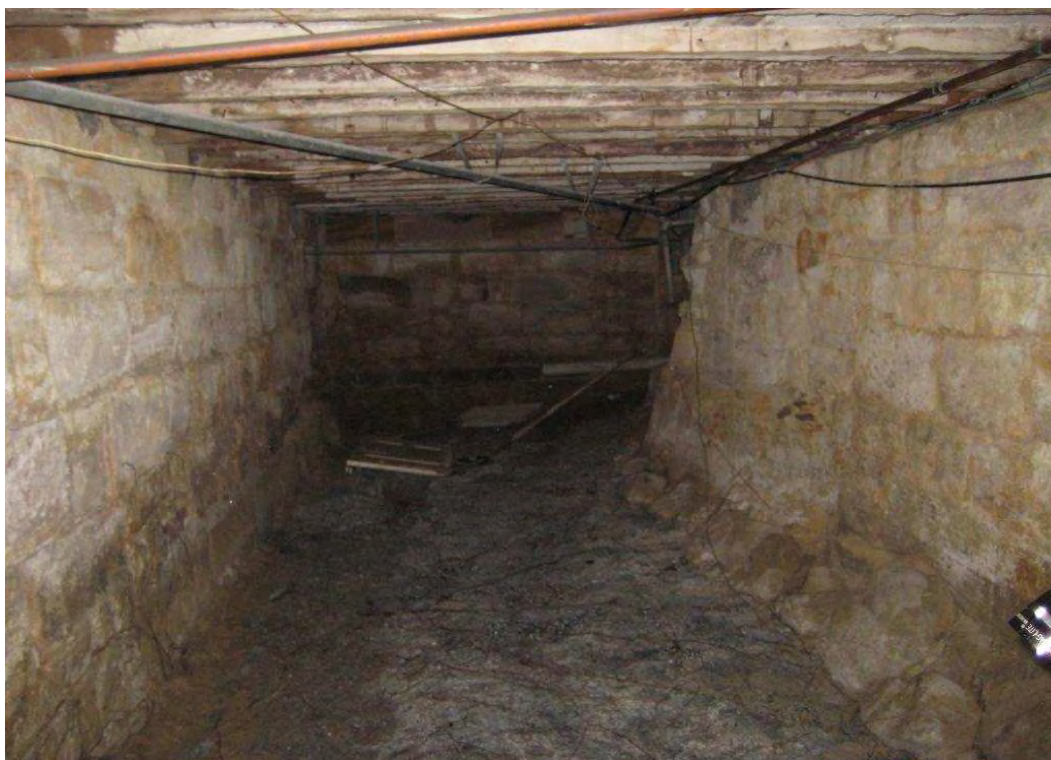
Figure 3.21 looking south in basement room B1 (under the entrance hall).
Source: Tanner Architects 2010.

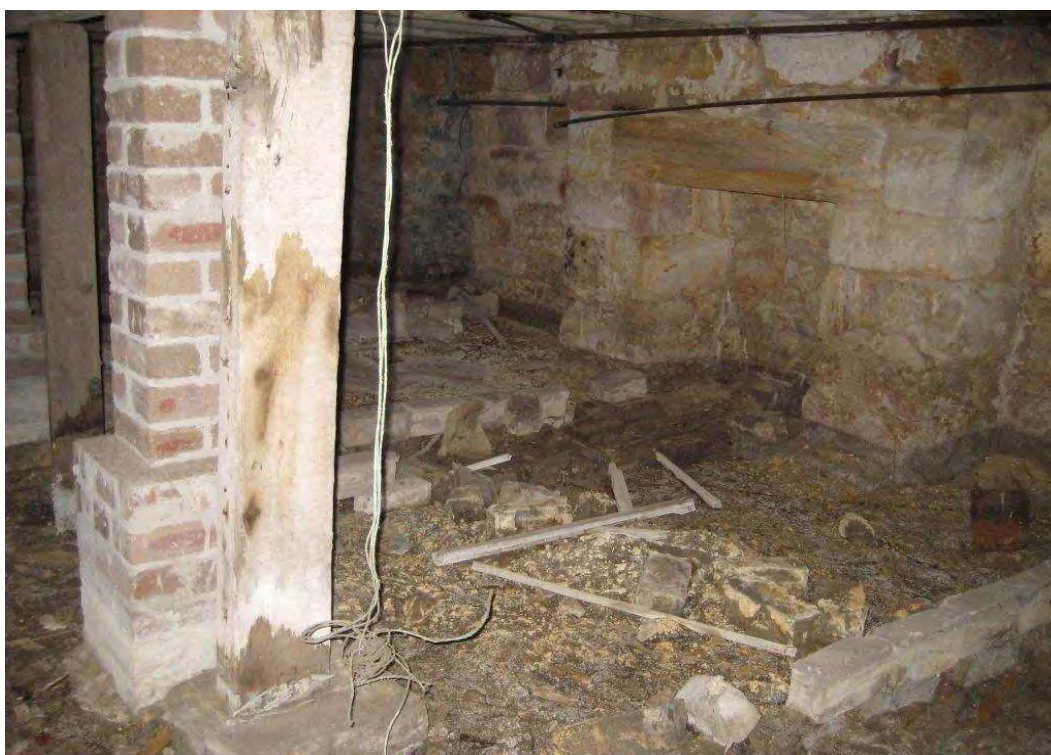
Figure 3.22 Basement room B3, showing masonry support for fireplace and additional brick pier and timber post supports.
Source: Tanner Architects 2010.

The sandstone walls generally support the walls of the house above although there is a substantial cross wall under the reception room (G6), which does not appear to provide any structural support. The fireplaces in the reception room are supported by sandstone walls in B2 and B3. The width of the walls in spaces B1, B2 and B3 are greater than the walls in B4, providing evidence of the different phases of construction between the west wing (c1859) and the main part of the house (c1874). It is possible that the stone used in B1-B3 were salvaged from the c1833 Euroka Cottage. The width of the sandstone wall on the west side of B1 (and in the entrance hall (G5) above) varies, suggesting that the wider section may in fact form part of the western wall of the c1833 Euroka Cottage. The timber ceiling/floor joists in B1 are adzed, suggesting that they may be remnants of Euroka Cottage or may have been salvaged and re-used in c1874 to support the tessellated floor in the entrance hall. The soil floor of the basement may conceal stone flagging although none is currently evident. There is a later (c1980s) secondary system of structural support provided by brick piers supporting the ceiling/floor joists throughout B2, B3 and B4 (see Figure 3.21).

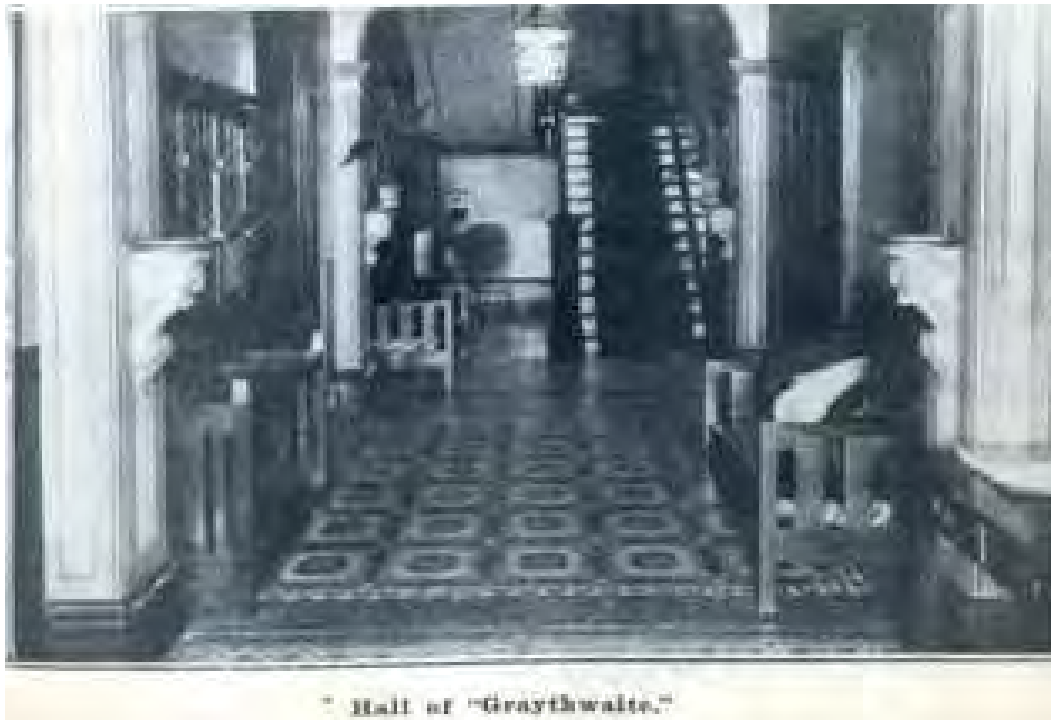
Figure 3.18 The entrance hall in 1916 at the time of the opening of the Red Cross Convalescent Home. Note that the stair window has already been modified.
Source: Stanton Library.

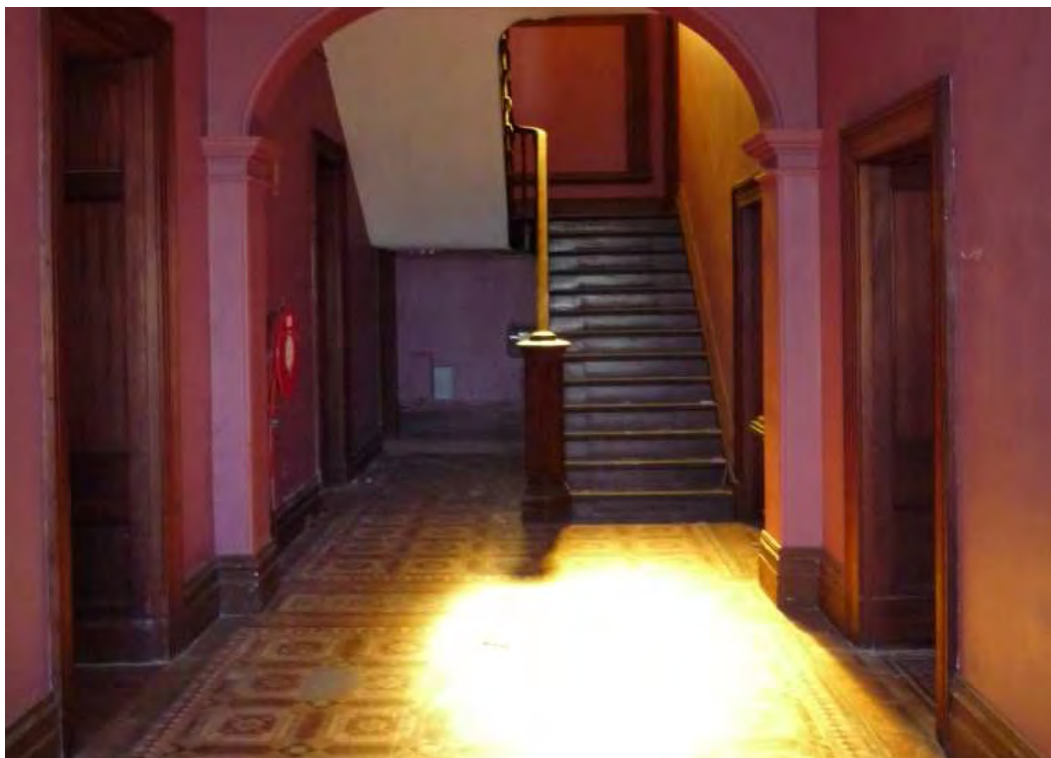
Figure 3.19 The entrance hall today. Note the tessellated tiles have been retained, while the wall brackets (on each wall nib) have also been salvaged and stored elsewhere in the building.
Source: Tanner Architects 2010.

The entrance hall incorporates the east wall of the west wing constructed by Sayers c1859, the wider sections of which may in fact be the western wall of the c1833 Euroka Cottage. The Dibbs phase fittings such as the tessellated tile flooring, skirting boards, architraves, archways, staircase doors, cornice and ceiling are largely intact. The window (W1.A5) on the stair landing, however, has been altered with the removal of the lower sash, infilling of the opening, and re-glazing of the remaining sash. This change is likely to have occurred in late 1915 when the lavatory block (G11 and F16) was added. The painted wall treatment of the Dibbs phase (ashlar stone work and dado) is visible in part and further areas and the ceiling are probably recoverable upon investigation. The joinery, where not painted, has a dark varnished surface treatment. The doors in most instances retain timber signs dating from the 1916 fit out by the Red Cross identifying room uses and major donors.

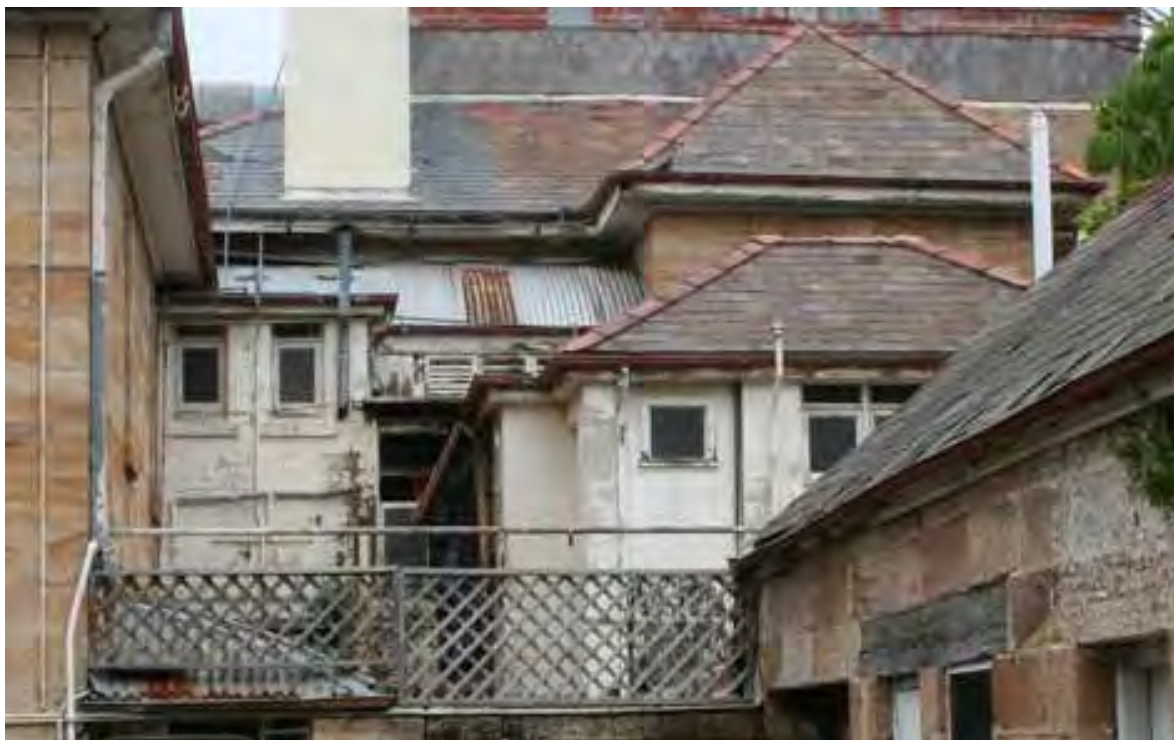
Figure 3.28 The exterior of the first floor of the bathroom and lavatory block addition. Note the form of the c1874 part of the House (beyond) and Kitchen Wing (at left).
Source: Tanner Architects 2010.

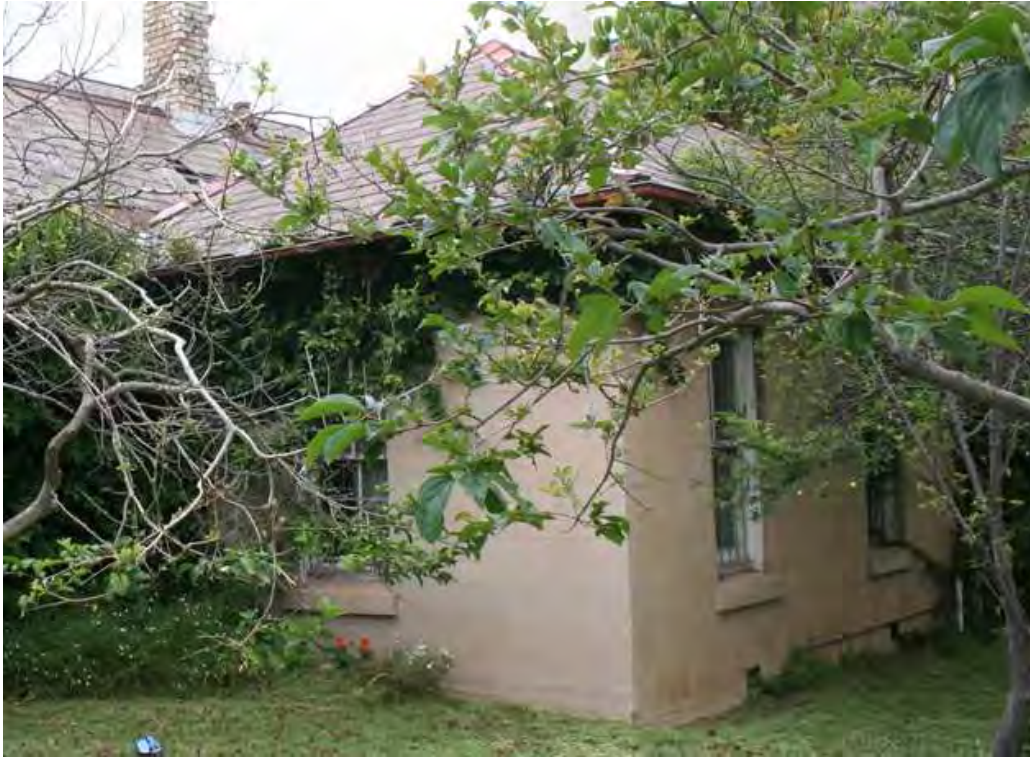
Figure 3.30 The exterior of the former Massage Room/Doctor's Room.
Source: Tanner Architects 2010.

The building is a single storey brick building rendered with ashlar coursing and with a hipped roof clad in slate tiles and partly abuts the former stables building. An unpainted section of the wall finish visible in the link with the house (G10) indicates the cement mix was coloured to give a sandstone-like appearance. The east wall is formed in part by the sandstone wall of the stables building. Internally, the walls are plastered with timber picture rails and skirting boards, the ceiling in the lower section is pitched, and the doors are four panelled. The floor is timber under vinyl. The interior is well-lit by a number of double sash windows.

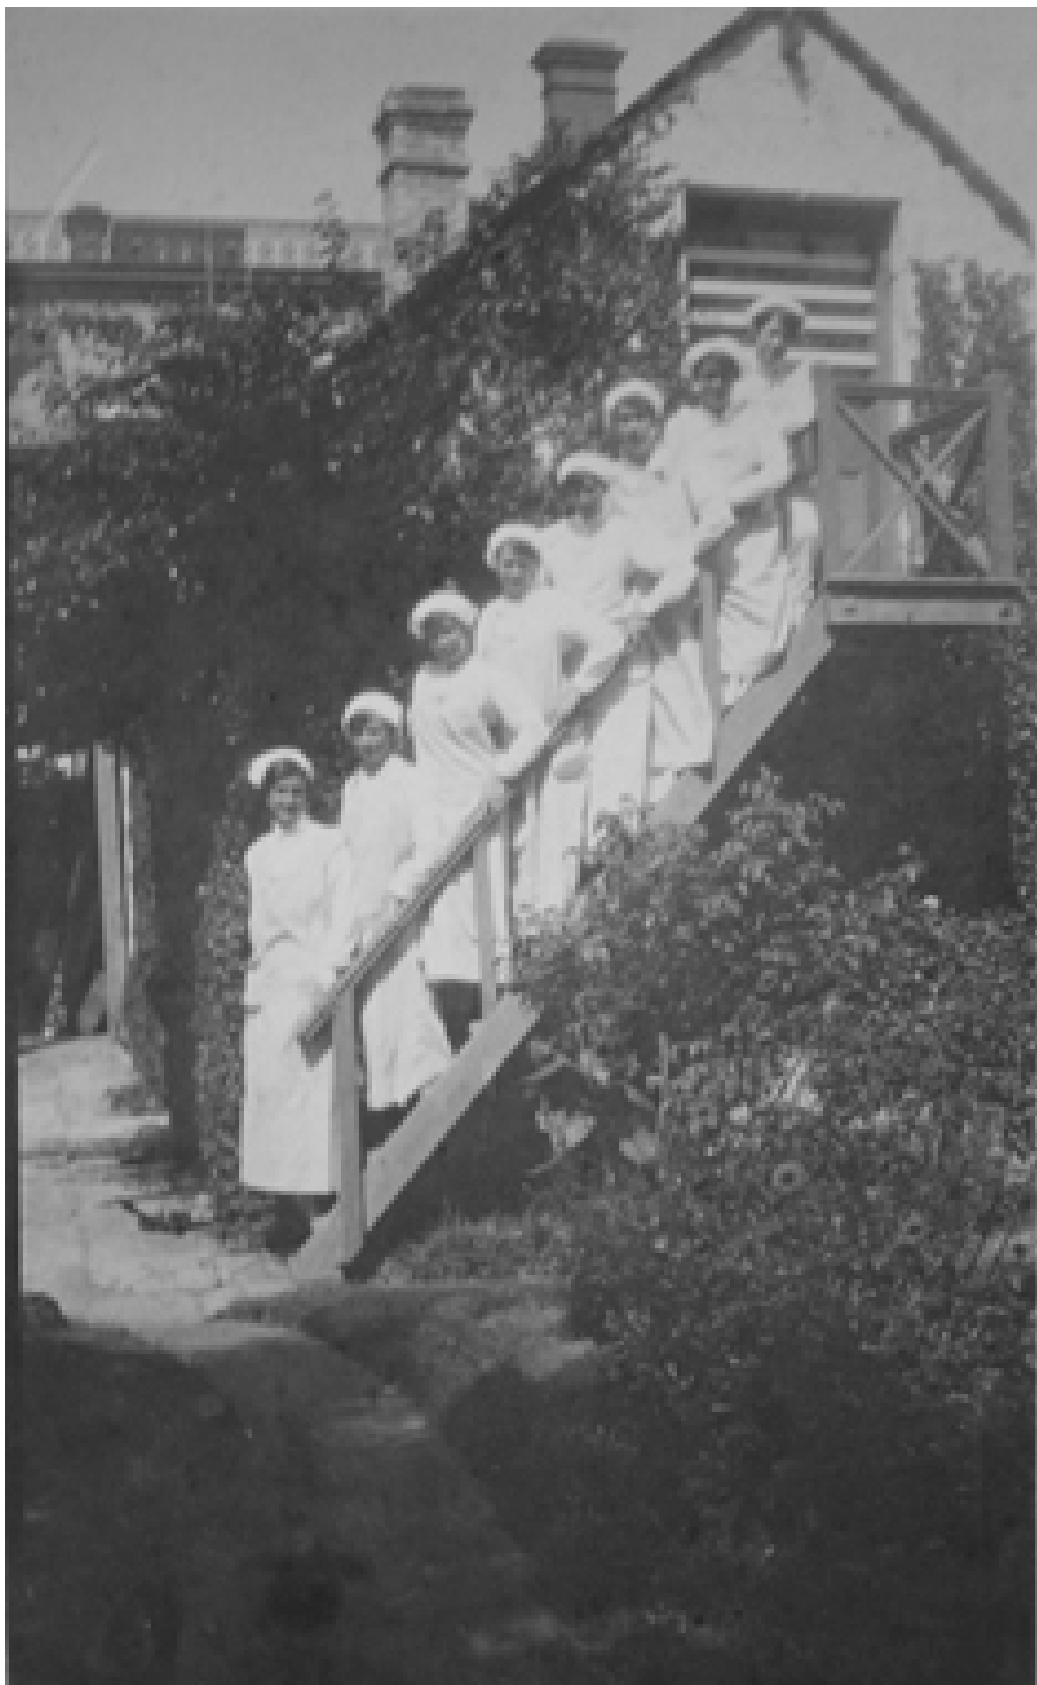
Figure 3.34 Nurses posing on the north elevation of the Stables Building with the now removed timber stair and landing, c1916-1919.
Source: Red Cross Archives (Sydney).

The original planning seems to have been inclusive of a groomsman's room (G19a), coach house (G19b or c), and stable (G19c or b) with feed loft above. The door entry to the loft has been altered after c.1920 to a window (W3.G19) and the timber stair removed. The loft was not accessible at the time of the inspection.

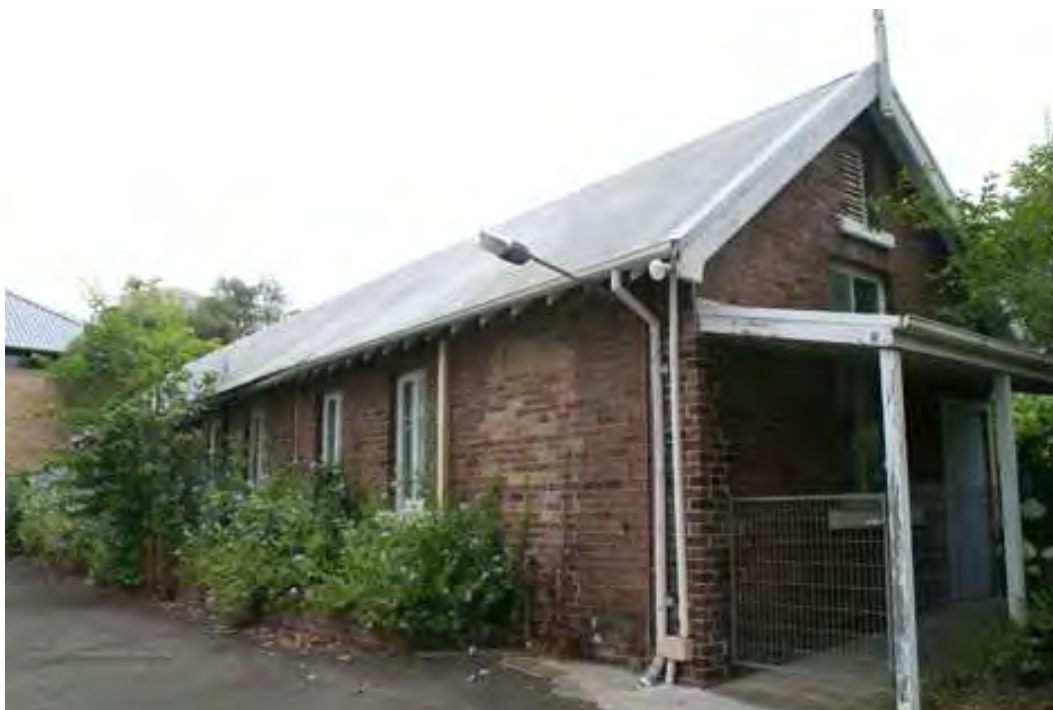
Figure 3.38 The west and south elevations of the former Laundry and Billiard Room (now known as the Tom O'Neill Centre).
Source: Tanner Architects 2010.

The building is a single storey structure built in brick laid in a Flemish bond of three rows of stretchers between the row of alternating header/stretcher. The colour of the brick varies randomly in the wall plane, but is consistently darker in the window and door lintels; the sills are cement rendered. The roof is part gabled and part hipped with overhanging exposed eaves. The roof is clad in corrugated metal and there are decorative finials and bargeboards. There is a later (1950s?) skillion-roofed porch on the south elevation. The windows are timber-framed casements comprising two glazed panels each and with rounded heads. A window opening on the west elevation has been bricked-in. The external doors have been replaced throughout with fire rated flush doors. Overall the external presentation has a high level of integrity as there have been no changes to the roof form, wall finishes, and door layout and minor but reversible change to the window layout.

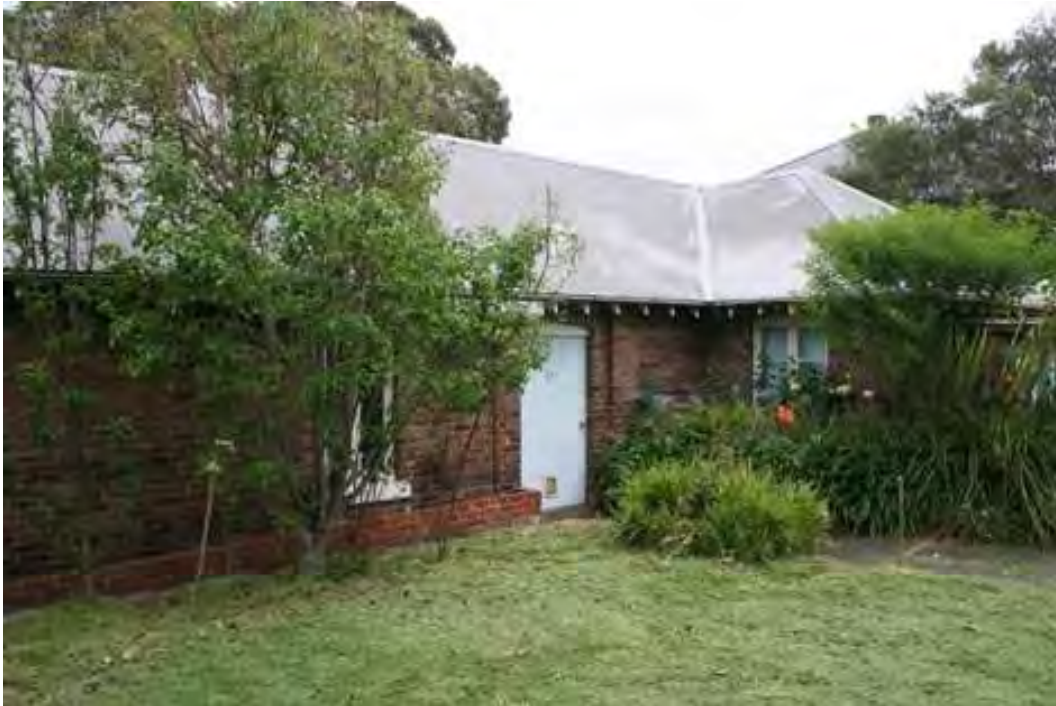
Figure 3.39 The east elevation of the former Laundry and Billiard Room (now known as the Tom O'Neill Centre). The projecting wing housed the billiard room.
Source: Tanner Architects 2010.

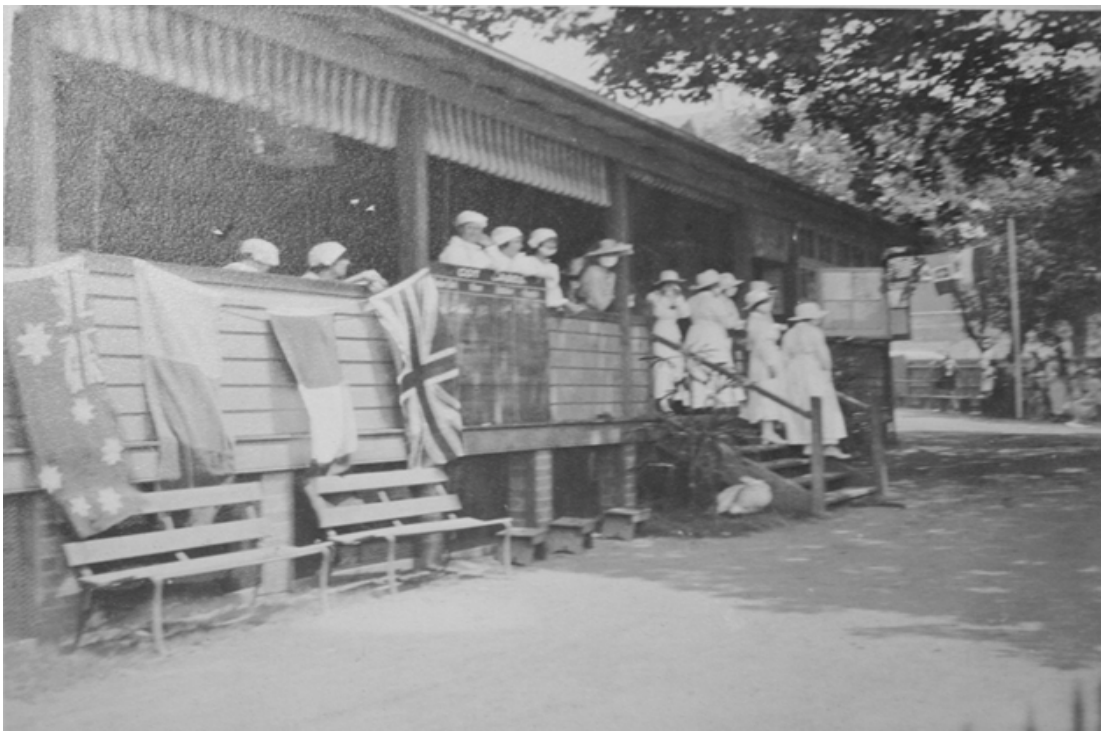
Figure 3.40 The east elevation of the Ward Building on ANZAC Day in 1919.
Source: Red Cross Archives (Sydney).

Attached on the eastern side of the ward building is the bathroom/lavatory block. This is a brick building that is contemporary with the main ward. It has been totally refurbished internally, the windows replaced, and some doors and windows have been bricked-in. The connection to the wards, originally open, has been enclosed.

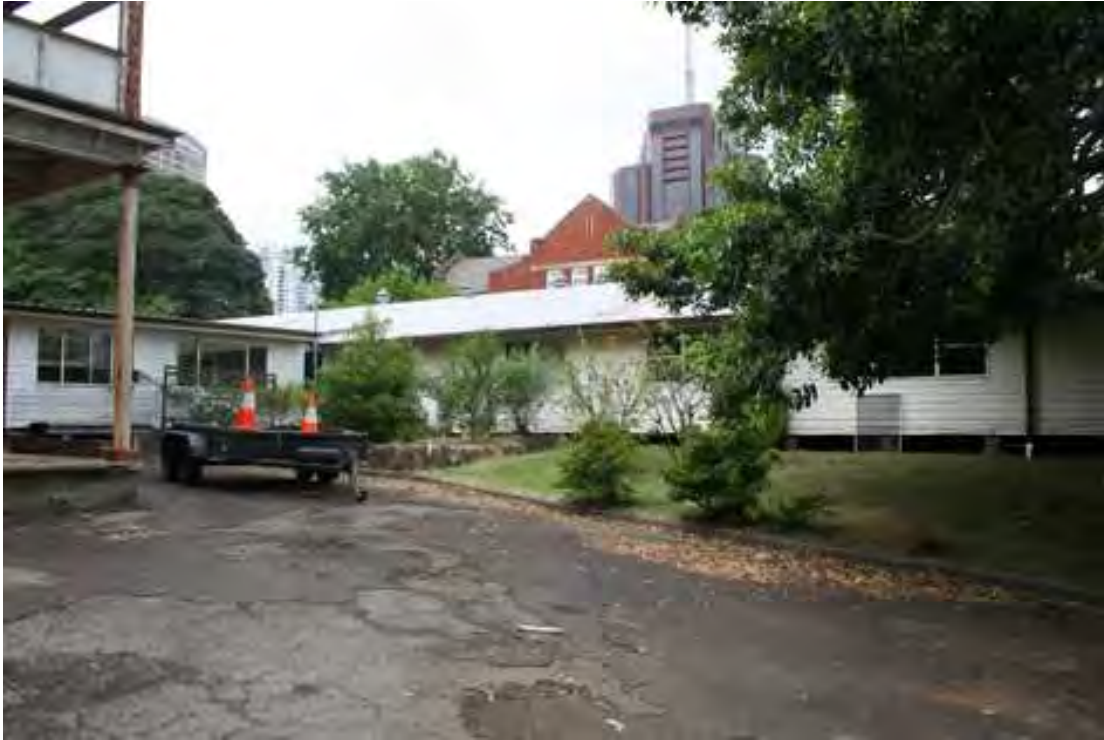
Figure 3.41 The west elevation of the Ward Building today. The original low-lying form of the building remains but the verandahs on both sides have been enclosed.
Source: Tanner Architects 2010.

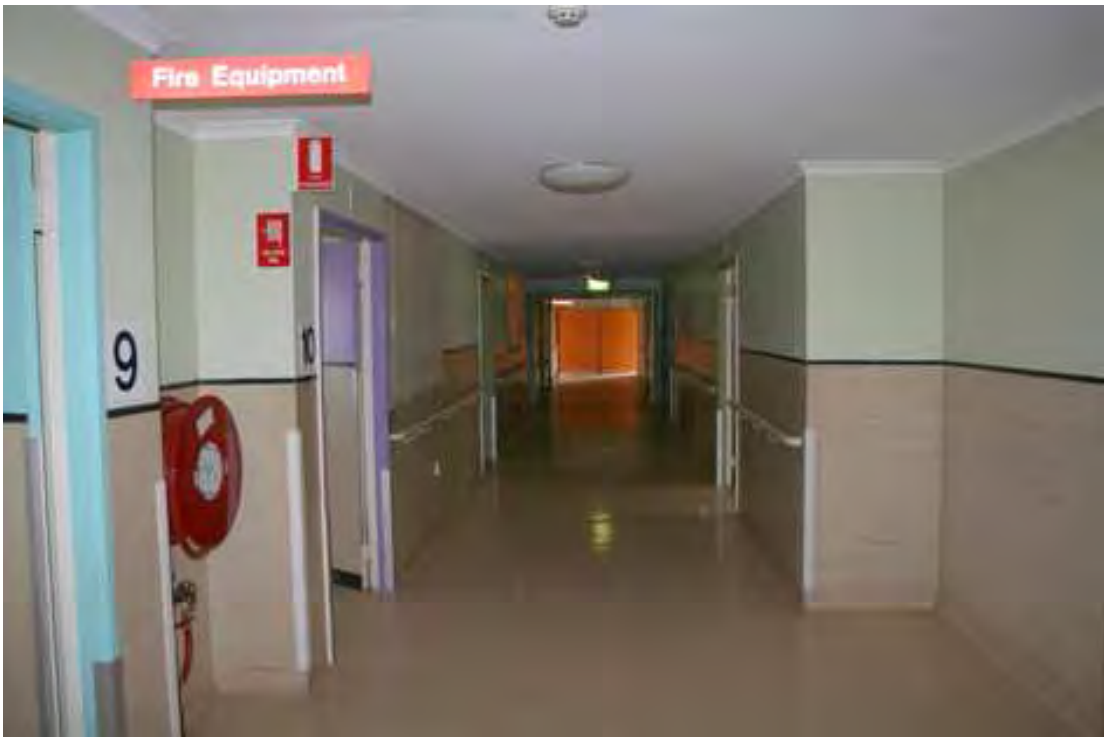
Figure 3.42 The existing corridor of the Ward Building. It was formed in the early 1980s with the partitioning of the originally open ward.
Source: Tanner Architects 2010.

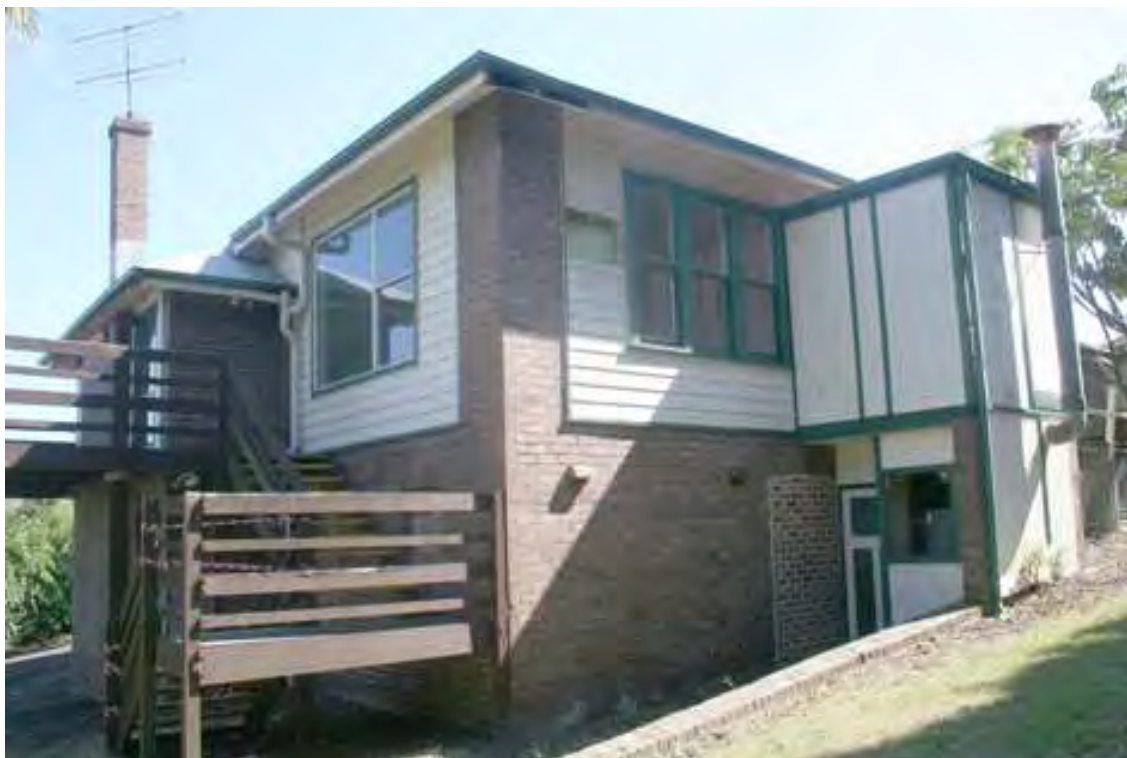
Figure 3.40 The former recreation room at the southern end of the Ward Building.
Source: Tanner Architects 2010.

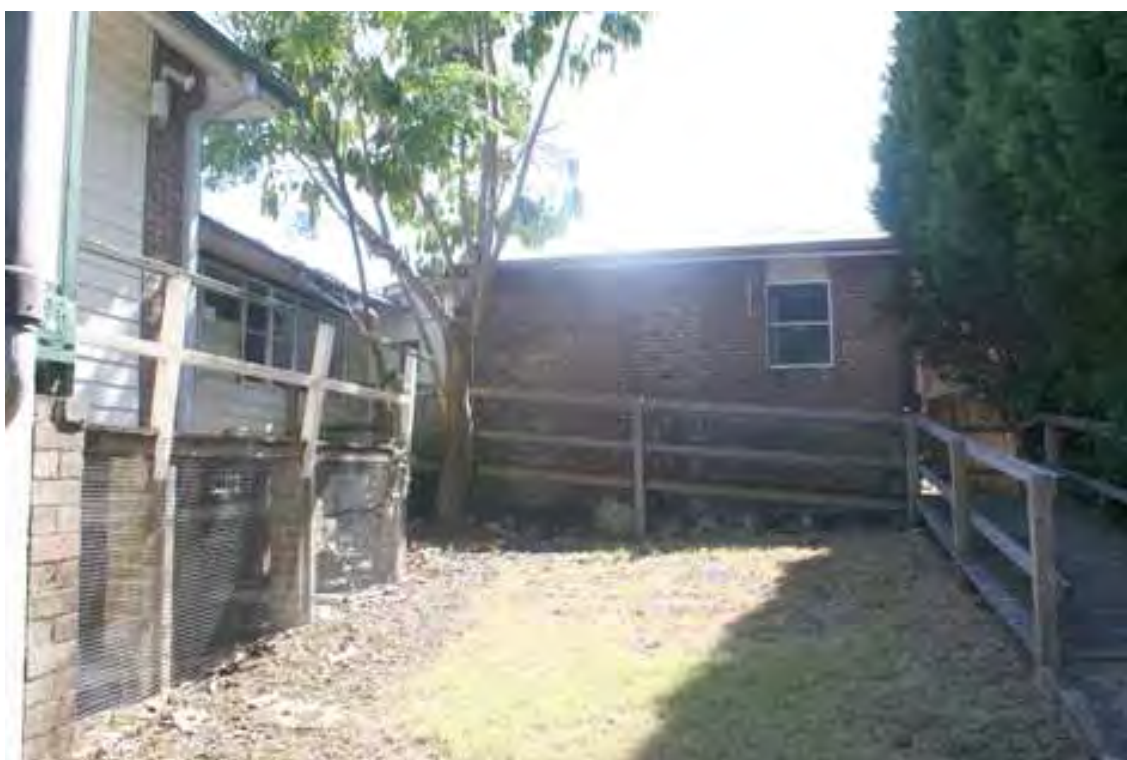
Figure 3.43 The lavatory and bathroom block on the east side of the Ward Building.
Source: Tanner Architects 2010.

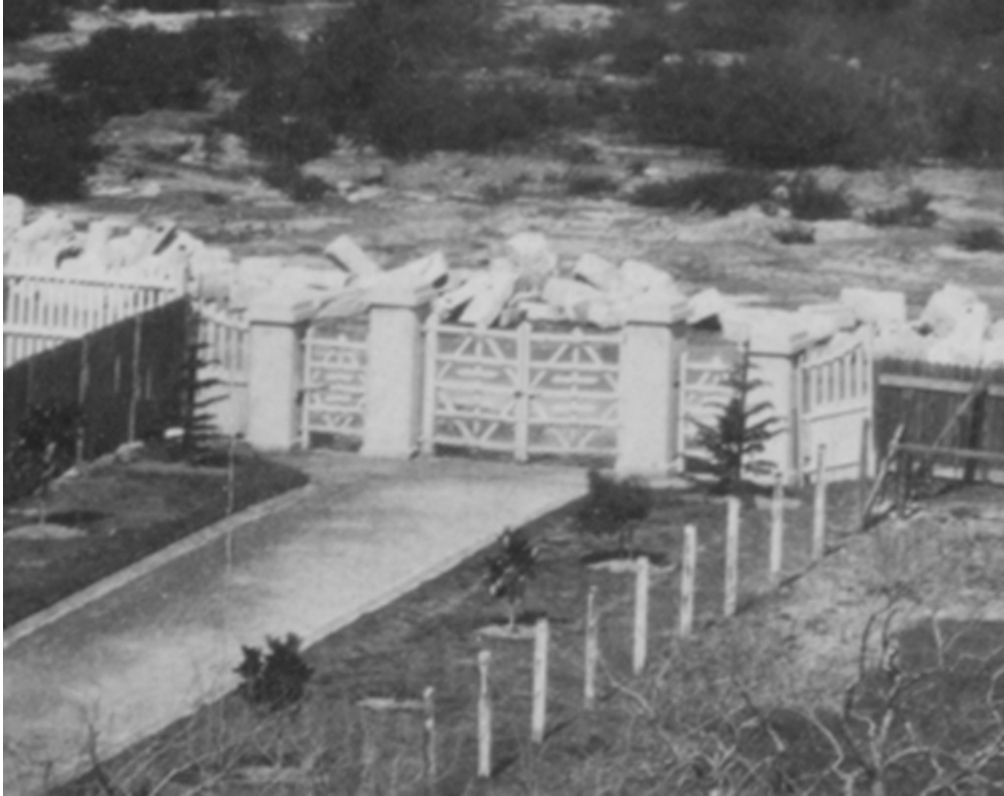
Figure 3.44 The Union Street entrance gates and driveway. Undated but possibly c1880.
Source: National Library of Australia.

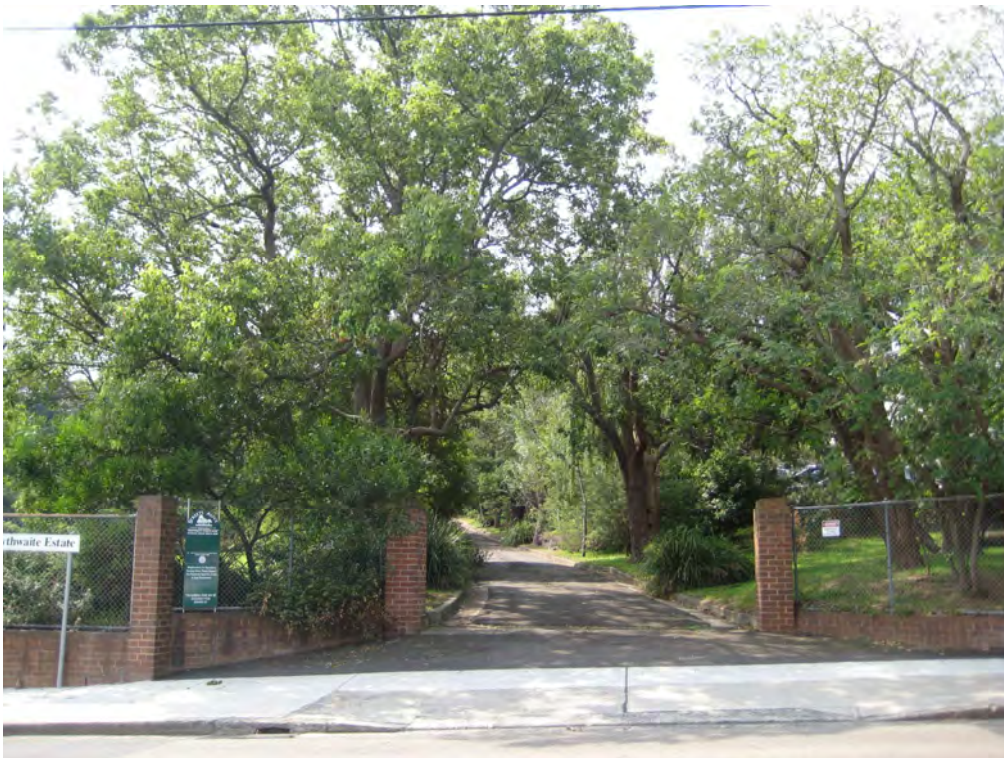
Figure 3.45 The Union Street entrance gates and driveway today.
Source: Tanner Architects 2010.

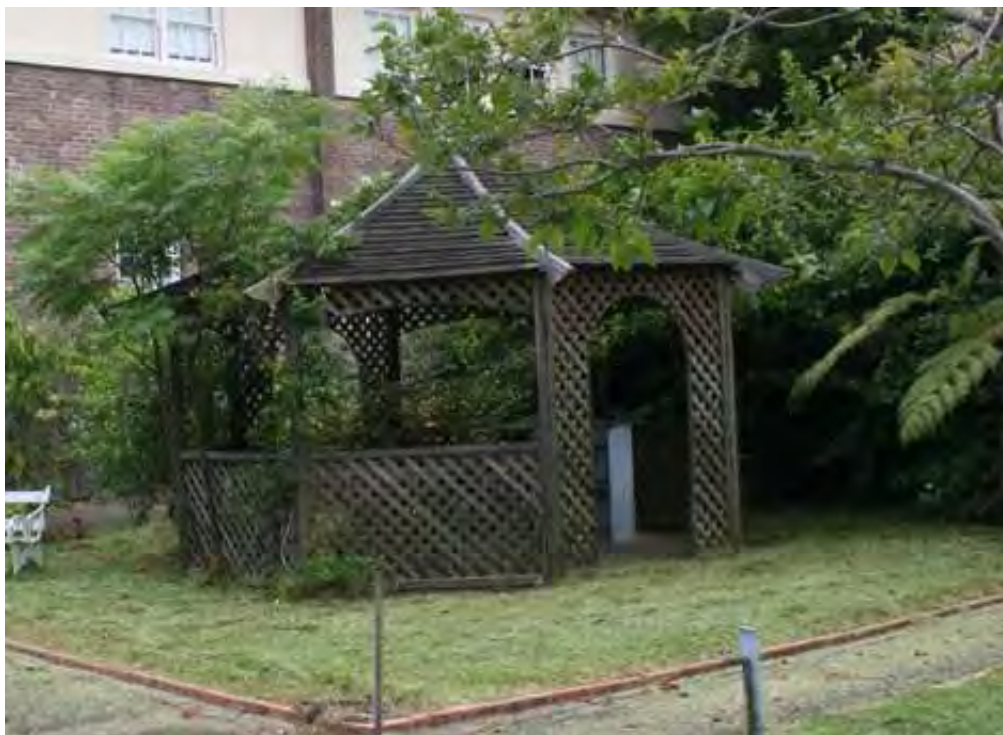
Figure 3.46 Timber-framed pergola in the west garden.
Source: Tanner Architects 2010.
