**PROPOSED SUBDIVISION -  
RIVERSIDE ESTATE PROJECT  
APPLICATION AND MASTER PLAN  
AREA, TEA GARDENS**

GEOTSGTE20248AA-AF  
4 July 2008

**RE: PROPOSED SUBDIVISION**  
**RIVERSIDE ESTATE PROJECT APPLICATION AND MASTER PLAN AREA, TEA GARDENS**  
**GEOTECHNICAL AND ACID SULFATE SOILS ASSESSMENT**

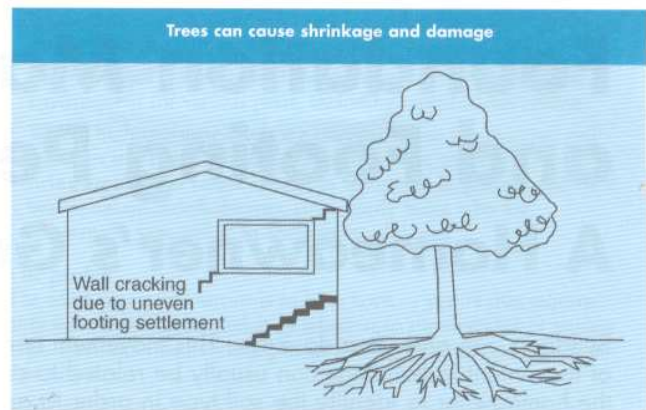
As the moisture absorption process completes its journey to the innermost areas of the building, the internal footings will rise. If the spread of moisture is roughly even, it may be that the symptoms will temporarily disappear, but it is more likely that swelling will be uneven, creating a difference rather than a disappearance in symptoms. In buildings with timber flooring supported by bearers and joists, the isolated piers will rise more easily than the strip footings or piers under walls, creating noticeable doming of flooring.

As the weather pattern changes and the soil begins to dry out, the external footings will be first affected, beginning with the locations where the sun's effect is strongest. This has the effect of lowering the external footings. The doming is accentuated and cracking reduces or disappears where it occurred because of dishing, but other cracks open up. The roof lines may become convex.
