10.2.2. Results and Discussion

11.0 Threats Associated with formalising the beach access

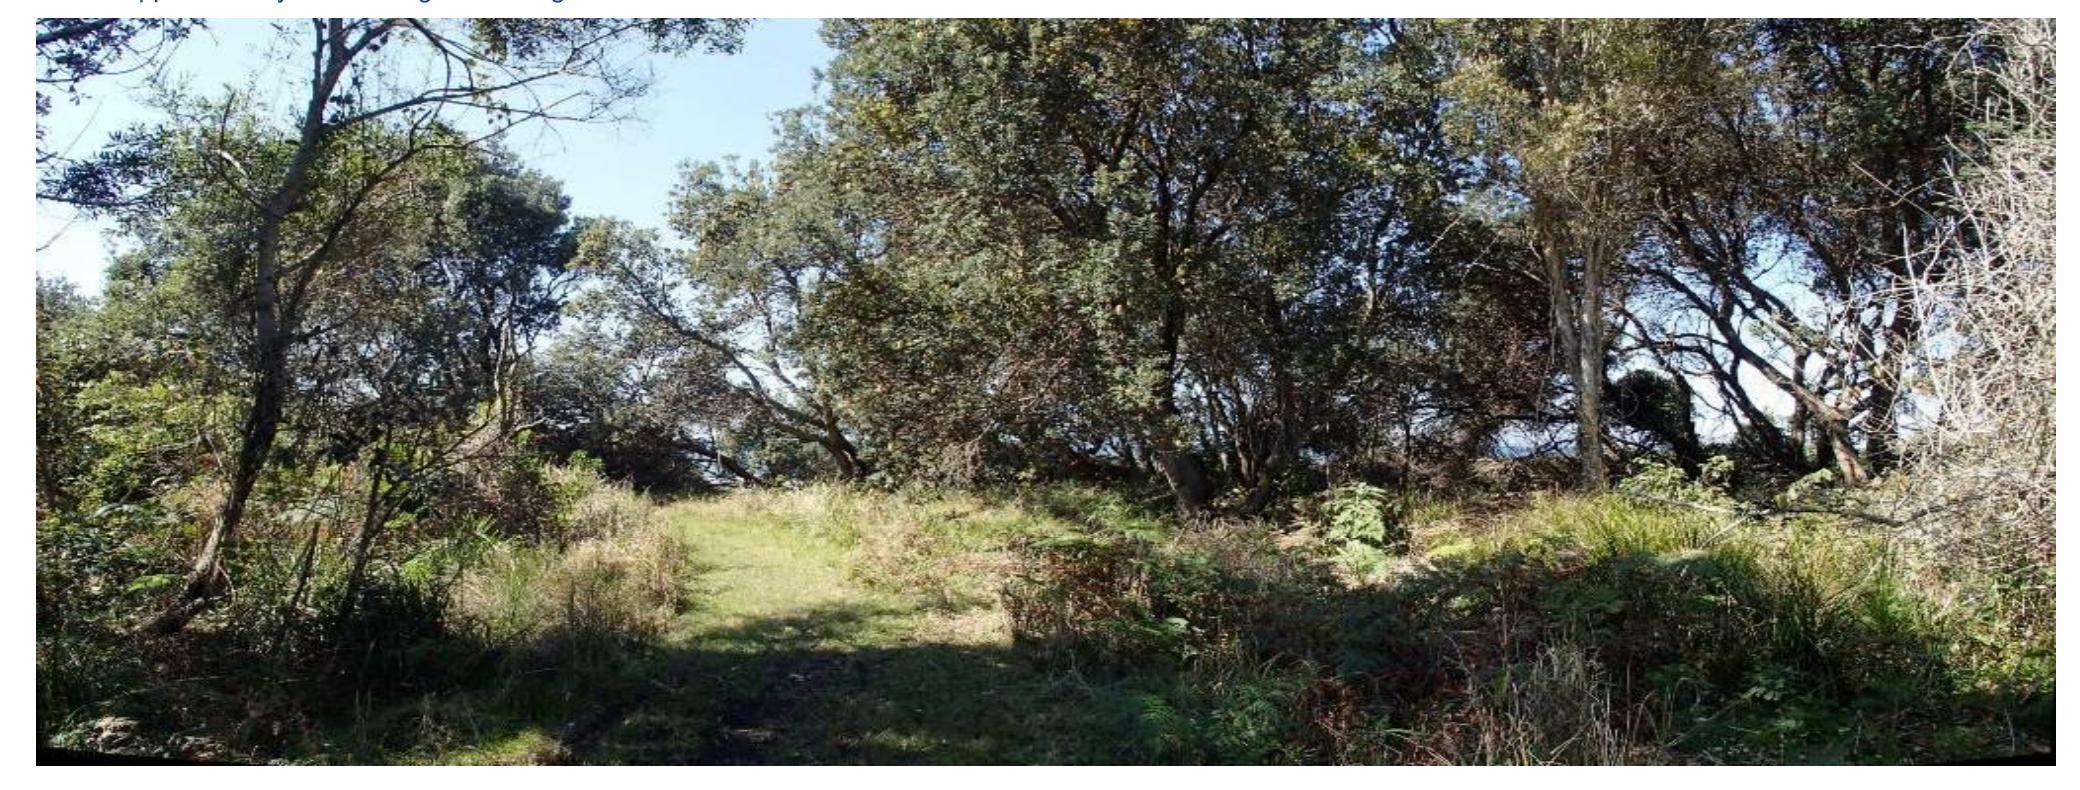
Photo 13: Approximately 70m from gate viewing east into Banksia Woodland in 2013

The Banksia woodland in the immediate vicinity of the track was previously heavily infested with Bitou. Major works funded by the proponent in this area has eliminated the main infestation and significantly opened up this community. The dead vegetation on the right is the remains of a Lantana infestation.

Follow-up treatment is required to prevent re-infestation and dense infill planting to create a buffer to maritime stresses on the Littoral Rainforest behind this community. Exotic grasses and common pastoral weeds are now the main weed in this area.

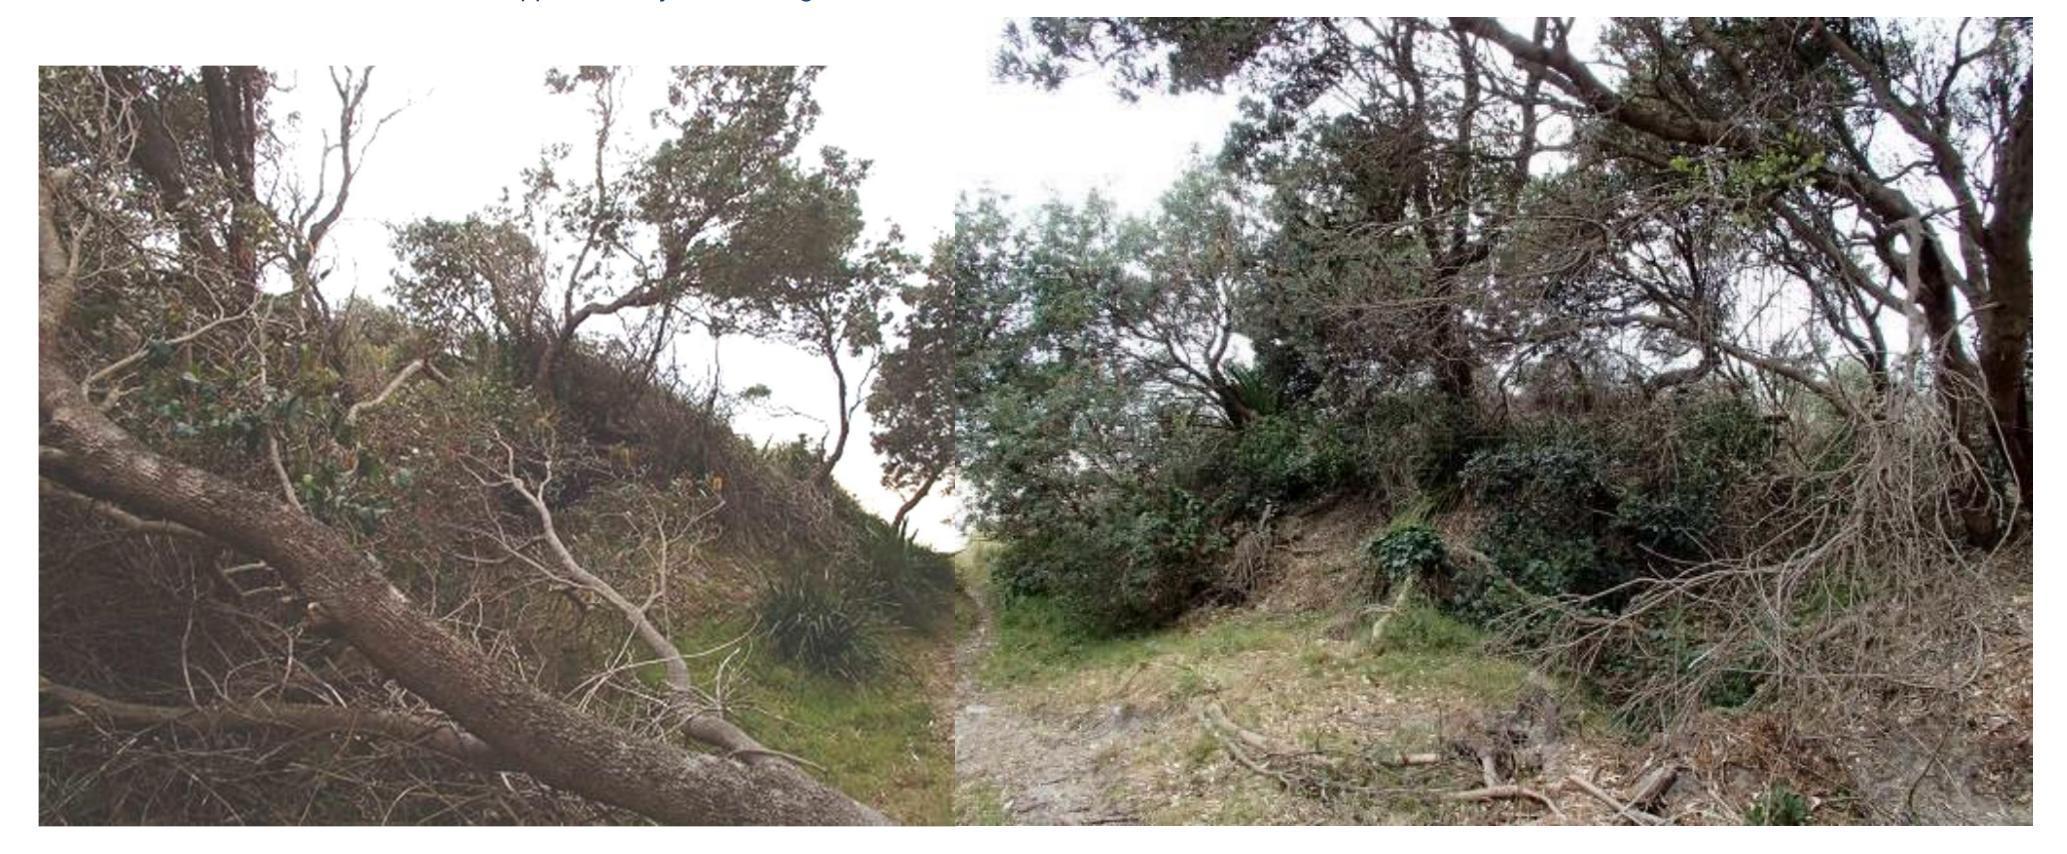
Photo 15: View east down to beach access approximately 75m from gate in 2013.

The open nature of the vegetation at the beach access point allows deep penetration of maritime stresses, hence infill planting here will also add to the buffer zone to the Littoral Rainforest. This area was formerly heavily infested with Bitou.

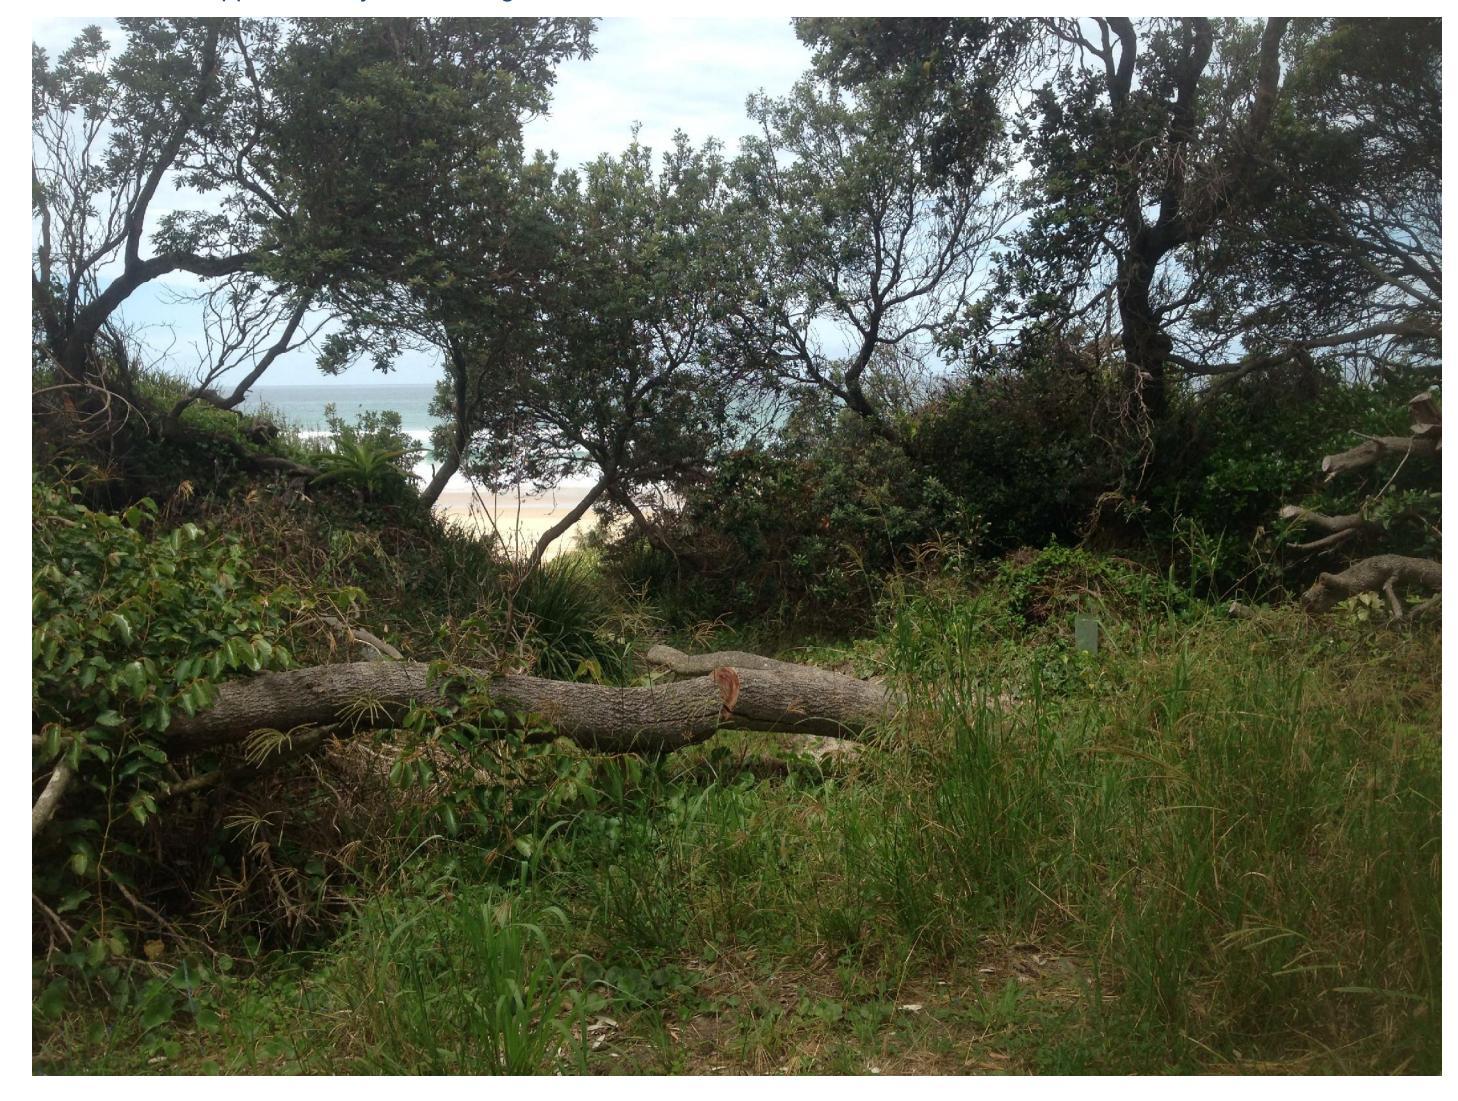
Photo 17: View west of existing beach access from the beach in 2013

Active beach erosion processes will require an access design that can cope with a variable berm, as shown in the photo.

Weed cover is low in this area due to extensive Bitou control by Landcare along the Reserve (note dead plants). The proponent has funded planting of *Casuarina equisetifolia* on the berm to enhance stabilisation at and adjacent to the access exit (indicated by arrows).

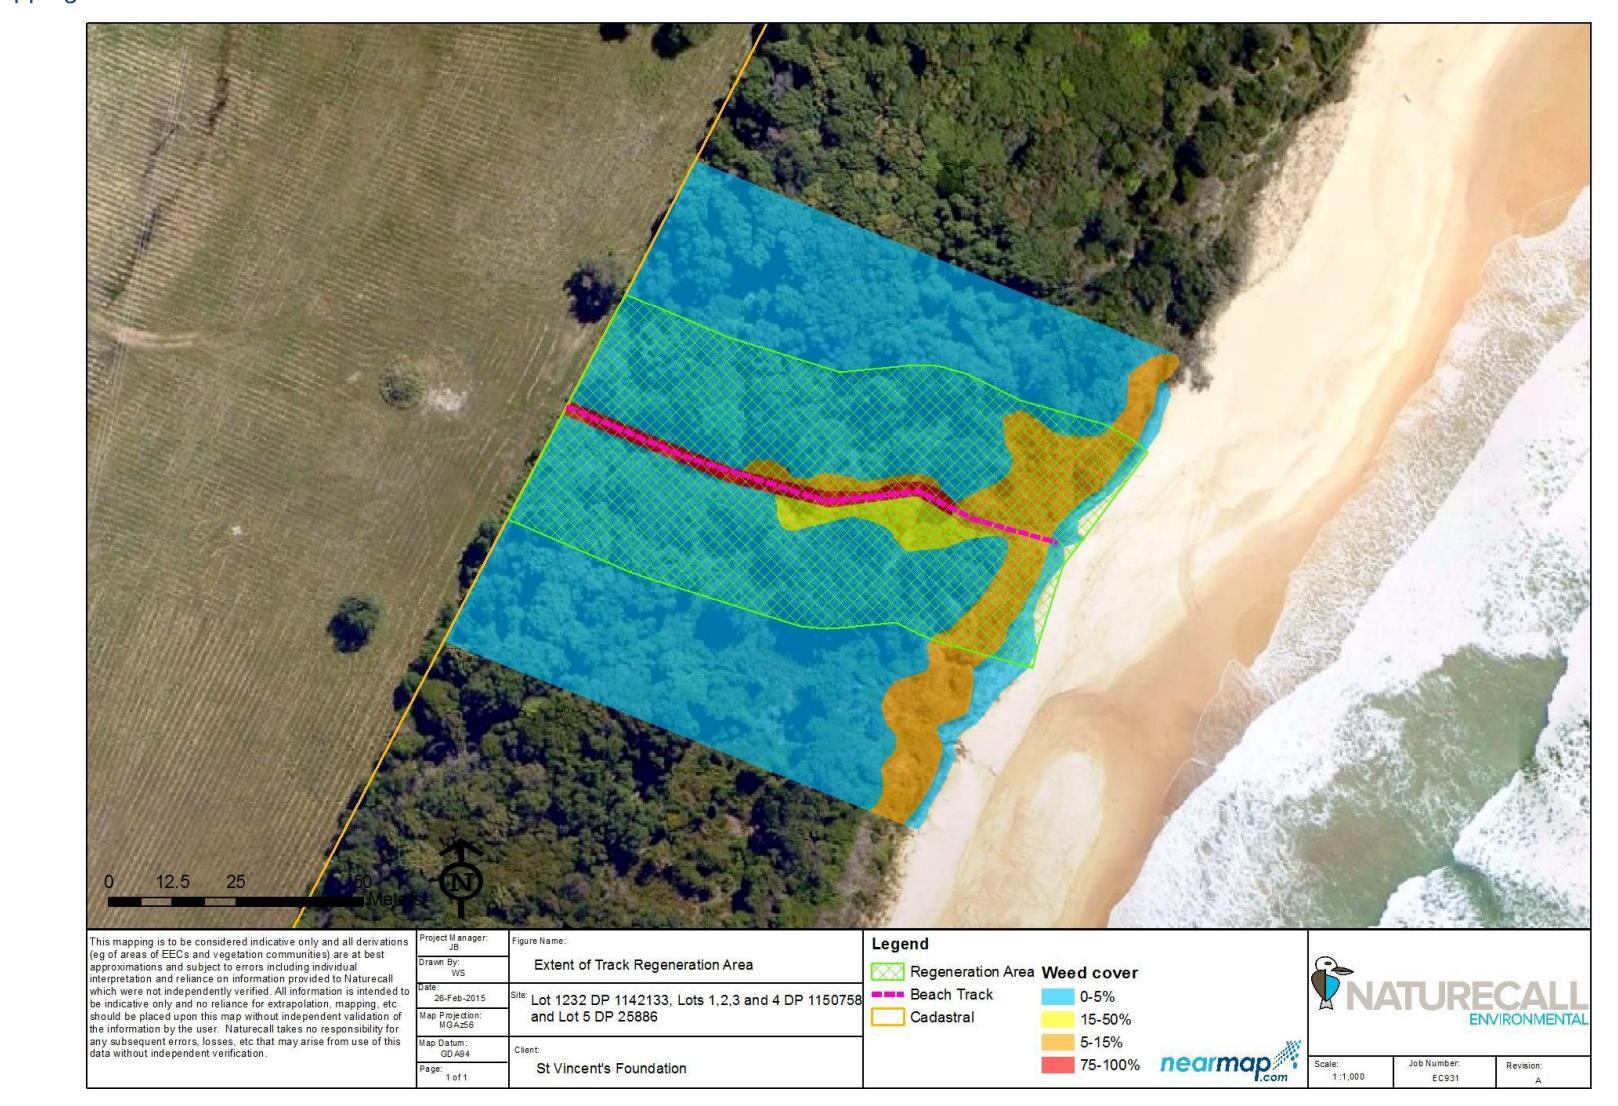
Figure 10: Weed mapping within 50m of the beach access and recommended treatment zone

Figure 10 reflects the above series of photos, i.e. the highest density of weeds is now only along the edges of the track itself. This is due to the fact that previously severe weed infestations adjacent to the track have been largely removed by works undertaken by both Landcare and a bush regenerator funded by the proponent. This has significantly opened up the forest edges (especially the Banksia woodland) and created some canopy gaps as shown by the area mapped as yellow. These areas were previously highly infested with Bitou Bush and Lantana, and occur on or just behind the foredune (pers. obs.). Weeds in these areas are now primarily young plants regenerating from seed stock and pending follow-up treatment. Plantings of native tree species have been made to infill these gaps.

This Figure and the photos illustrates that the immediate sections of forest adjacent to the track are the most vulnerable to re-invasion and hence dominance by weeds (e.g. due to greater access to solar radiation and less competition with native plants), and hence require the most intensive level of treatment. In general, the forest beyond this area is in very good condition following bush regeneration over several years, and limited active treatment is needed (eg follow-up weeding and infill planting). The remainder of the Reserve is under ongoing management by Landcare and, as detailed in the following table, is not likely to be significantly affected by the formalisation of the track.

Hence the nominated vegetation management area for the purposes of Concept Approval Condition C23 is considered sufficient to be 25m north and south of the track, with works aiming to effectively enclose the track within closed forest to buffer effects associated with the track's formalisation (see Section 12.
