SUBJECT: THE DAN LAND, 290 AND 302 MINMI ROAD FLETCHER - SECTION 75W APPLICATION TO MODIFY CONCEPT PLAN 06_0031

Arborist Report

Project - Stage 10 The Outlook

Stage 10 development guidelines

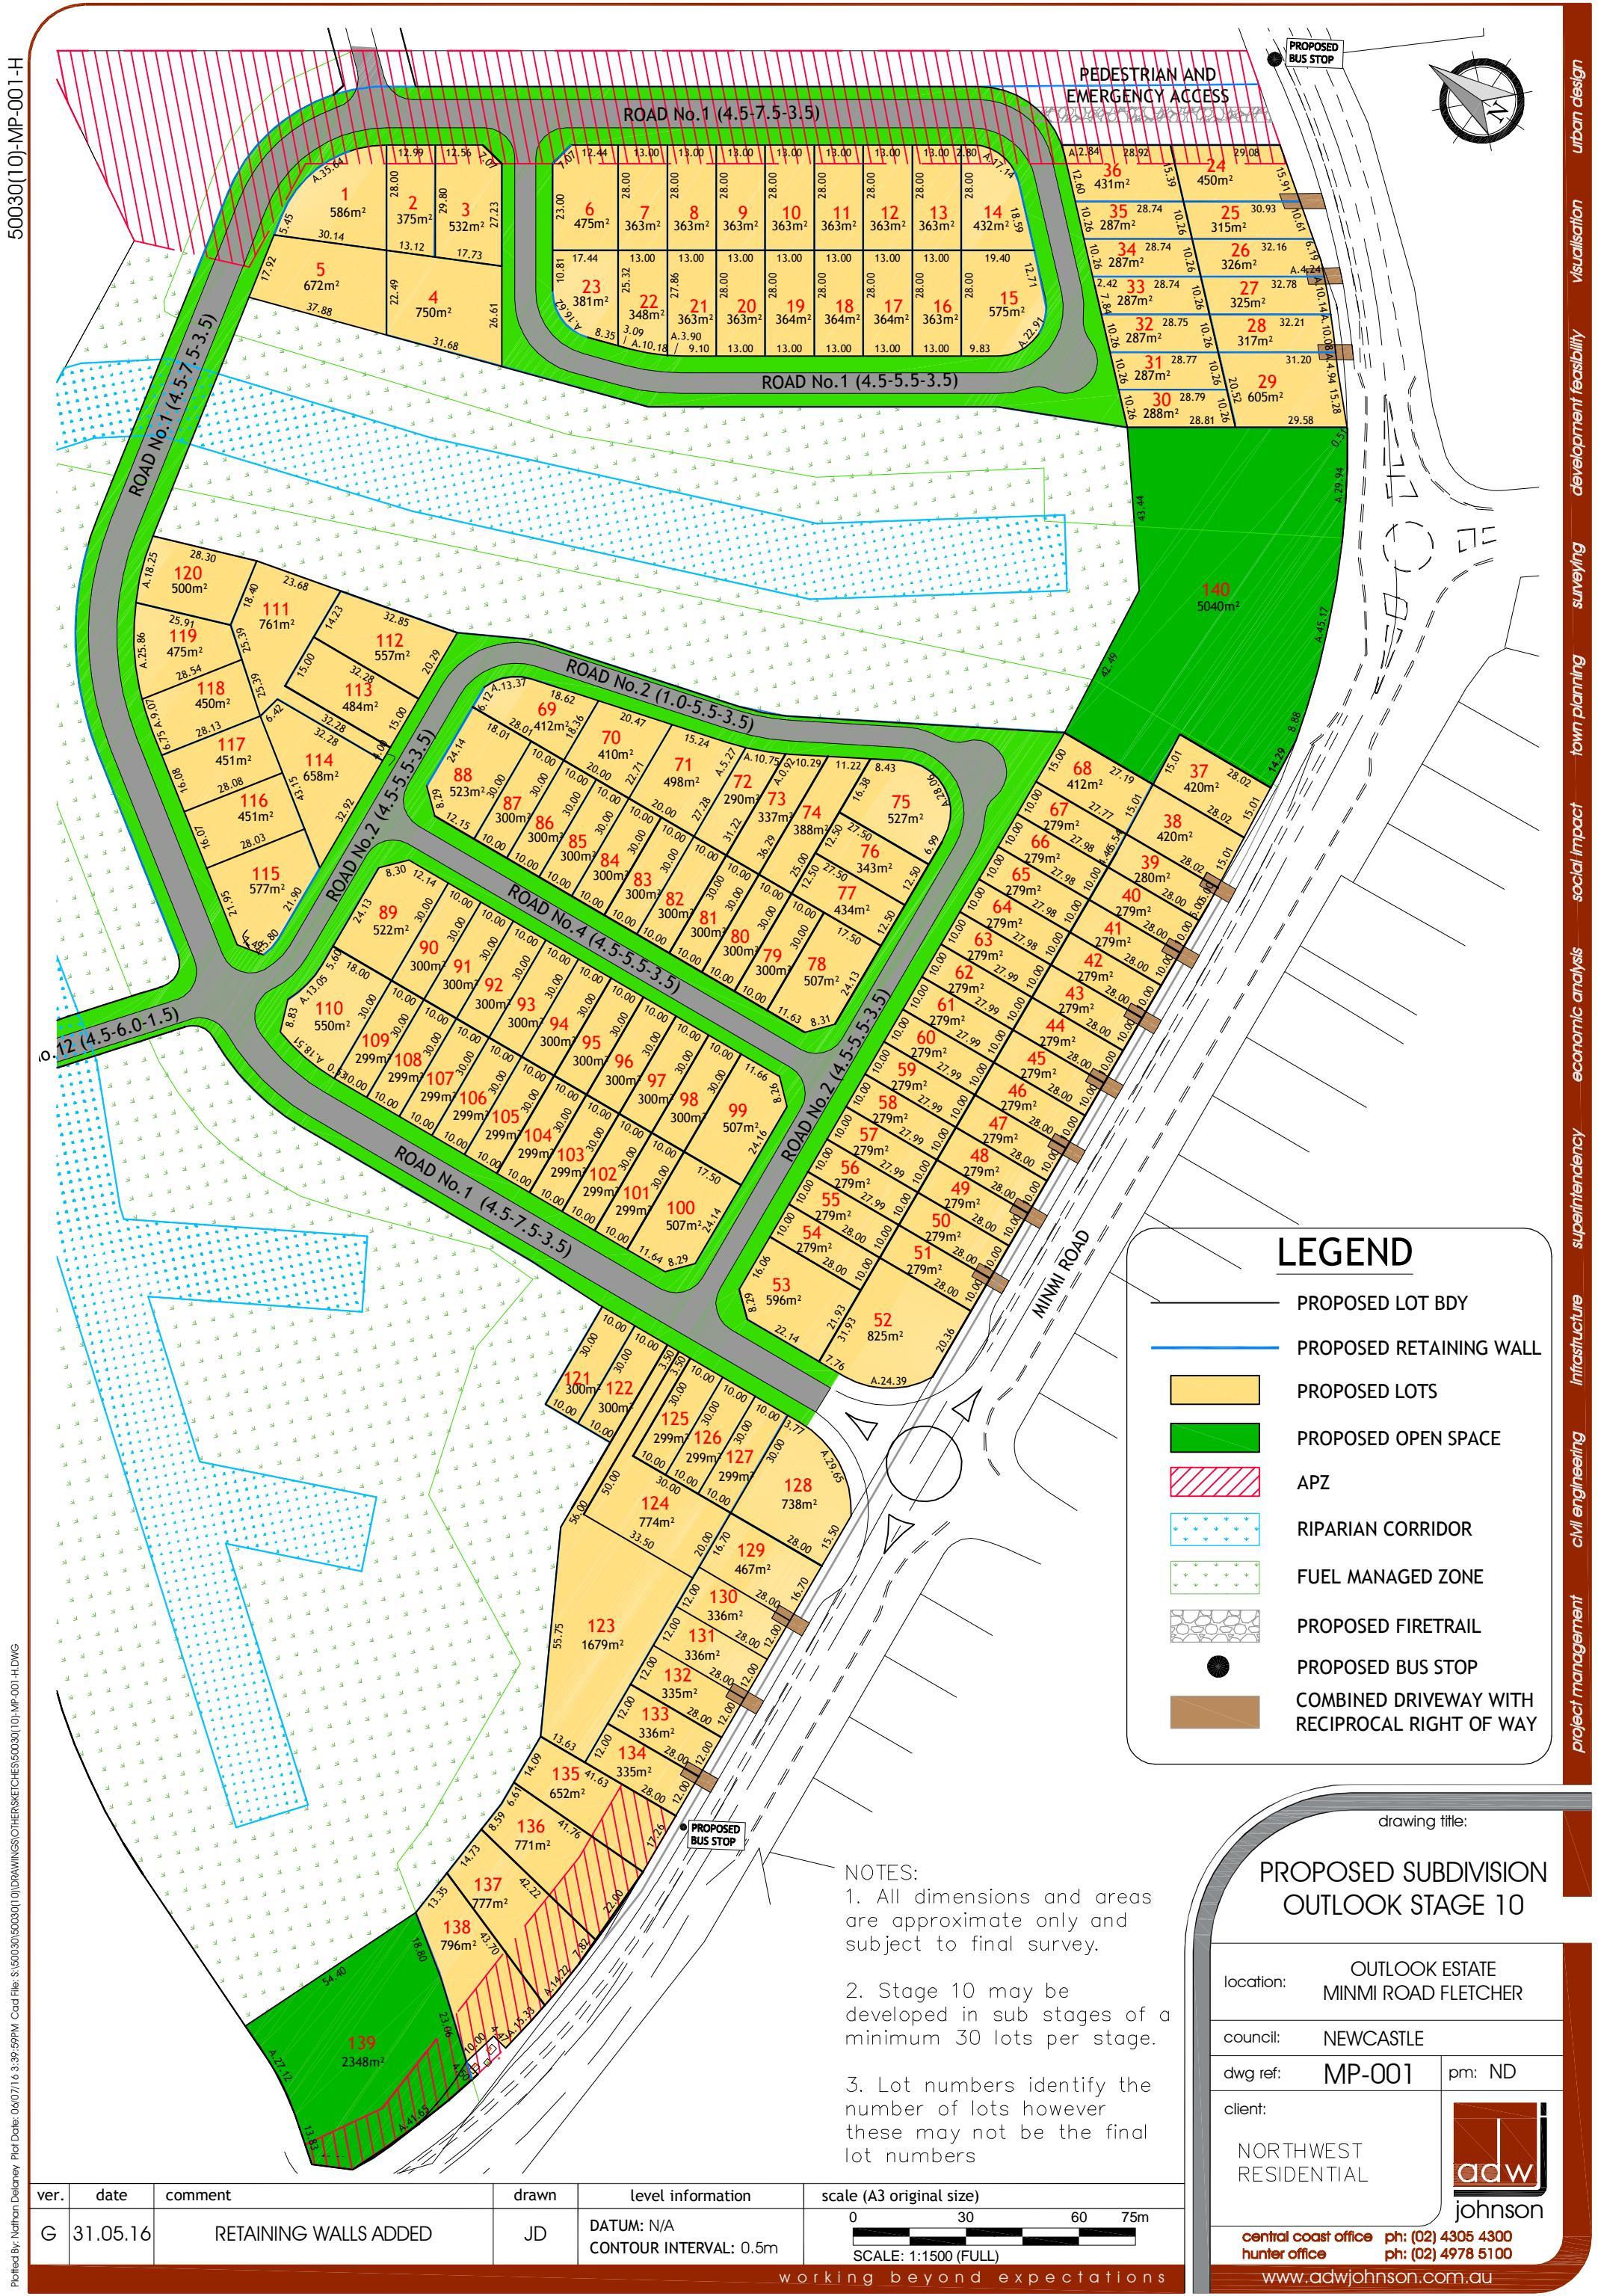
ATTACHMENT 1 - AMENDED SUBDIVISION LAYOUT PLAN

The proposed subdivision layout has been amended, in part to show a road reserve

SUITE 2, 14 WATT STREET, NEWCASTLE NSW 2300 TEL +61 2 4925 3286 FAX +61 2 4925 3403 WWW.CITYPLAN.COM.AU CITY PLAN STRATEGY & DEVELOPMENT P/L ABN 58 133 501 774 connection to the adjoining Urban Growth NSW residential subdivision to the northeast. The amended subdivision layout is shown at Attachment 1.

In response to SECA Solution's recommendation that the design of the Minmi Road-frontage lots incorporate combined driveways to service two adjacent lots, the subdivision layout has been amended accordingly (refer Attachment 1). The design guidelines at Attachment 4 also include this recommendation (refer p.8).

As shown in the proposed subdivision layout plan, the plan has been amended to eliminate certain battle-axe lots discussed at our meeting on 23 March by the introduction of a loop road (road no. 2). As a result, only three battle-axe lots now remain (lots 72, 123 & 124).

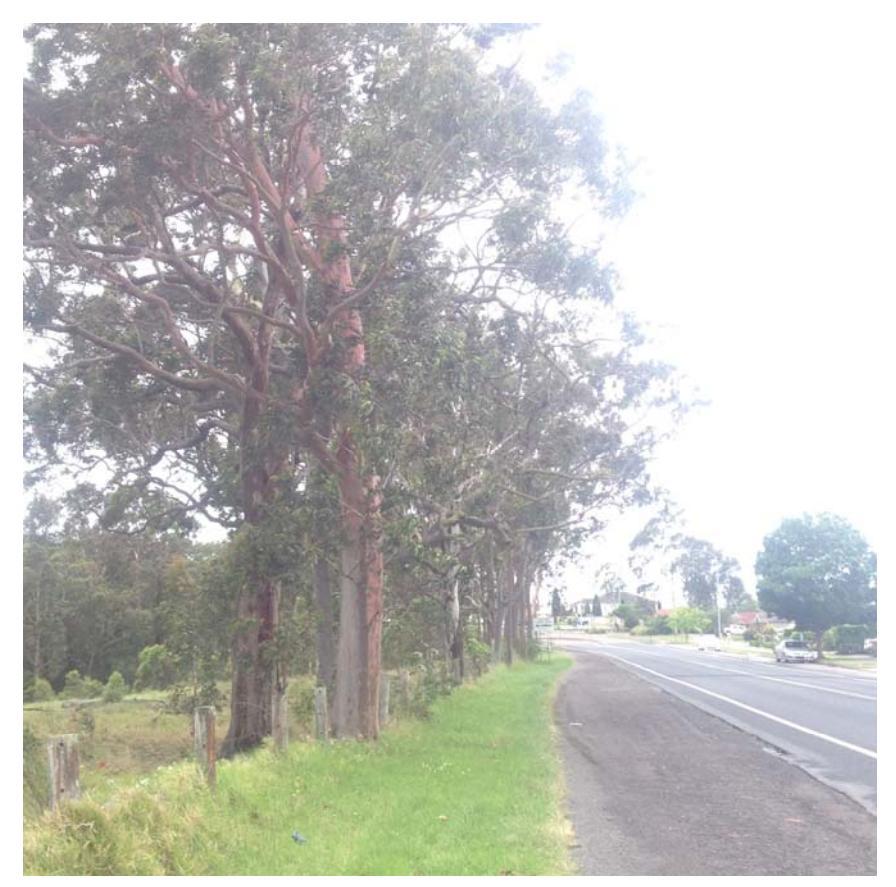
Figure 1. Looking east along Minmi Road.

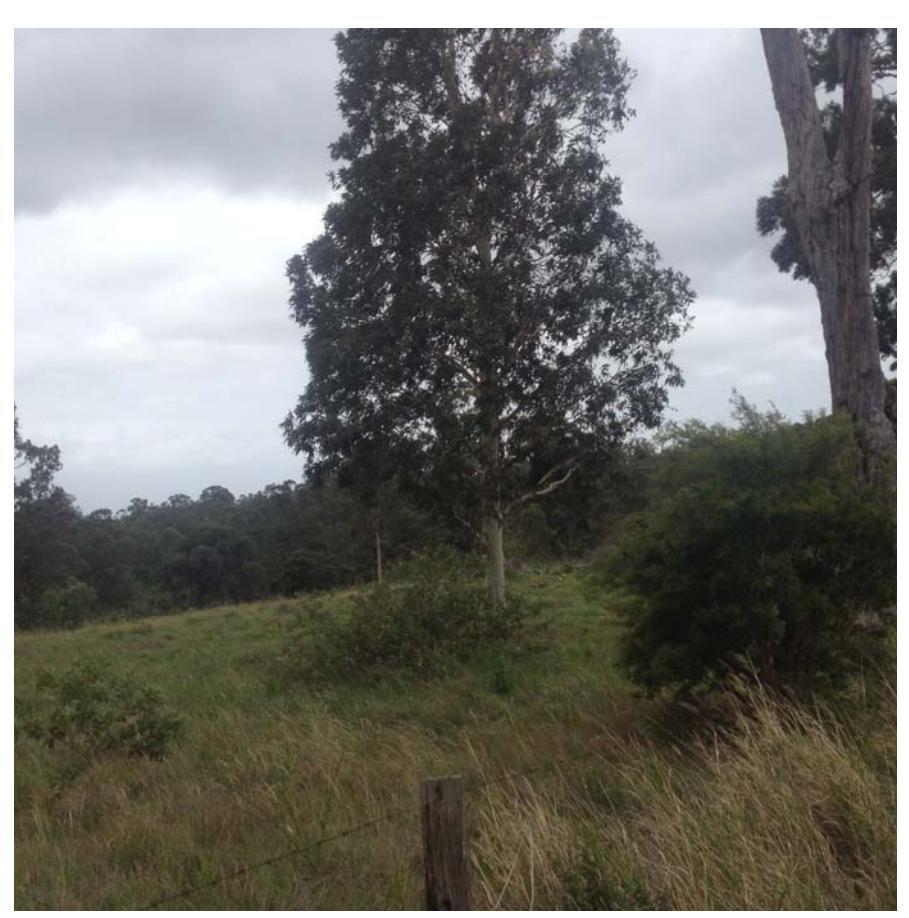
Figure 2. There are many immature trees some of which could be retained.

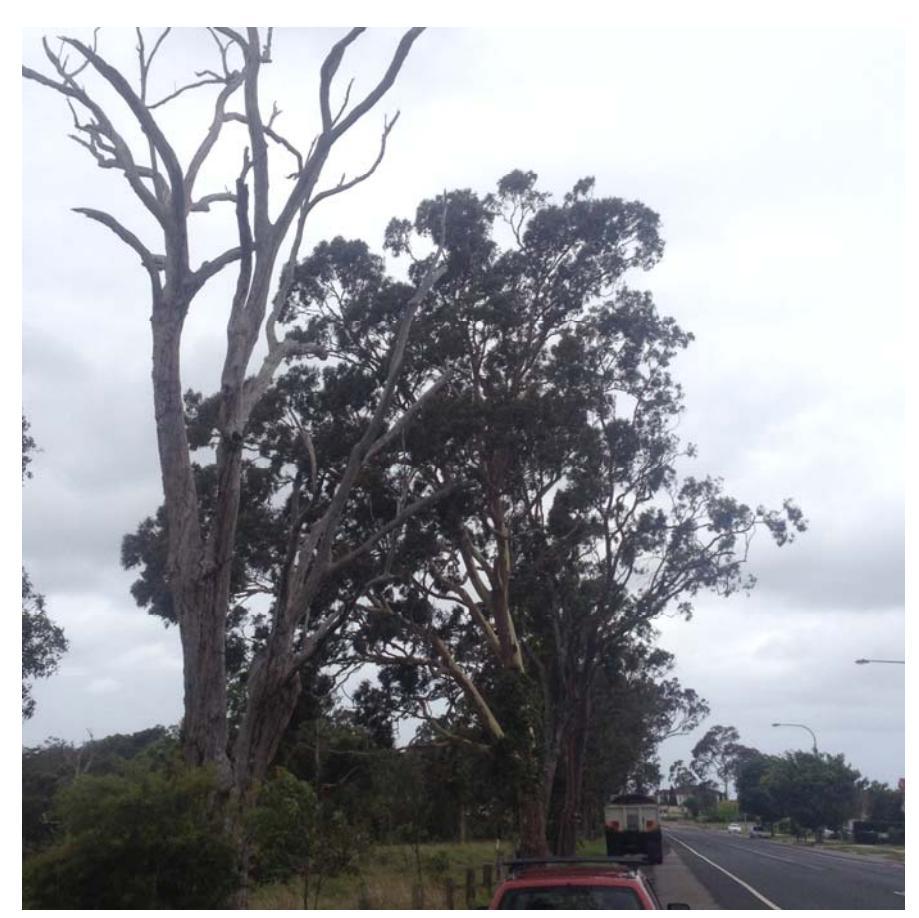
Figure 3. There a number of dead and over mature trees located along Minmi Road.

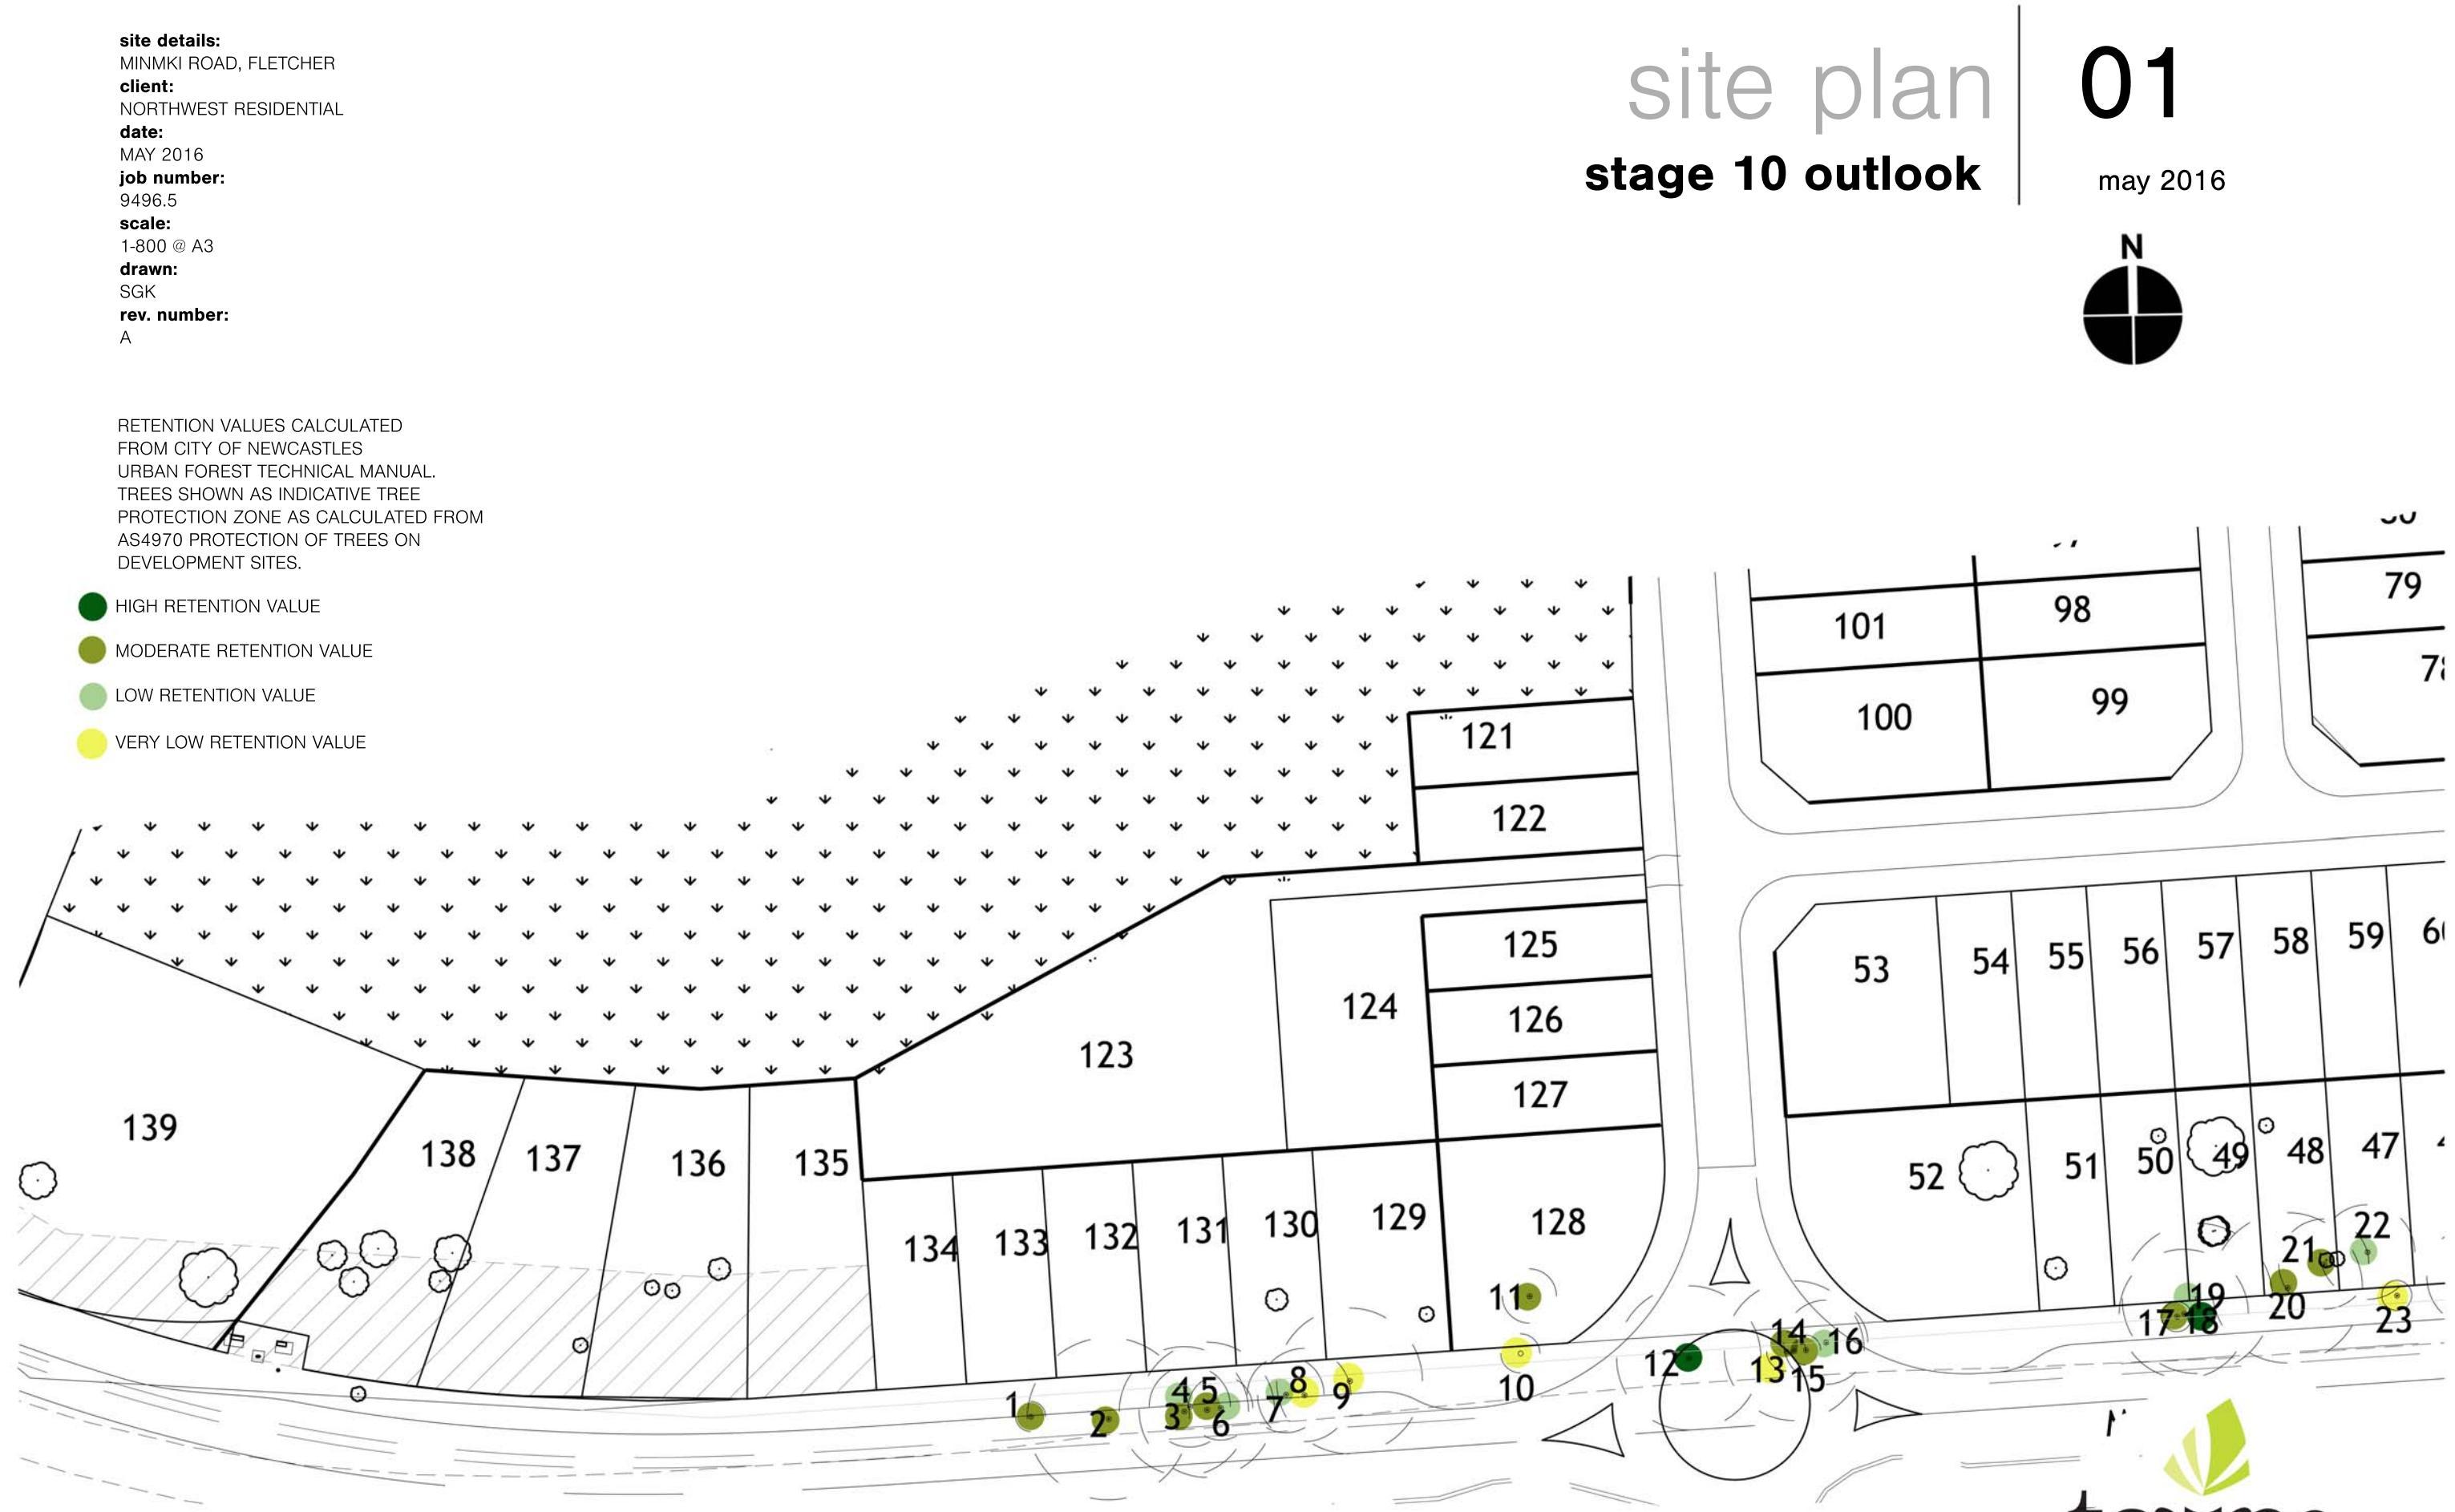
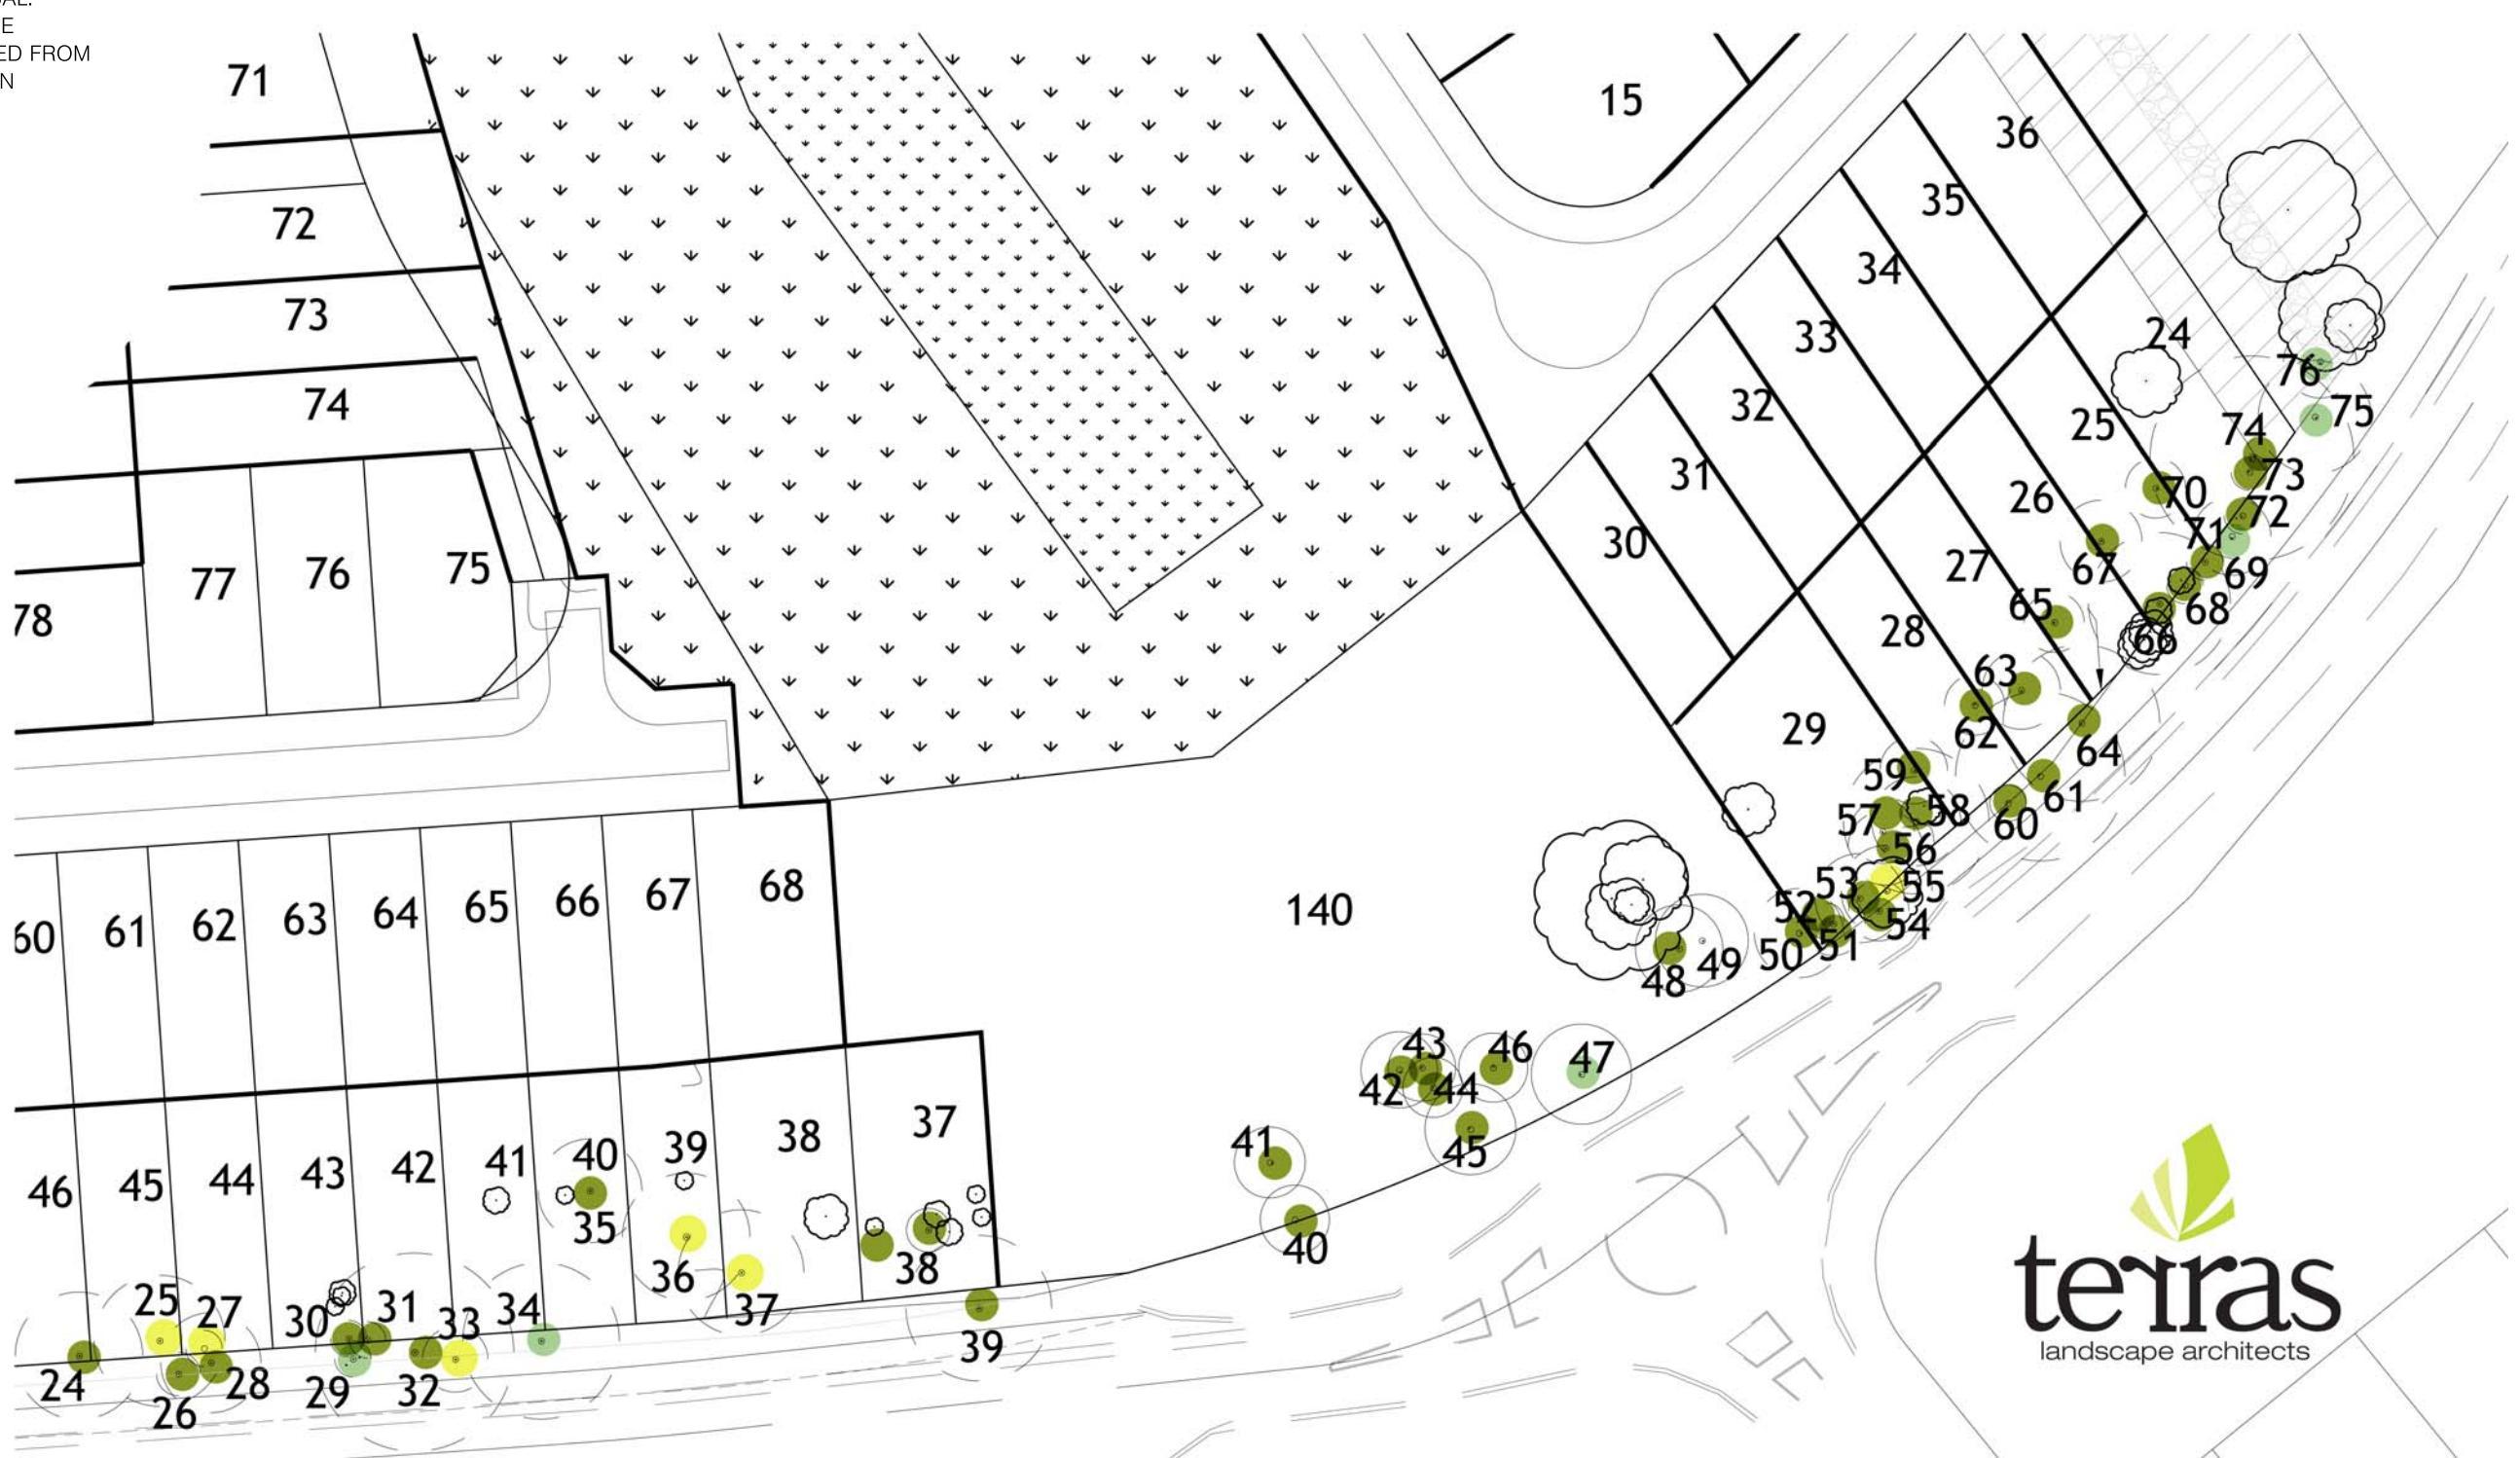
10 appendix 1 retention values drawing -site plan

RETENTION VALUES CALCULATED FROM CITY OF NEWCASTLES URBAN FOREST TECHNICAL MANUAL. TREES SHOWN AS INDICATIVE TREE PROTECTION ZONE AS CALCULATED FROM AS4970 PROTECTION OF TREES ON DEVELOPMENT SITES.

Trees located along Minmi Road within the proposed open space can be retained. These include: Trees 40, 41, 42, 43, 44, 45 46, 47, 48 and 49.

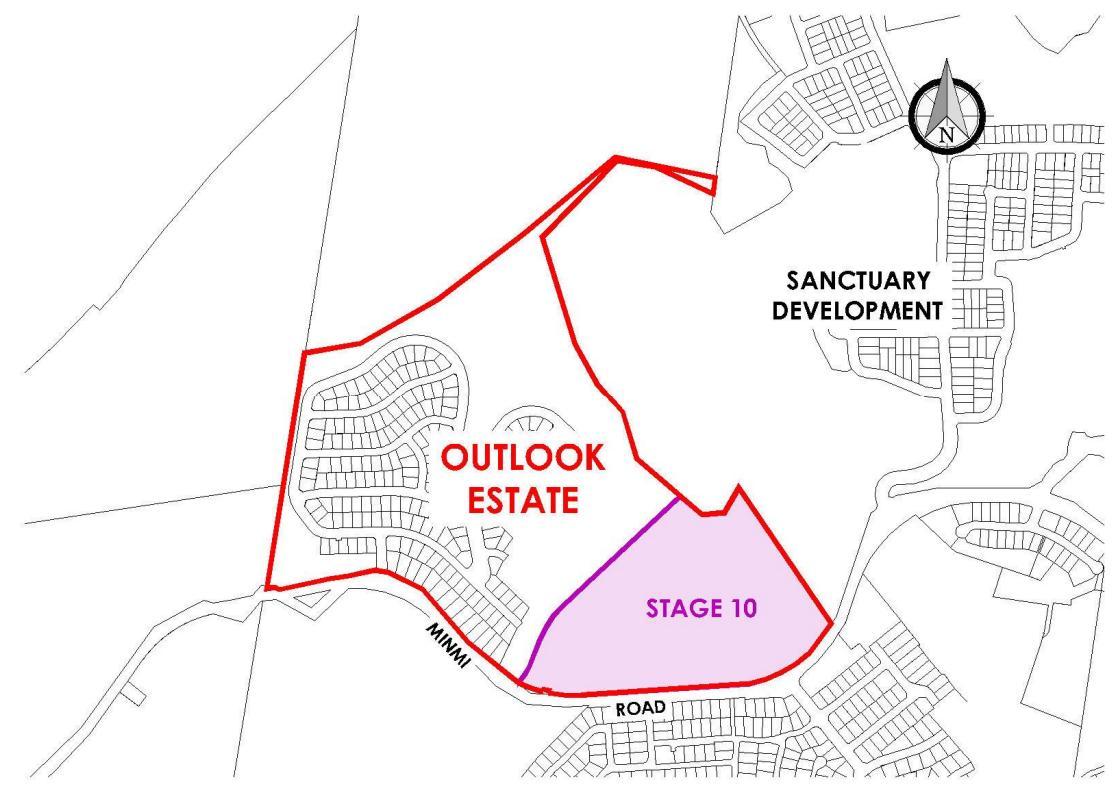
The Guidelines have been prepared specifically for Stage 10 of the community titled subdivision known as the Outlook Estate, located along Minmi Road, Fletcher, NSW. Stage 10 is identified as Lot 10 in DP 270583. A plan showing the location of Stage 10 (purple hatched area) within the Outlook Estate (solid red outline) can be seen below in Figure 1.

Figure 1: Land to which the guidelines apply

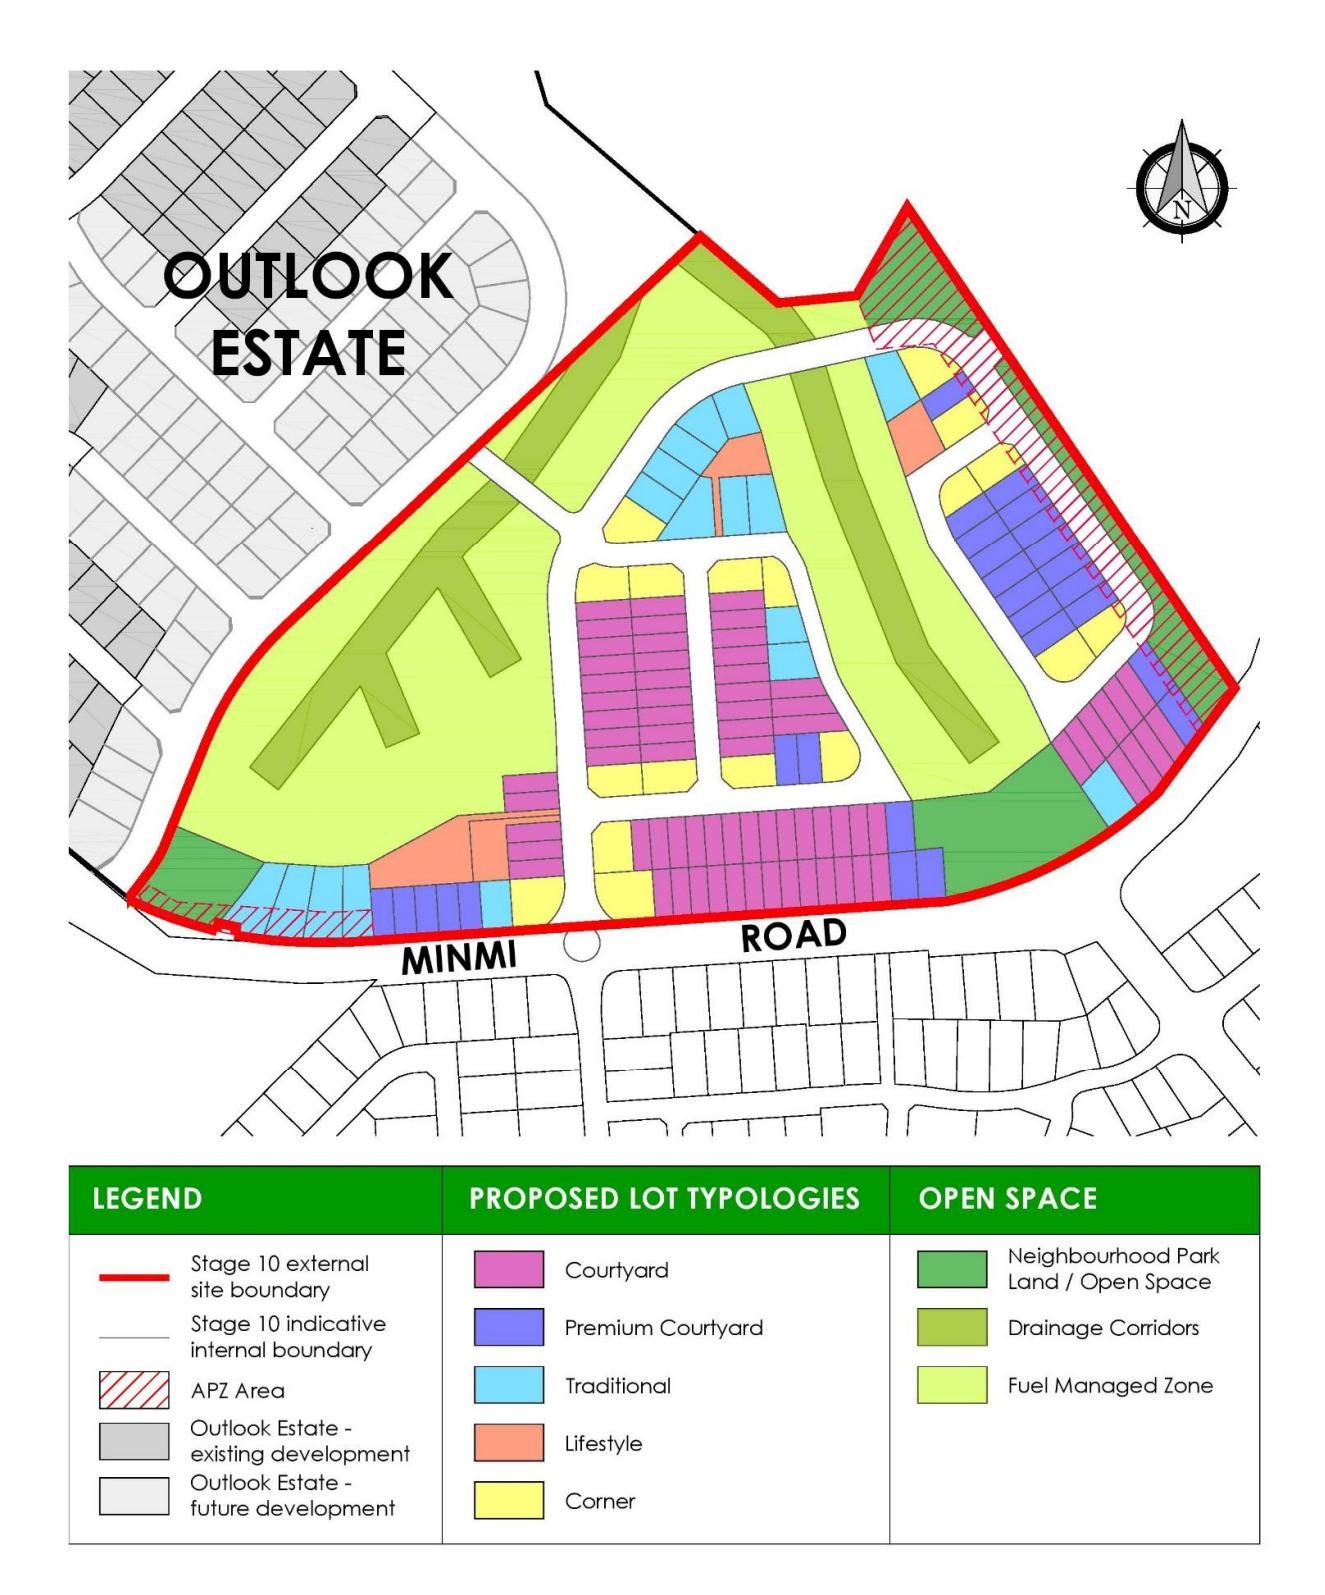
- 1. A revised lot layout for the Stage 10 of the Outlook Estate, generally in accordance with that shown in Figure 2, shall be provided for approval under Section 75W of the Environmental Planning and Assessment (EPA) Act 1979.
- 2. Lot typology, lot frontage, minimum lot size and depth shall be provided in accordance with Table 1.
- 3. Local access road connection points, cycleways and pedestrian pathways, generally in accordance with that shown in Figure 3, shall be provided.
- 4. Road widths shall be as per the masterplan submitted and approved as Concept Approval MP06_0031 Mod 3.

Figure 2: Indicative Lot Typologies Plan
