Clover Hill Subdivision Biodiversity Management Drainage line assessment

1 Introduction

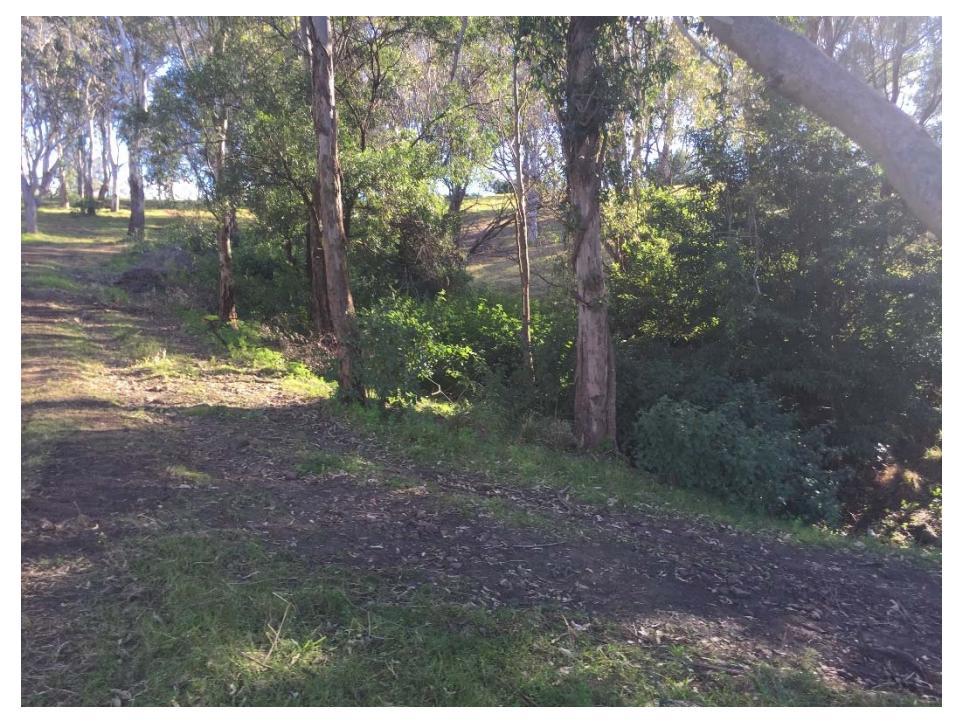
GHD Pty Ltd ABN 39 008 488 373 Level 3 GHD Tower 24 Honeysuckle Drive Newcastle NSW 2300 PO Box 5403 Hunter Region Mail Centre NSW 2310 Australia T 61 2 4979 9999 F 61 2 4979 9988 E ntlmail@ghd.com W www.ghd.com native vegetation occupying approximately 4 - 5m either side of the centre line of the drainage line. This section is largely contained within the E3 zone. Vegetation present is degraded and consists of occasional canopy trees and an understorey dominated by Lantana (*Lantana camara*).

Photo point 1 - Vegetation associated with drainage line head water

- Retaining the vegetation associated with the head waters of the drainage line and rehabilitating a Vegetated Riparian Zone (VRZ). This zone would be approximately 10m wide on either side of the drainage line contained within the E3 zone.
- Piping the drainage line from immediately south east of the E3 zone through to the existing culvert associated with Escarpment Drive.
- Constructing an inlet structure, 'soft' engineering in design, at the beginning of the piped section to assist in managing inflows, erosion and water quality. The basin would be rehabilitated using native ephemeral species.

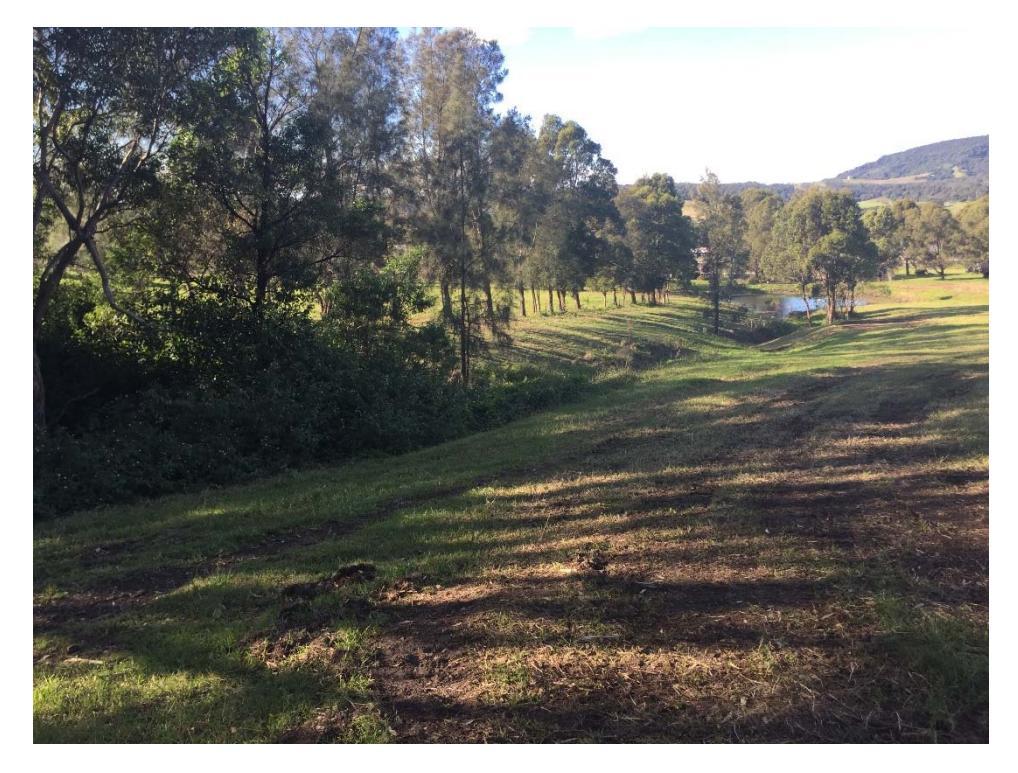
- Downstream from this location the remaining drainage line exists as a degraded flow path containing introduced grasses only. This area has been impacted by long term grazing and shows evidence of active erosion and very limited biodiversity or geomorphic values.
- In the south east of the site the drainage line has been impacted by the construction of two small dams to provide a watering option for grazing stock. These dams have significantly altered the flow path and a defined channel no longer exists in this section.
- Below Dam 2 the drainage line exists as an over land flow path consisting of introduced grasses only before entering a culvert under Escarpment Drive.

Photo point 2 – Middle reach looking south east through to Dam 1

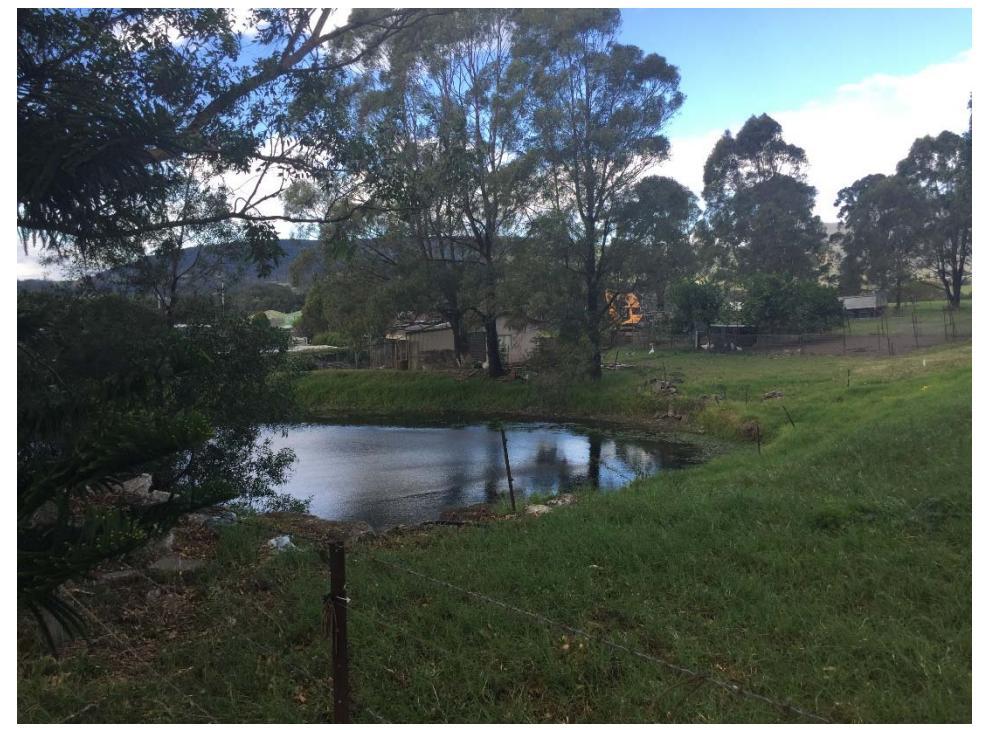
Photo point 3 – Dam 1 including entry flow path

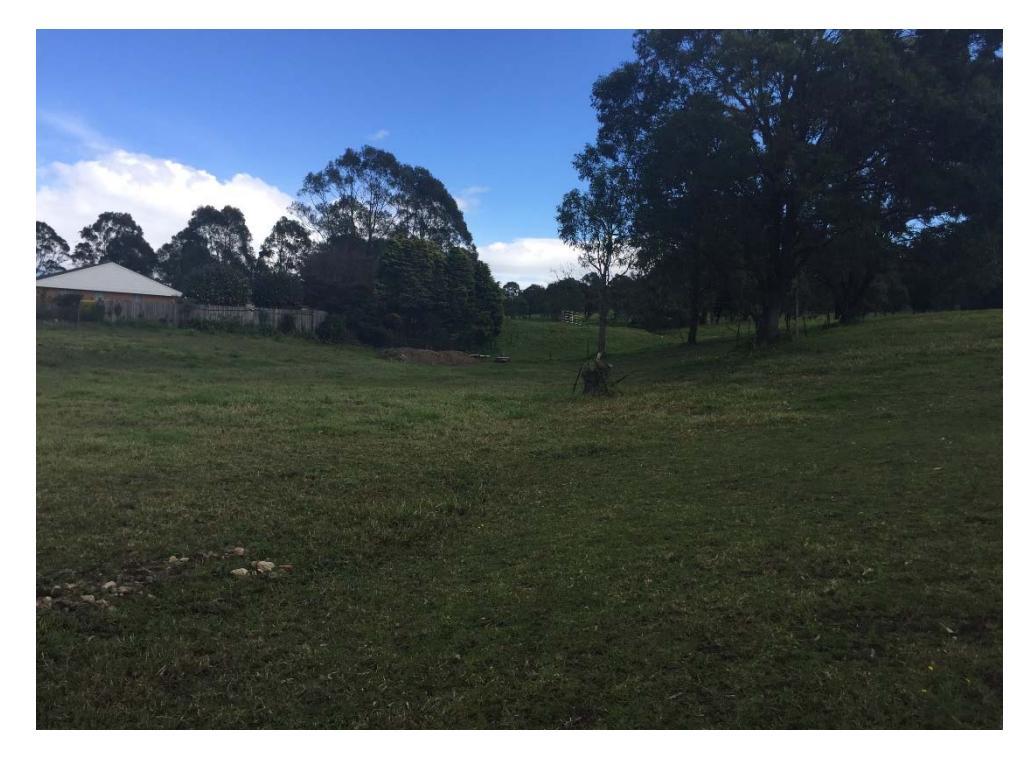
Photo point 4 – Overland flow path below Dam 2 through to culvert under Escarpment Drive

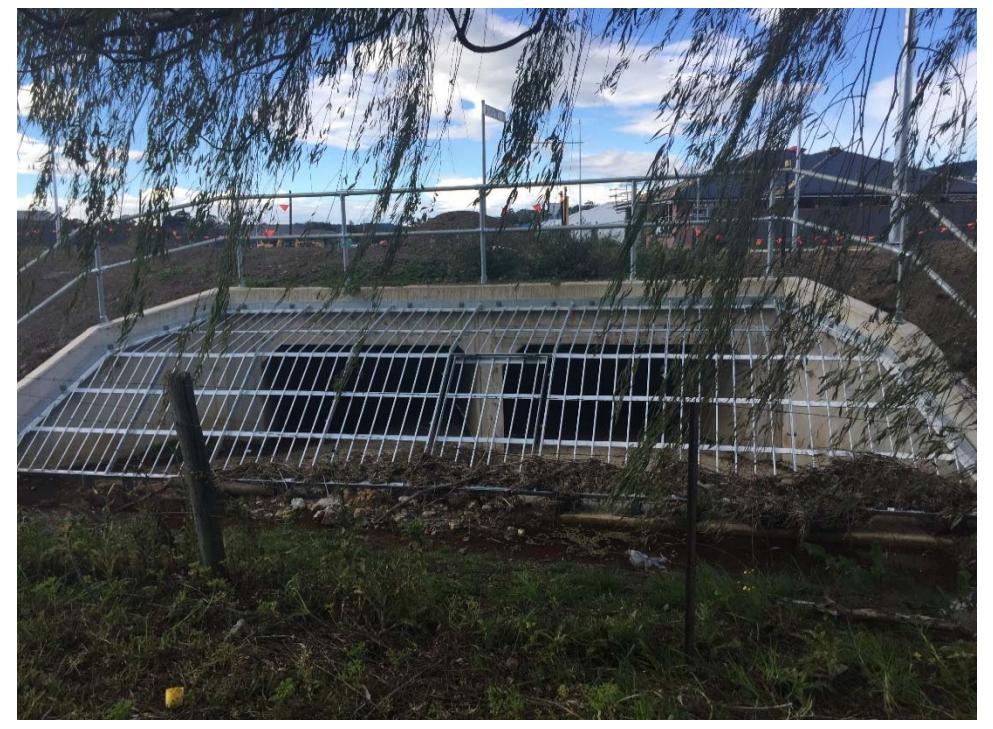
GHD's also inspected the drainage line to the south east of Escarpment Drive. This inspection indicated the drainage line has been 'piped' from the culvert associated with Escarpment Drive right through to Macquarie Rivulet. A portion of this piped section of the drainage line appears to include a section which may have been classified as a 2nd order stream under the Strahler classification system.

Photo point 5 – Drainage line entering culvert and then piped section through to Macquarie Rivulet.
