Proposed Remediation of Contaminated Land

***Lots 1-4 DP 818957
Addiscombe Road, Manly
Vale***

Project Application and Preliminary Environmental Assessment

August 2006

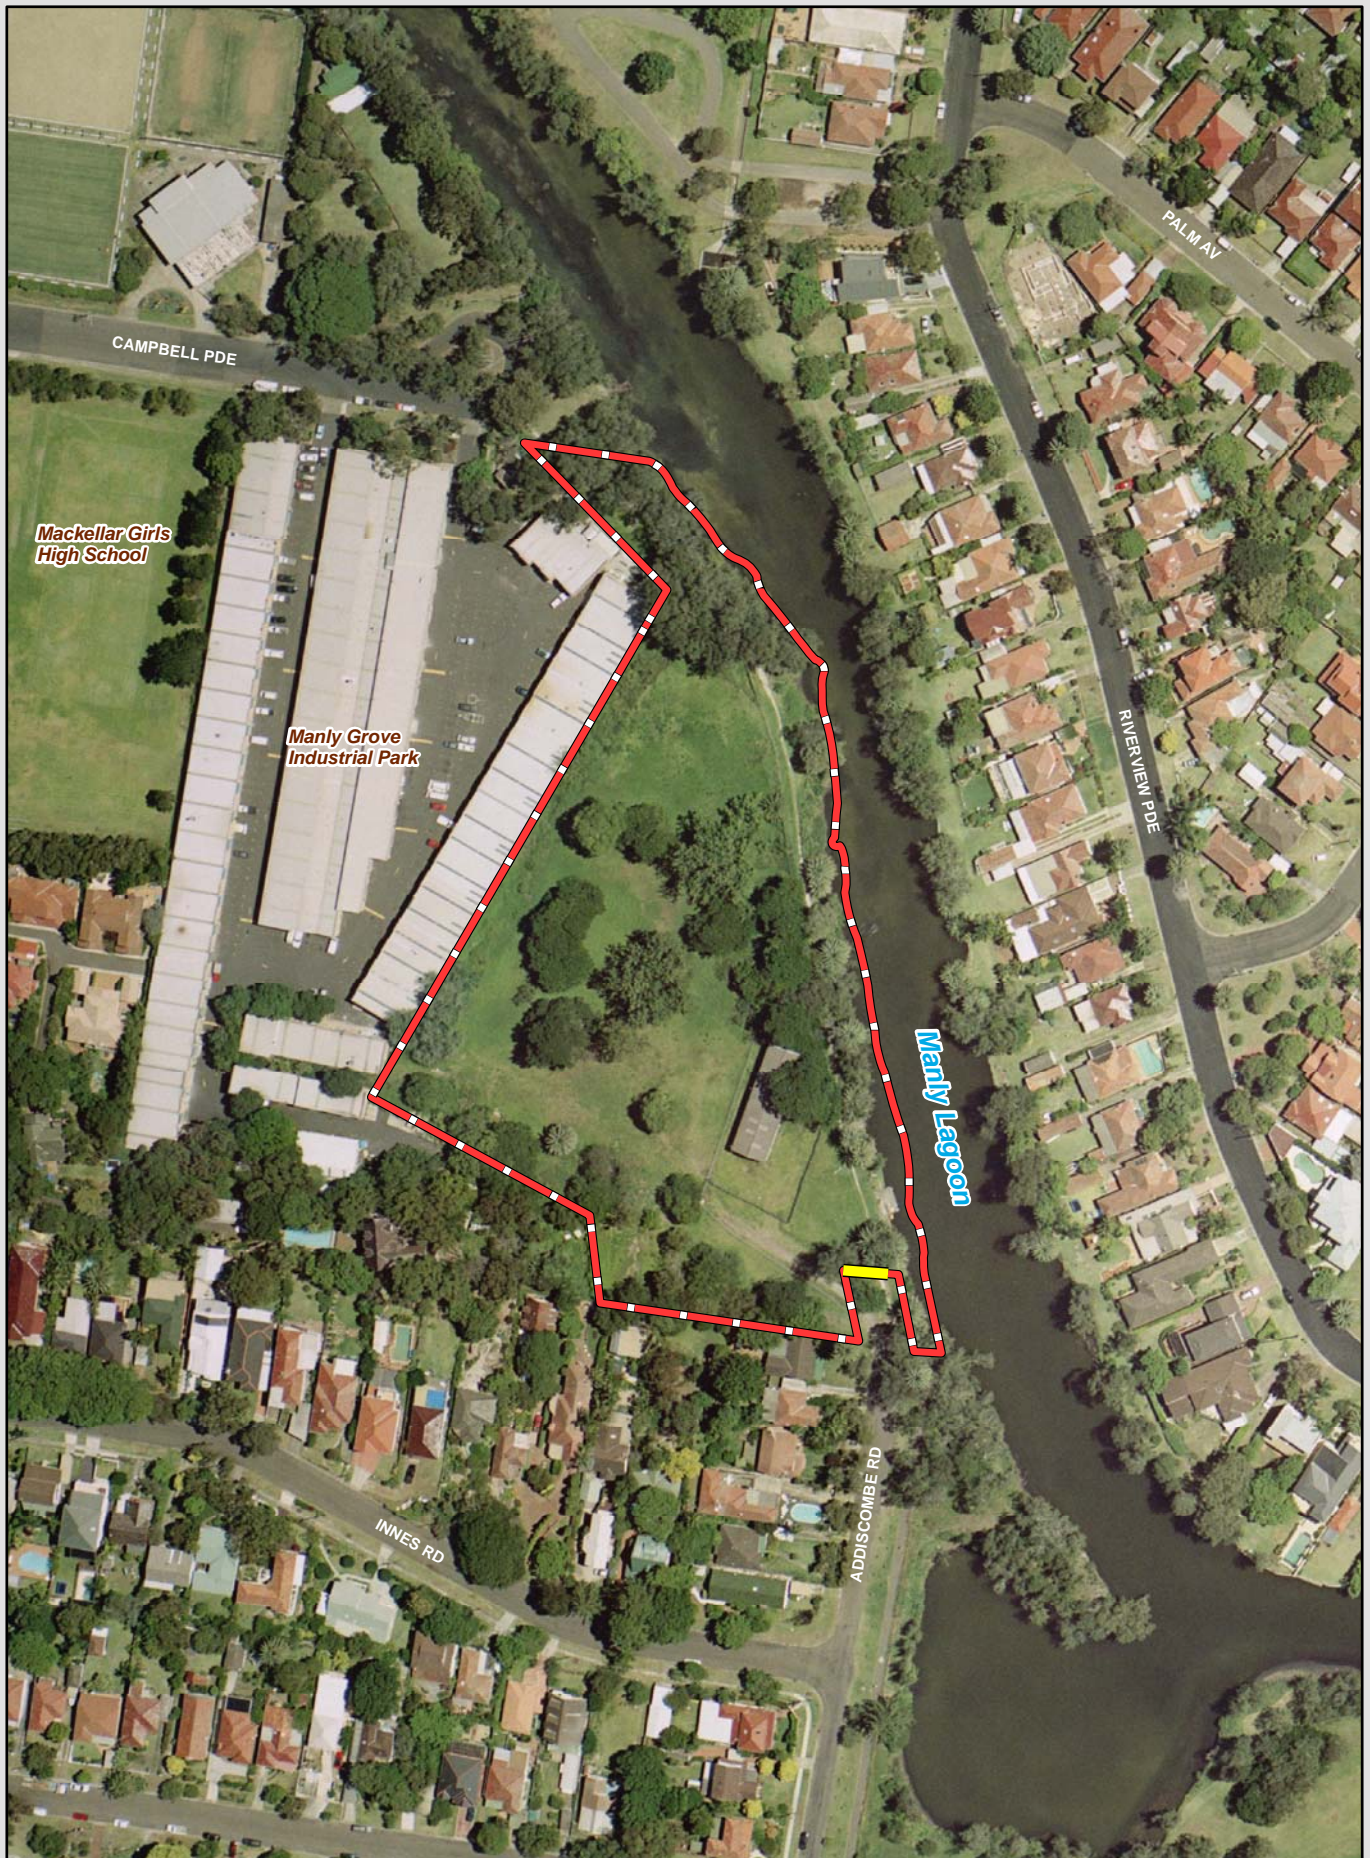
Figure 2.1 Proposed remediation site

Proposed remediation site
-

Site access

0 20 40 60 80 Metres
Scale 1:2,000

The proposed remediation site is located at the northern end of Addiscombe Road, Manly Vale, adjacent to Manly Lagoon. The site is on the northern border of the Manly local government area, adjoining the suburb of North Manly and the Warringah local government area. *Figure 2.1* shows the location of the site and surrounding land use features.

Figure 2.1 shows the proximity of surrounding land uses to the Addiscombe Road site.
