# *Sapphire*

## Landscape Masterplan Report ADDENDUM

prepared by  
Jackie Amos Landscape Architect

for  
Sapphire Beach Development Pty Ltd  
December 2006

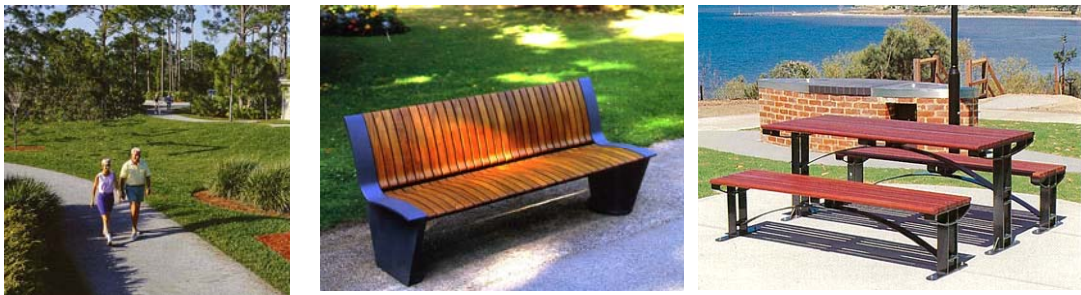
A north/south pathway provides a walk through the Beachfront parkland. The northern pathway is linked to the access to the Coastal Walk to create a potential walking circuit. A loop is provided at each pathway end. Shade trees, existing Pandanus and existing dune vegetation at the northeast extent of the site would provide shade to this parkland with seating located at shaded locations. Low planting of coastal plants would provide amenity and define significant locations such as the picnic and BBQ areas.

The north/south pathway is intended as a walking area with quiet seating areas for passive recreation. The picnic/BBQ at the intersection of this pathway and the link to the beach is intended as a gathering point. The central parkland either side of the link to the beach is 27m wide and is proposed as the zone for active play.

A seating area would be located either side of the beach access. These locations would have views to the ocean and would be located below existing Pandanus. Access to these areas would be controlled as part of the dune fencing.
