### 1.4.3 Character Area Type 3

#### *grassed batter with landscaping*

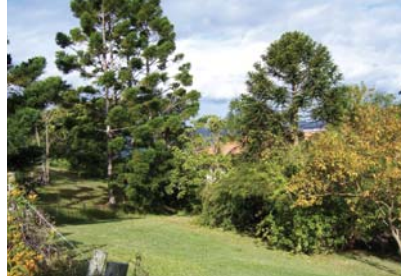
This area is located south of the former restaurant and elevated grassed spur. It represents one of the steeper parts of the site with a fall from 26.500 to 20.000. The area is part of the landscaped surrounds to the resort and includes isolated trees and grass. The location is south facing. Species include exotics such as Leopard Trees and native species (not local) such as a Bunya Pine.

Hoop Pines & Bunya Pine at top of batter

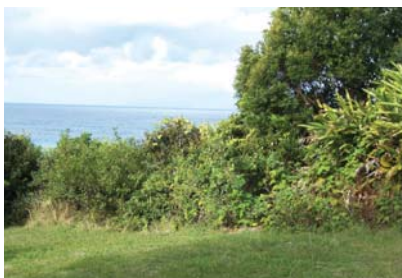
western edge of 7(a) zone with weeds at interface between vegetation and grassed spur

This area represents the steepest part of the resort site with an approximate slope of 1:2. The area is east of the grassed spur and extends to just above the recreational facilities associated with the former resort. The area is zoned 7(a) Environment Protection Habitat/Catchment. The vegetation is described as Dry Sclerophyll Forest and is mostly regrowth vegetation. This pocket of vegetation is approximately 4000 square metres in size. The vegetation pocket is currently weed infested, particularly at the edges. The area represents one of only two pockets of remnant vegetation on the site. It includes a number of mature trees.

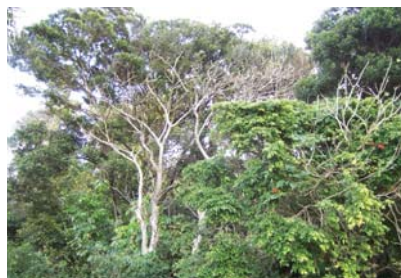
eastern edge of 7(a) zone adjacent to existing recreational area of resort

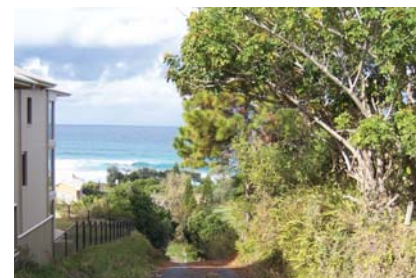
northern edge of 7(a) vegetation with weed infestation adjacent to existing access

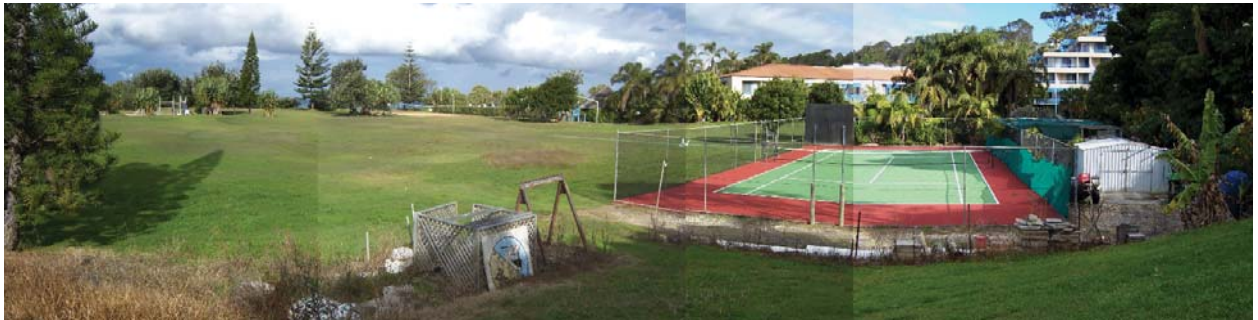
This character area is the largest at the site and covers the recreational facilities and open spaces associated with the former resort. There are two main areas with the first east of the 7(a) vegetation. This space includes a basketball court, open grassed area with BBQs, a childrens playground, a beach volleyball court and a mini golf course. There are also a number of isolated trees with the most common species being Norfolk Island Pines, Screw Pines (*Pandanus pedunculatus*), Coastal Banksias (*Banksia integrifolia*). This area is relatively level and is located at the lowest part of the site. There is an existing depression at RL5.500 just to the east of the tennis court. The second location of this type is to the east of the main resort building and includes the pool, additional tennis courts, the access to Campbells Beach and an area of parkland behind the beach. This area is slightly more manicured than the grassed open space. The pool area sits immediately behind the beach with the pool located below the dune level. The immediate surrounds include paving, shade shelters, tree planting of *Pandanus pedunculatus* and sub-tropical species.

open grassed space and recreational facilities east of the 7(a) vegetation

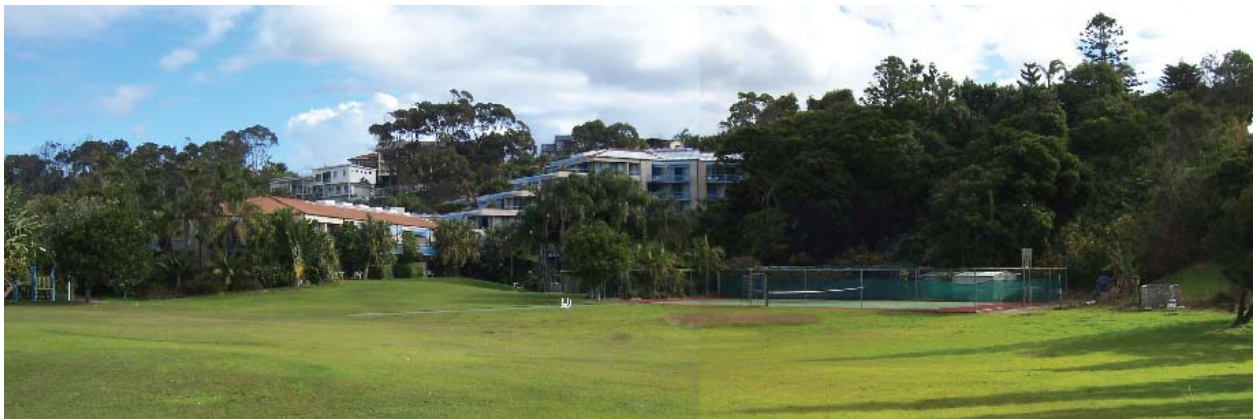
grassed depression east of the tennis court that represents the lowest point on the site

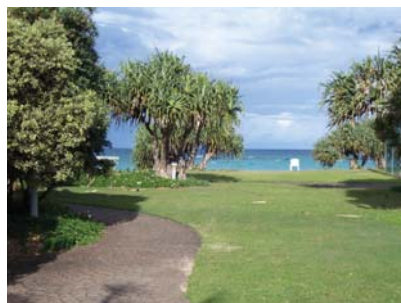
The dune area beyond this recreational area represents a highly manipulated coastal environment. Nearly all the dune vegetation has been removed and there is only a scattering of spinifex immediately behind the beach. The dune vegetation has been replaced with plantings of *Pandanus pedunculatus* and these are contributing to dune stability. Turf has been planted behind the dune and this virtually reaches the top of the sand.

lawn area behind beach

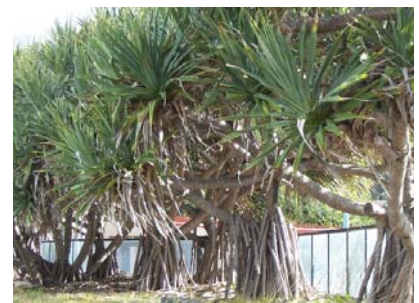
Pandanus between beach and pool

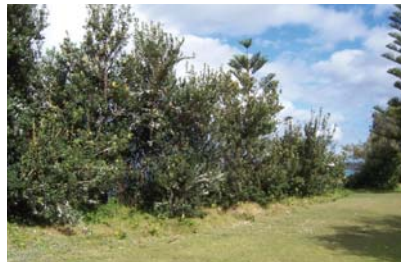
This area is located immediately behind Campbells Beach at the northeastern corner of the site. It represents the second area of indigenous vegetation within the site. Native vegetation includes Blackwood Wattle, Coastal Wattle, Coastal Banksia, Geebung and grass species. The area is highly infested with weeds and shows signs of previous garden waste having being dumped at this location. Of the entire site, this is the only area that represents a location where the hind dune has not been completely manipulated and grassed. The existing vegetation is providing stability to the hind dune.

Banksias, part of the hind dune vegetation

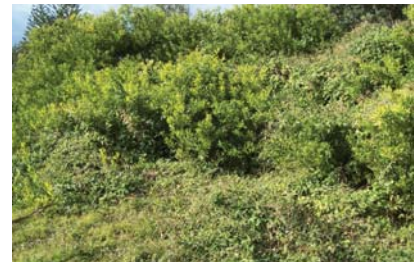
weed infestation to hind dune vegetation

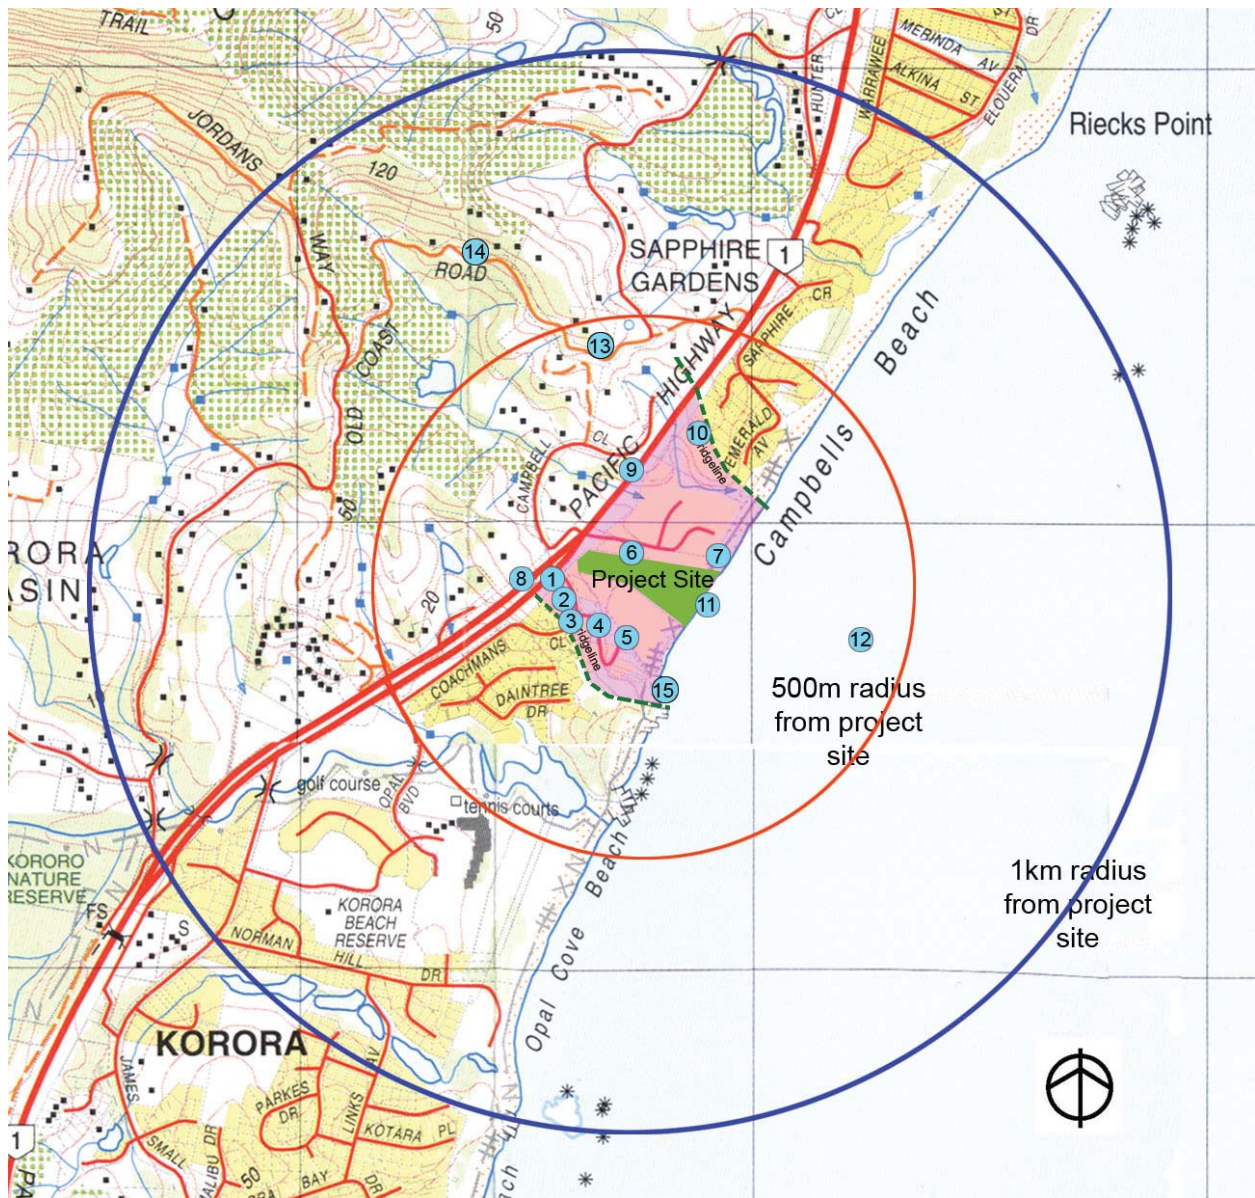
Illustration 6 - Views from Public Locations

The following illustration indicates the views that are possible to the project site from public locations within a 1km radius of the site.

These locations represent public locations within a 1km radius of the project site from which it is possible to see part or all of the project site. Analysis does not include private residences, however, to the south of the site locations 1 to 5 have been utilised to make a preliminary assessment of views from the nearby residences. For each photograph, the yellow line indicates the approximate extent of the project site.

There are two main factors that affect how the site is viewed. The first is that the site is located between two ridgelines approximately 260 metres apart. Locations south of the southern ridgeline and north of the northern ridgeline do not have views to the project site. Refer to the Illustration 1. Secondly, the site is located below the highway with much of the site at the same elevation as the foreshore. This means that for many locations west of the highway, the site is at too low an elevation to be viewed and for locations that can view the site, it is only the higher part of the site that is visible.

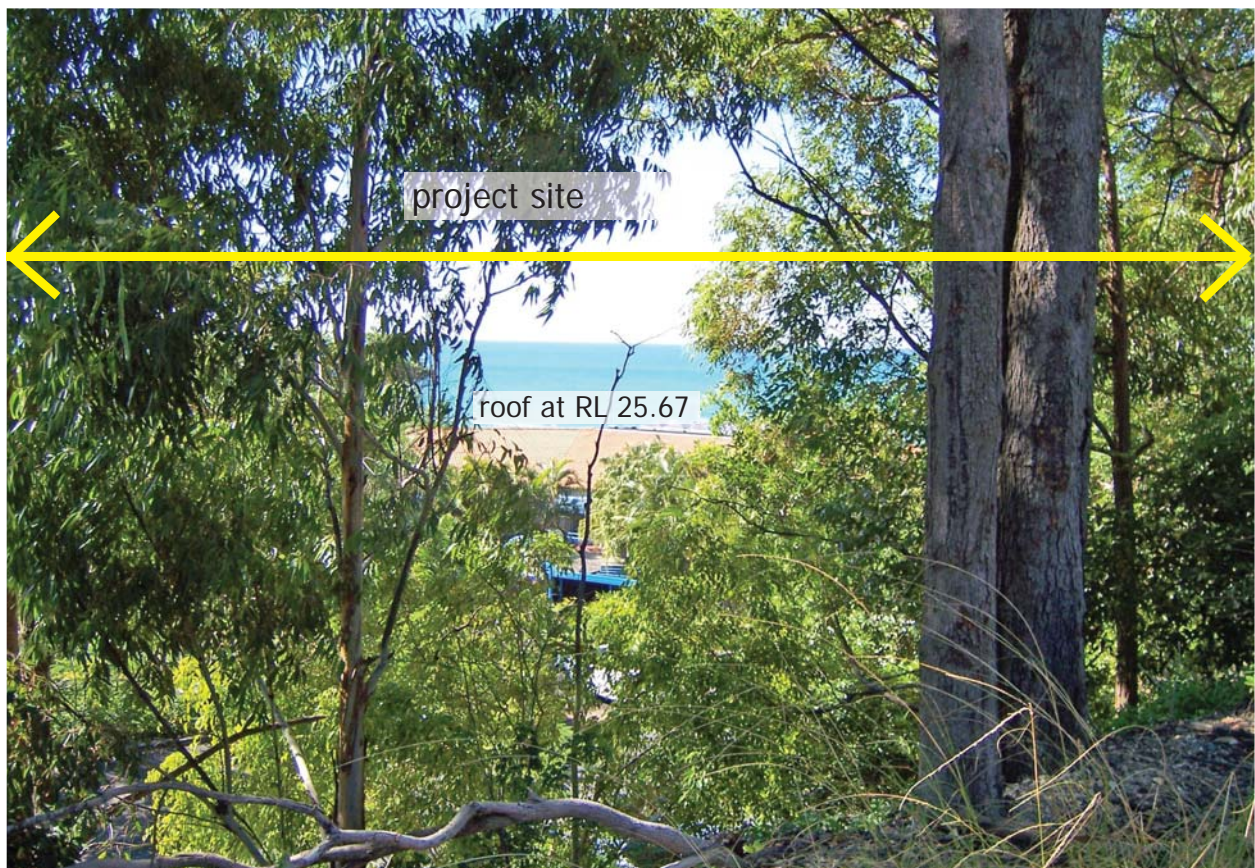
### View 1 - northern end of Coachmans Close

This view is from the northern end of Coachmans Close, south of the project site. It is indicative of the view from the residences at the end of Coachmans Close. In actual fact the residences are elevated at least another 2m above this location. Only limited views are possible due to the tall trees on the bank between the site and Coachmans Close.

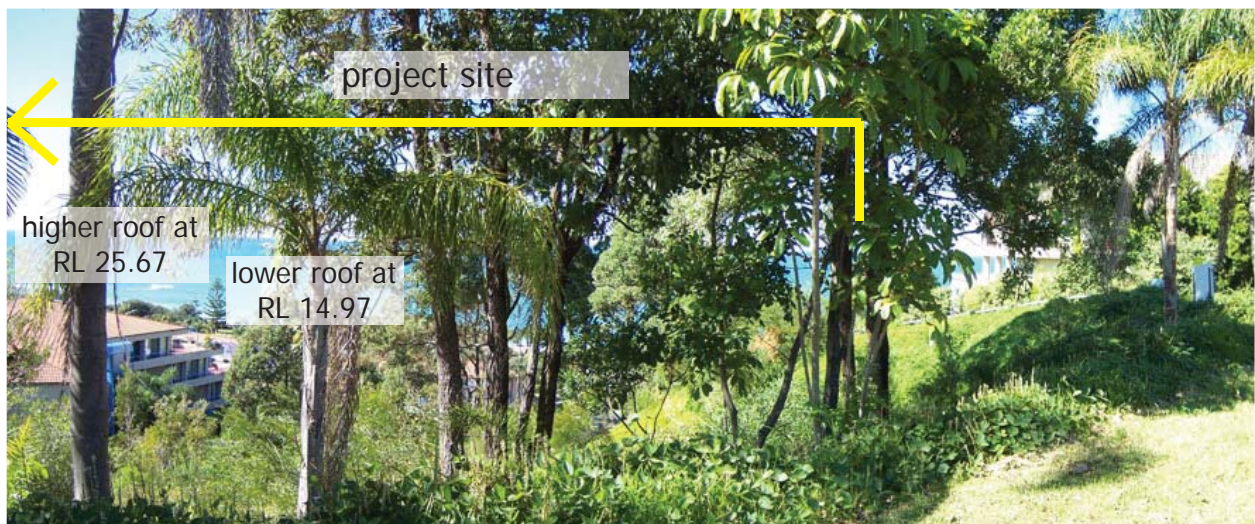
### View 2 - northern end of Coachmans Close

This view is taken at the northern end of Coachmans Close where the Eucalypts end on the bank between the project site and Coachmans Close and it is possible to get a better view of the existing resort. Once again the residences at this end of Coachmans Close are elevated at lease another 2m above this location.
