Bore No: SB22
Client: Costco Wholesale (Australia) Pty Ltd
Project: Phase I and II Site Investigations
Box 1 of 1
Depth: 5.4 - 10.0 m
Date: 31 May 2009

Phone:
Fax:Project Reference: **Preliminary
Geotechnical
Assessment**Client: **Costco Wholesale (Australia) Pty Ltd**Drilling Contractor: **Macquarie Pty Ltd**Project No.: **43217997**Location: **17-21 Parramatta Road, Lidcombe**Logged By: **J Kor**
Checked By: **V Tandjiria**
Date Started: **31-5-09**
Date Finished: **31-5-09**Bore Size: **100mm mm**
Casing Size: **mm**
Total Depth: **8.40 m**
Borehole Inclination and
Bearing: **90° from horizontal
at ° True North**Relative Level: **mRL**
Coordinates: **6252928.00 mN
319646.00 mE**
Permit No:Drill Type: **NMLC - Diamond Impreg. Bit**
Drill Model: **Truck Mounted Rig**
Drill Fluid: **Water**

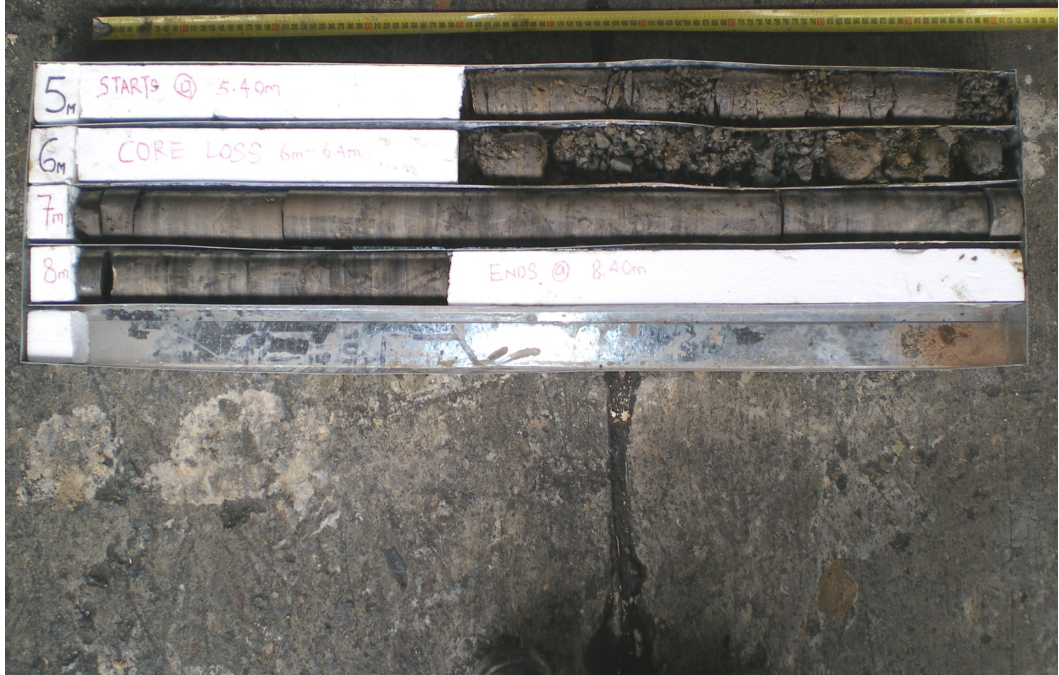
5.4				Continues from non-cored log at 5.40m SHALE, extremely low to very low strength, extremely weathered, dark grey, thinly laminated, fragmented to highly fractured	XW		5.4			5.56m to 5.68m, Fractured
				6								5.95m to 6.00m, Fractured

6.50m to 7.00m, Fractured
		86%		7		SHALE, medium strength, slightly weathered, dark grey, thinly laminated, slightly fractured Point Load Test at 7.08m A=0.60, D=0.73	SW		46			7.74, BG, 0°-5°, Pl, S, KL
				8		Point Load Test at 8.05m A=0.49, D=0.51						7.98, BG, 5°-10°, Pl, S, KL
						Discontinued at 8.40m, target depth reached						
				9								
				10

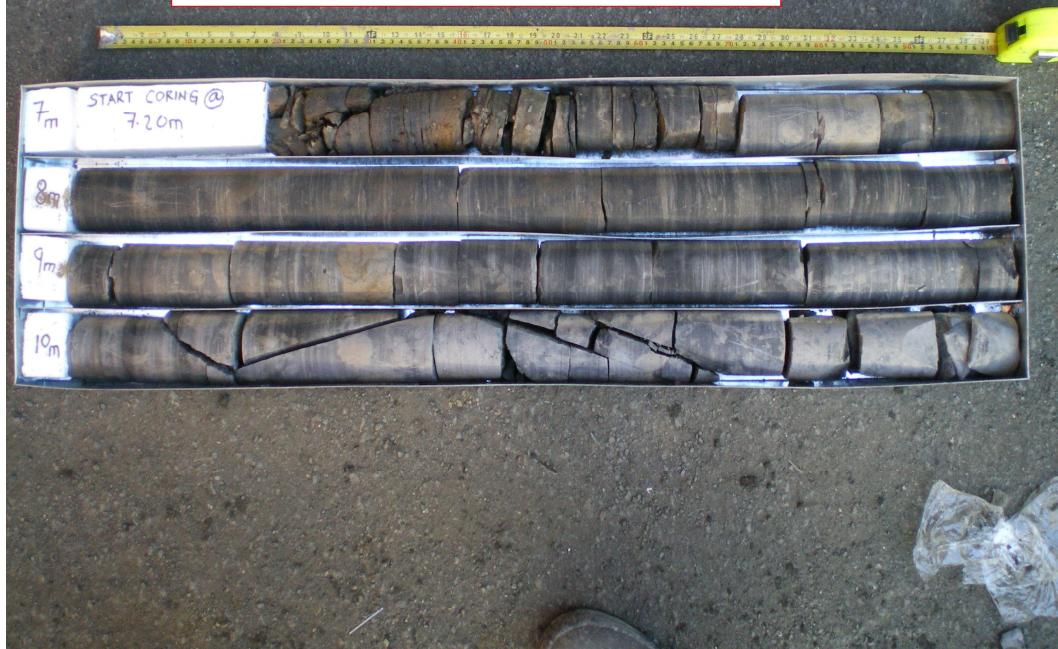
Bore No: MW1D
Client: Costco Wholesale (Australia) Pty Ltd
Project: Phase I and II Site Investigations
Box 1 of 2
Depth: 7.2 - 11.0 m
Date: 25 July 2009

DRILLING					MATERIAL DESCRIPTION					DISCONTINUITY DESCRIPTION				
METHOD	WATER	RUN/RECOVERY	FIELD TESTS/ SAMPLING	DEPTH (m)	GRAPHIC LOG	DESCRIPTION OF STRATA (Rock type, strength, Weathering, color, fabric, grain size, inclusions, degree of fracturing)	WEATHERING	STRENGTH Is (50) MPa	RQD (%)	DEFECT SPACING (mm)	DEFECT LOG	DEFECT DESCRIPTION (Defect type, inclination, shape, roughness, infill, thickness)		
HQ - DIAMOND IMPREGNATED BIT		100%		10		Fractured to highly fractured from 10.1m to 12.25m (A number of near vertical joints)	EL	0.03	60	0-19		JN, 50°-55°, Wa, Sr, KL JN, 40°-45°, Pl, S, KL		
							VL	0.1		20-49		BG, 5°-10°, St, S, KL JN, 75°-80°, Pl, S, KL BG, 5°-10°, Pl, S, KL JN, 55°-60°, Pl, S, KL		
							ML	0.3		50-99		BG, 10°-15°, Ir, S, KL JN, 80°-85°, Pl, S, KL		
							HL	1		100-199		BG, 0°-5°, Pl, S, KL Fractured (11.15m to 11.22m) JN, 50°-55°, Wa, Sr, KL JN, 40°-45°, S, Pl, KL JN, 90°, Pl, Sr, KL

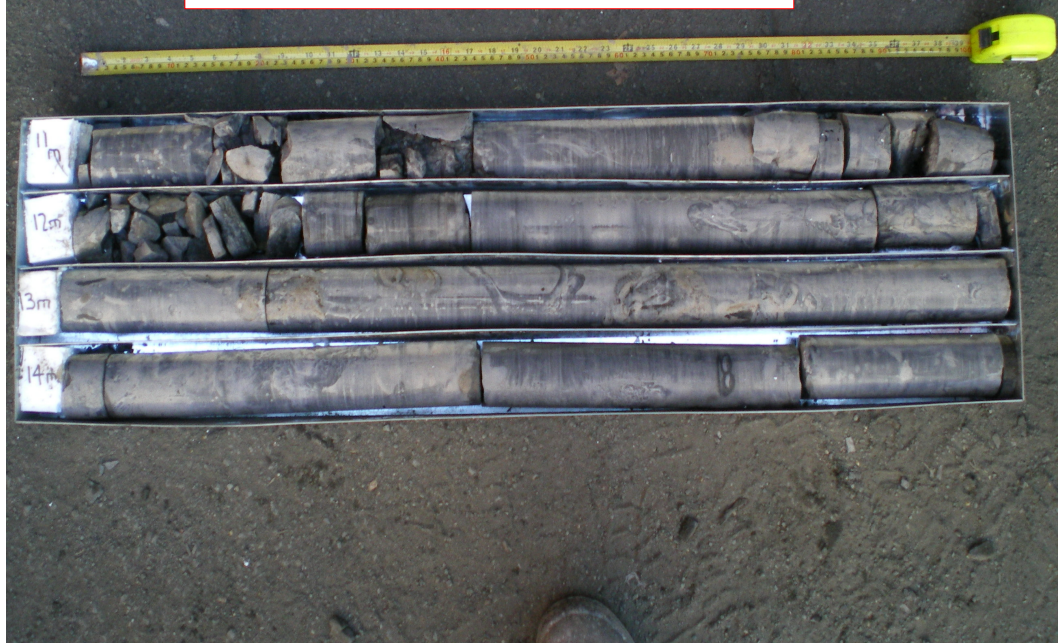
Bore No: MW1D
Client: Costco Wholesale (Australia) Pty Ltd
Project: Phase I and II Site Investigations
Box 2 of 2
Depth: 11.0 - 15.0 m
Date: 25 July 2009

VL	10		200-599		JN, 75°-80°, Pl, Sr, KL		
							ML					Fractured (12.04m to 12.25m)		
							HL					BG, 5°-10°, Pl, S, KL		
							EL							
							VL							
				11										
						Point Load Test (Is50) at 11.45m A=0.40, D=0.53								
				12					12.15
