| Cad ref : 071521-DETL-001D.dwg | | Sheet 2 of 2 | |
| JOB NUMBER<br>071521 | | DRAWING NUMBER / ISSUE<br>DETL-001 / D | |

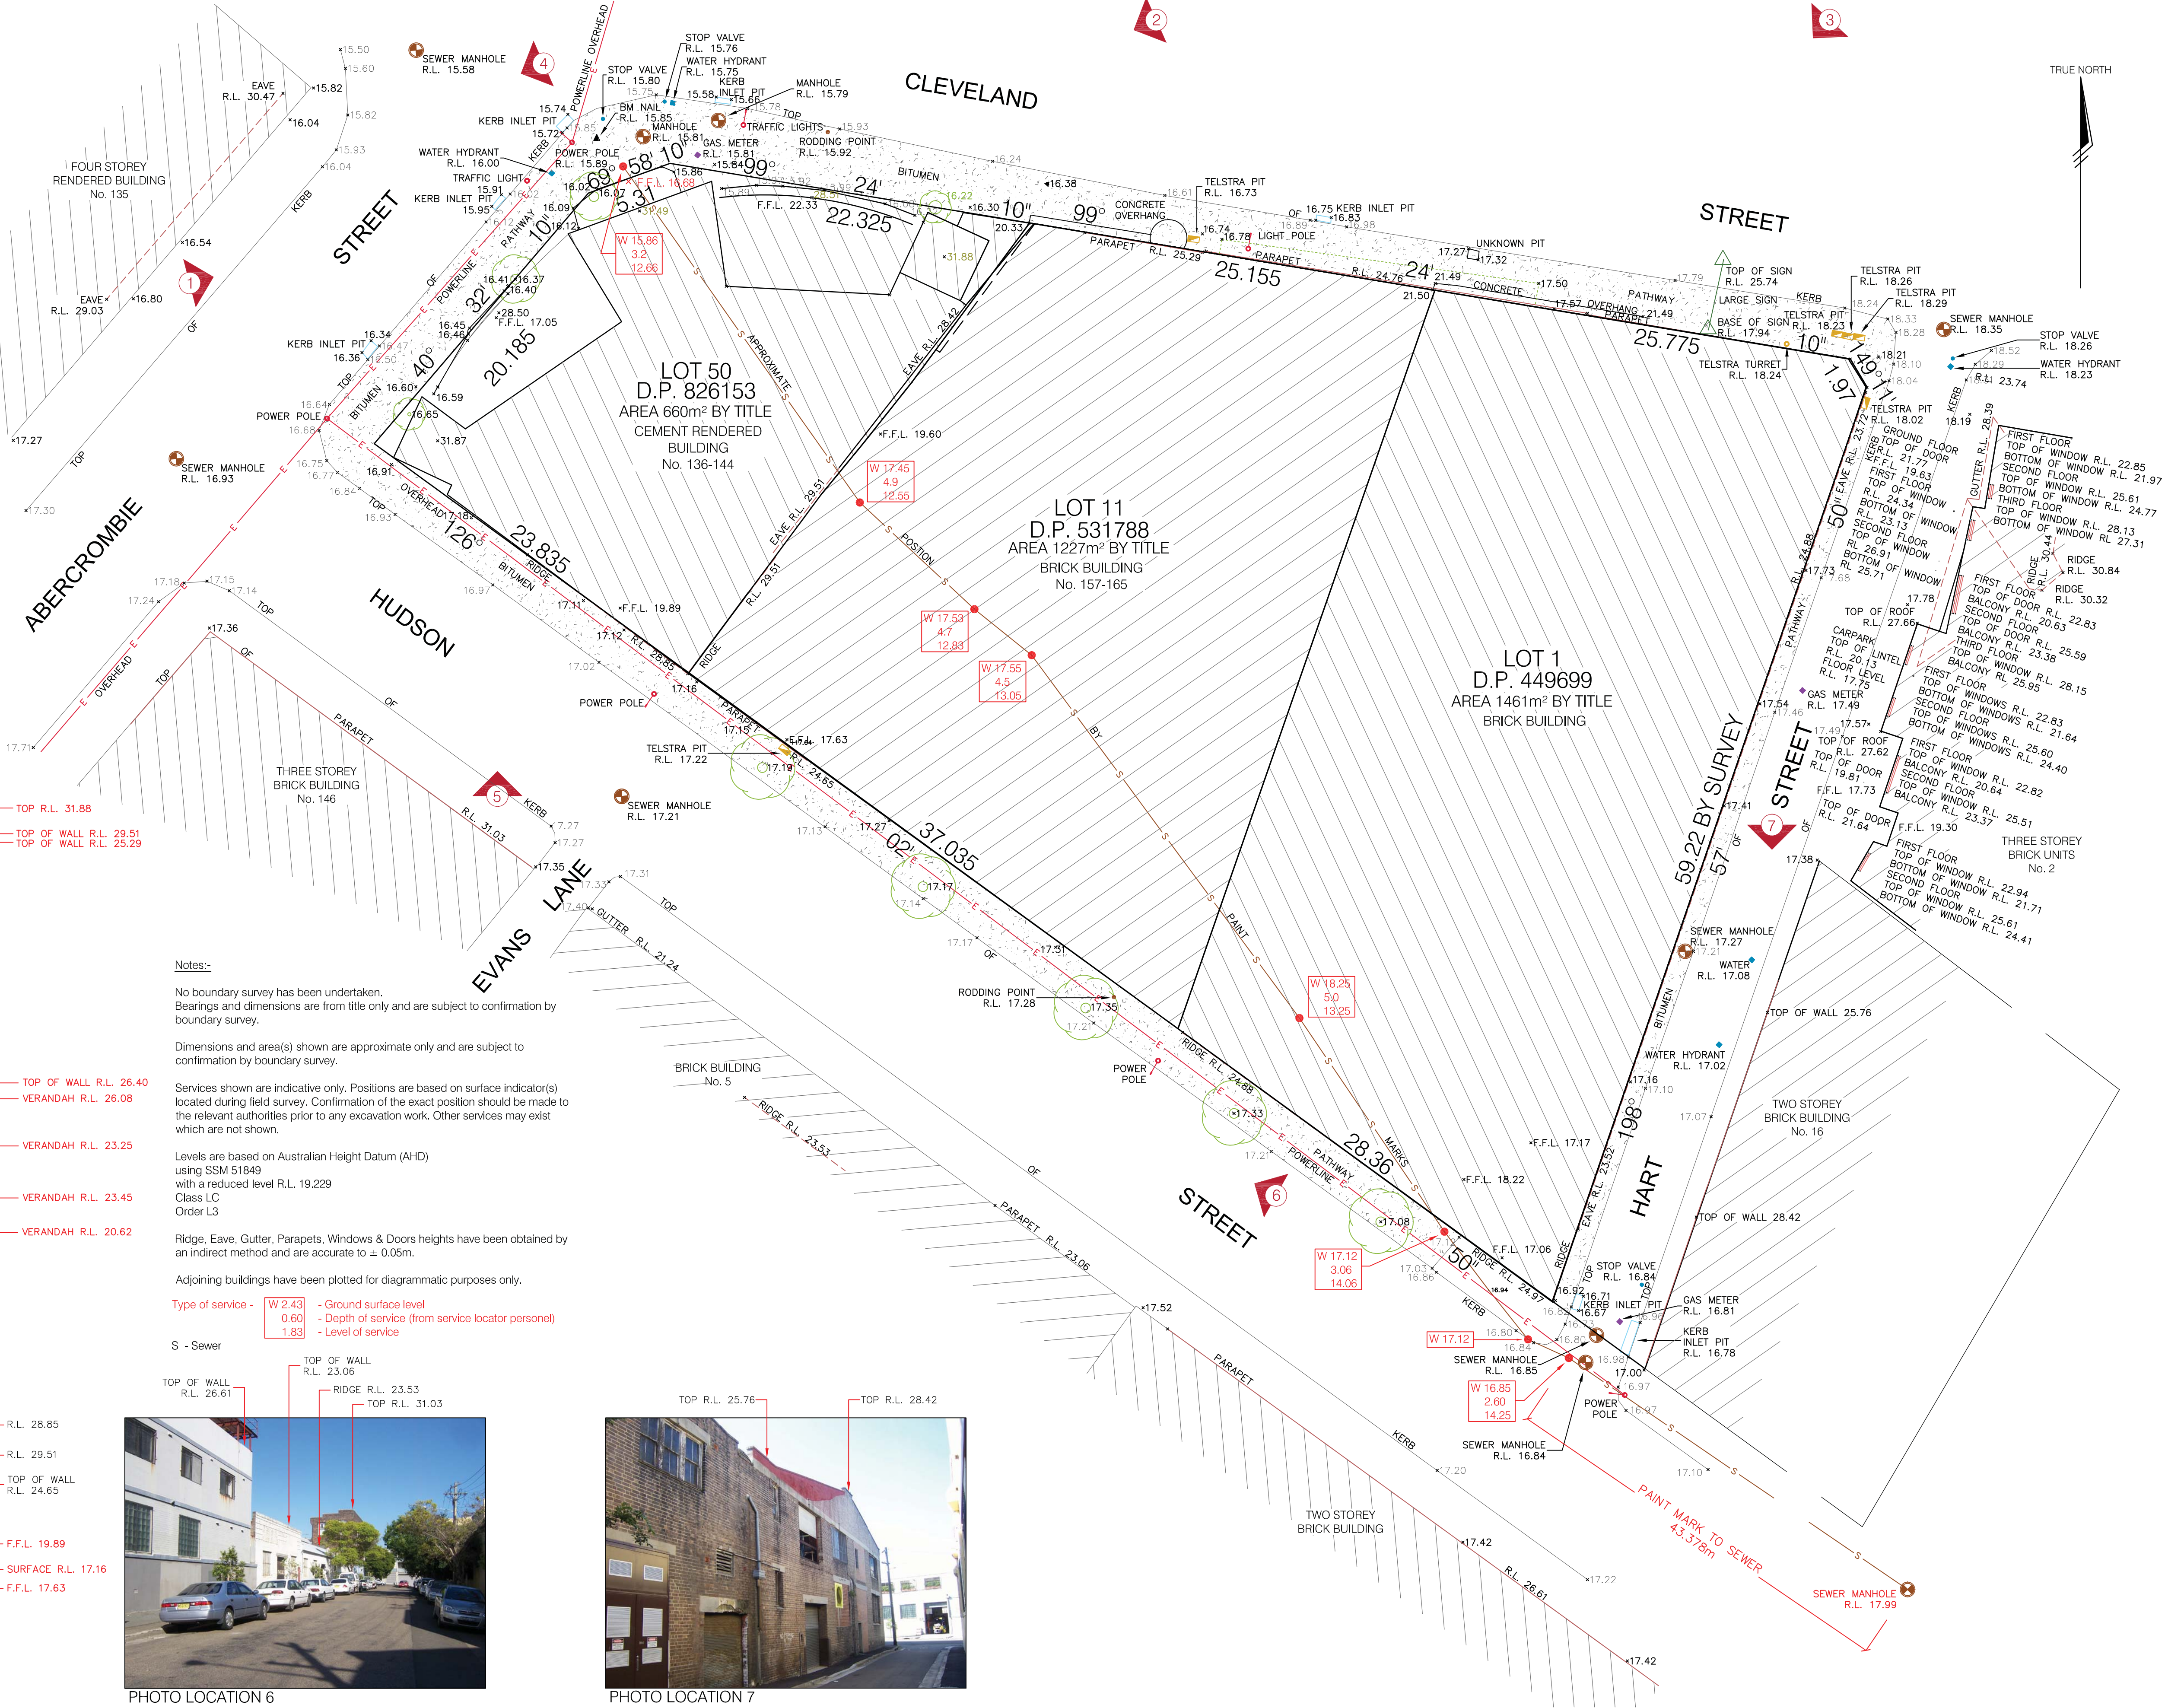
Levels are based on Australian Height Datum (AHD) using SSM 51849 with a reduced level R.L. 19.229 Class LC Order L3

Ridge, Eave, Gutter, Parapets, Windows & Doors heights have been obtained by an indirect method and are accurate to ± 0.05m.

Type of service -  
W 2.43 - Ground surface level  
0.60 - Depth of service (from service locator personnel)  
1.83 - Level of service

S - Sewer
