Visual Impact Assessment

PROPOSED RESIDENTIAL DEVELOPMENT

Vantage Point 6

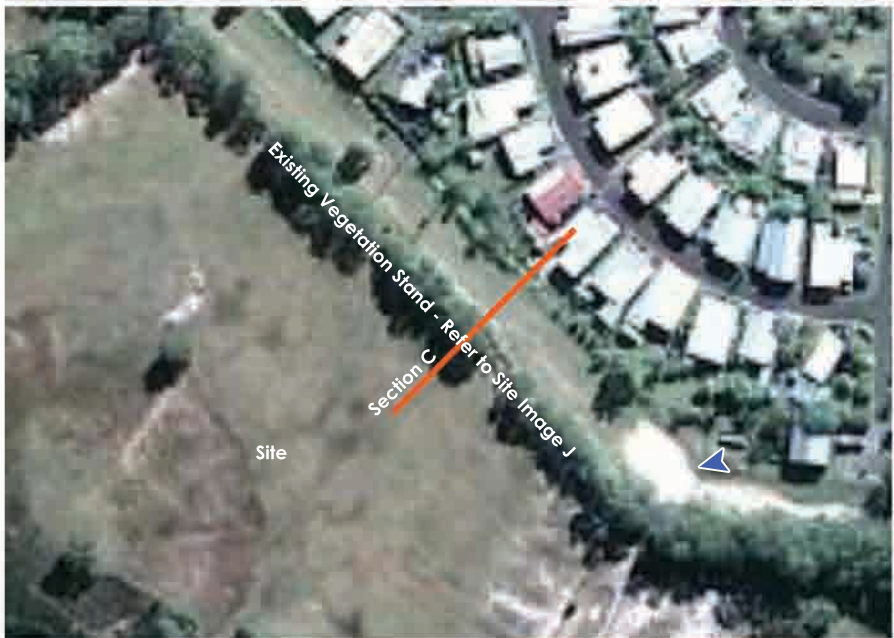
Site Image I shows existing vegetation stand to the perimeter of the subject site. As illustrated in Typical Section C, this vegetation stand is to be retained and will largely screen views into the subject site.
