2 Vegetation Assessment

3 Slope Assessment

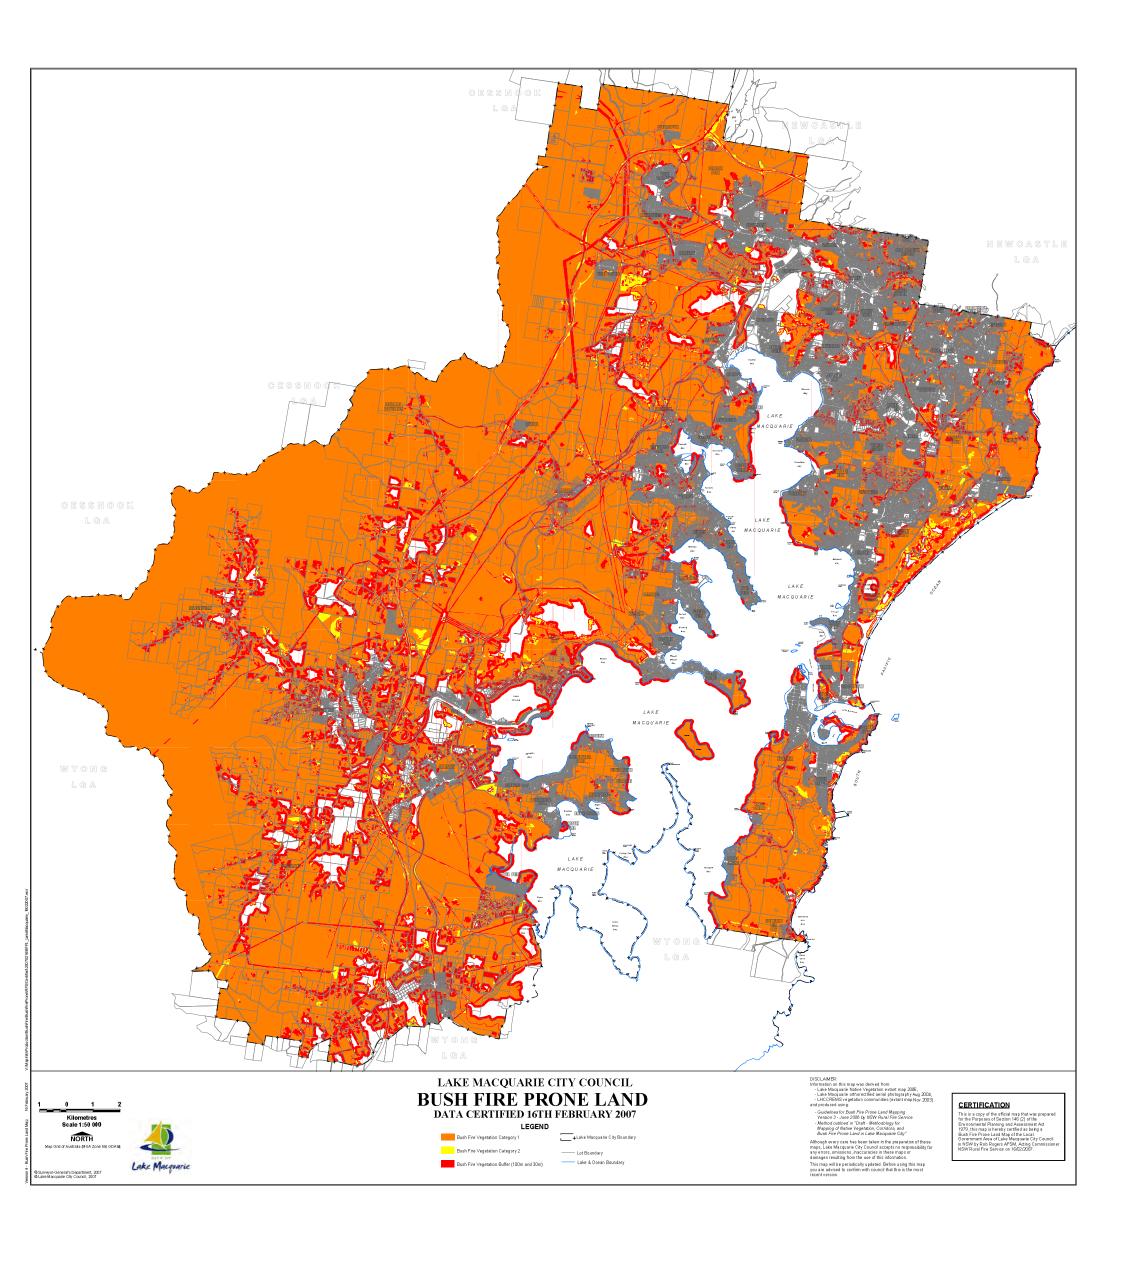
The vegetation in and around the Development Estate boundaries, to a distance of 140m, has been assessed in accordance with PBP 2006. This assessment has been made via a combination of aerial photo interpretation and ground truthing exercises. Refer to Figure 2-1.

These vegetation communities have been classified for bushfire purposes into structure and formation using the system adopted by Keith (2004) and using Table A2.1 within PBP (RFS, 2006). Refer to Table 2-1 overleaf. The vegetation type adjacent to the proposed Development Estate in all directions is Open Forest (Refer to Figure 2-1).
