Riverwood North Residential Renewal Project

LANDSCAPE PROPOSAL

STATUS: Concept Report

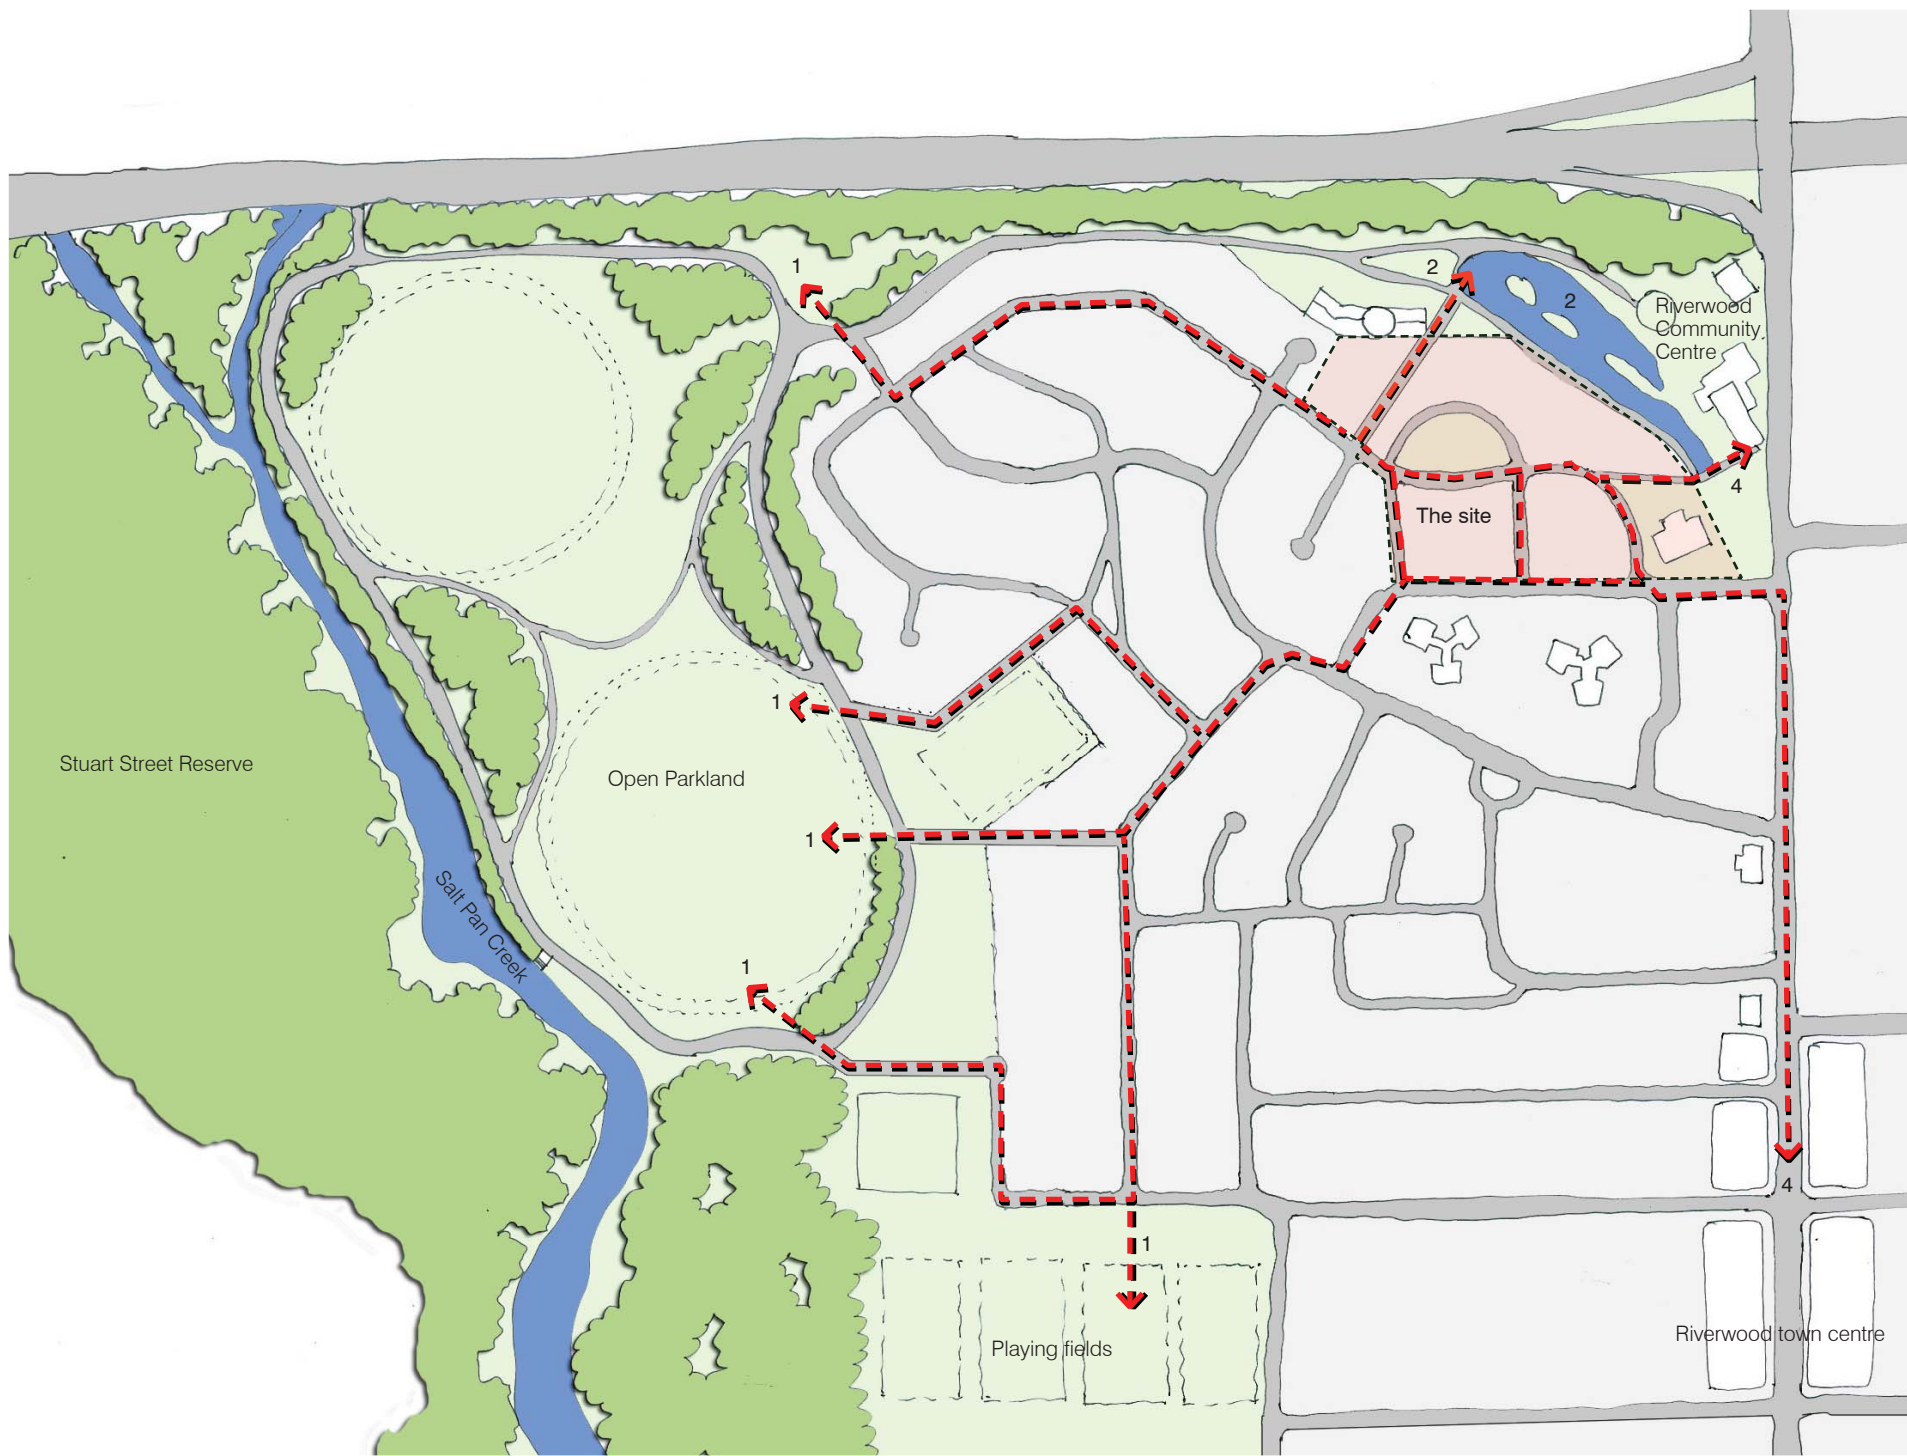
CONTEXT

- ← - - - Site connections to local recreational amenity
- 1. Potential pathway connections to Open Parkland and Stuart St Reserve
- 2. Connections to Salt Pan Creek Wetland.
- 3. Connections to Riverwood Community Centre via pedestrian bridge.
- 4. Connection to Riverwood town centre

The site is located within an established suburban area of Riverwood between Salt Pan Creek and Riverwood's main street Belmore Rd.

Immediately adjacent the site's northern boundary lies Salt Pan Ck Wetlands and Riverwood Community Centre offering both aesthetic qualities of large ponds and parklands, and community facilities. Just beyond the site's north western boundary also lies a vibrant community garden with grid plots of vegetables.

Existing vegetation throughout the area is a typical ad hoc mix of native and exotic trees and shrubs. However, The local area enjoys a strong leafy green aesthetic through substantial tree planting. The vegetation generates rich spatial mixes and high aesthetic values, while masking building mass.

The NPWS Cumberland Plain vegetation maps identifies the site's natural heritage as being Turpentine / Ironbark forest and Shale / Sandstone Transition Forest.

Opportunities exist to connect to future parkland facilities and open spaces within the neighbourhood providing generous recreational opportunities.

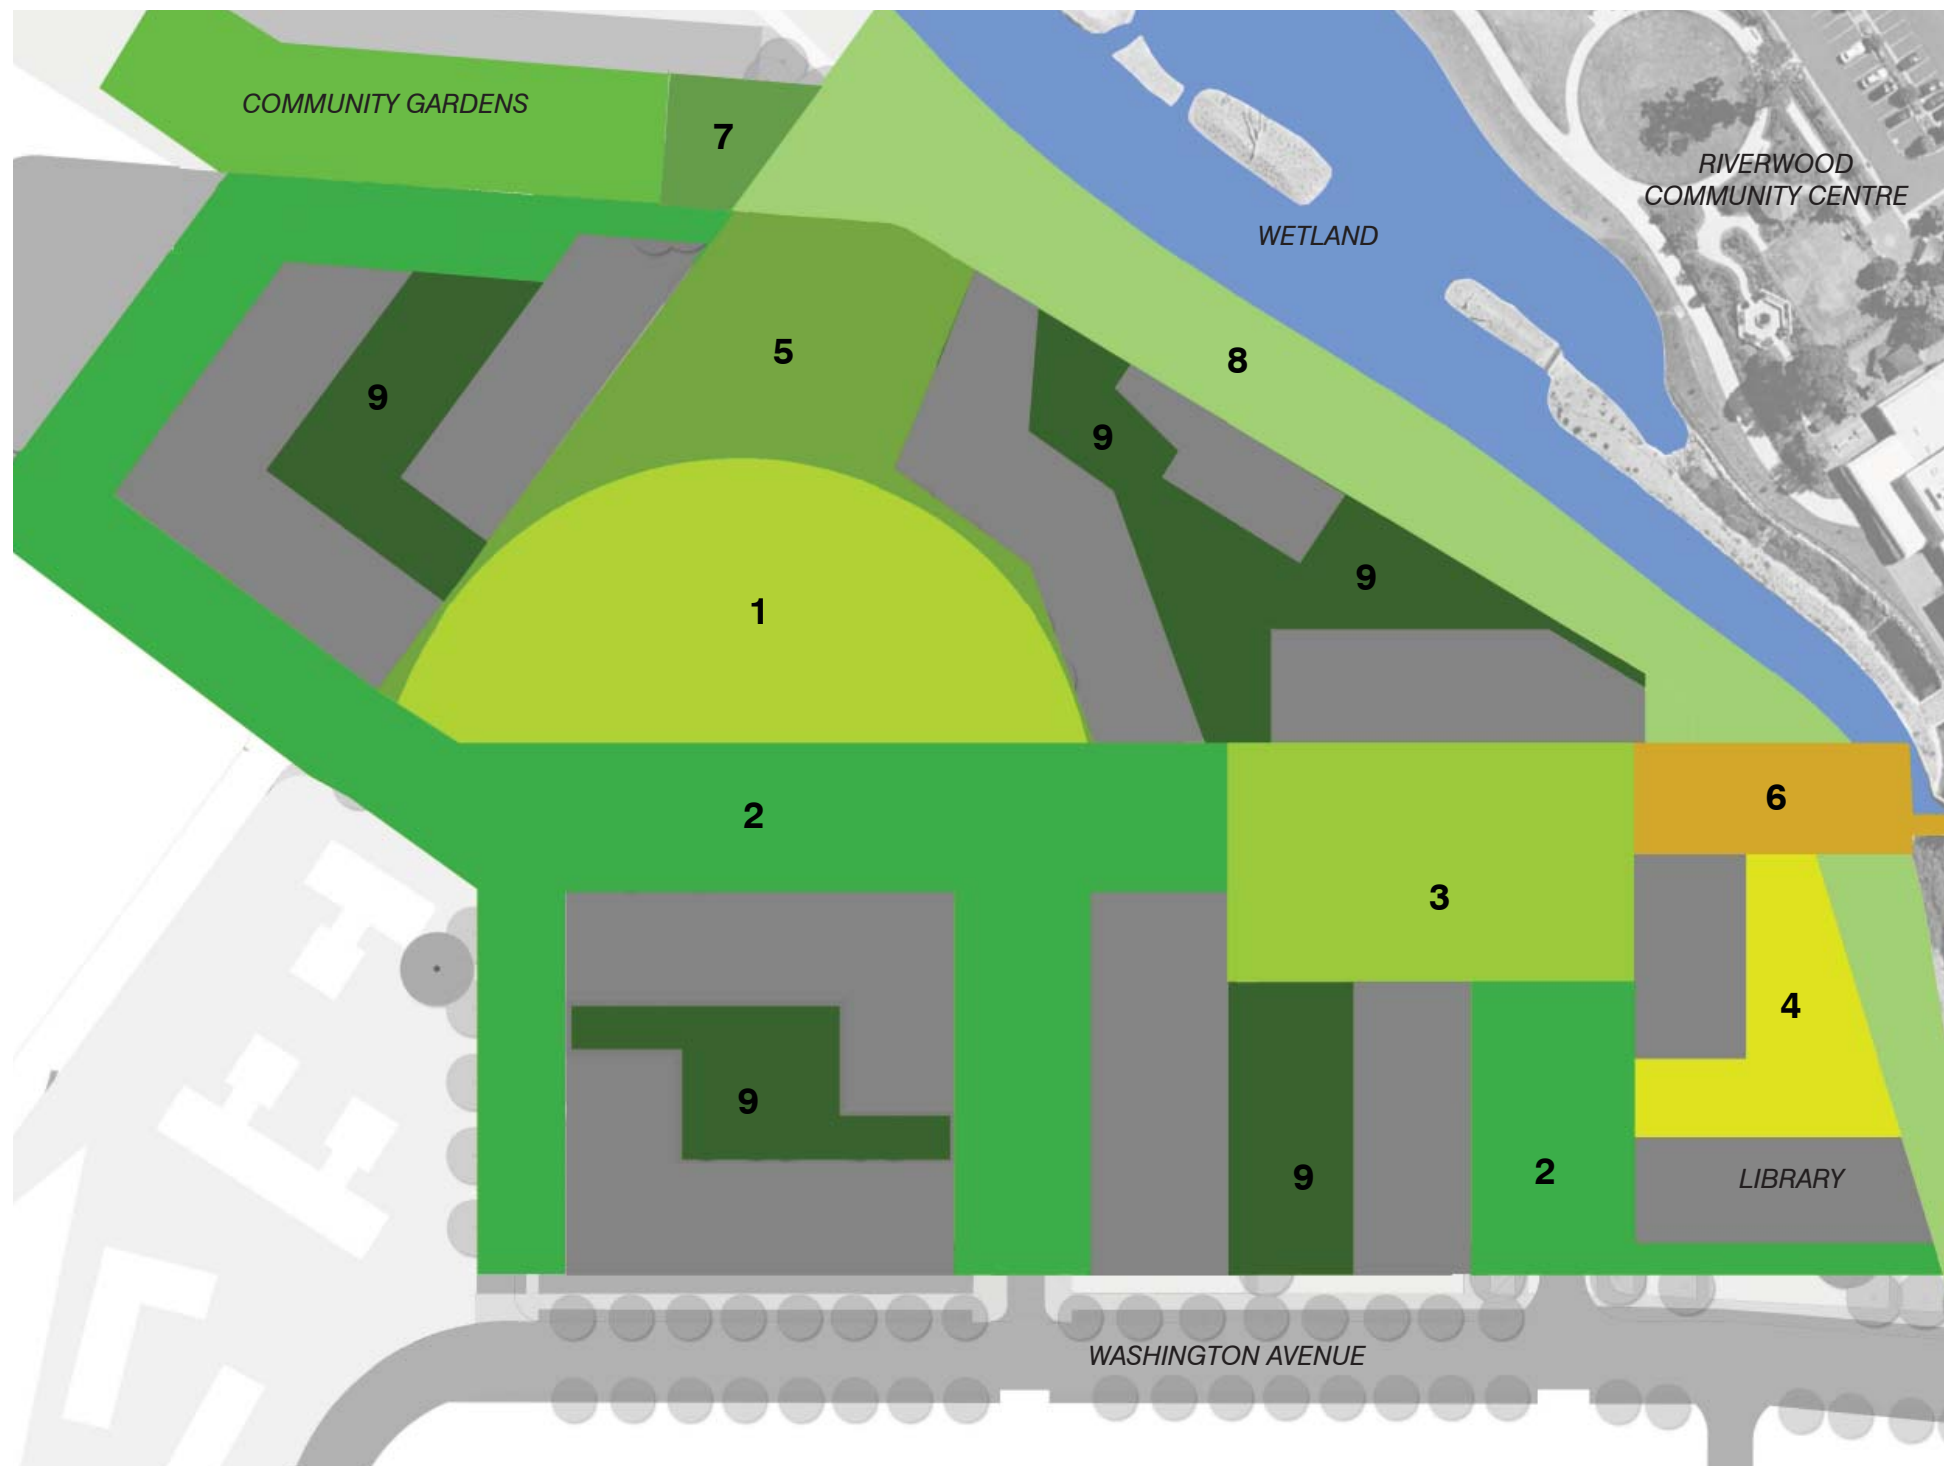
KEY SPATIAL TYPES

1. CENTRAL PARK

Create a high quality central park within the development as a primary recreational space for community gathering.

2. GREEN STREETS

Increase street tree planting increasing environmental quality.

3. GARDEN SQUARE

Create a garden square character with high quality paving, gardens, seating, and trees in a formal arrangement responding to architectural geometries.

4. LIBRARY PLAZA

Create a space that connects with library uses.

5. THROUGH SITE CONNECTIONS

Create through site connections to encourage adjacent parkland use.

6. BRIDGE LINK

Formalise bridge access to adjacent community centre by creating a small formal square connecting to the garden square.

7. COMMUNITY GARDENS EXTENSION

Extend existing community gardens to cater for increased population.

8. WETLAND EDGE

Provide additional tree planting along parkland edge to accentuate high visual quality of pond views beneath tree canopies, and enhance recreational opportunities.

9. COMMUNAL COURTYARDS

Provide high quality communal courtyards with rich planting and landscape treatments. Where possible encourage long views across public open space and wetlands.

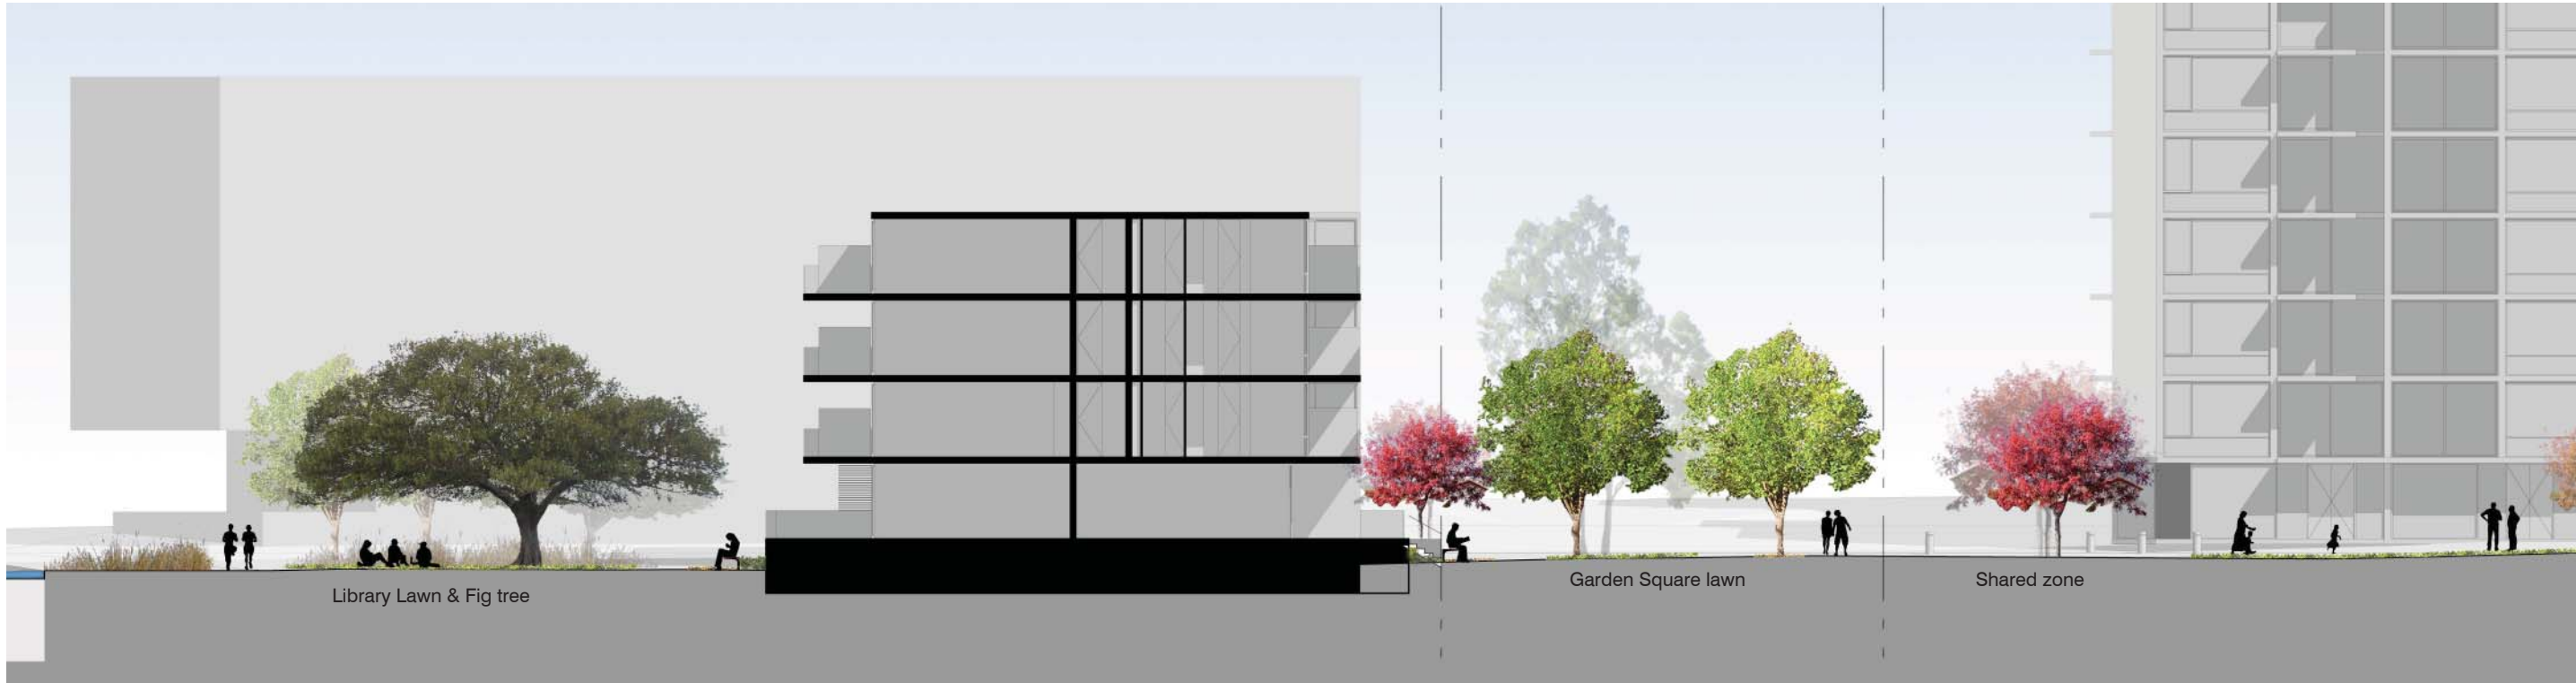
Section A - Library Lawn & Garden Square

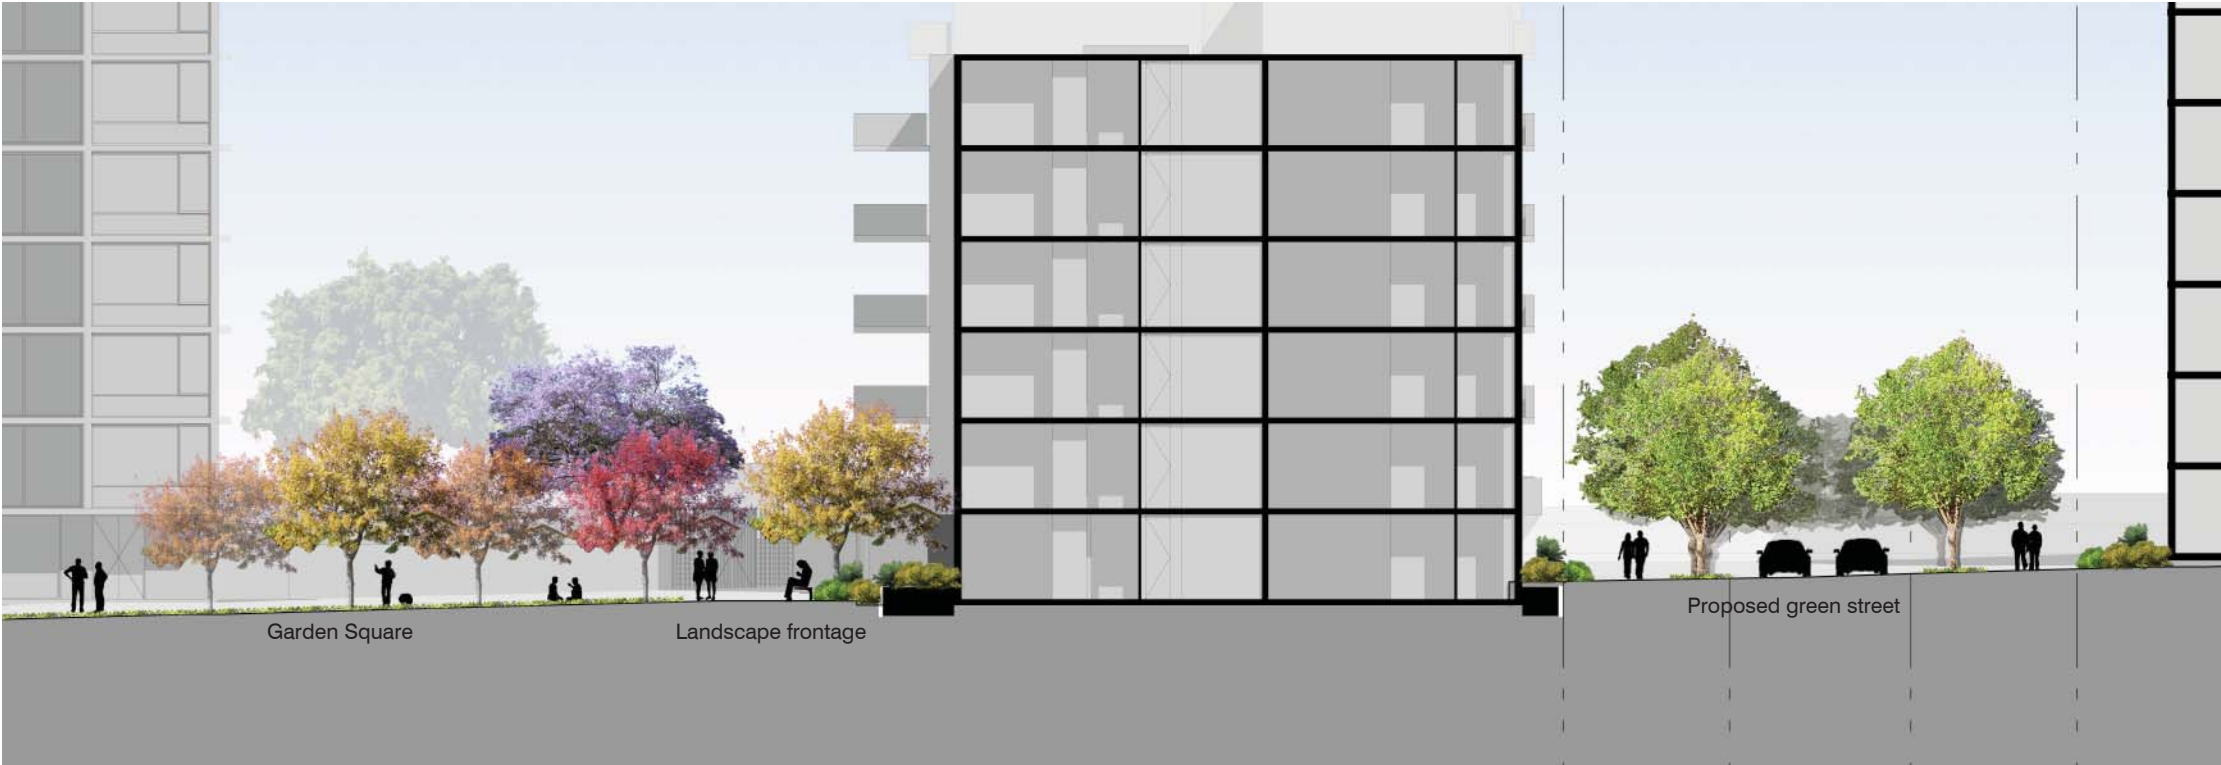
Section A - Green street & communal courtyard

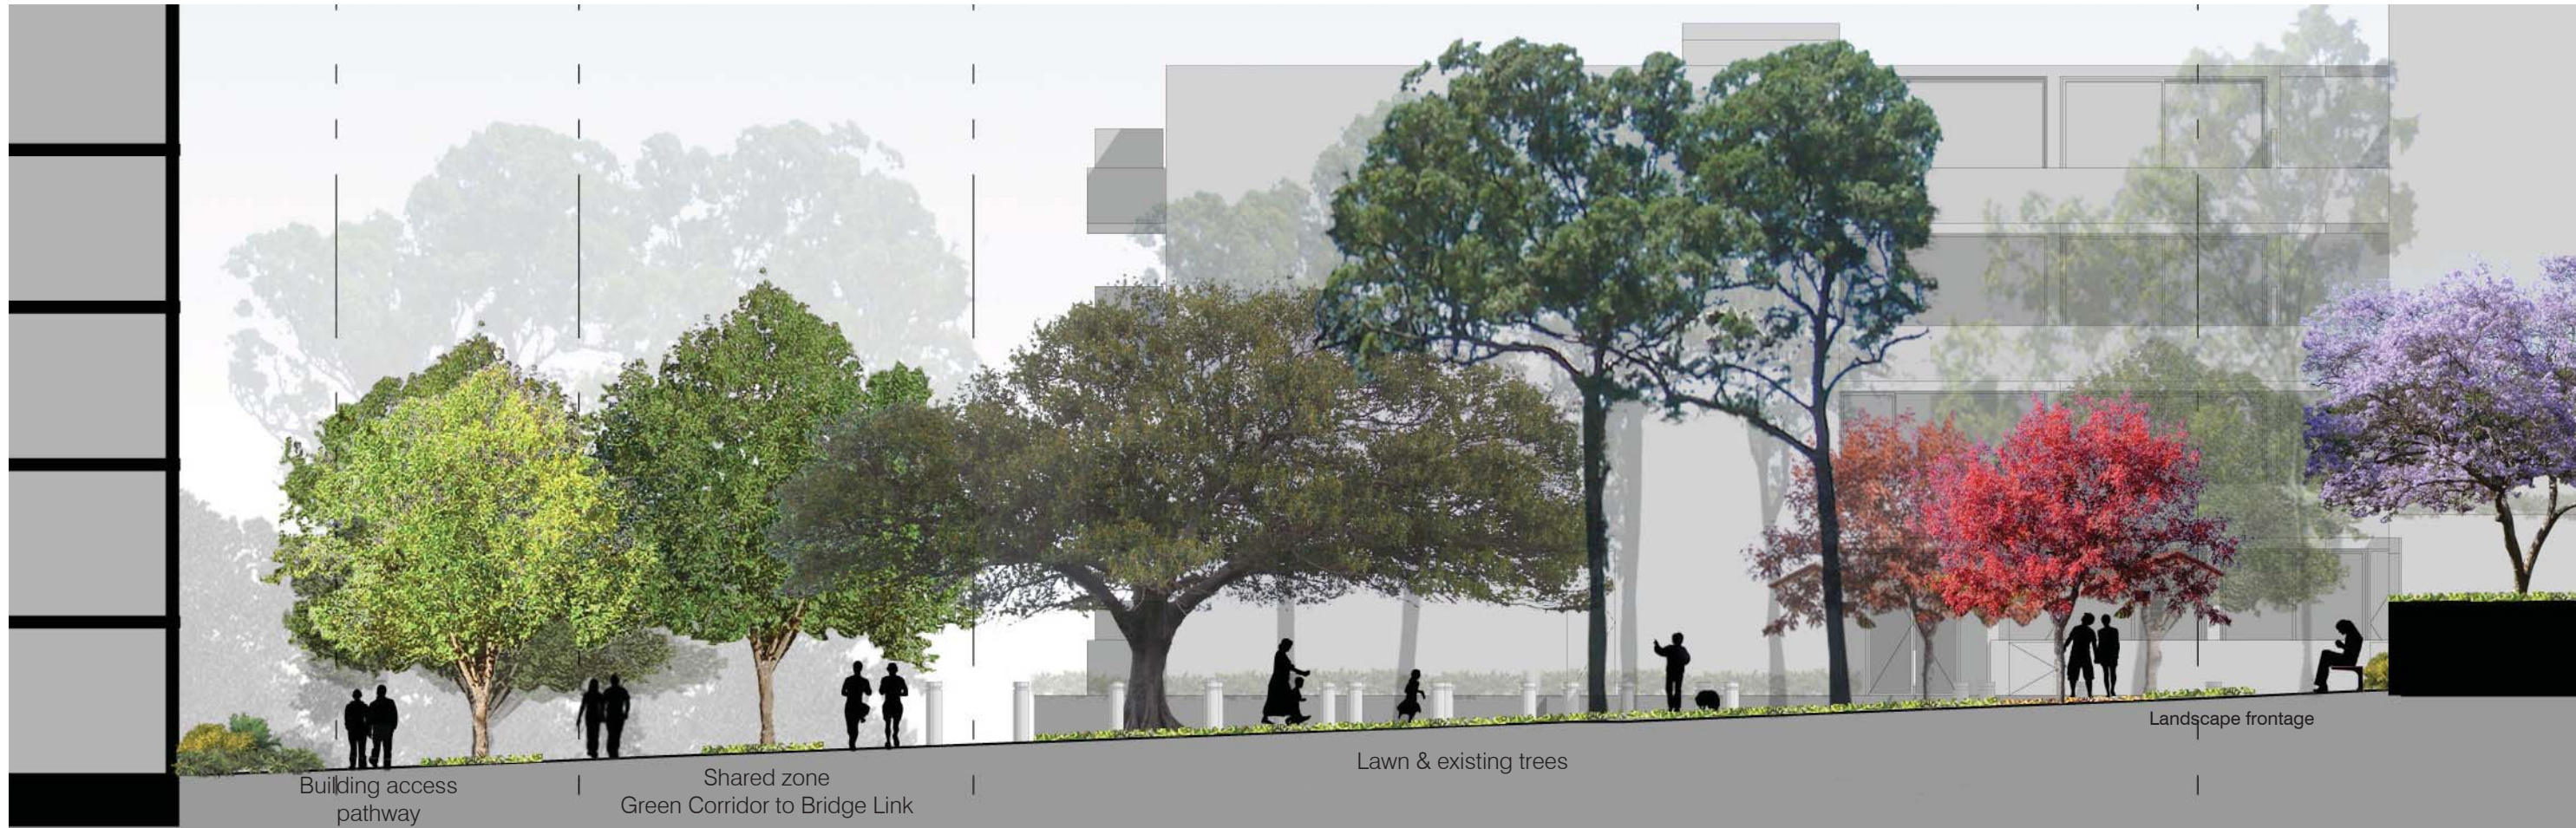
Section B - Garden Square 1-125 @ A3

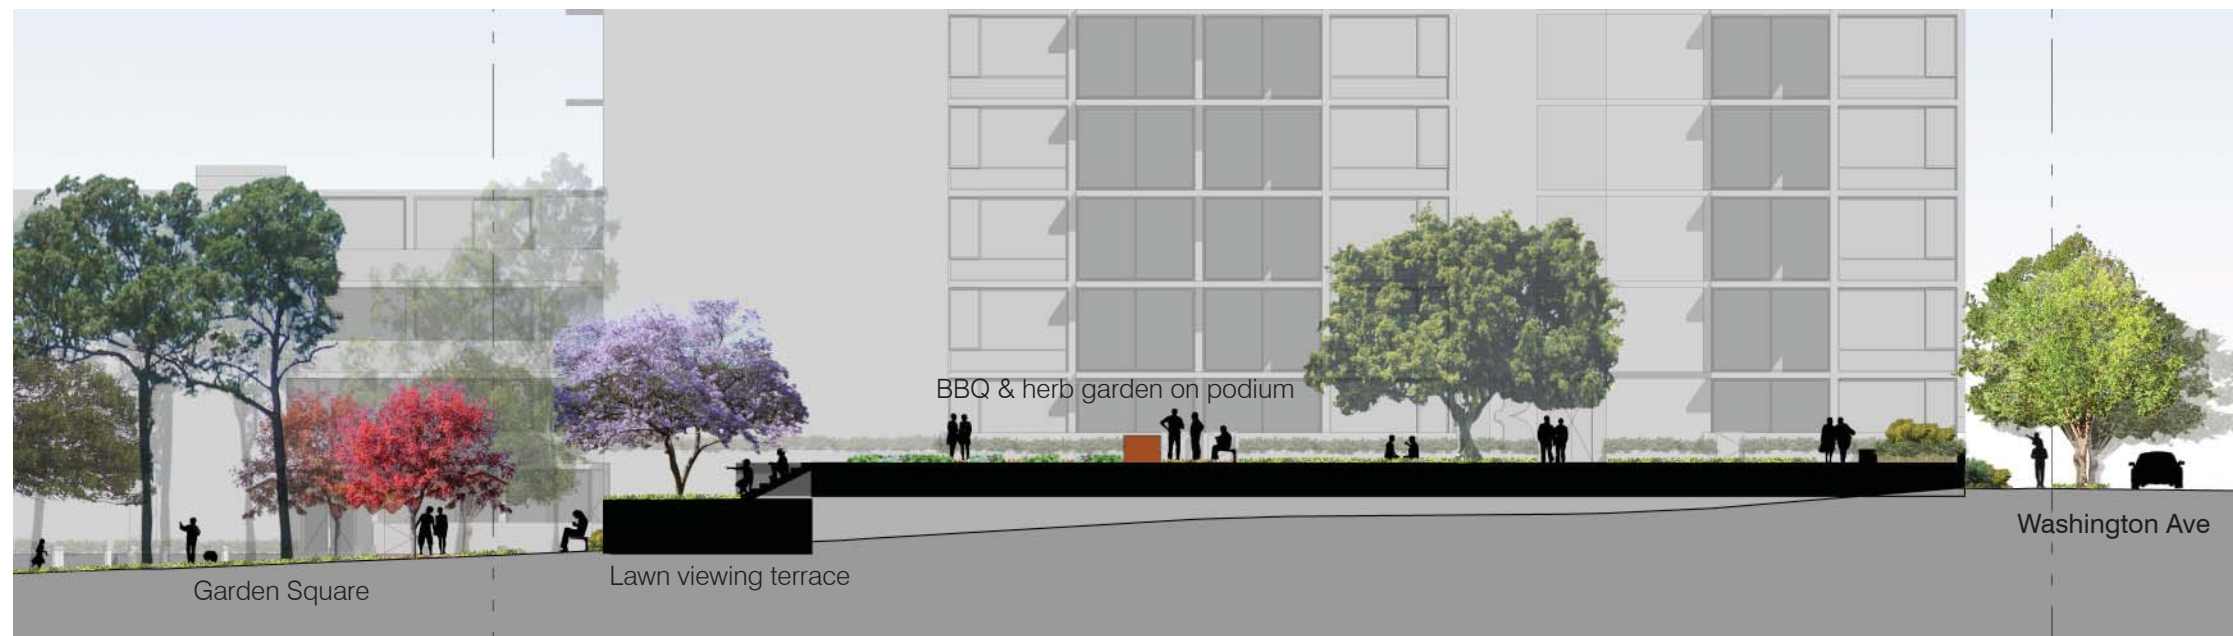
Section B - Communal Courtyard 1-250 @ A3

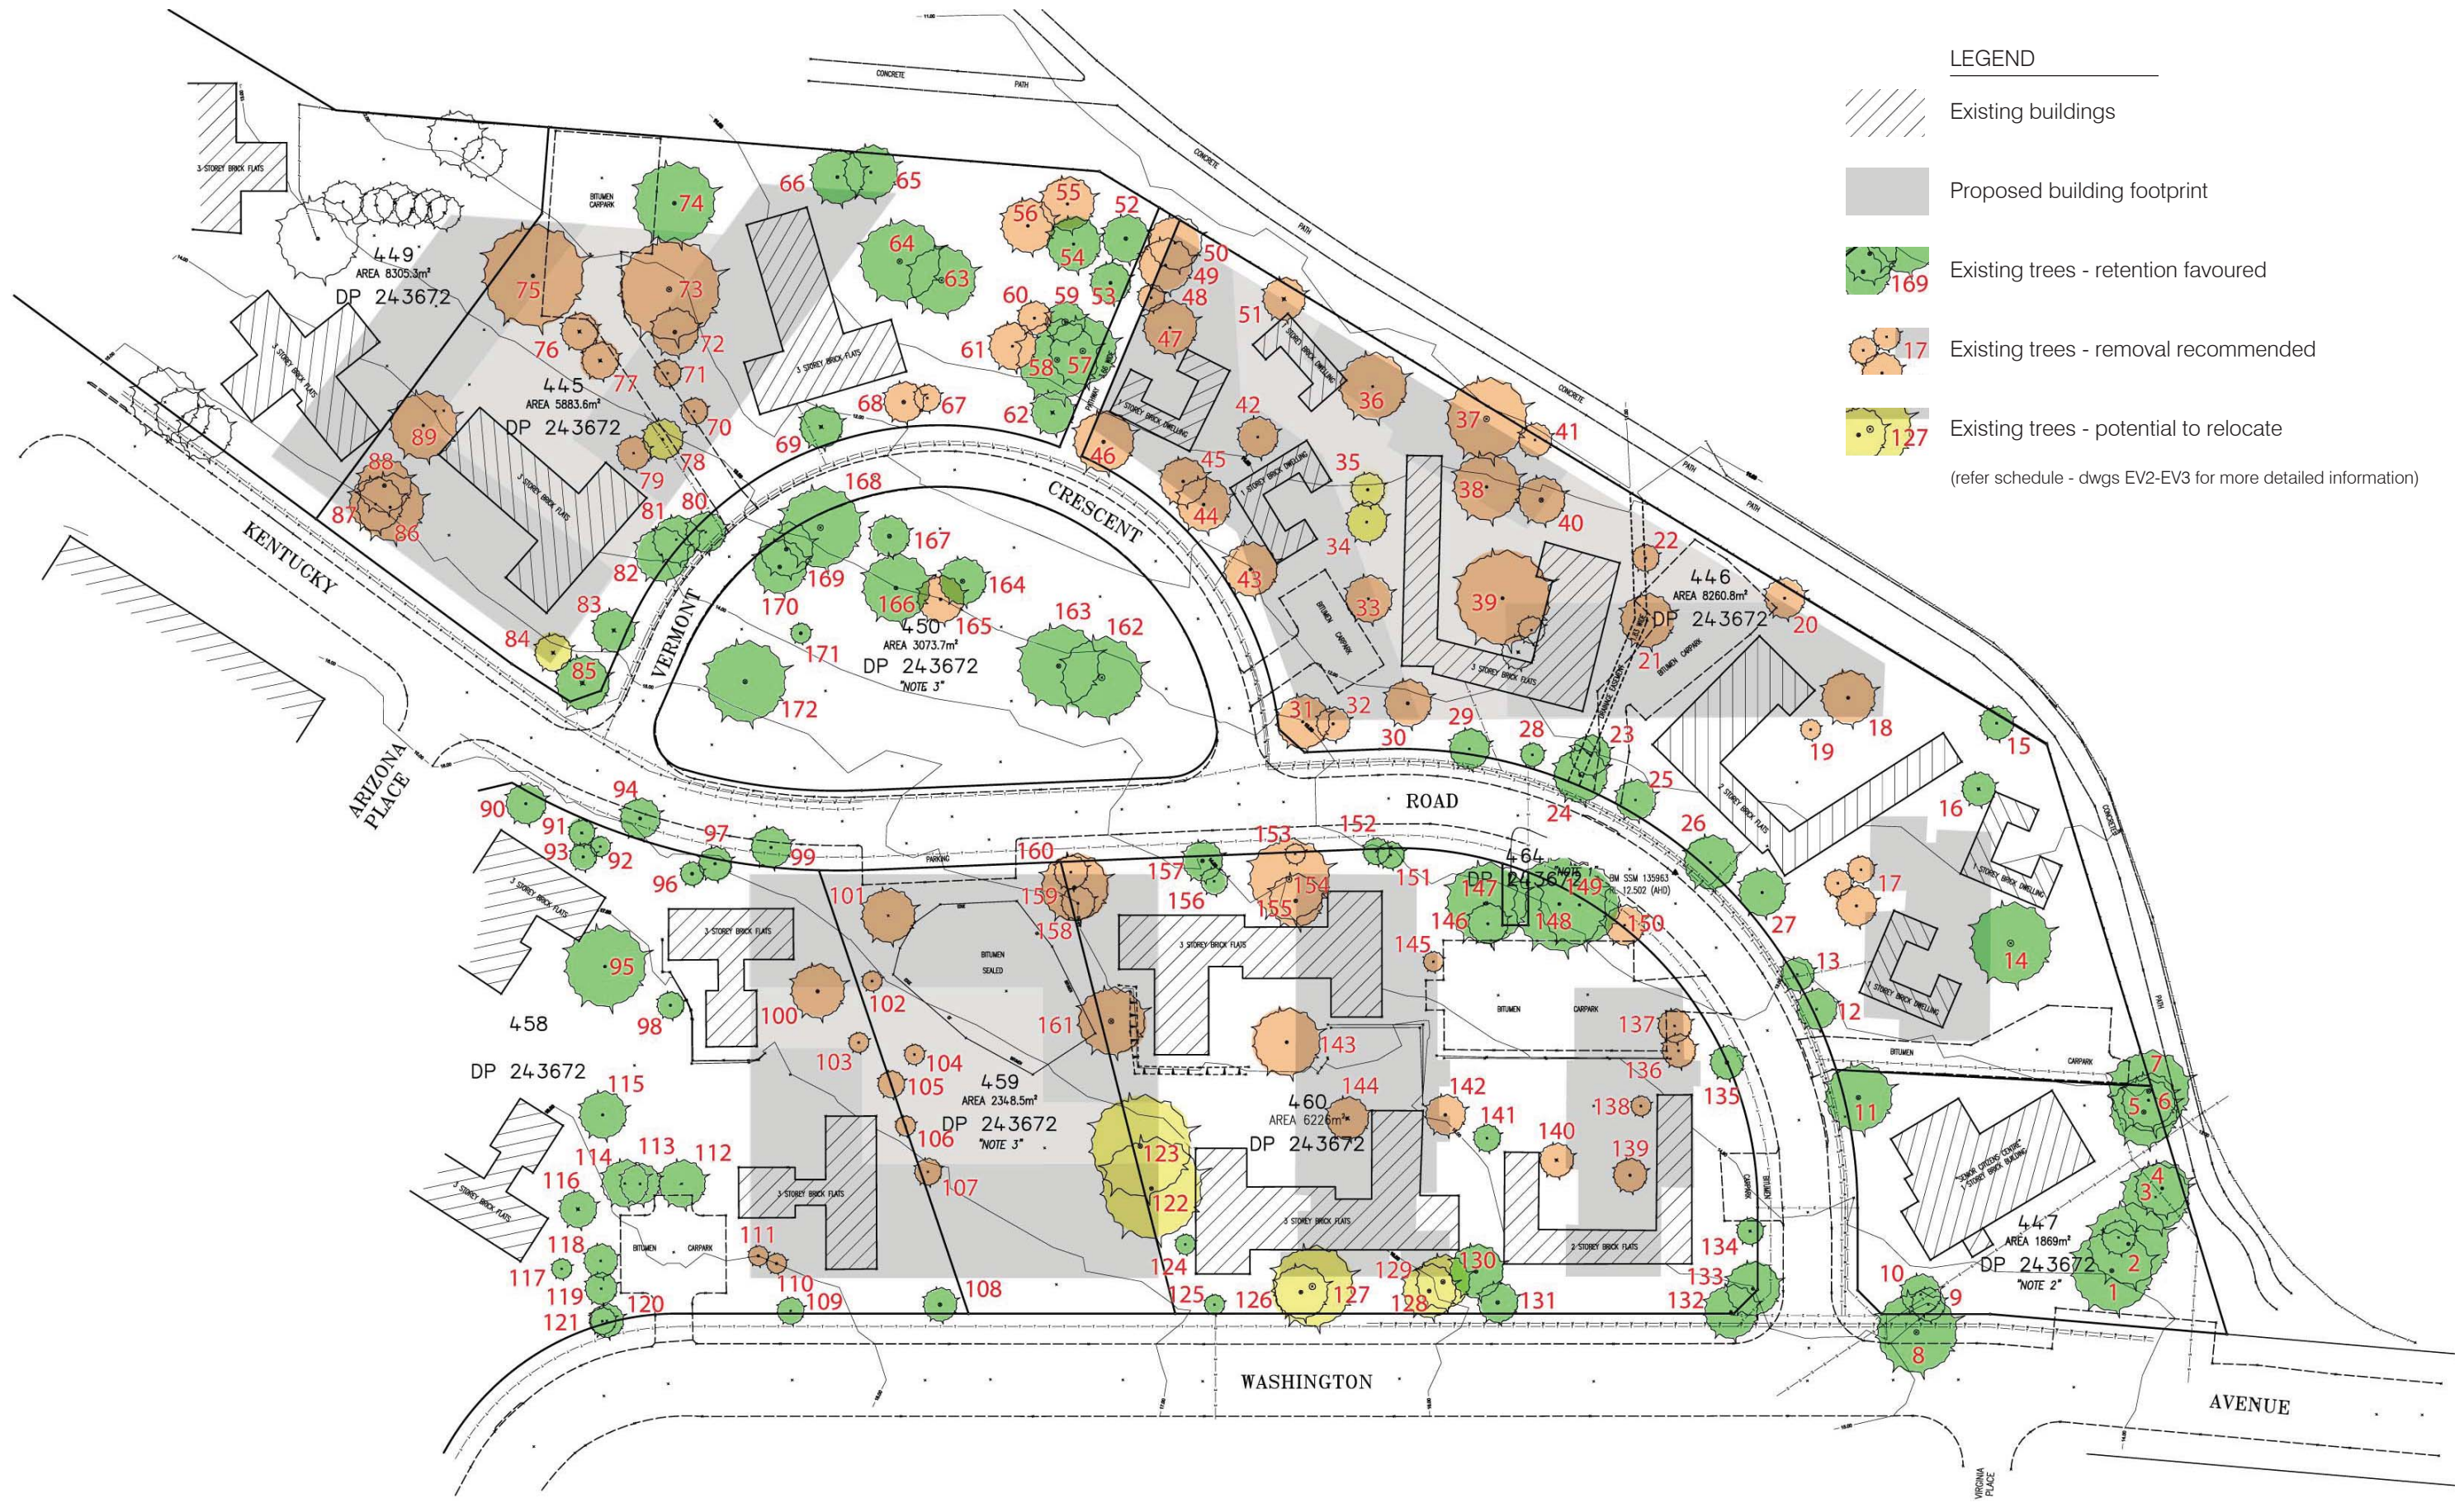
EXISTING TREE
ASSESSMENT

- Existing buildings
 - Proposed building footprint
 - Existing trees - retention favoured
 - Existing trees - removal recommended
 - Existing trees - potential to relocate
- (refer schedule - dwgs EV2-EV3 for more detailed information)

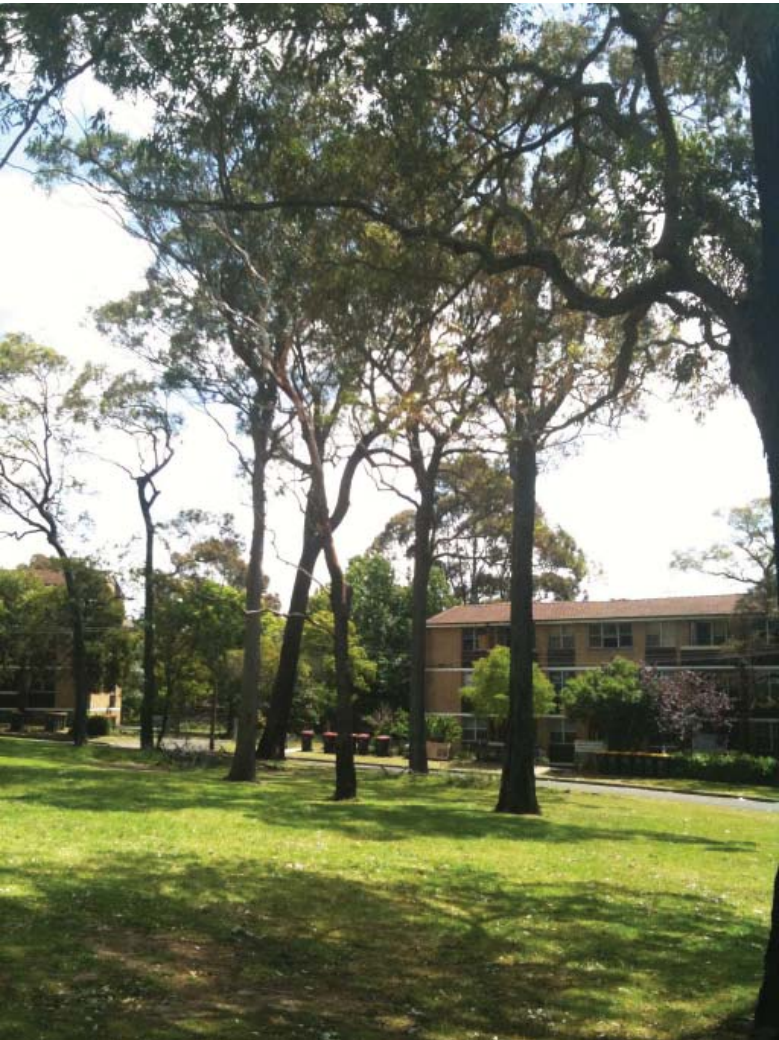
The Gandangara Local Aboriginal Land Council (GLALC) has been consulted as part of this project. Ian Edwards, from the GLALC, identified several mature gum trees as being of cultural significance to Aboriginal people. The trees are represented by numbers 162-172 within this document. Edwards has expressed concern that these trees might be affected by the proposed development, however this is not the case, given their location on Lot 450 (Central Park)

It is also noted that the Biosis Flora and Fauna study speculates that these trees have been “planted within recent decades”². Due to their age and current condition the trees may be considered as over-mature. Seed collection and supplementary planting strategy is recommended to ensure genetic integrity of these local species is not reduced any further.

In addition to their natural heritage significance, these trees were observed to provide habitat to native fauna.

Central Parkland Eucalypts

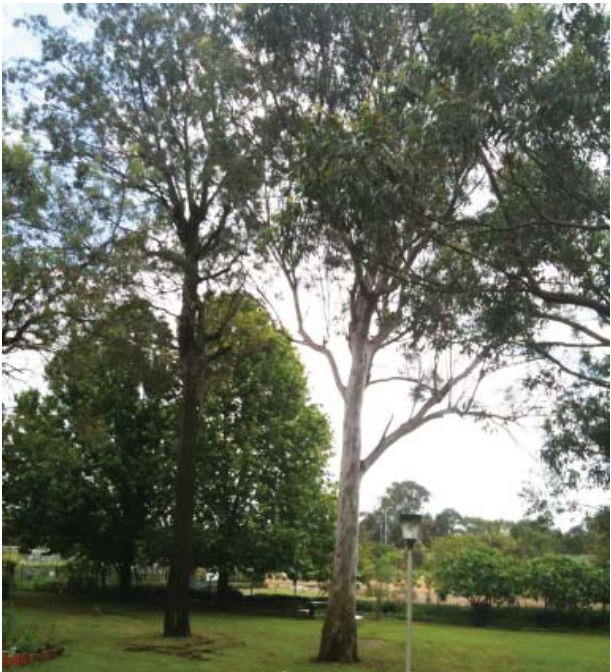
In addition to the Central Parkland Eucalypts, some native specimens within the site area are deemed to be significant, and possibly also remnant for the previously identified reasons. Of particular note are the trees represented by numbers 63 and 64 within this document, *Eucalyptus tereticornis* and *Eucalyptus crebra*, respectively.

Potentially remnant *E. tereticornis* and *E. crebra* (Ref # 63, 64)

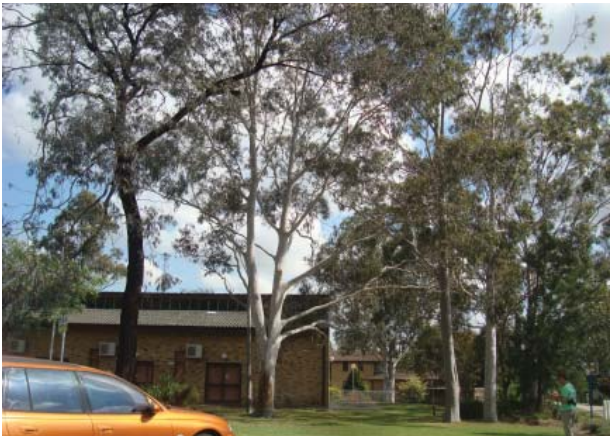
Other noteworthy native specimen trees include:
Corymbia citriodora (2-7)
Corymbia maculata (132, 133)
Eucalyptus sideroxylon (1)
Eucalyptus tereticornis (14)

Large Eucalypts outside existing seniors centre (Ref # 1-4)

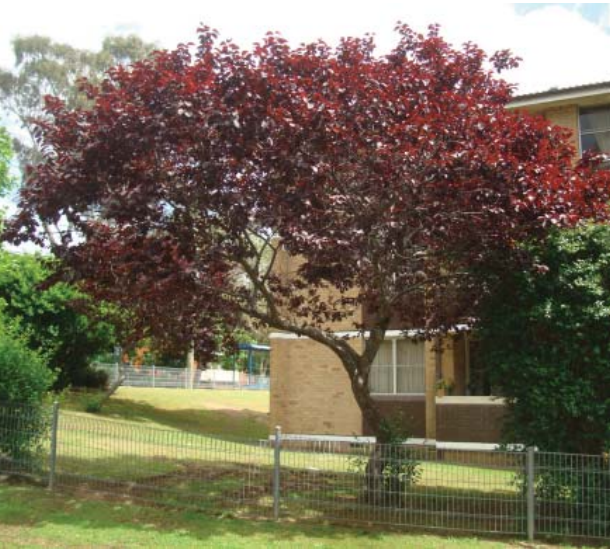
Prunus x blireana tree potentially worth salvaging (Ref #83)

There are a number of exotic specimens currently located within the site which are potentially useful for salvaging during the development phases and replanting within new landscape works. Further assessment will be required though potential exists with species such as:
Ficus hillii,
Acer negundo,
Jacaranda mimosifolia,
Prunus x cerasifera 'Nigra', and
Sapium sebiferum.

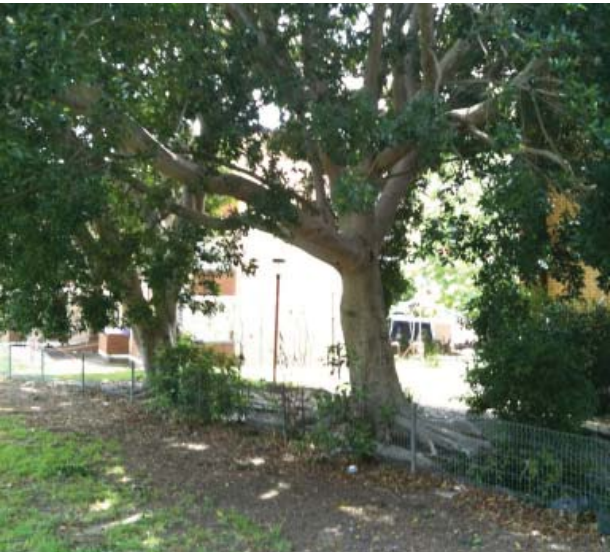
Ficus hillii trees potentially worth salvaging (Ref #122,123)
