Riverwood North Residential Renewal Project

LANDSCAPE PROPOSAL

STATUS: Concept Report

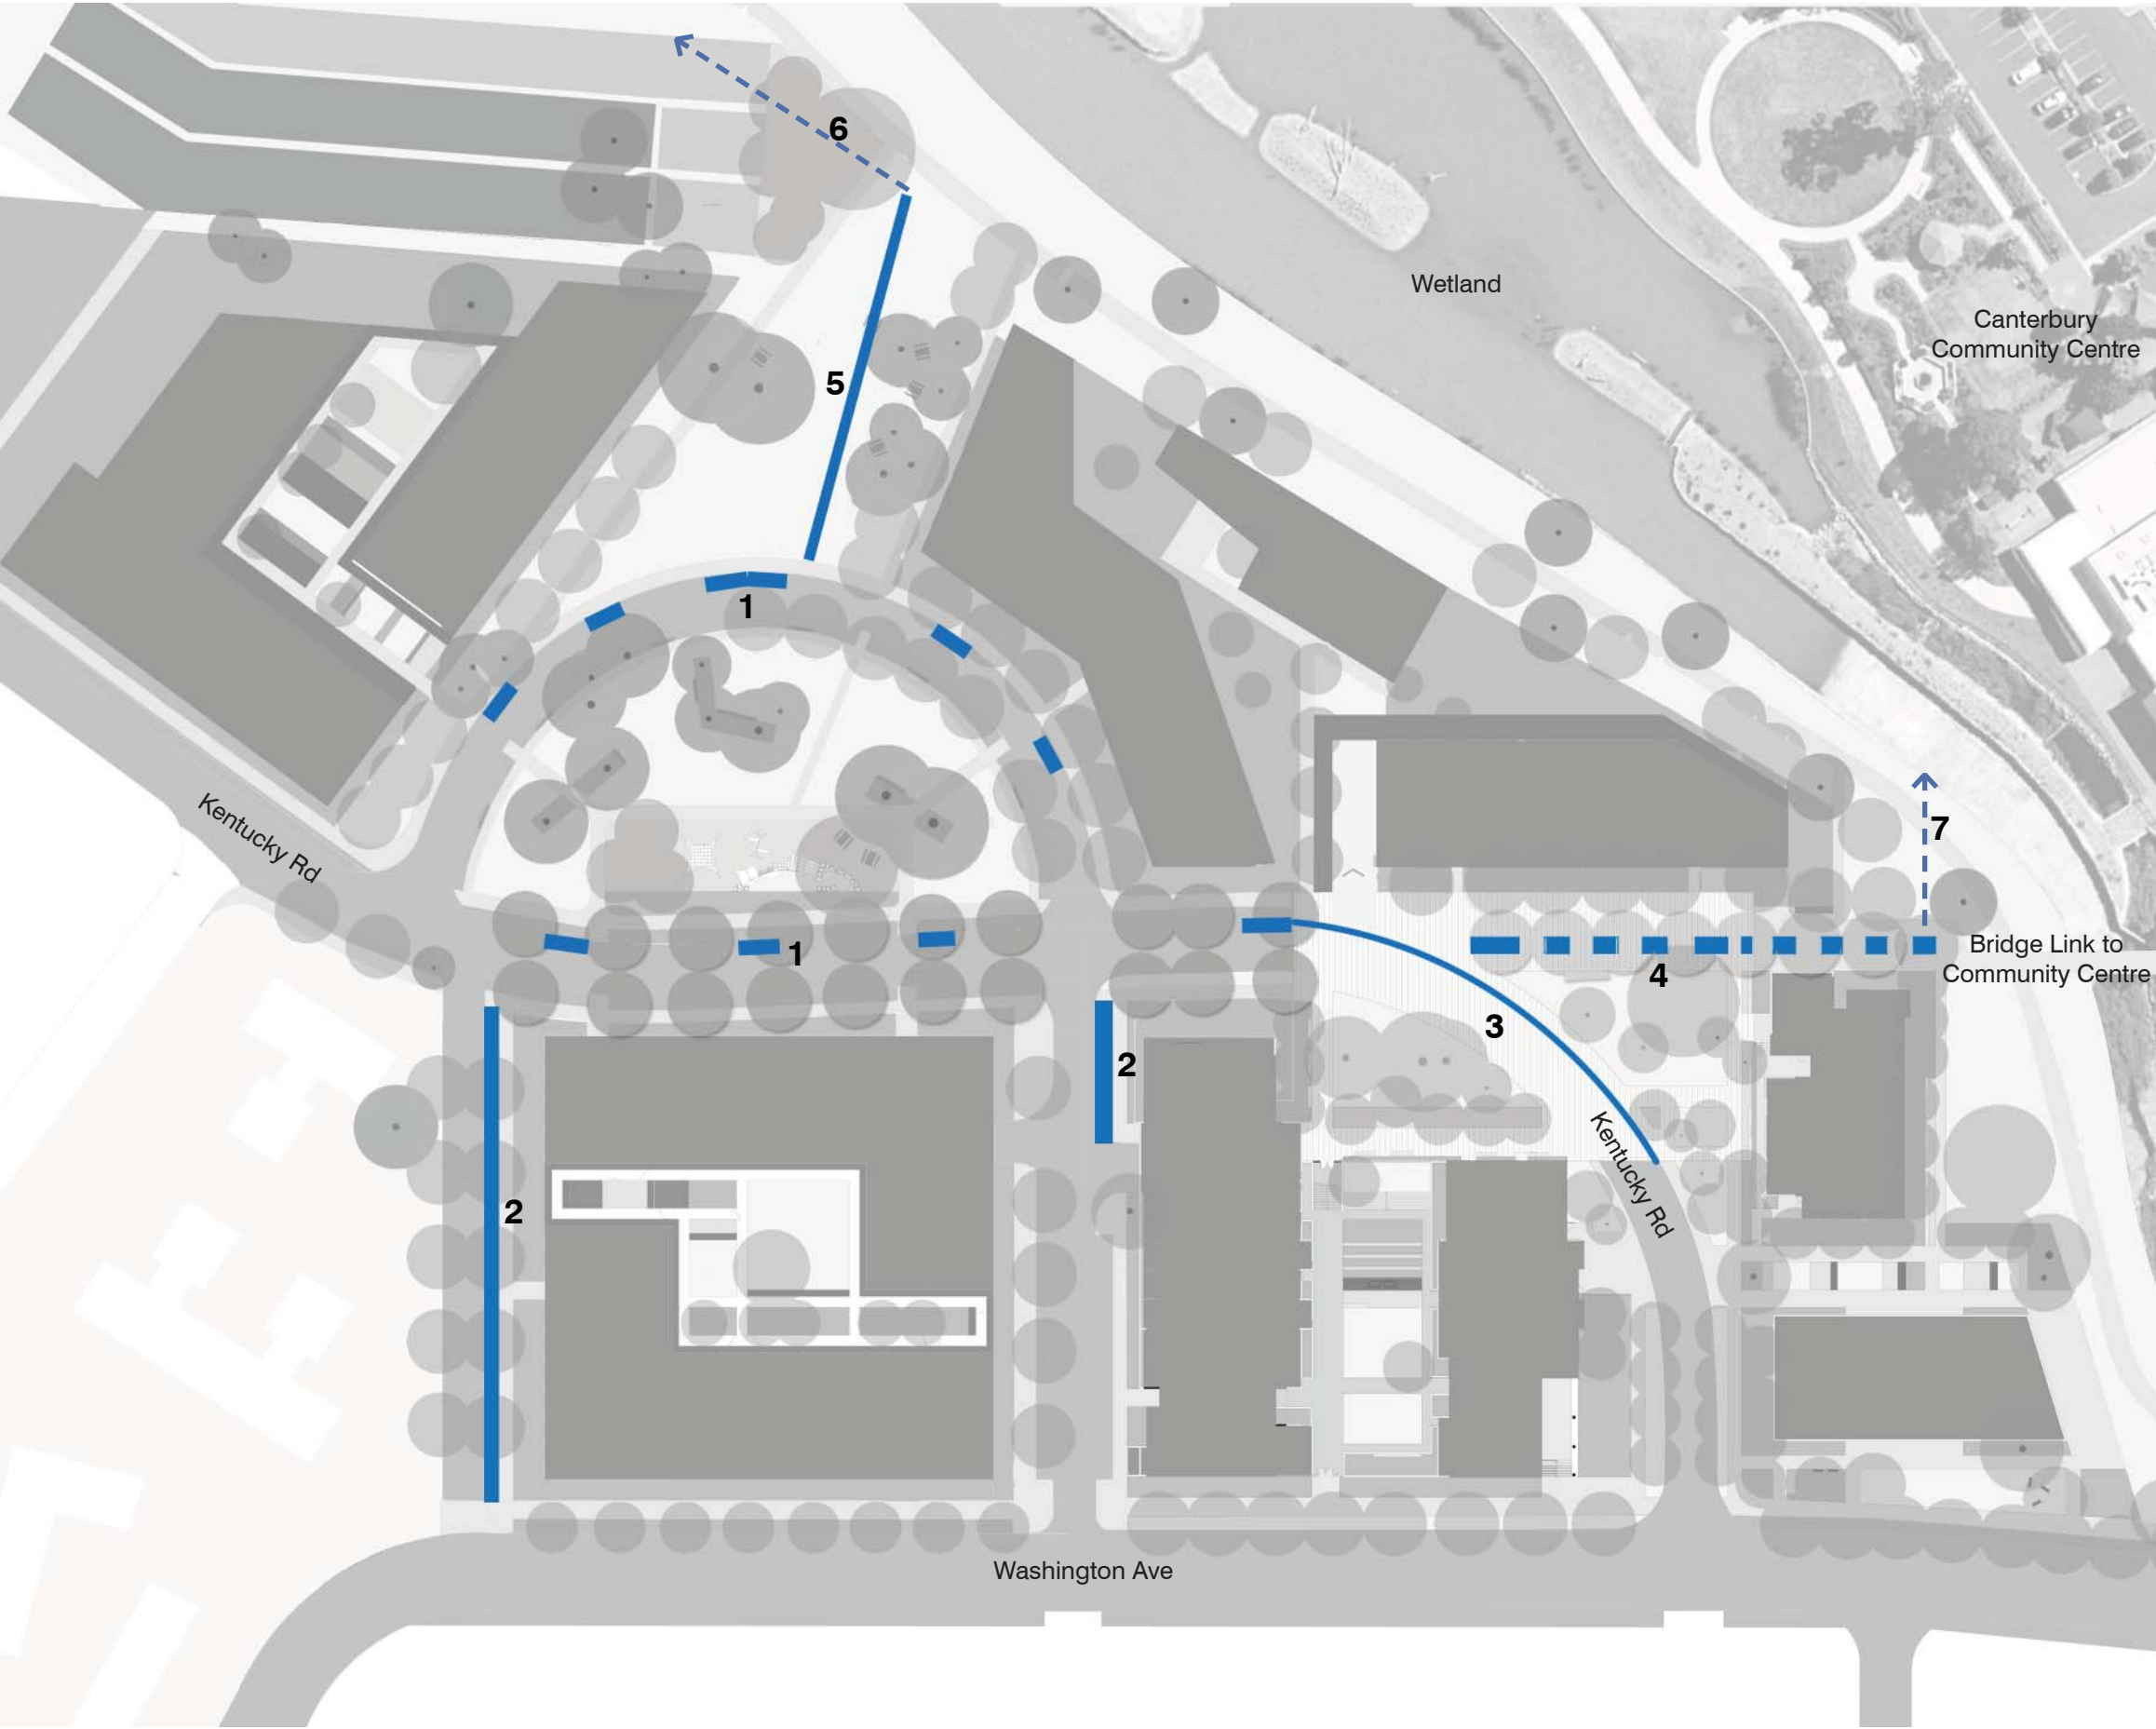
- 1. PARKING LANE BIORETENTION GARDENS**
Raingardens incorporated into new roadside verge. Refer sketch detail WS3.
- 2. VERGE TREATMENT**
Existing roadside grass verge retrofitted with rain gardens - extent of water retention dependent on location/depth of existing underground services. Refer detail WS1.

- 3. DISH DRAIN**
Spoon drain to follow Kentucky Rd alignment and direct flows into terminating Rain Garden. Drain to assist in legibility of trafficable zone.

- 4. GARDEN SQUARE TREATMENT**
Rain gardens used to filter overland flow from Garden Square pavements. Refer detail WS2.
- 5. LINER SWALE**
Potential ornamental linear bioretention swale through open space. Provide running water interest in rain events. Incorporate timber bridge access points and public art. Alignment to prevent damage to significant tree roots.

- 6. CONNECTION INTO EXISTING SWALE**
Connect linear swale into existing swale skirting community gardens.
- 7. PIPED CONNECTION INTO WETLAND FLOODWAY**
Potential to pipe filtered water into existing wetland system.

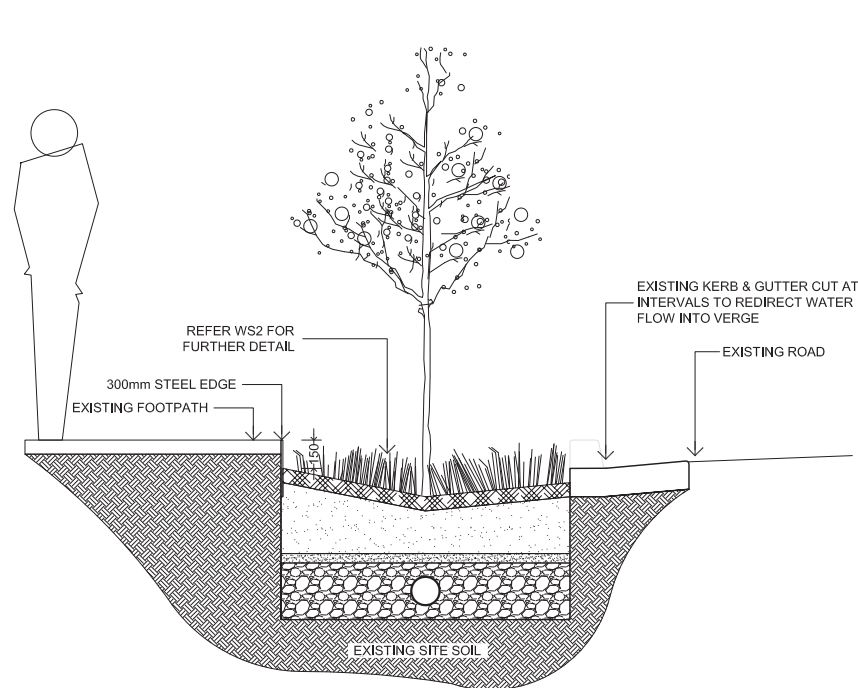
WS1 - VERGE TREATMENT
SCALE 1:40

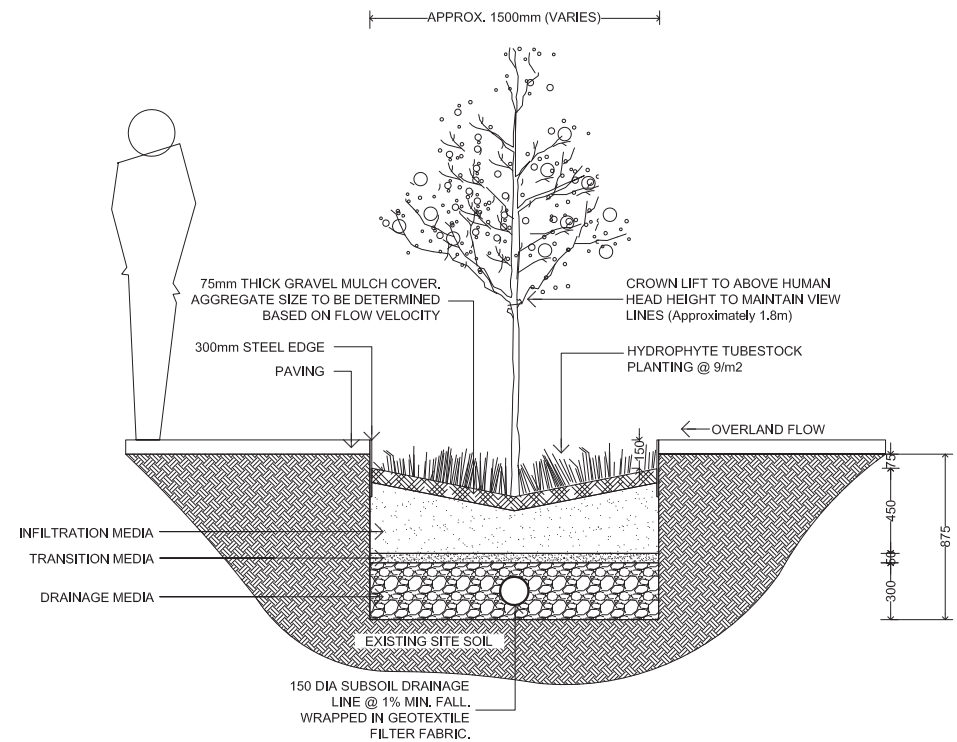
WS2 - GARDEN SQUARE TREATMENT
SCALE 1:40

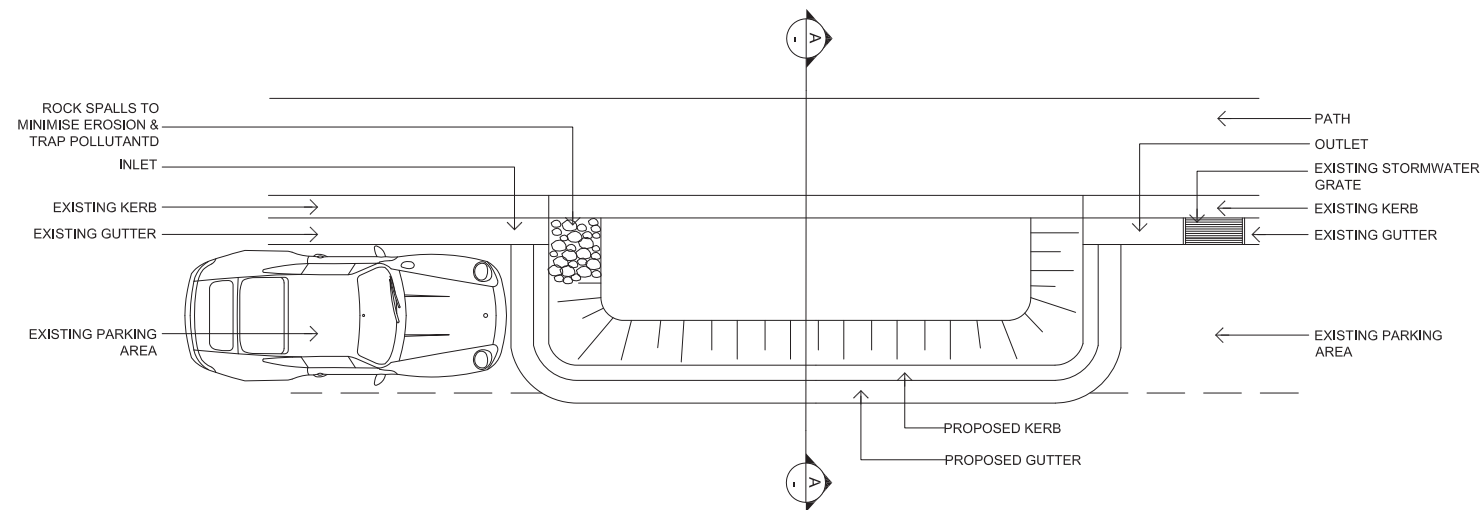
WS3 - PARKING LANE BIORETENTION GARDENS
PLAN
SCALE 1:100

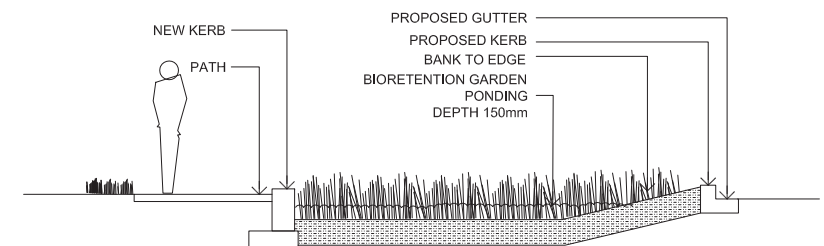
WS3 - PARKING LANE BIORETENTION GARDENS
SECTION A-A
SCALE 1:100
