**GEOTECHNICAL STUDY
PROPOSED CONCEPT DEVELOPMENT
AUSTRALIAN CATHOLIC UNIVERSITY,
STRATHFIELD CAMPUS, NSW**

Australian Catholic University Ltd

GEOTLCOV24279AA-AF
14 December 2011

Australian Catholic University - Strathfield Campus Concept Development

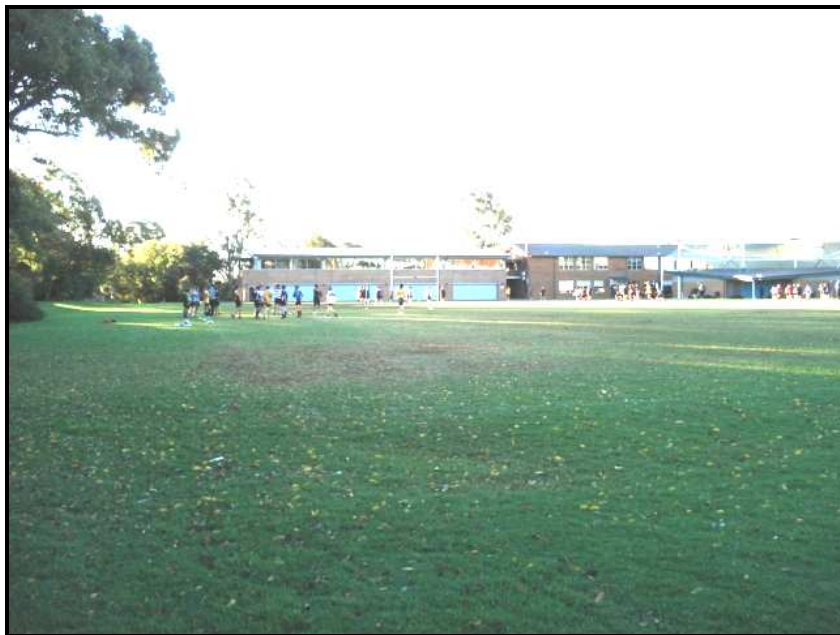
As shown in photograph 1, the grassed sports fields within the western portion of the campus are near level and appear relatively well drained. The southern and western portions of the fields appeared to have been formed in cut whilst the northern portions are natural ground or relatively shallow fill.

Photograph 1: Western sports fields with St Patricks College in background

Bulk excavation of the sports field is proposed to create an underground carpark.

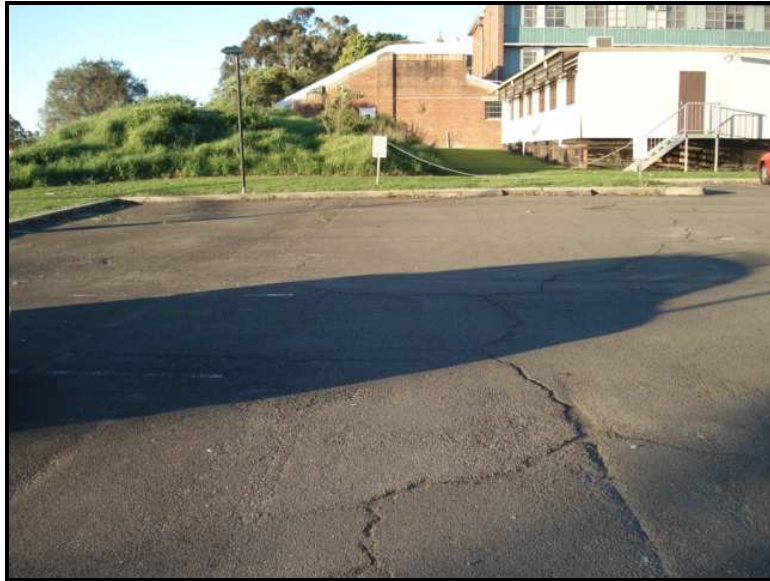
Photograph 2 shows part of the existing carpark located in the southwest corner of the campus where it is proposed to construct the Precinct 3 building and associated basement carparking. The asphalt paved carpark appeared to be in natural ground or relatively shallow fill. Numerous longitudinal cracks and block crack patterns were observed in the pavement. The pavement was graded towards a concrete dish drain located in the western end of the carpark which fed into a stormwater system.

Photograph 2: Part of existing carpark in southwest corner of campus and proposed Precinct 4 in background

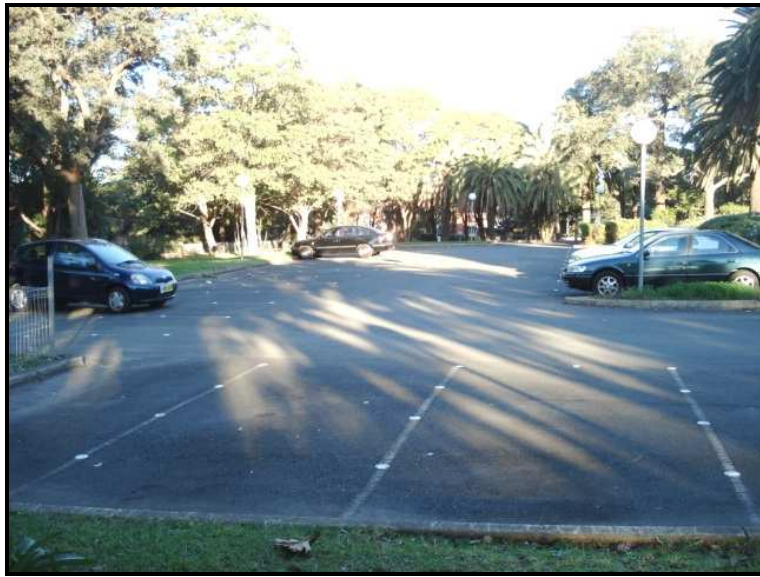
Photograph 3 shows part of the existing asphalt paved carpark located in the southeast corner of the campus where it is proposed to construct Precinct 1 – library and learning commons buildings. The asphalt carpark appears to have been constructed in predominantly cut and was observed to slope towards the east. The pavement appeared to be in reasonable condition although a few longitudinal cracks were observed. The carpark was surrounded by grass verges and numerous trees. No rock outcrops were observed.

Photograph 3: Part of existing carpark in southeast corner of campus

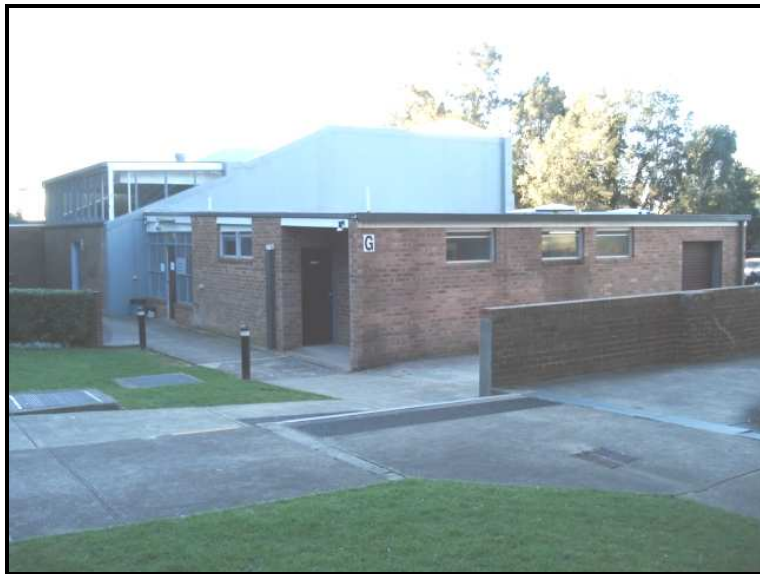
The existing Block G buildings appeared to be located over level, natural ground and were of one and two level brick construction. The exterior of the buildings appeared in good condition. The Illustrative Concept Plan suggests that these buildings are to be demolished and replaced with a new building (Precinct 2).

Photograph 4: Existing Block G Buildings in eastern end of campus

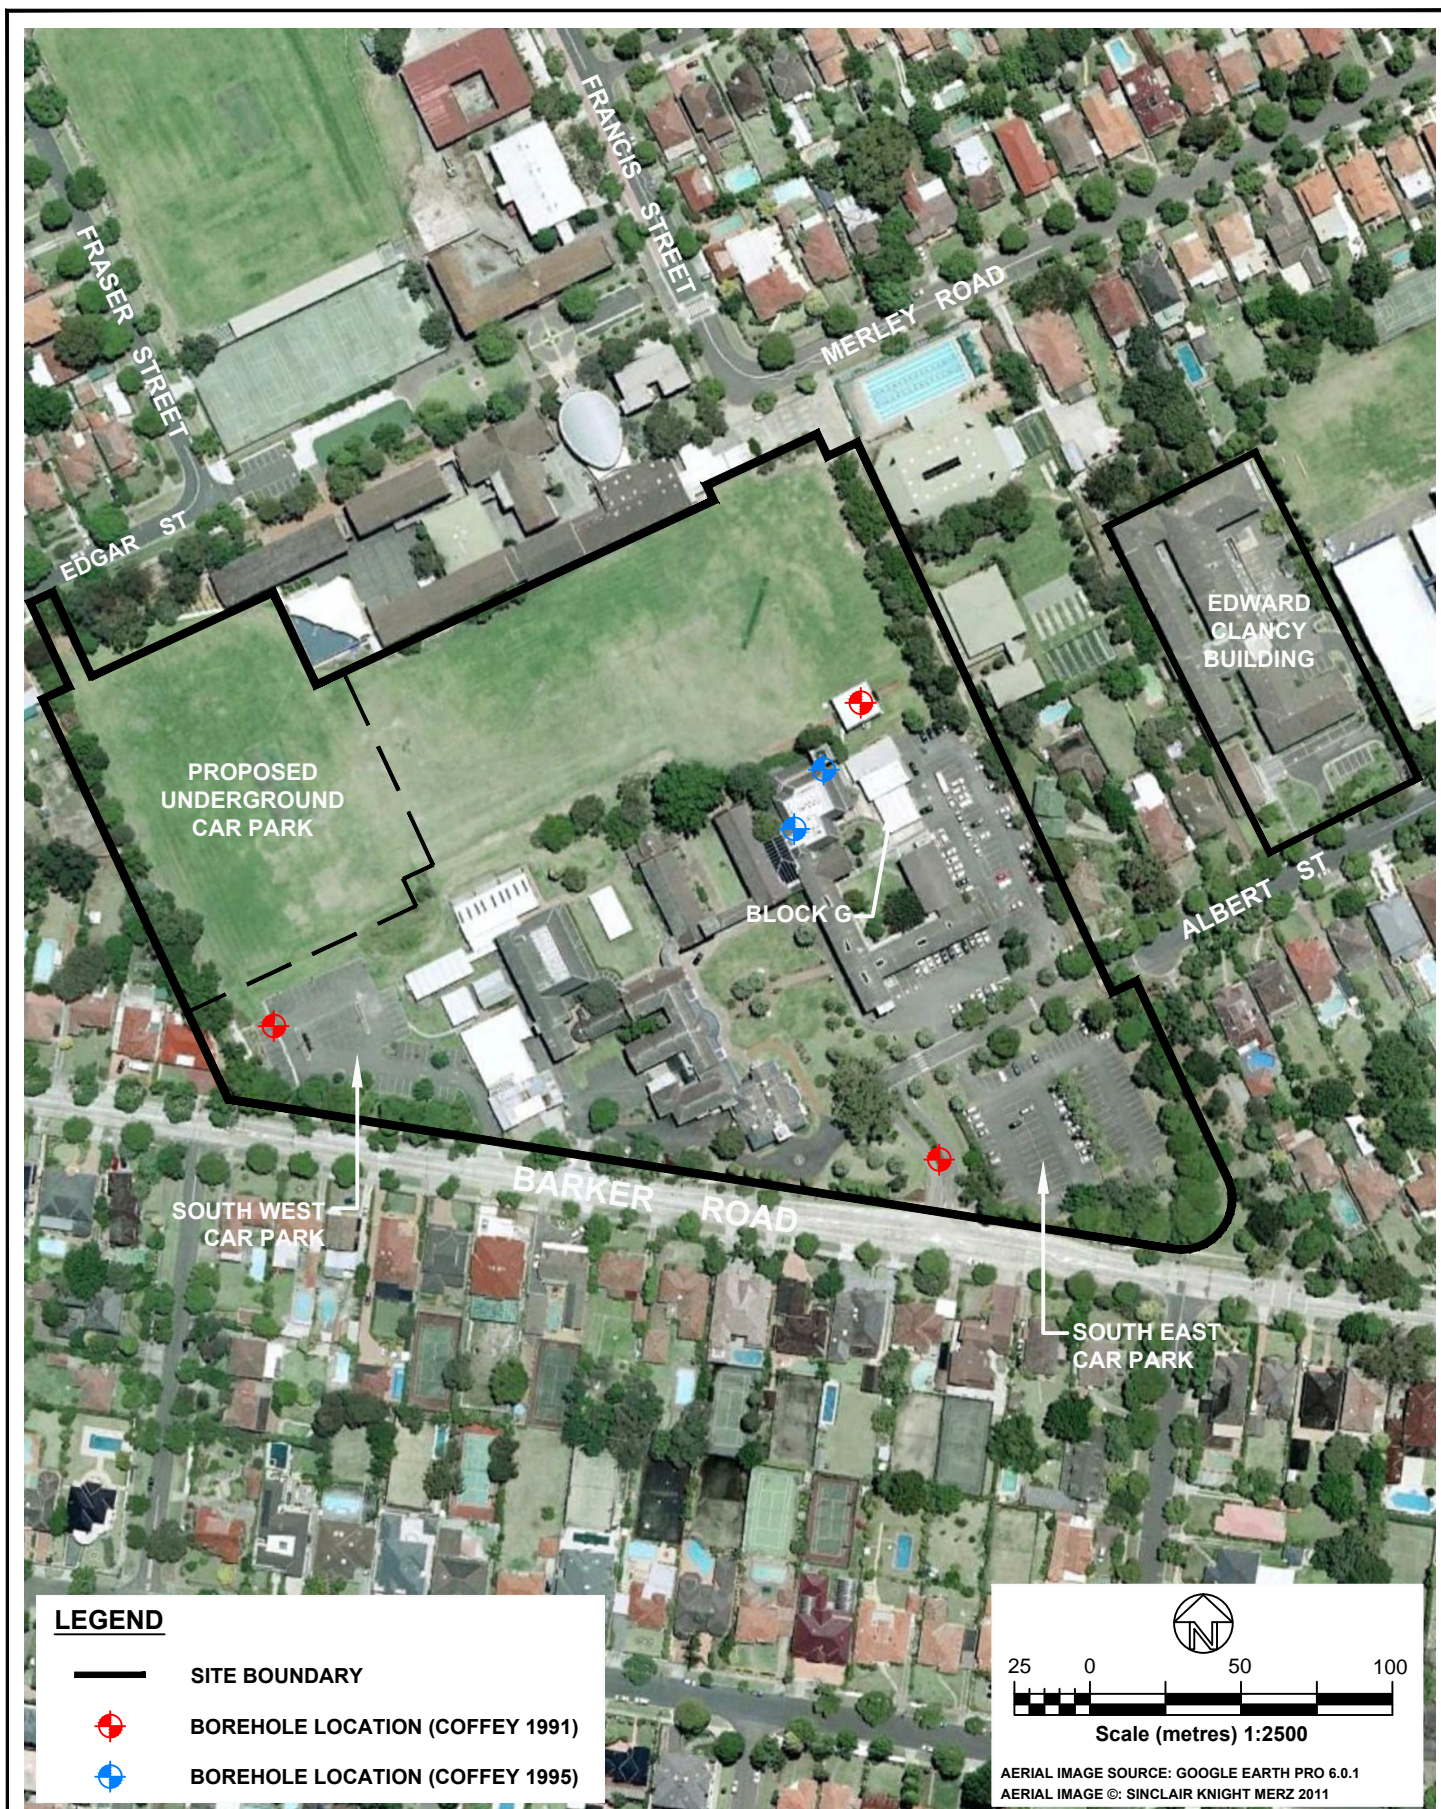
As shown on Figure 1, the main ACU campus is situated within an established residential area in gently undulating topography. The campus is bounded by Barker Road to the south and St Patricks College to the north. A strip of residential property is situated along the eastern boundary and separates the Edward Clancy building from the main campus.

The locations of these boreholes from previous investigations are presented on Figure 1.

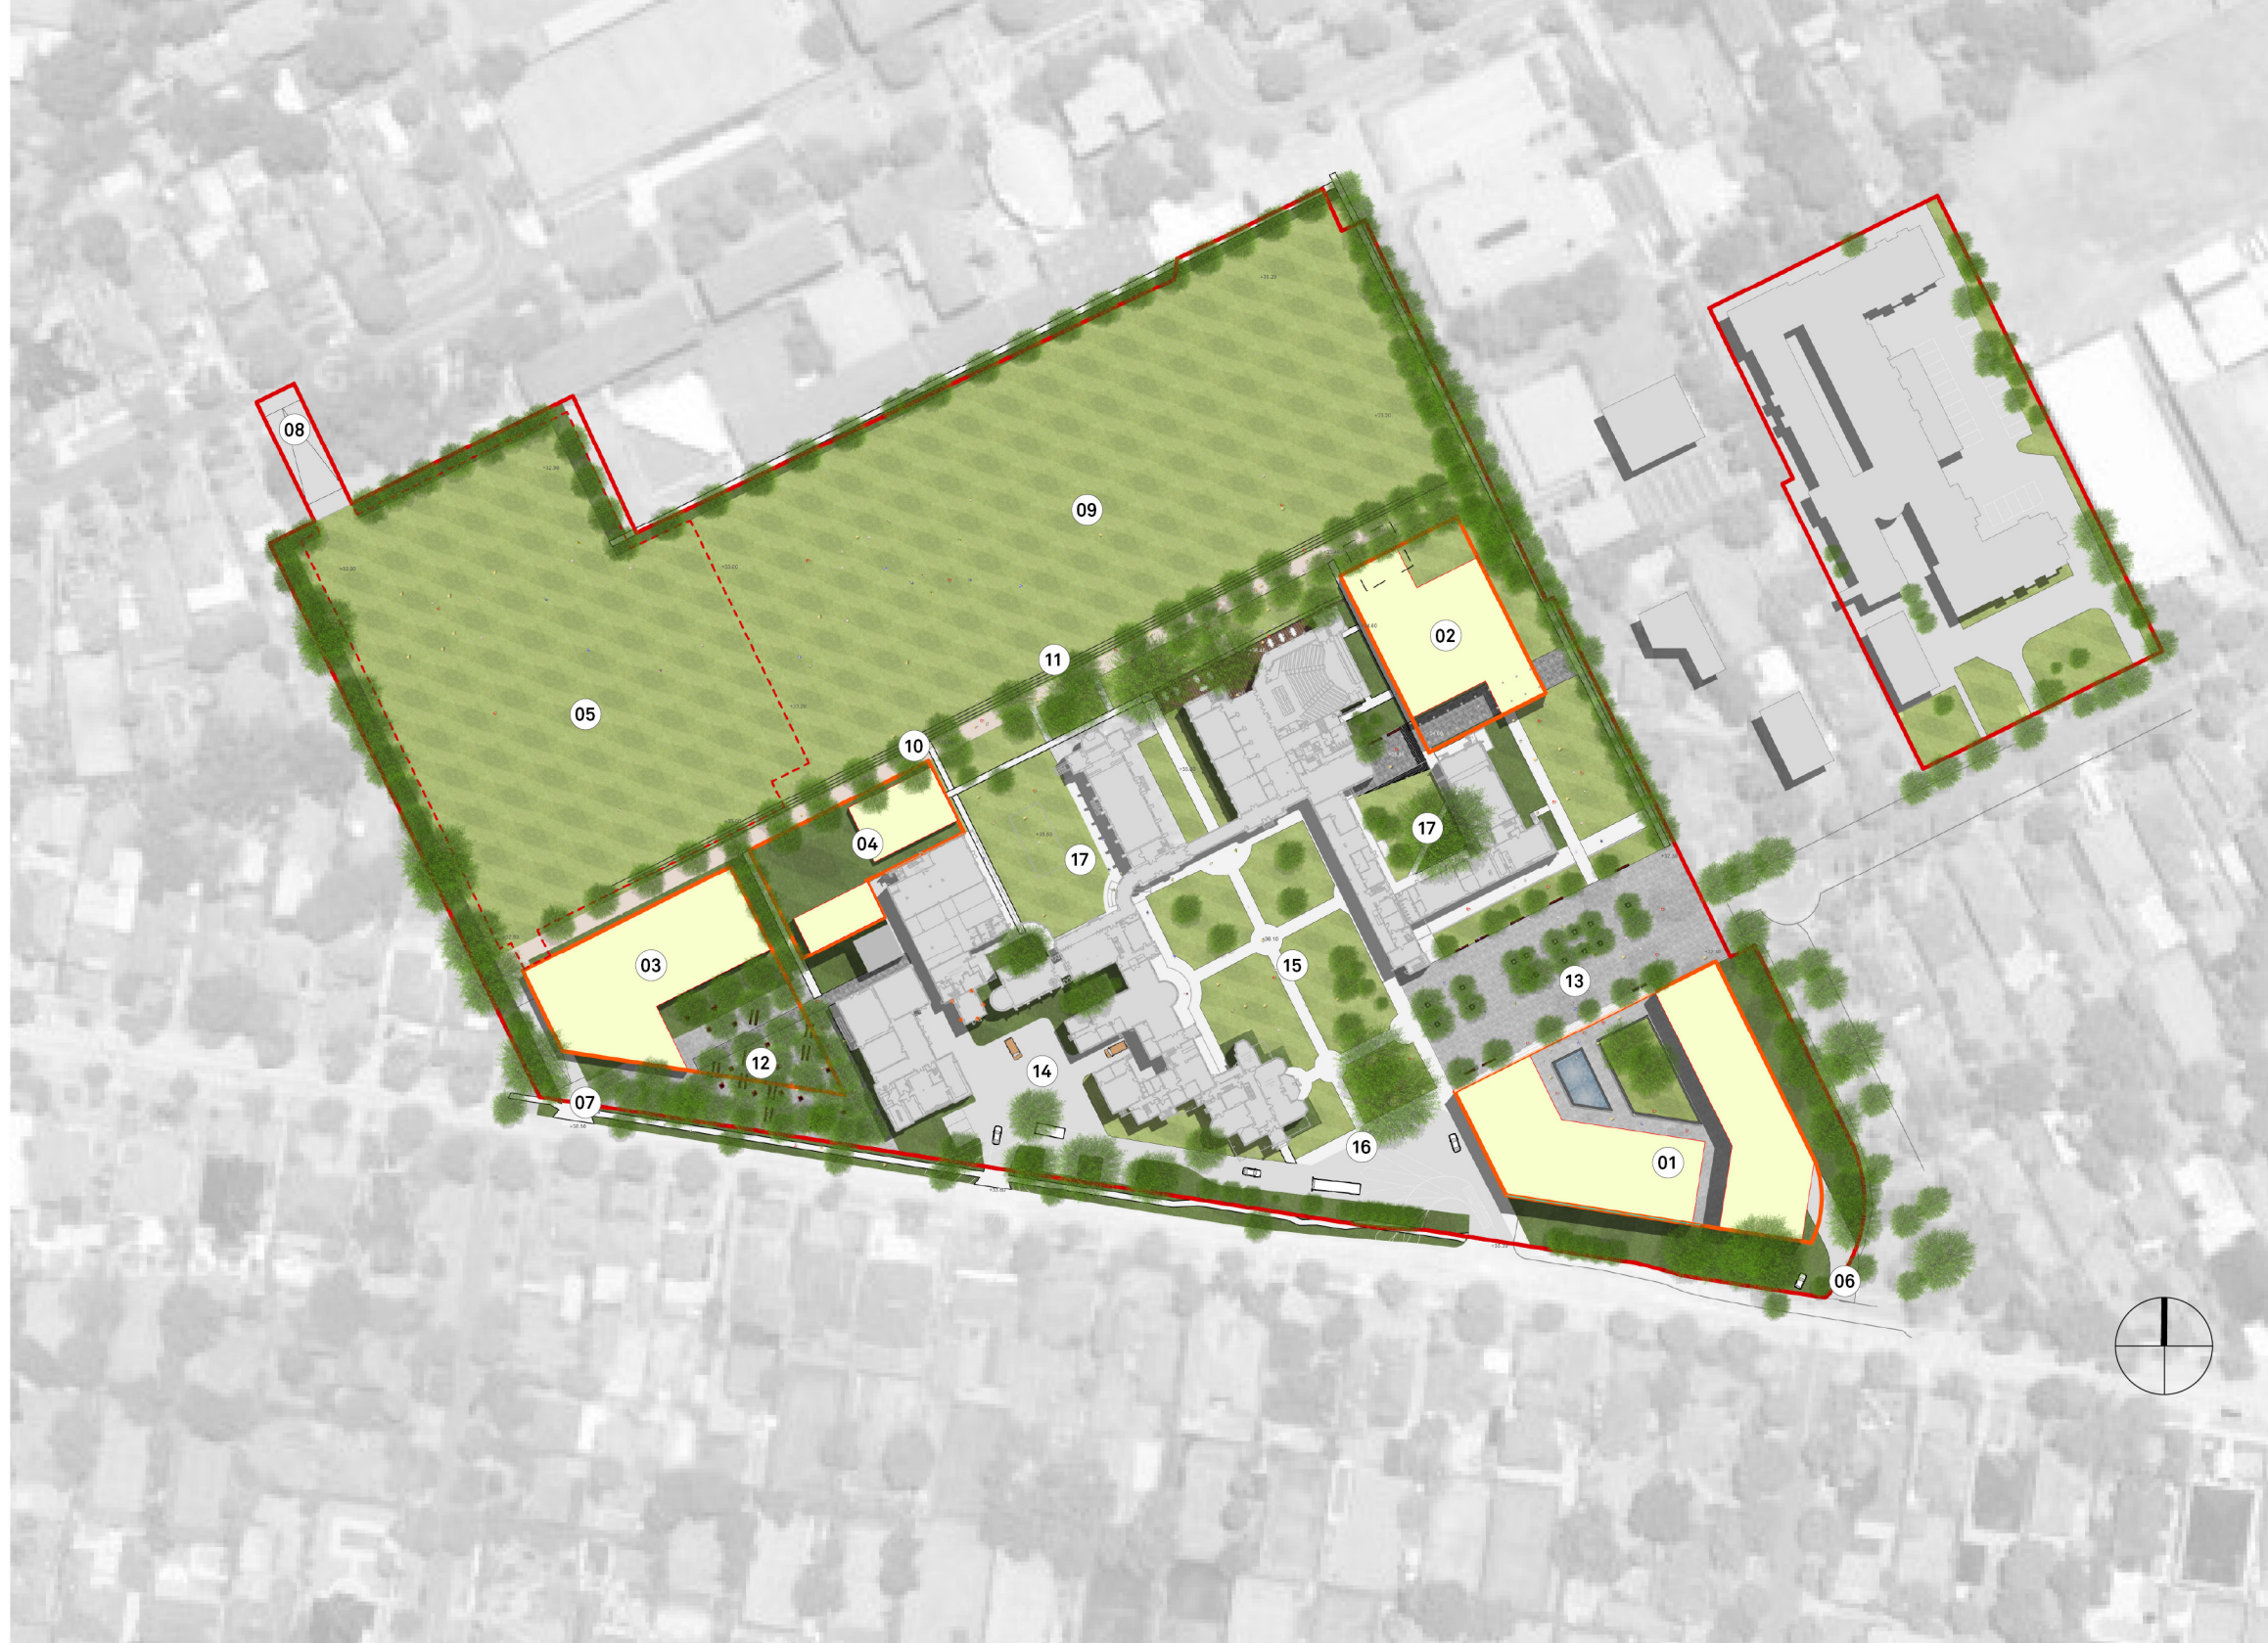
ILLUSTRATIVE CONCEPT PLAN

- 01_ Precinct 1: Library and learning commons
- 02_ Precinct 2: Eastern
- 03_ Precinct 3: Western
- 04_ Precinct 4: Central
- 05_ New underground car park
- 06_ New Gate 1 access
- 07_ New Gate 4 access
- 08_ New gate access on Edgar Street
- 09_ Existing sports field to be retained
- 10_ Edge promenade
- 11_ Outdoor seating area and bleacher steps to sports fields
- 12_ New pedestrian only shaded public space
- 13_ Proposed pedestrian only library commons
- 14_ Existing service area to be retained and enhanced
- 15_ University commons to be retained and enhanced
- 16_ Proposed bus drop off and pick up zone
- 17_ Upgraded 'green rooms'

The Illustrative Concept Plan is appended showing the proposed development layout.
