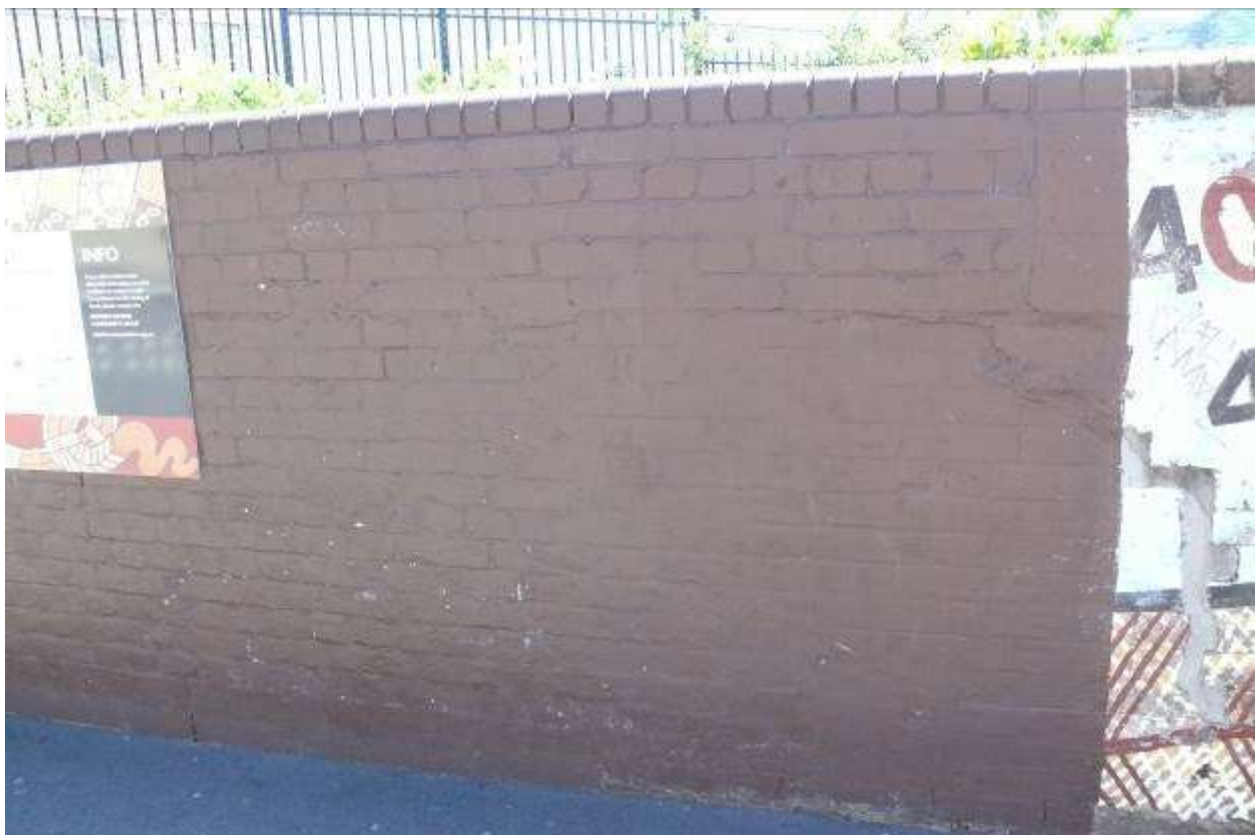
Figure 20 – Crack propagation through boundary wall observed from Lawson Street Overpass Bridge

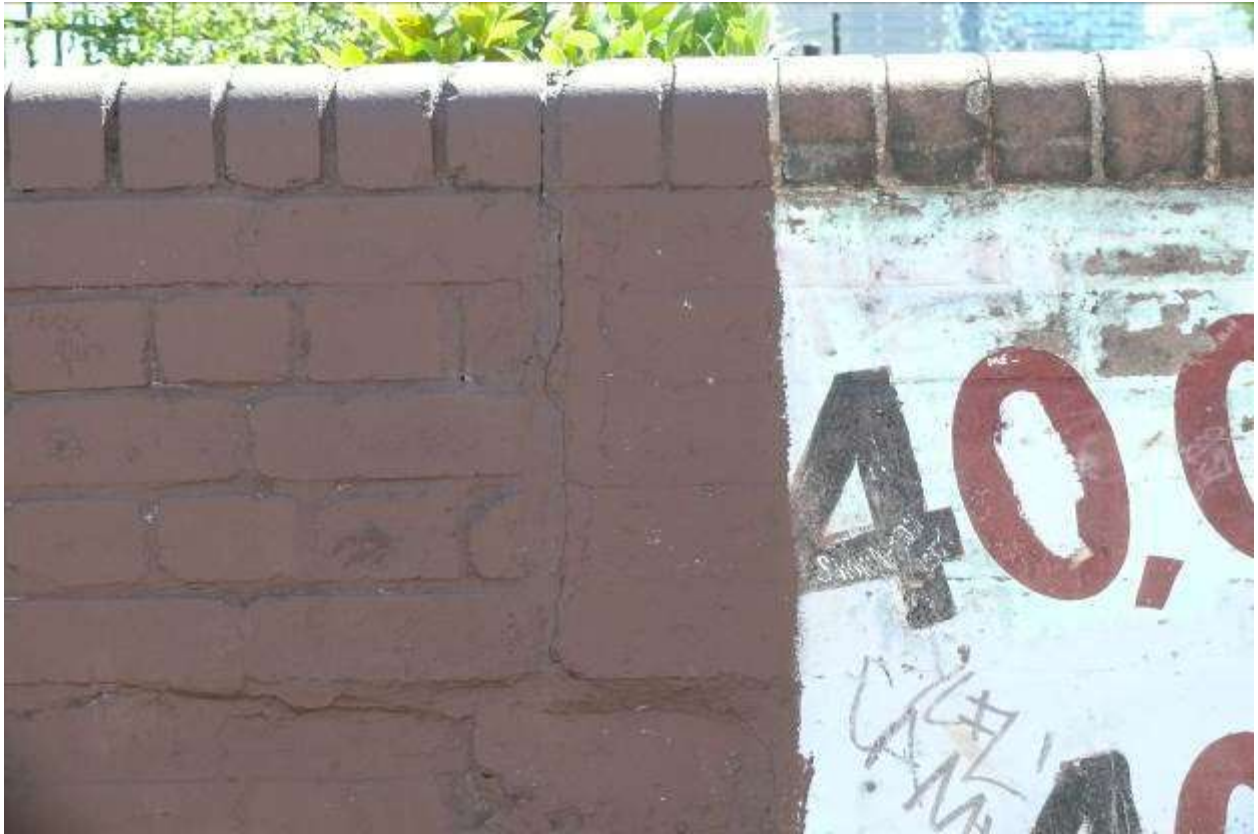
Figure 21 – Crack propagation through boundary wall observed from Lawson Street Overpass Bridge

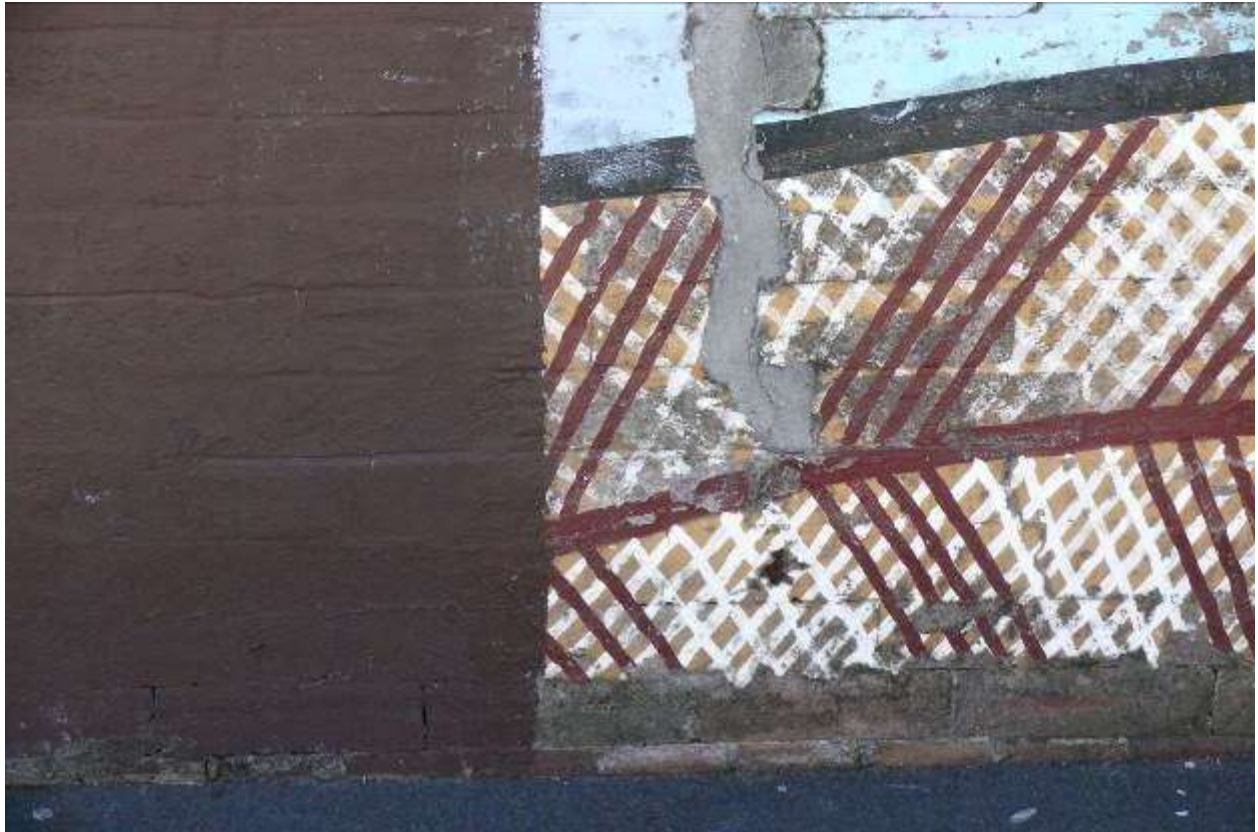
Figure 23 – Crack propagation and loss of material through boundary wall observed from Lawson Street Overpass Bridge

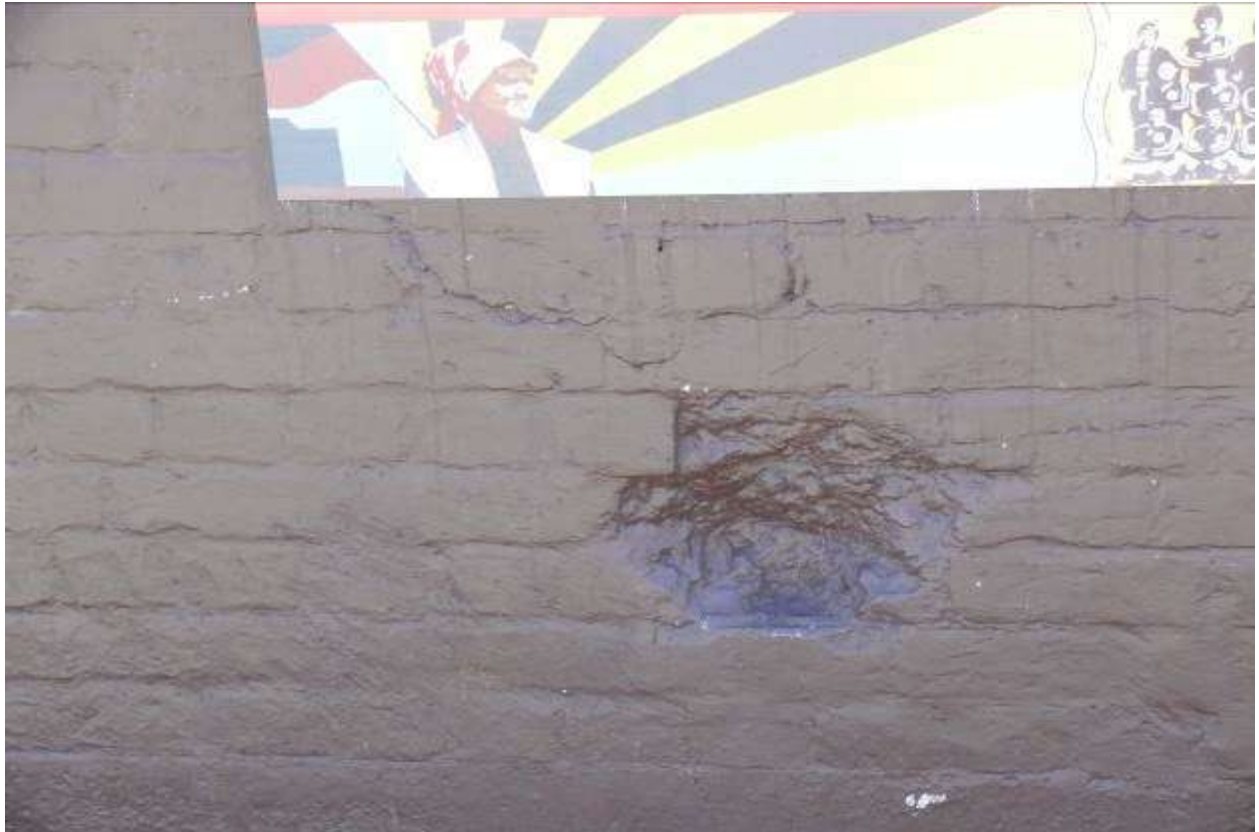
Figure 25 – Loss of material and evidence of patchwork through boundary wall observed from Lawson Street Overpass Bridge

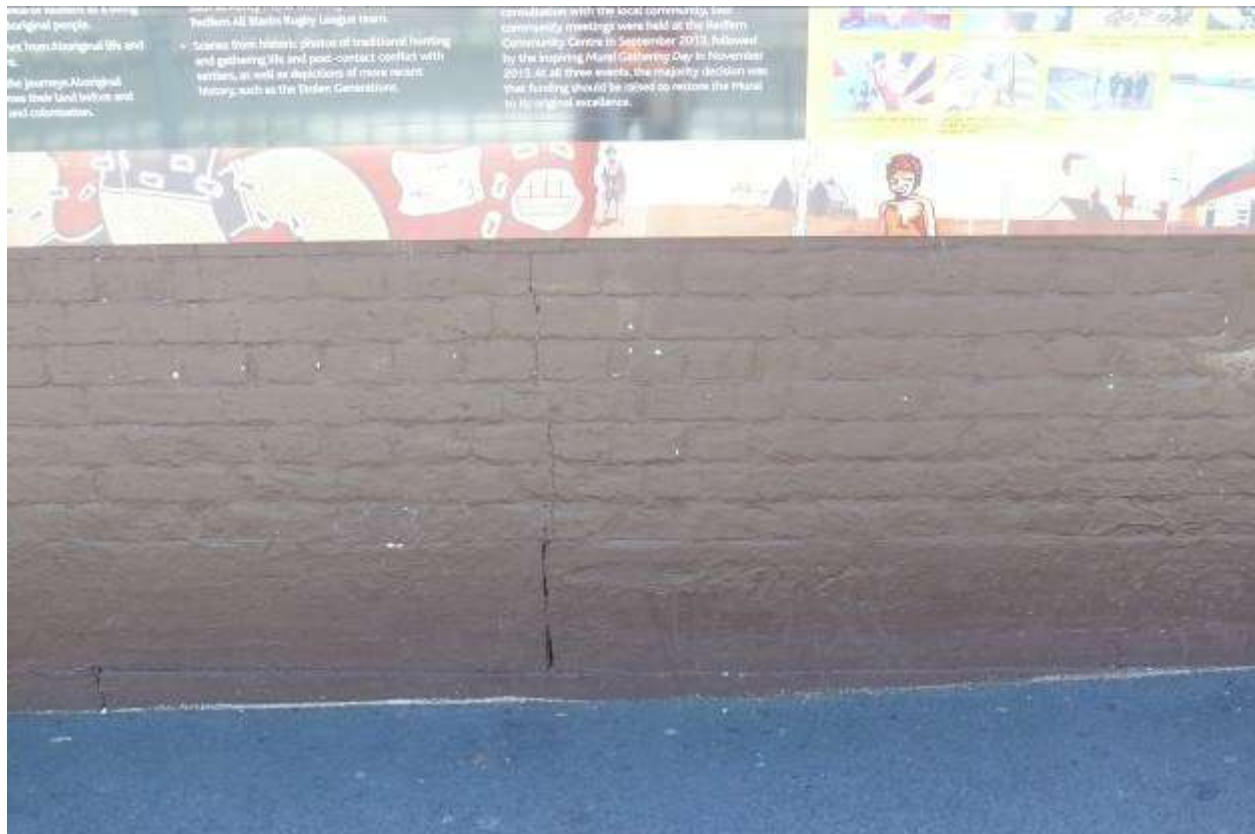
Figure 27 – Crack propagation through boundary wall observed from Lawson Street Overpass Bridge

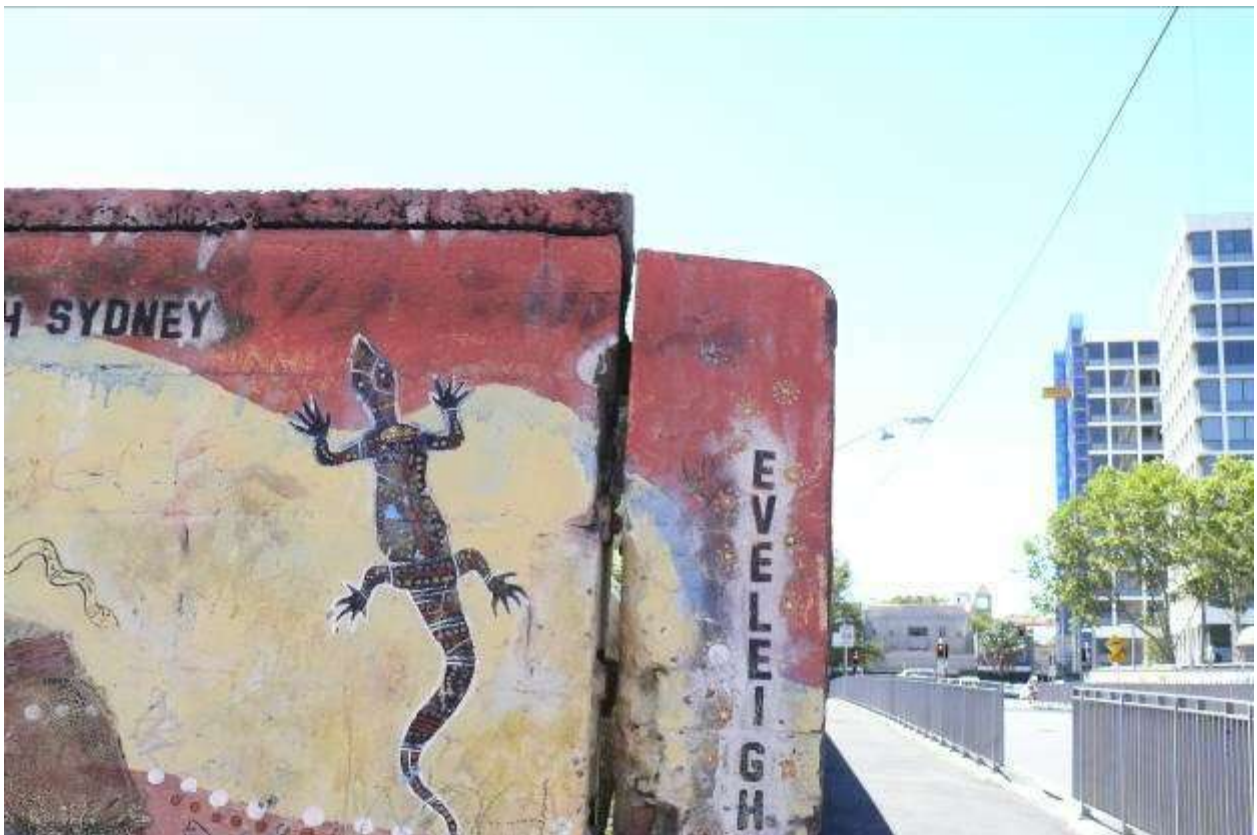
Figure 30 – Crack propagation, separation and loss of material through boundary wall

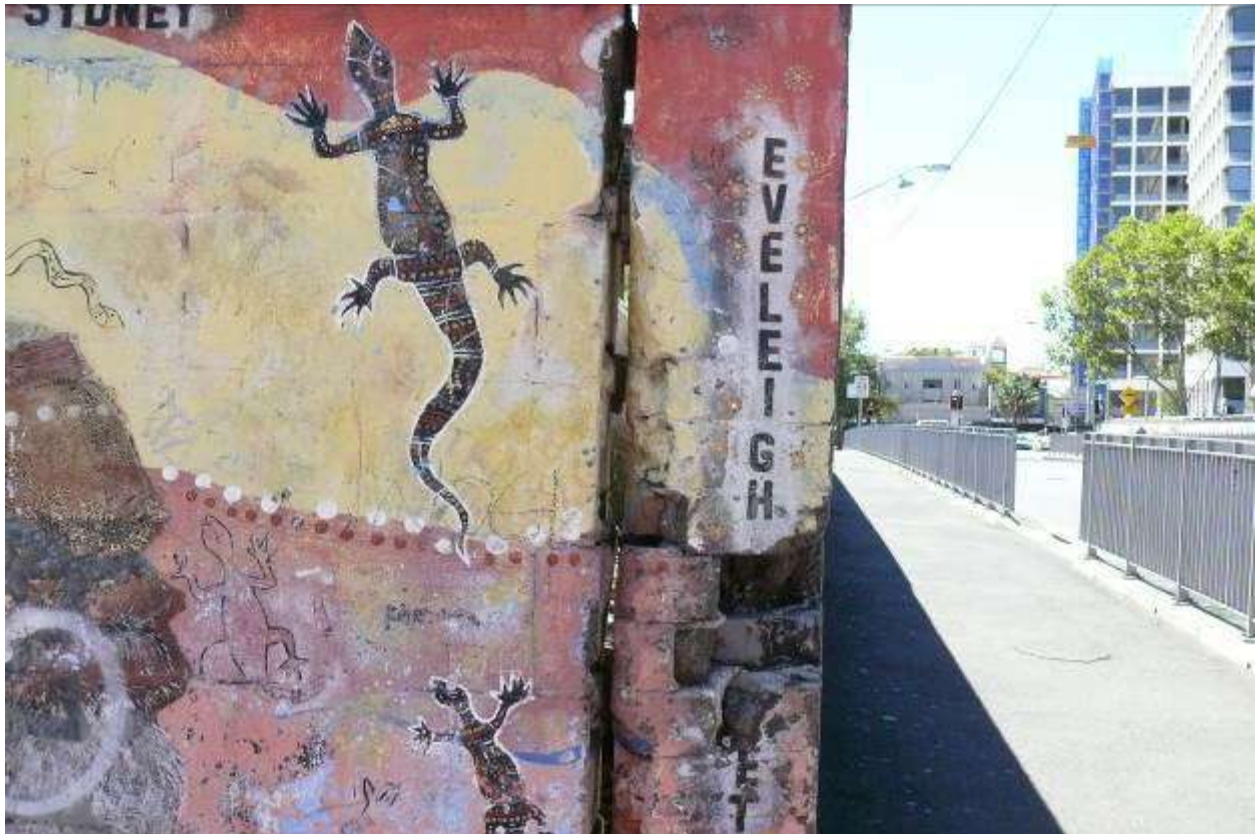
Figure 31 – Crack propagation, separation and loss of material through boundary wall observed from Lawson Street Overpass Bridge

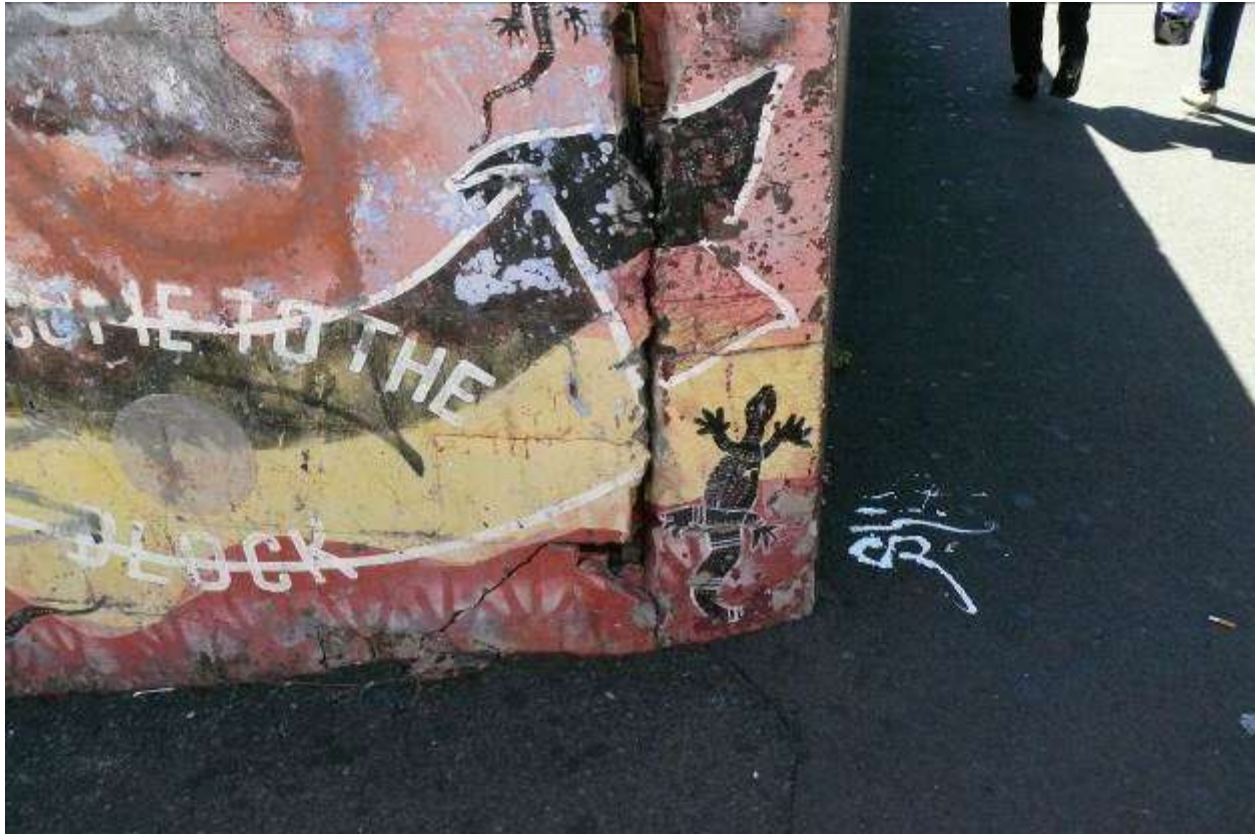
Figure 33 – Crack propagation, separation and loss of material through boundary wall observed from Lawson Street Overpass Bridge

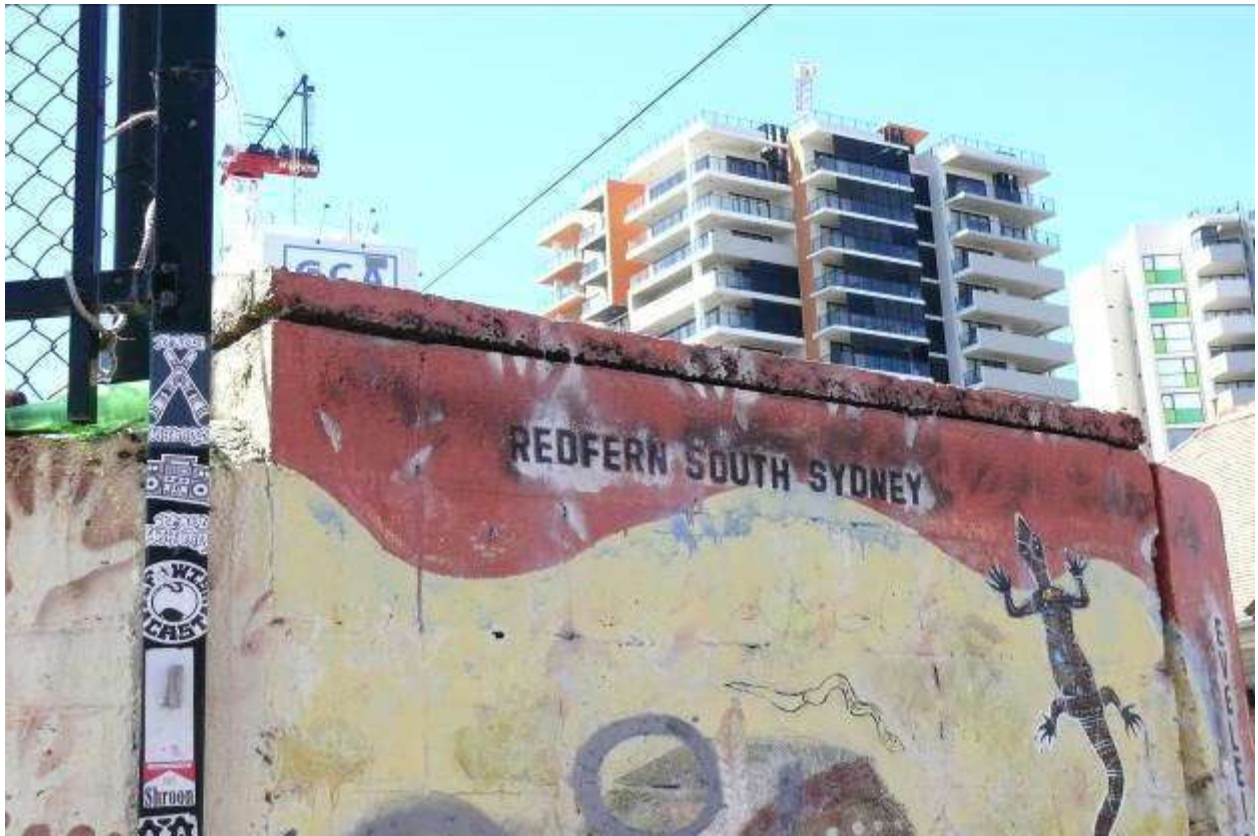
Figure 35 – Crack propagation, separation and loss of material through boundary wall observed from Lawson Street Overpass Bridge

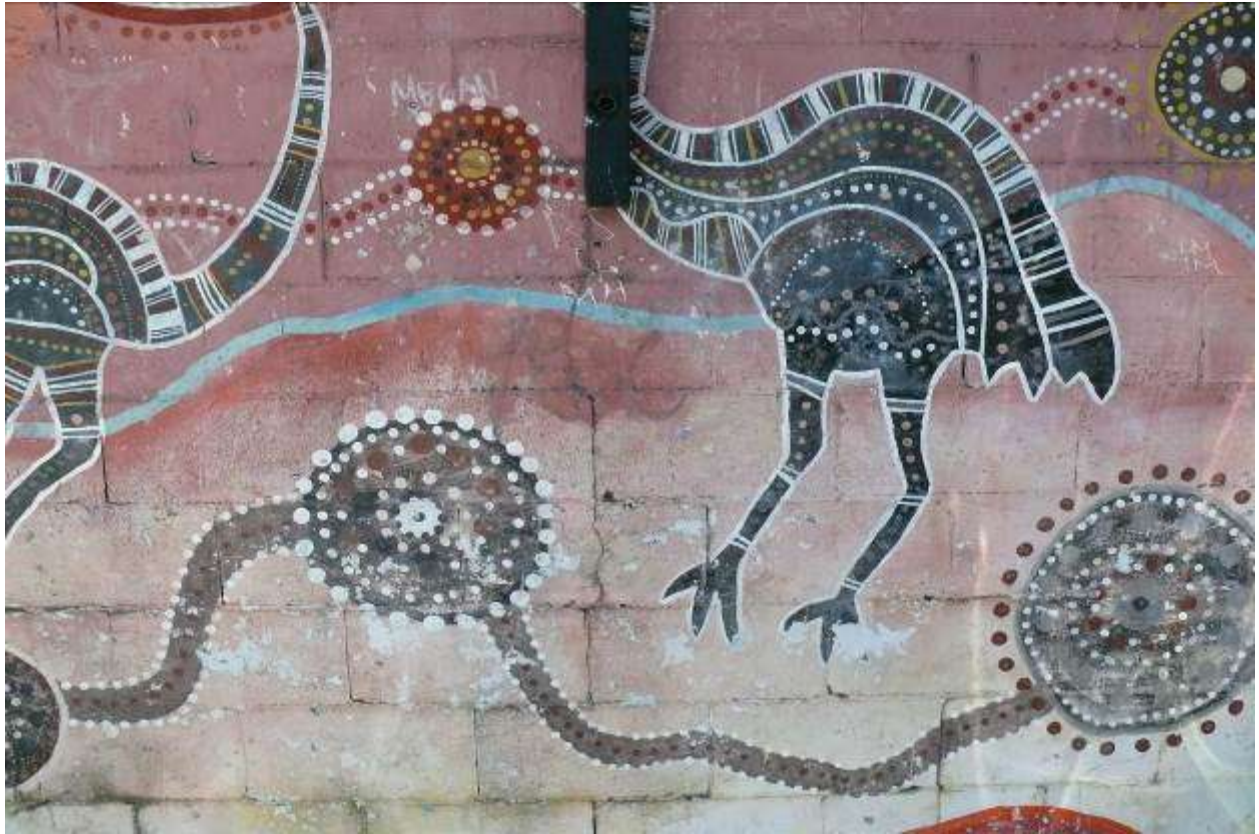
Figure 43 – Crack propagation through boundary wall observed from Eveleigh Street

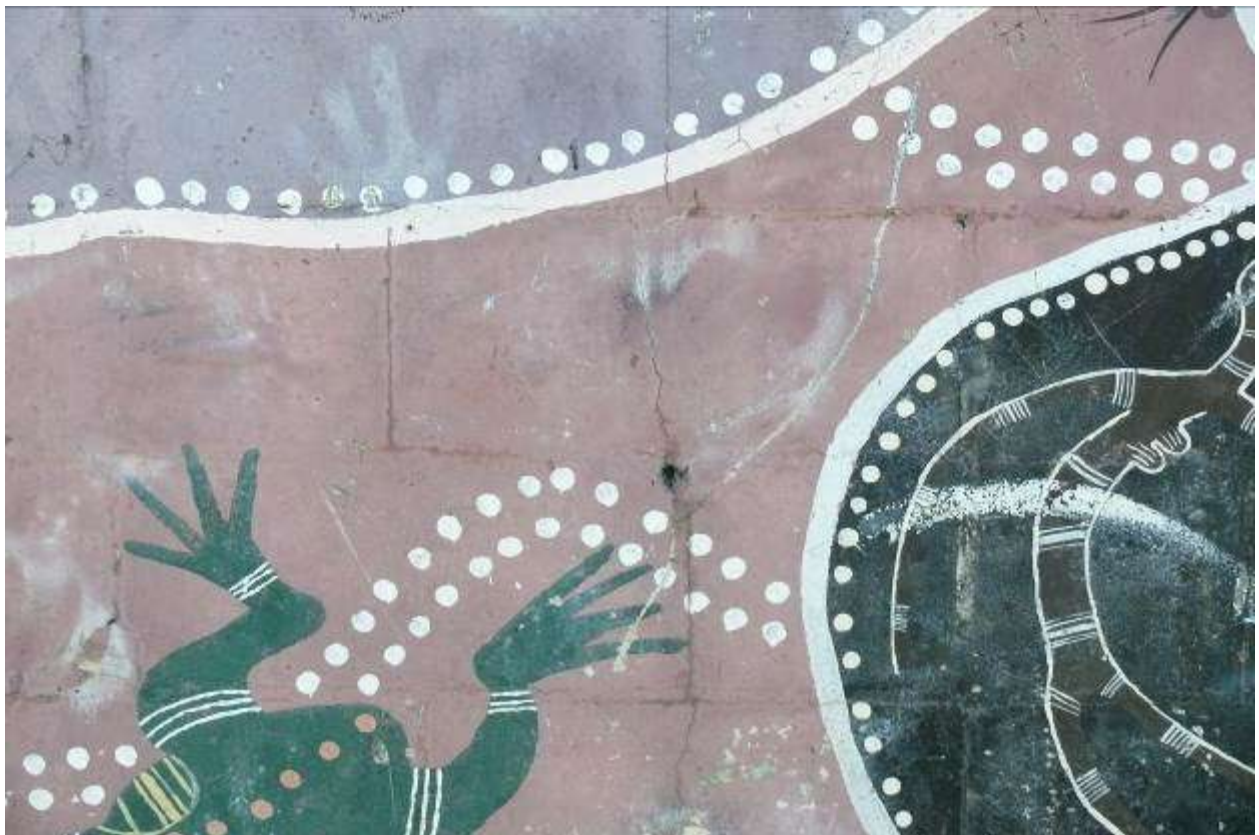
Figure 52 – Crack propagation through boundary wall observed from Eveleigh Street

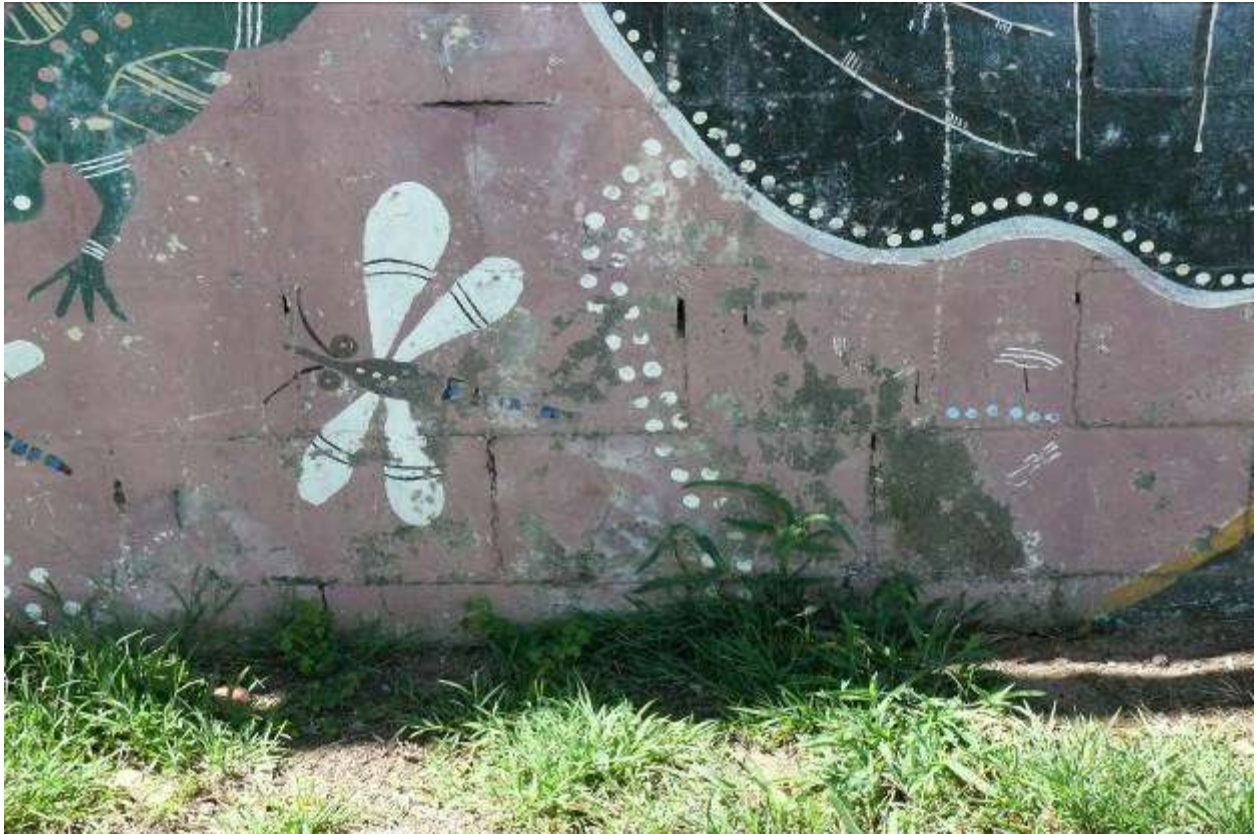
Figure 53 – Crack propagation through boundary wall observed from Eveleigh Street

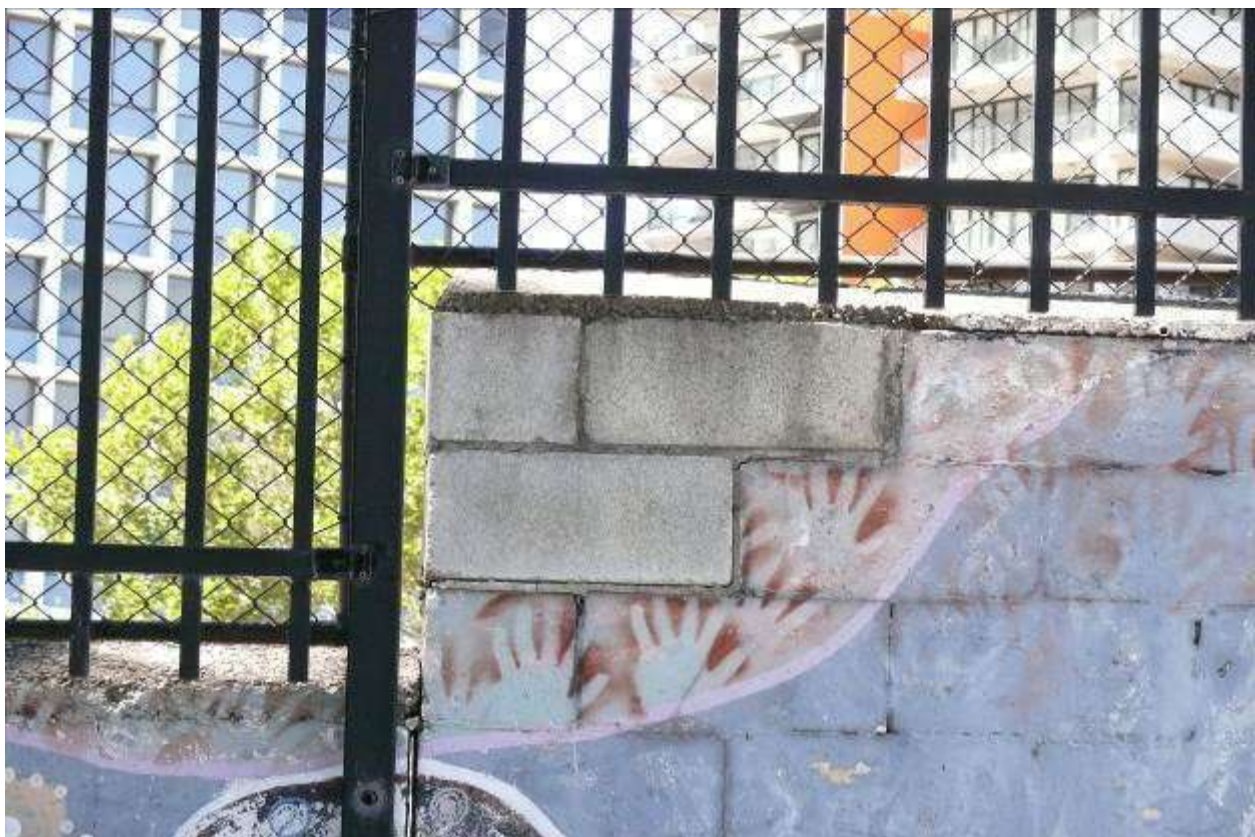
Figure 58 – Loss of material through boundary wall observed from Eveleigh Street

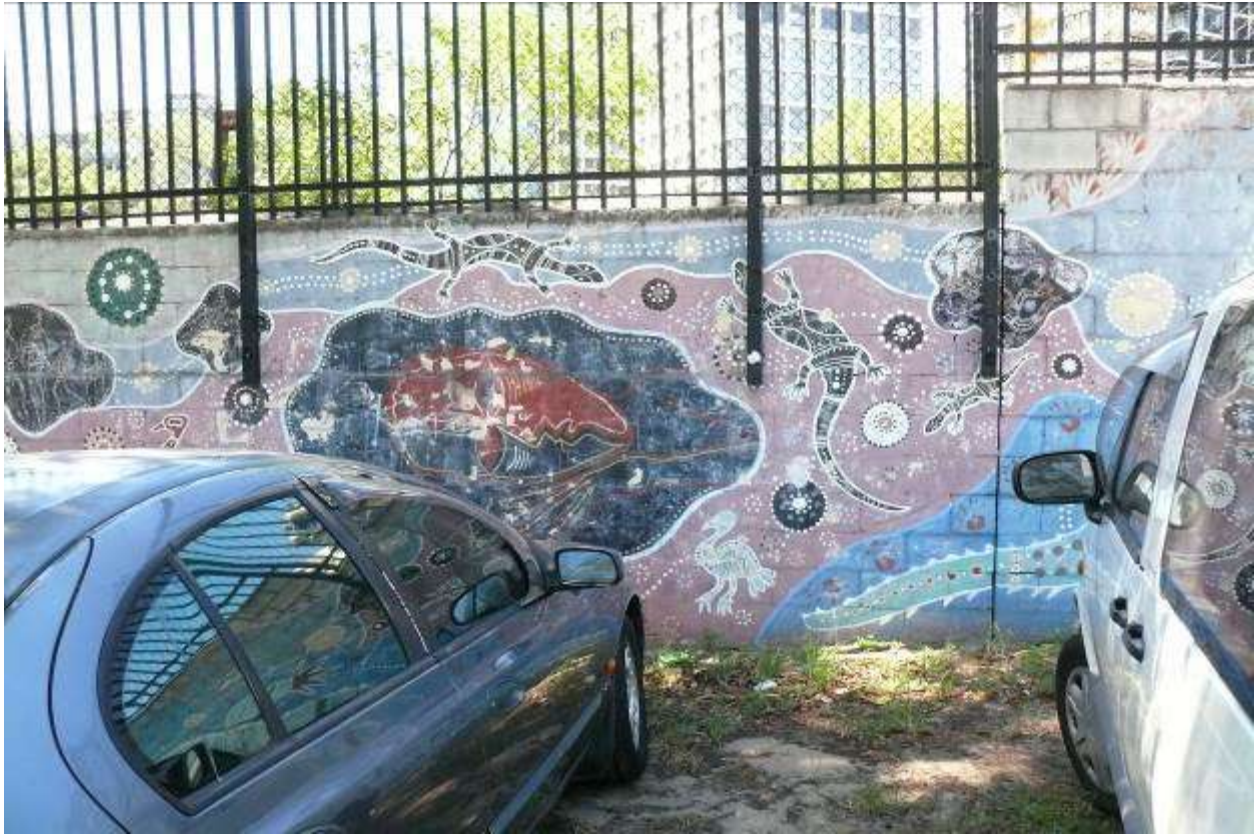
Figure 59 – General condition of RailCorp boundary wall observed from Eveleigh Street

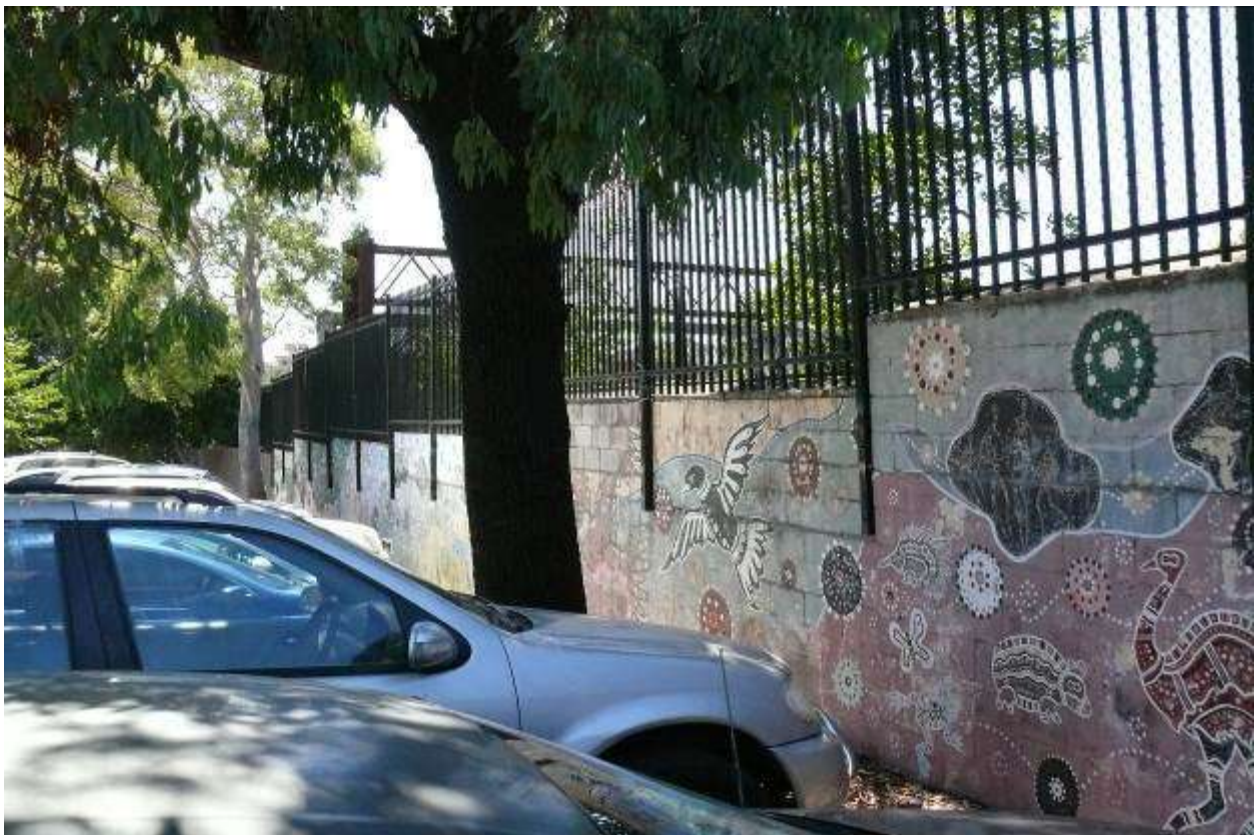
Figure 60 – General condition of RailCorp boundary wall observed from Eveleigh Street

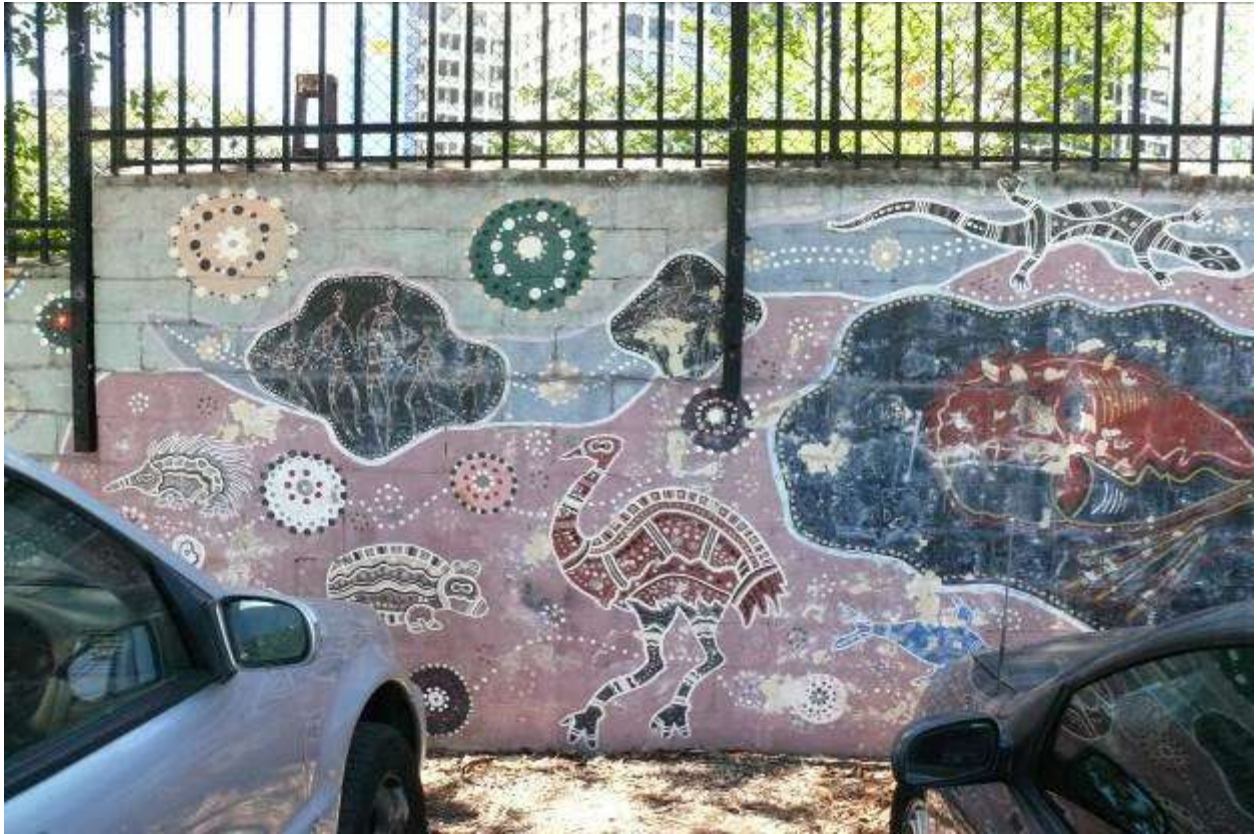
Figure 61 – General condition of RailCorp boundary wall observed from Eveleigh Street

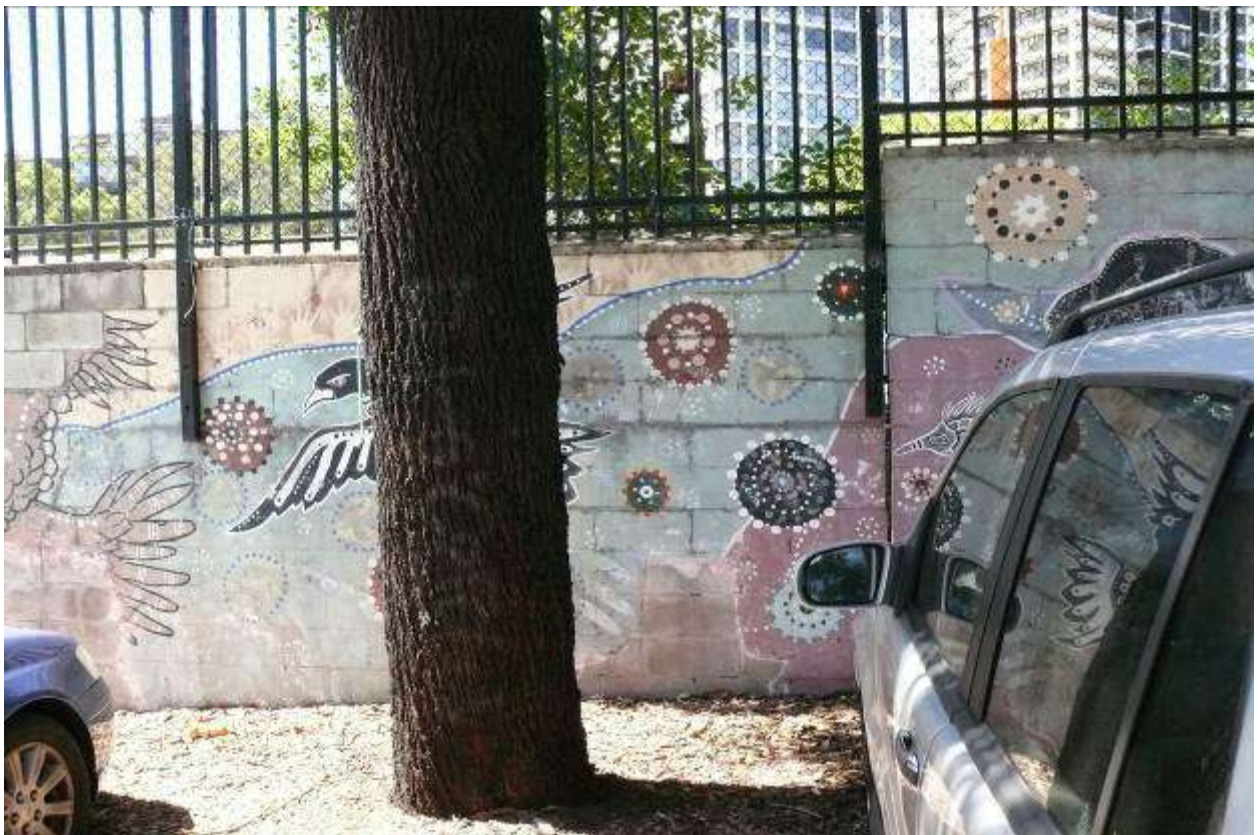
Figure 62 – General condition of RailCorp boundary wall observed from Eveleigh Street

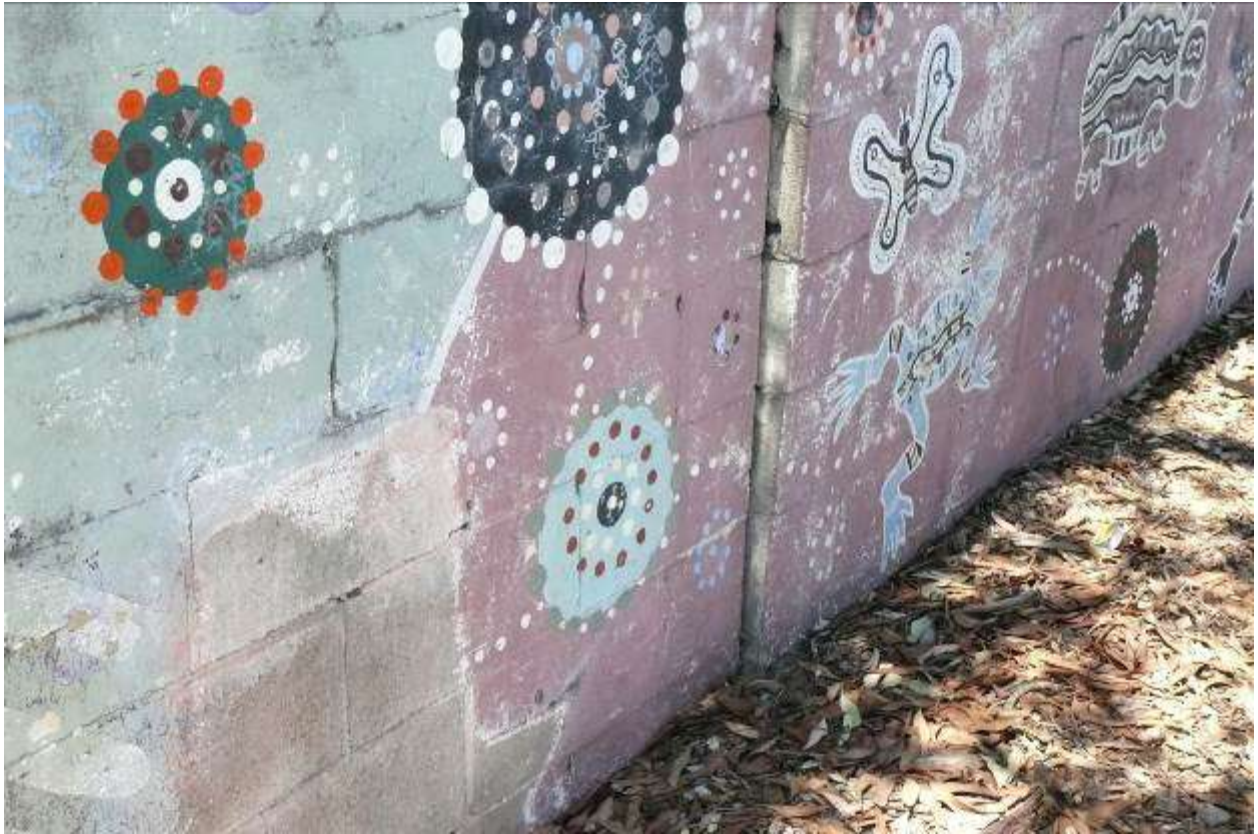
Figure 63 – Crack propagation and separation through boundary wall observed from Eveleigh Street

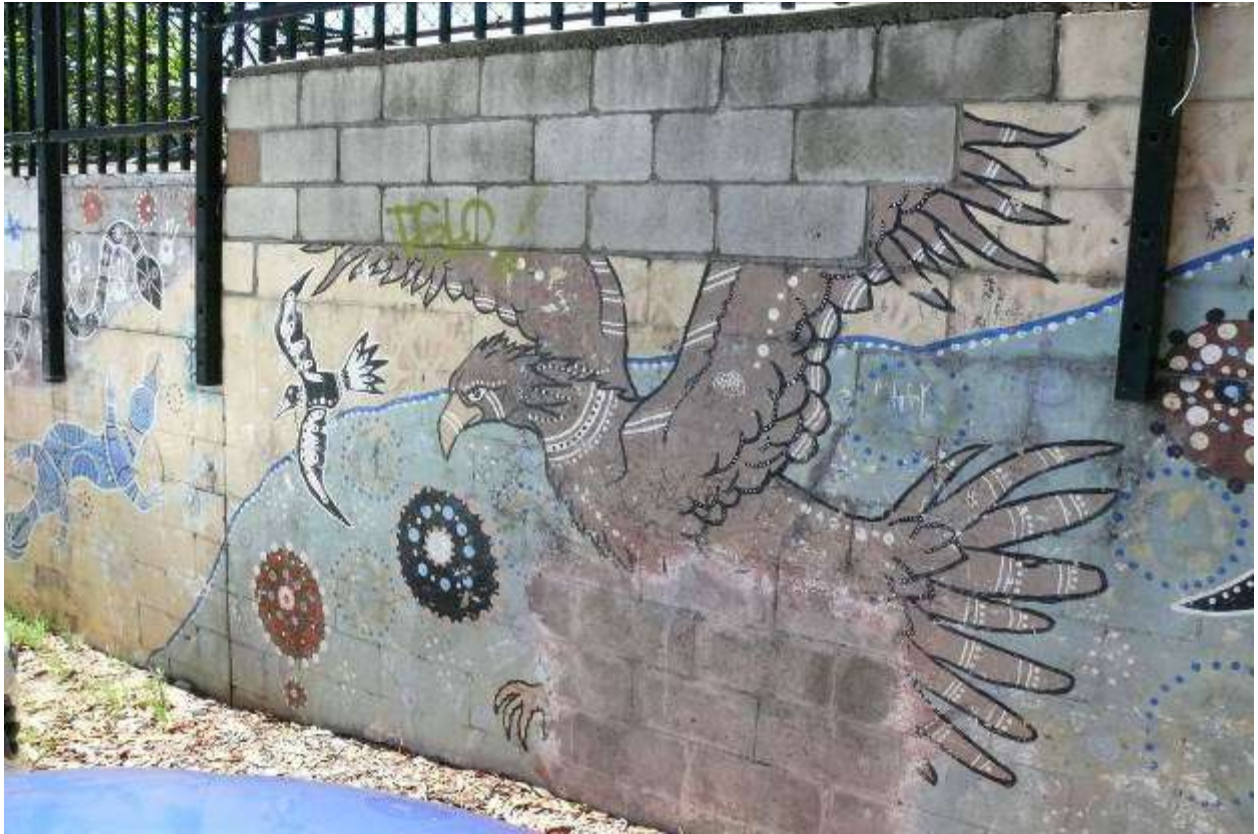
Figure 67 – Crack propagation through boundary wall observed from Eveleigh Street

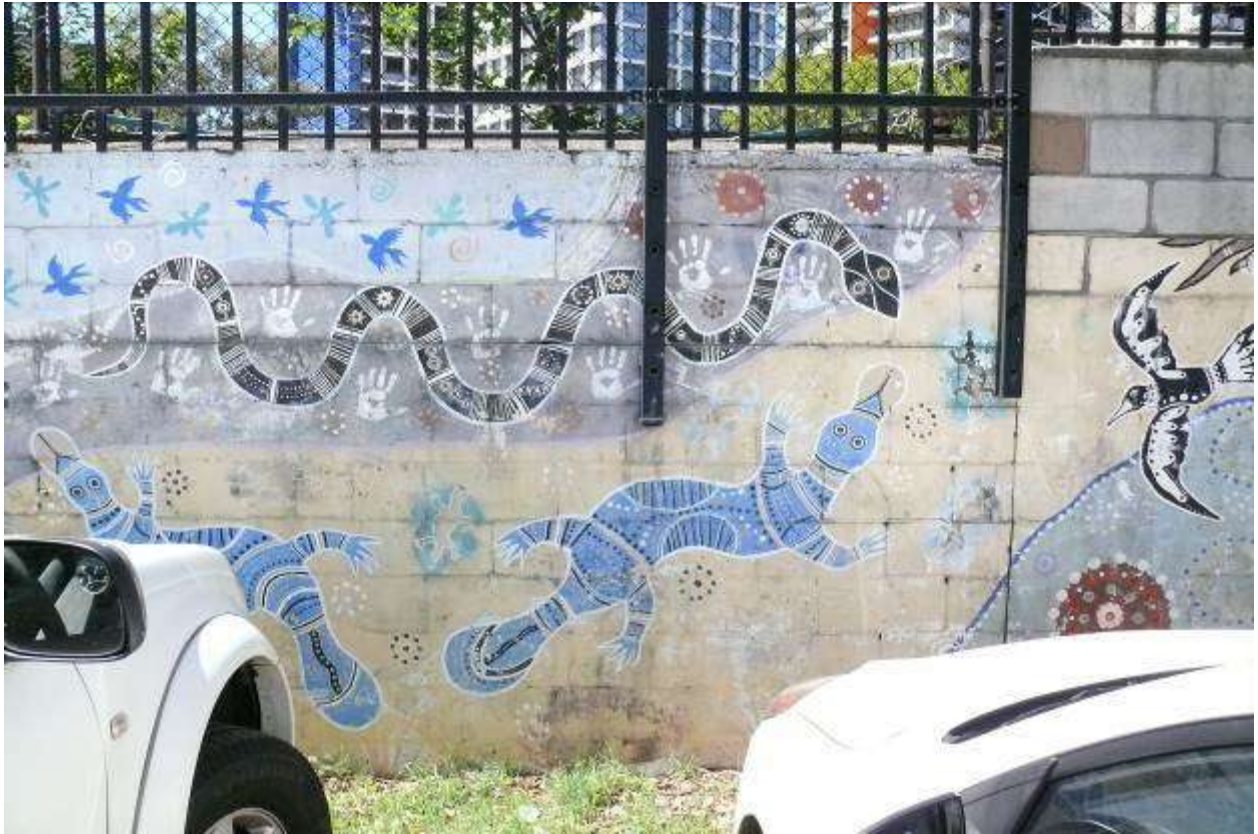
Figure 69 – General condition of RailCorp boundary wall observed from Eveleigh Street

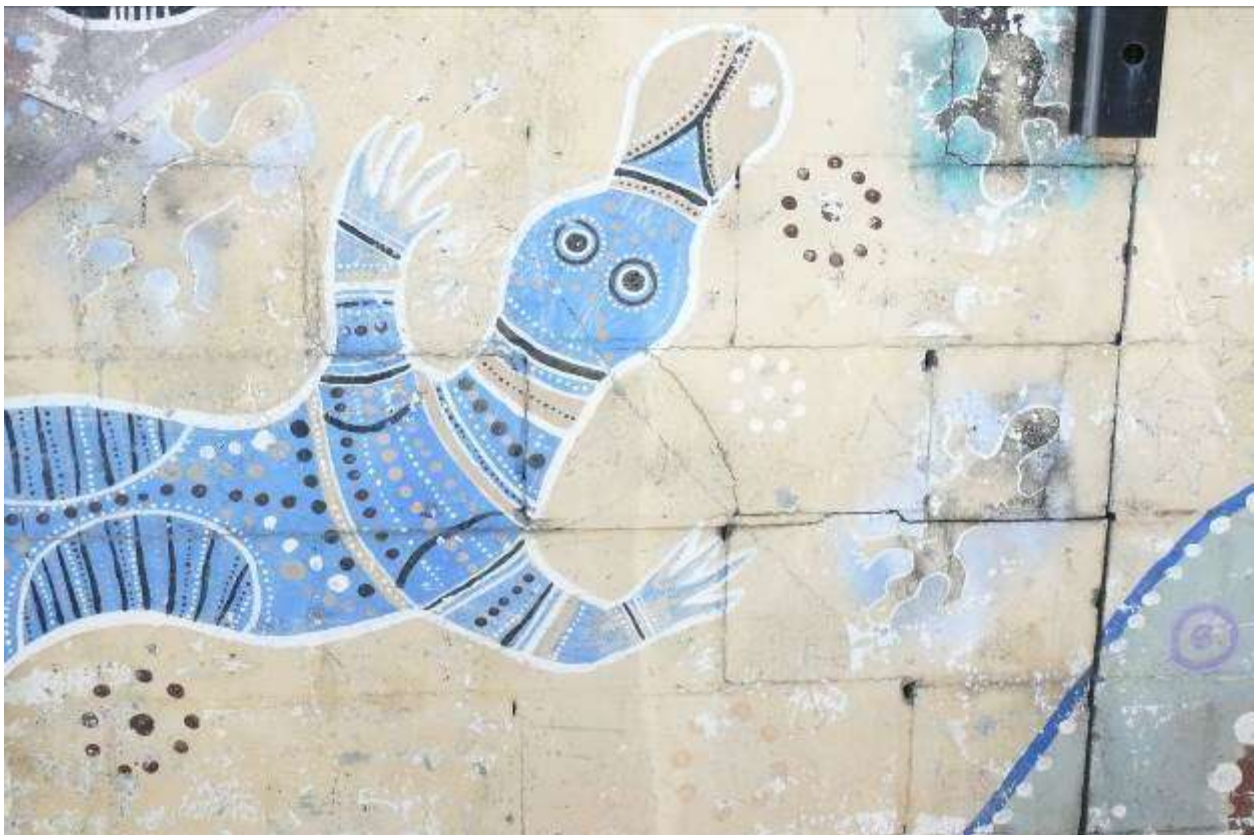
Figure 70 – Crack propagation through boundary wall observed from Eveleigh Street
