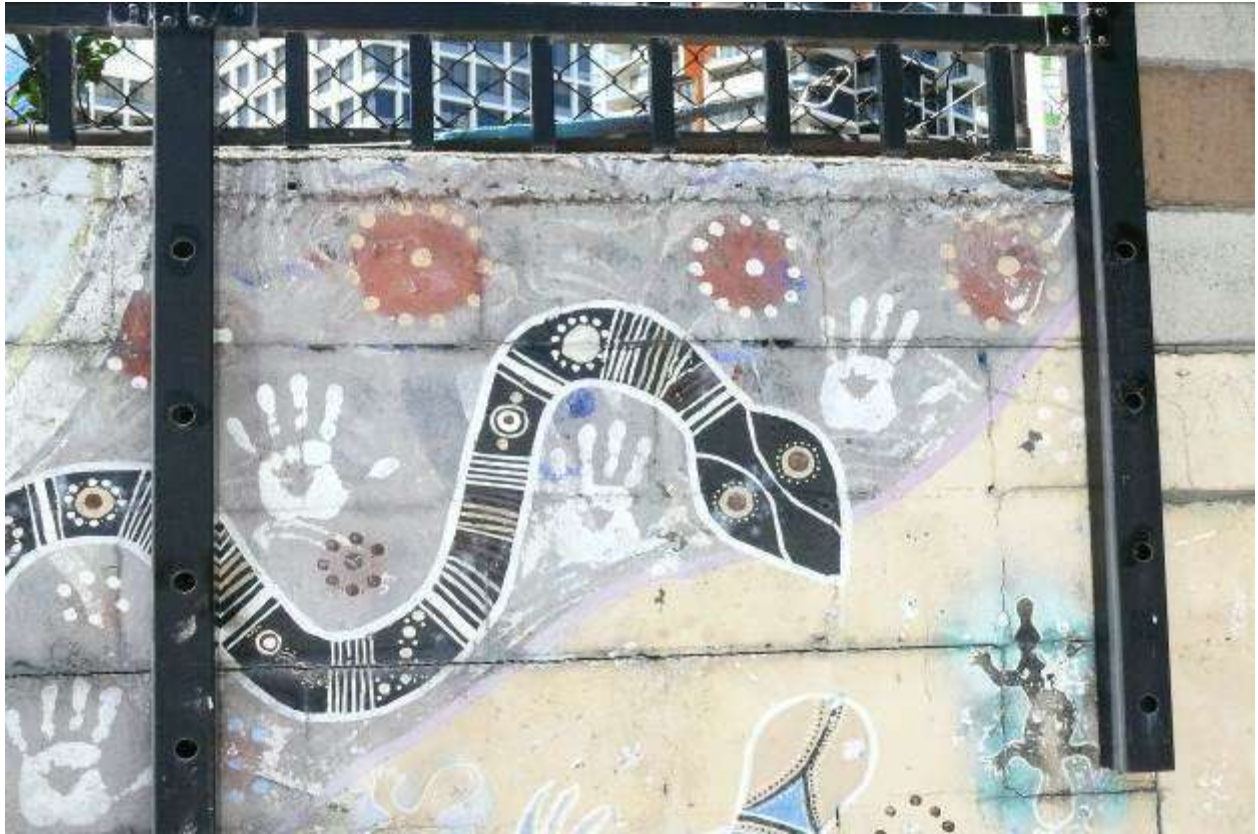
Figure 71 – Crack propagation through boundary wall observed from Eveleigh Street

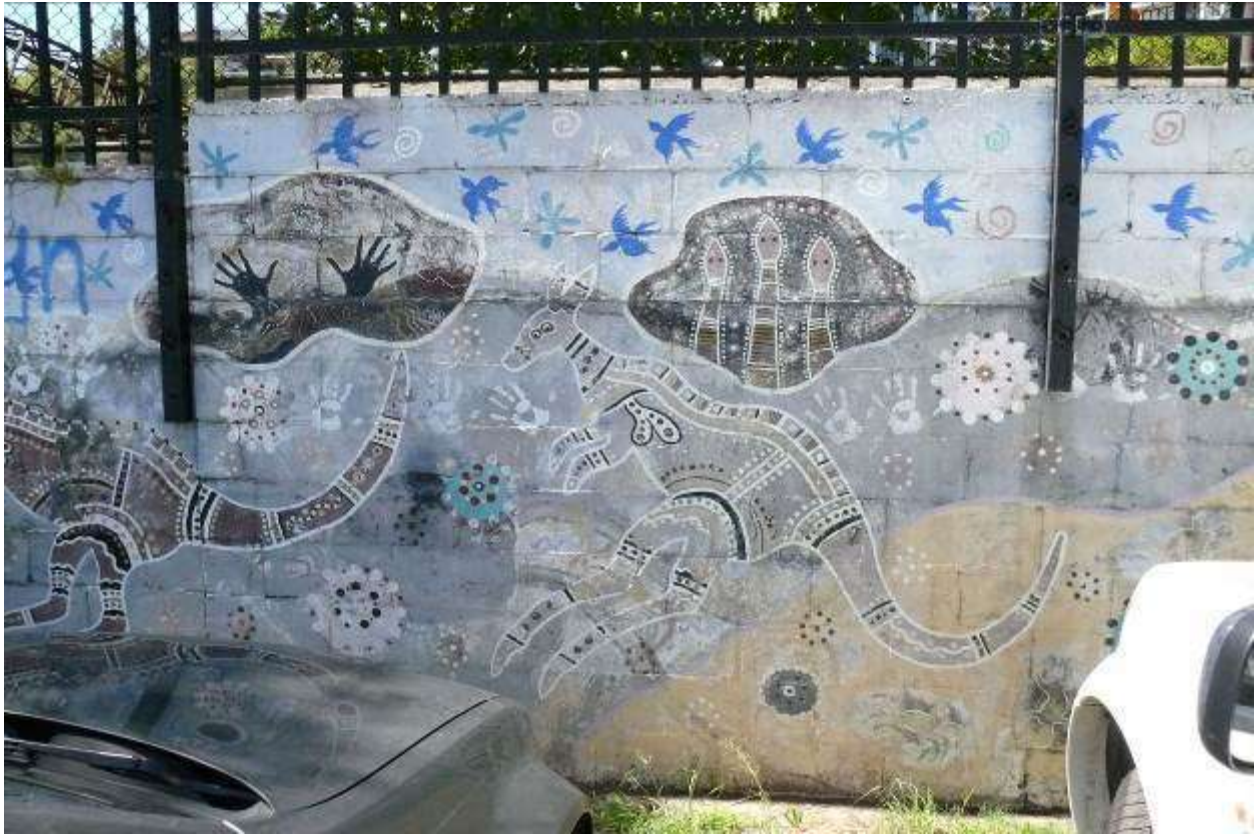
Figure 75 – General condition of RailCorp boundary wall observed from Eveleigh Street

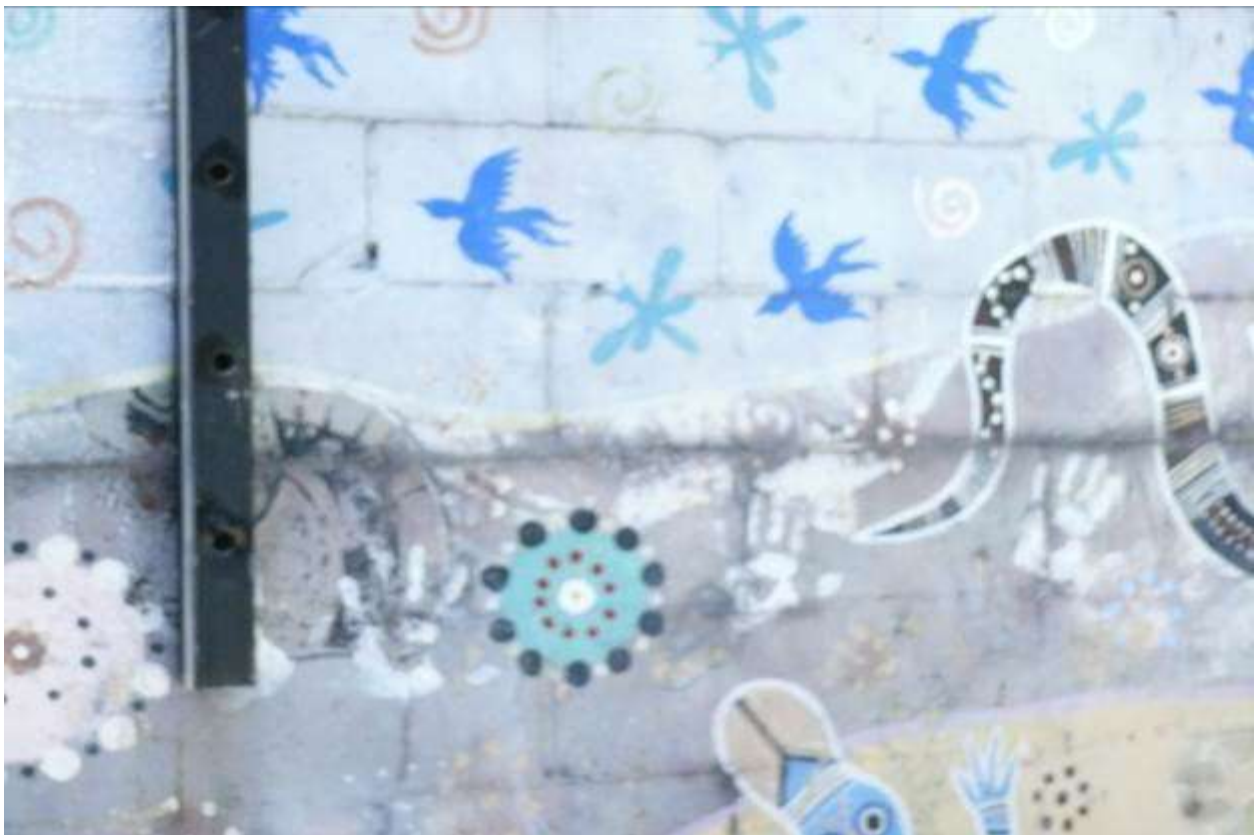
Figure 76 – Crack propagation through boundary wall observed from Eveleigh Street

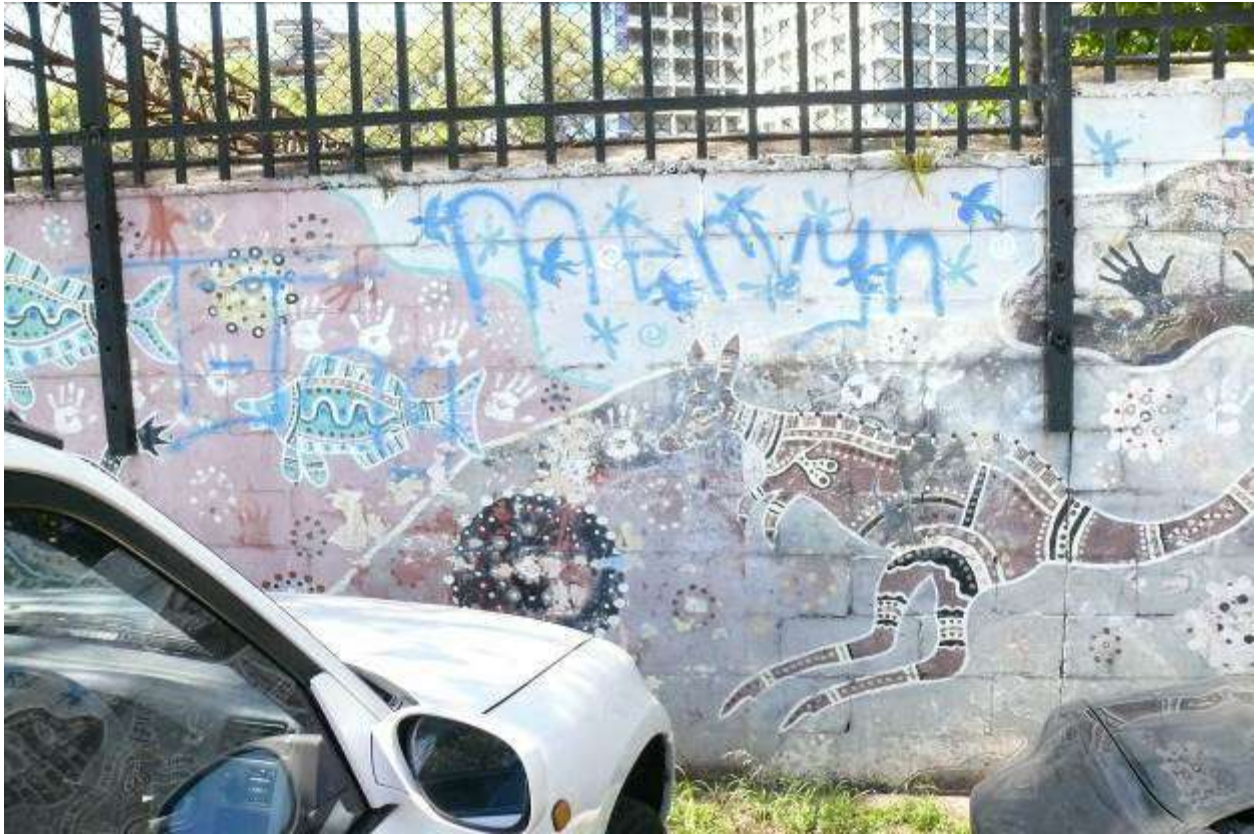
Figure 77 – General condition of RailCorp boundary wall observed from Eveleigh Street

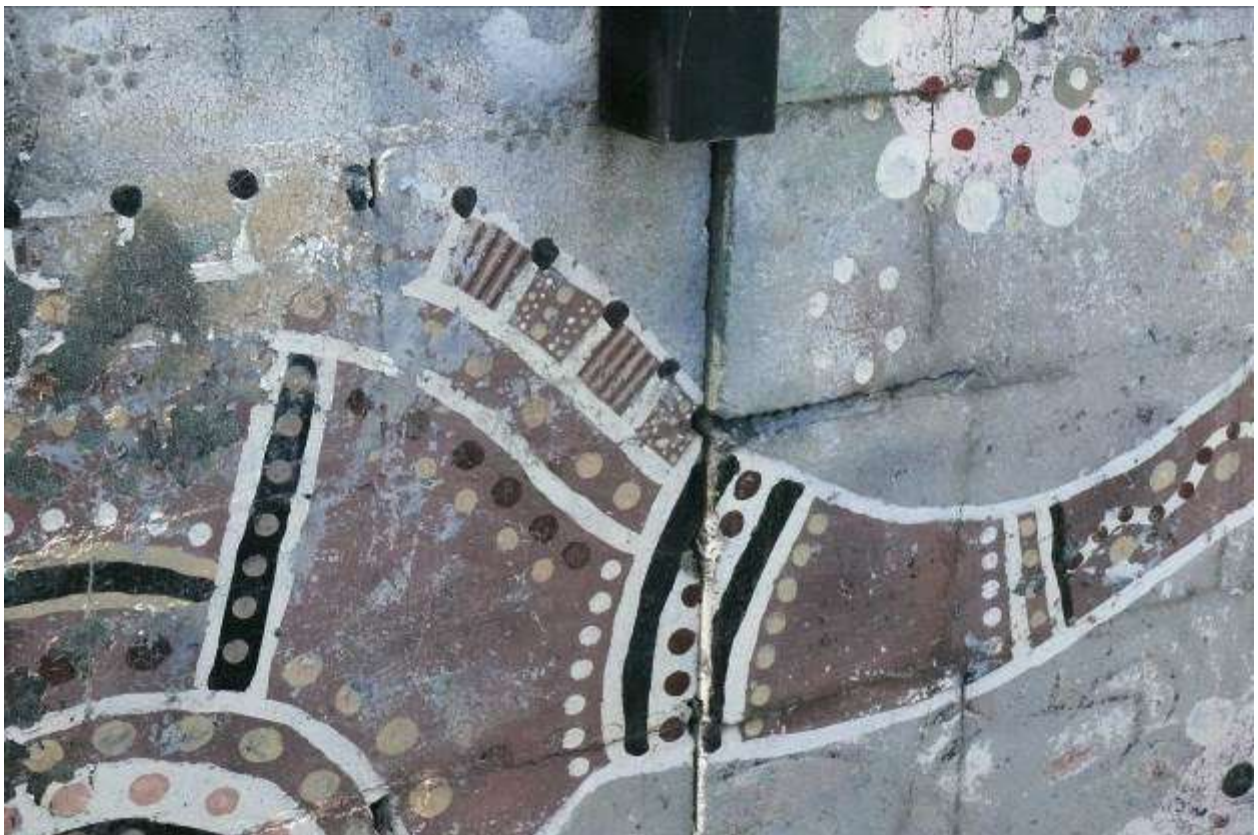
Figure 78 – Crack propagation and separation through boundary wall observed from Eveleigh Street

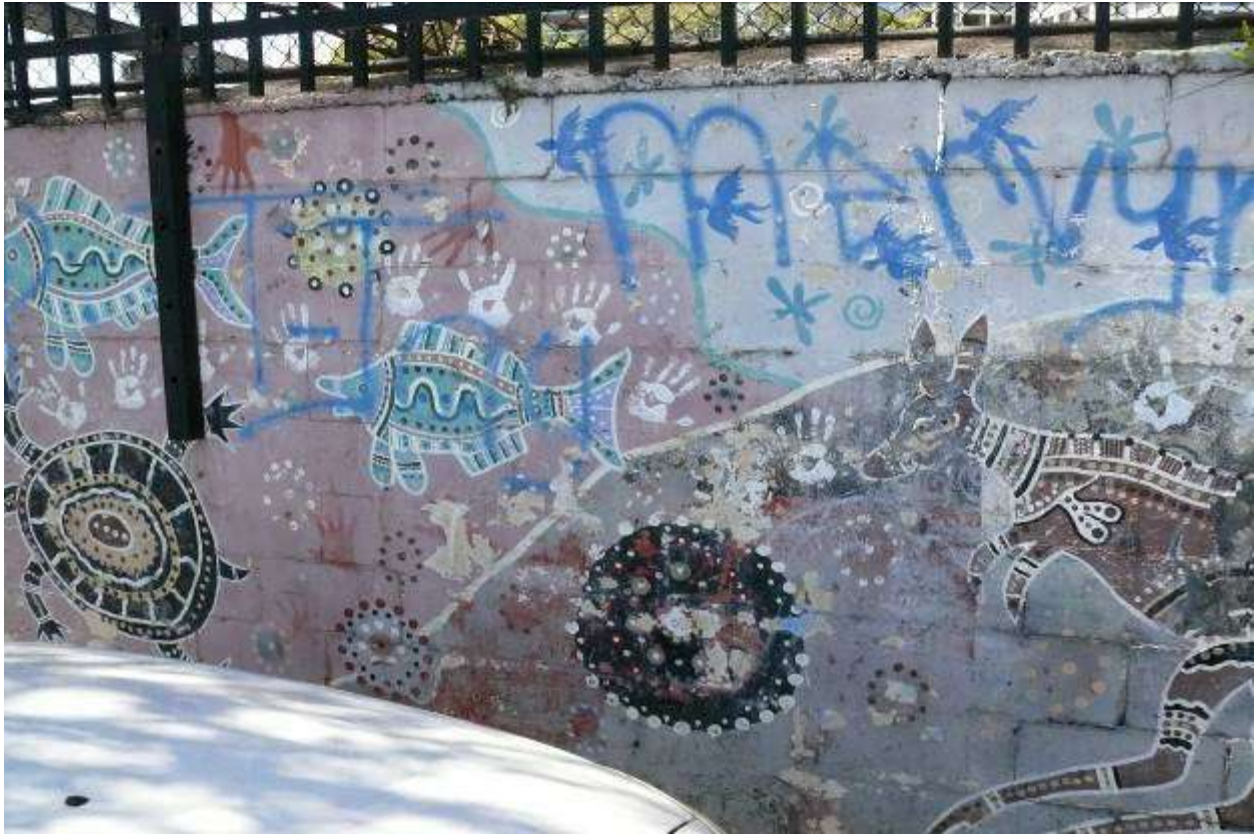
Figure 79 – General condition of RailCorp boundary wall observed from Eveleigh Street

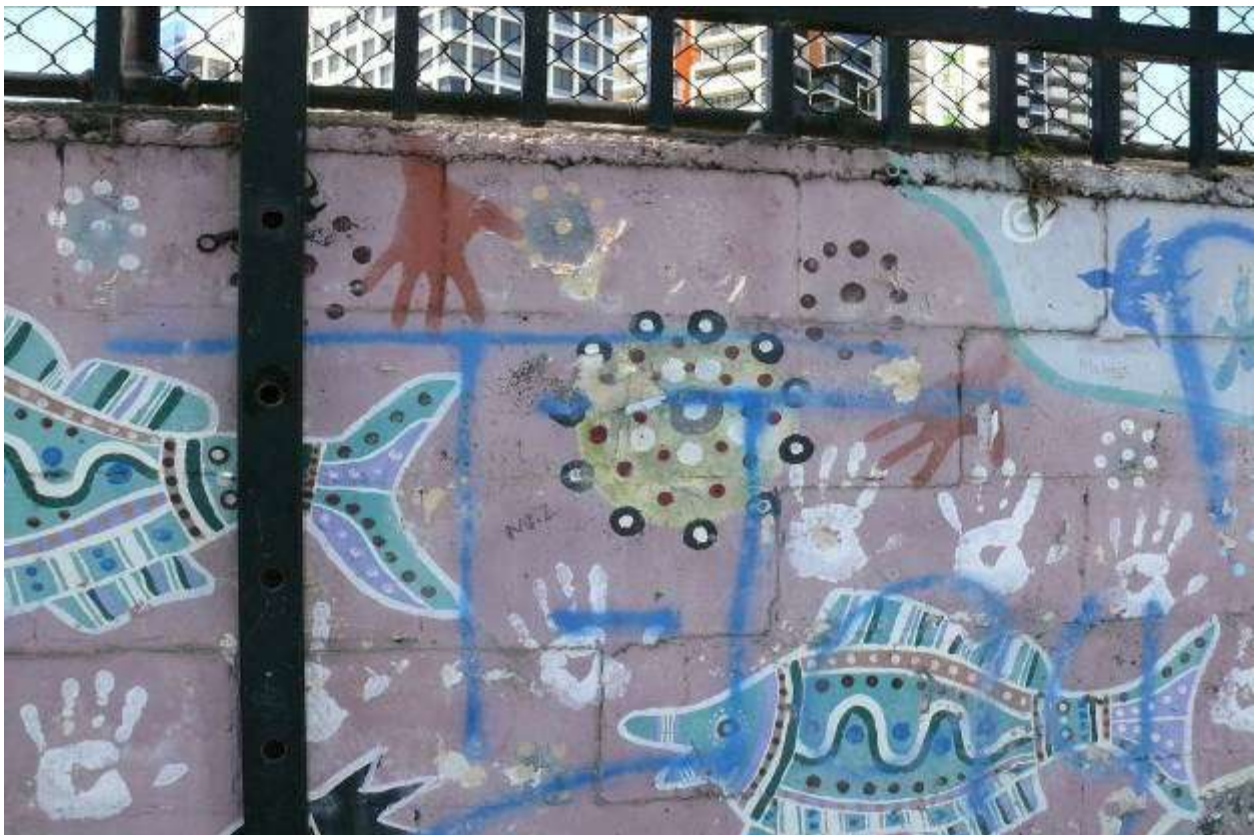
Figure 80 – Crack propagation through boundary wall observed from Eveleigh Street

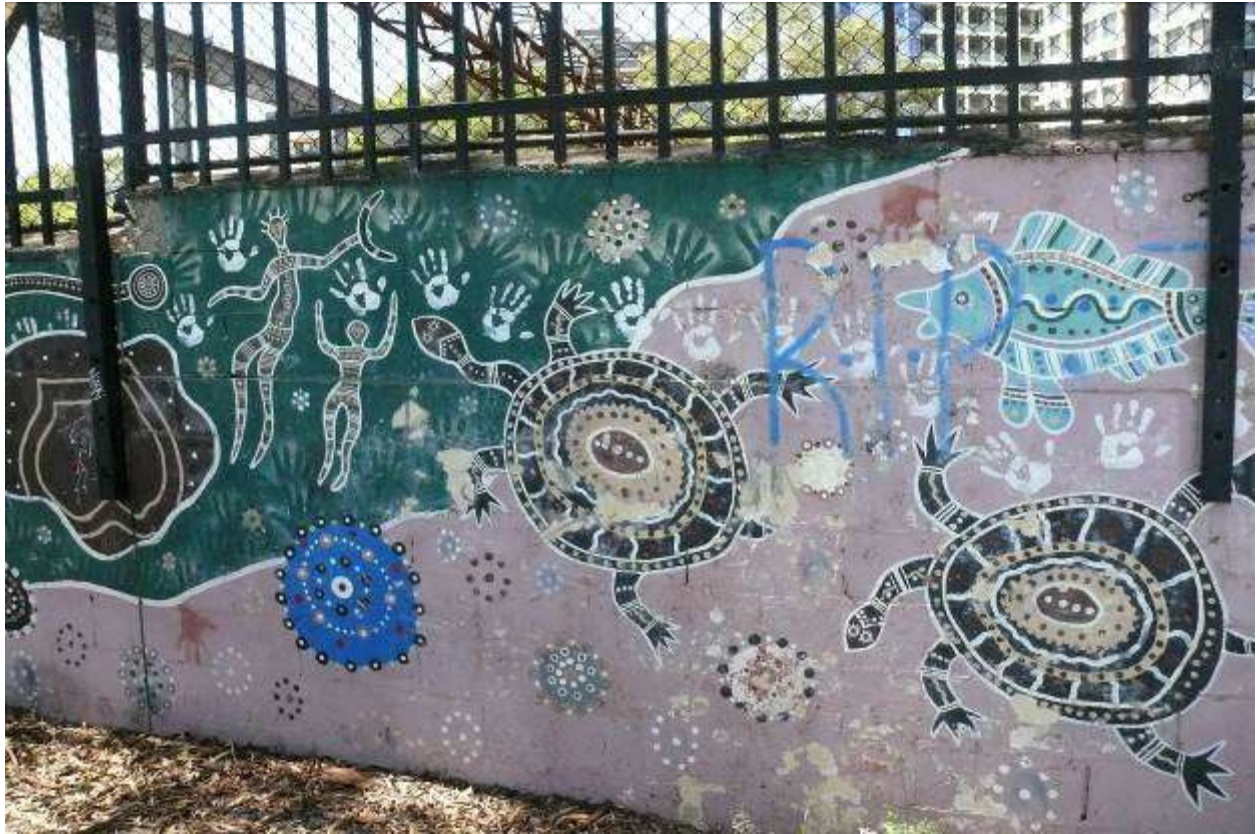
Figure 81 – General condition of RailCorp boundary wall observed from Eveleigh Street

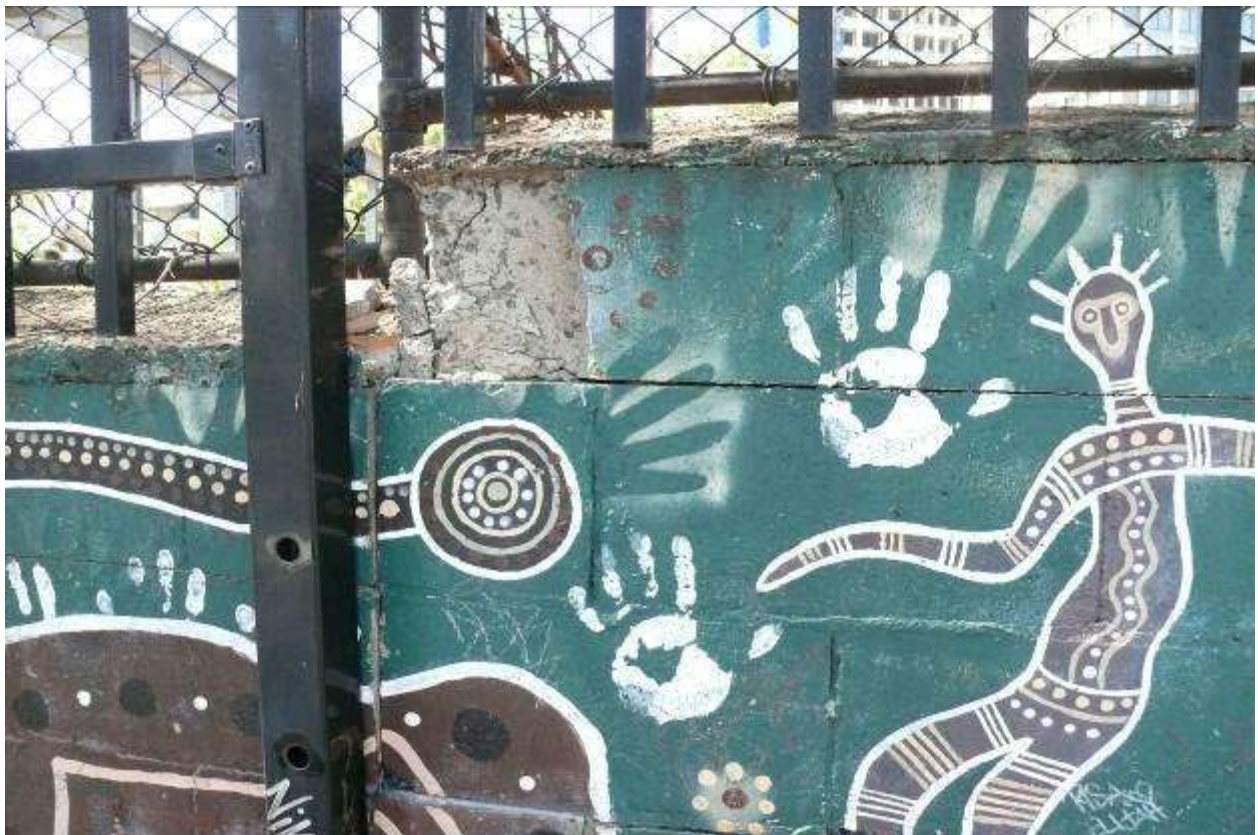
Figure 82 – Crack propagation and loss of material through boundary wall observed from Eveleigh Street

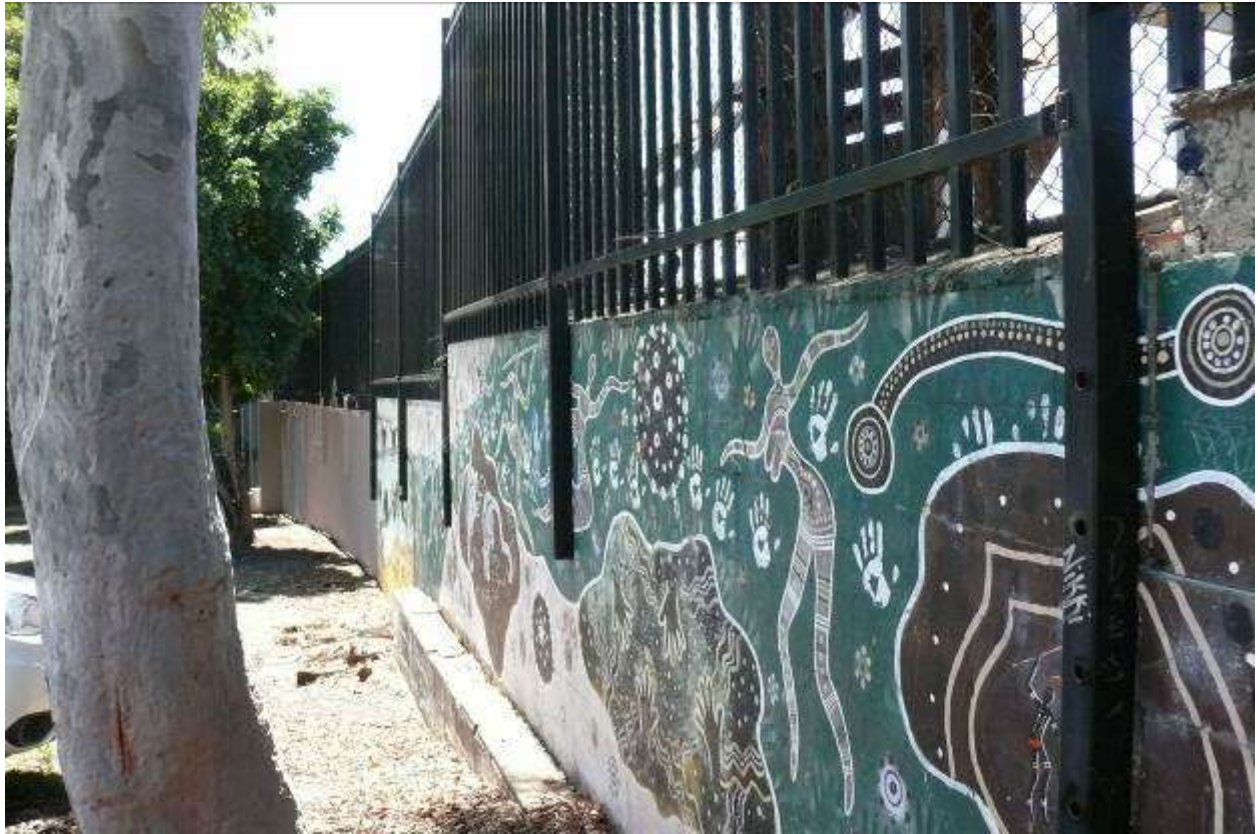
Figure 83 – General condition of RailCorp boundary wall observed from Eveleigh Street

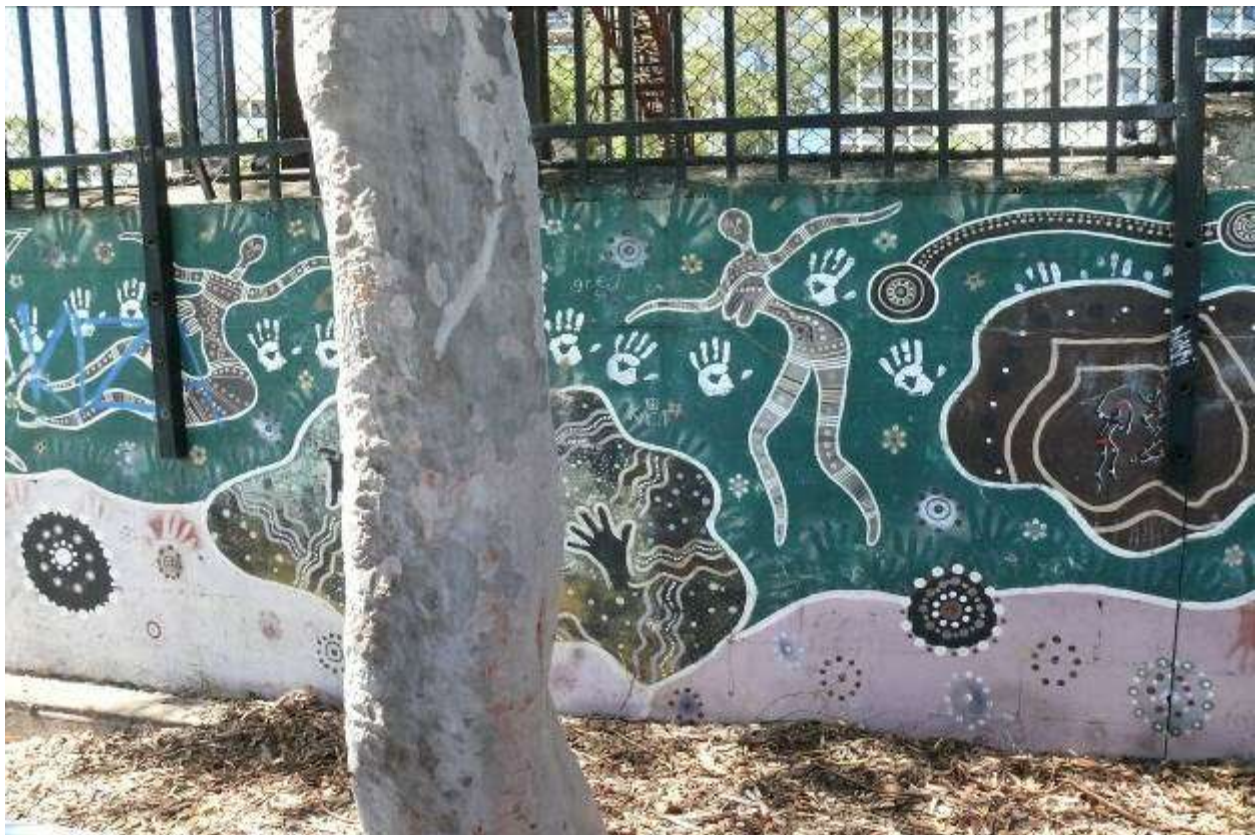
Figure 84 – General condition of RailCorp boundary wall observed from Eveleigh Street

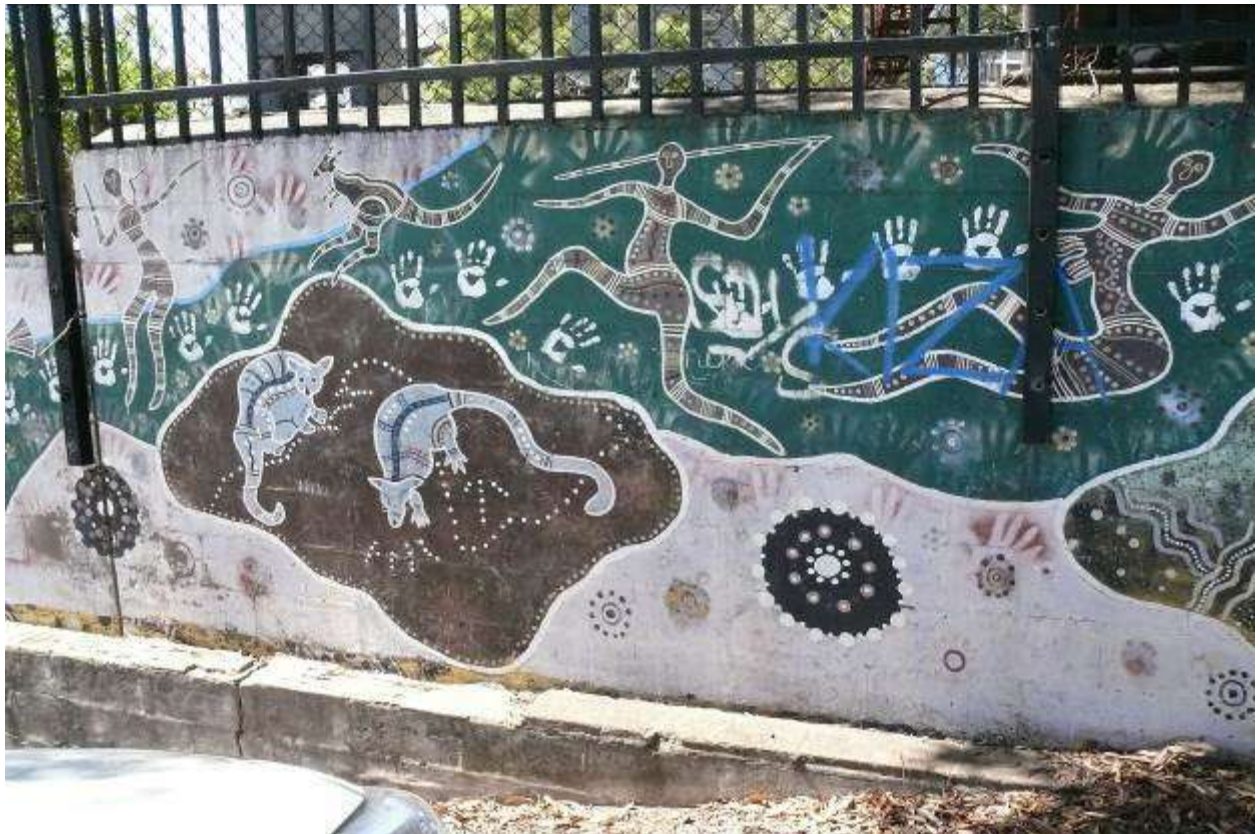
Figure 85 – General condition of RailCorp boundary wall observed from Eveleigh Street

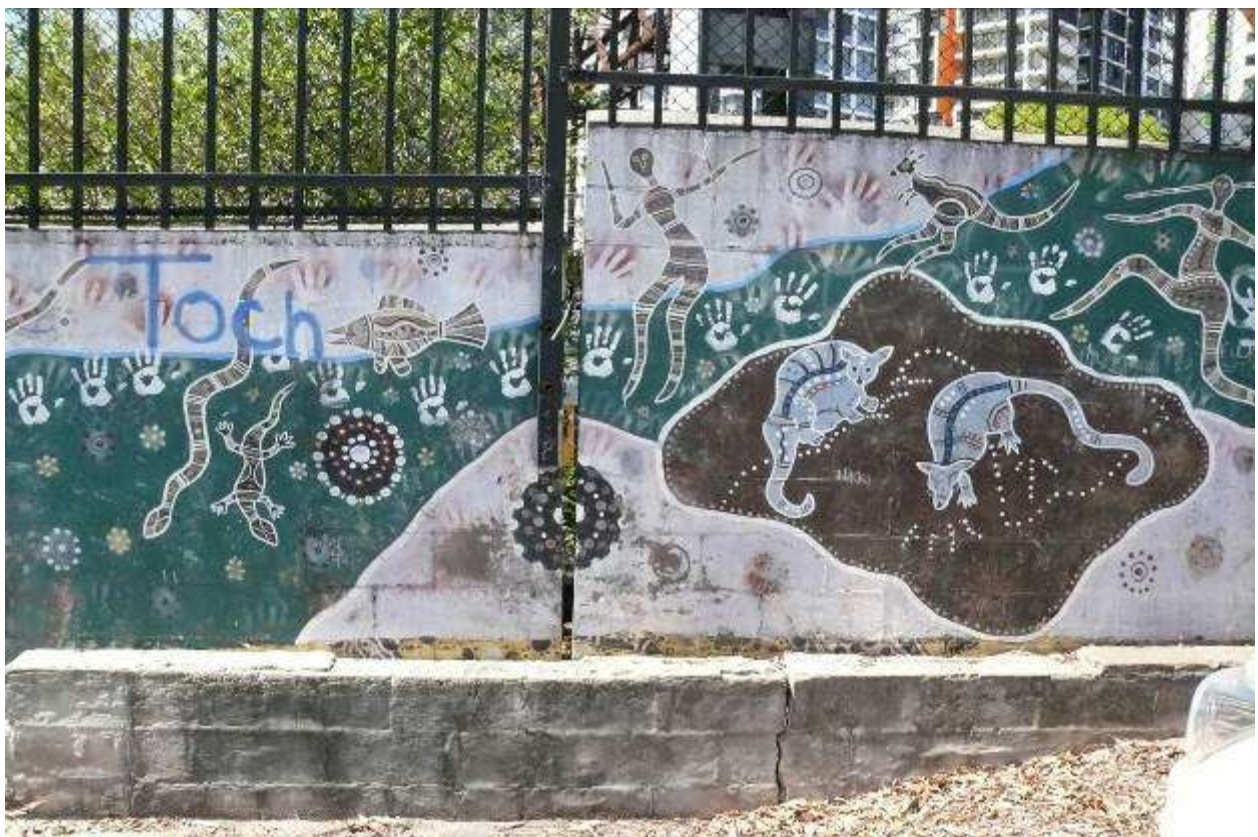
Figure 86 – General condition of RailCorp boundary wall observed from Eveleigh Street

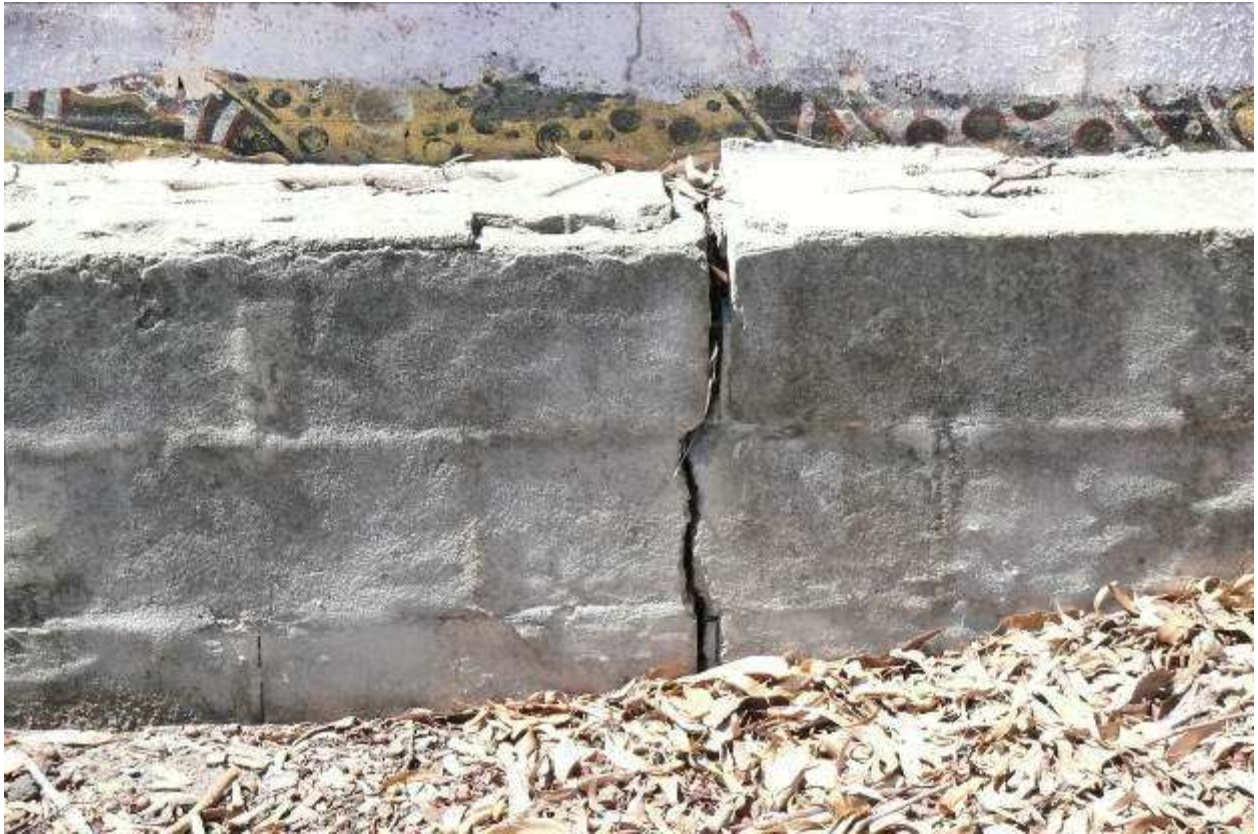
Figure 87 – Crack propagation and separation through boundary wall observed from Eveleigh Street

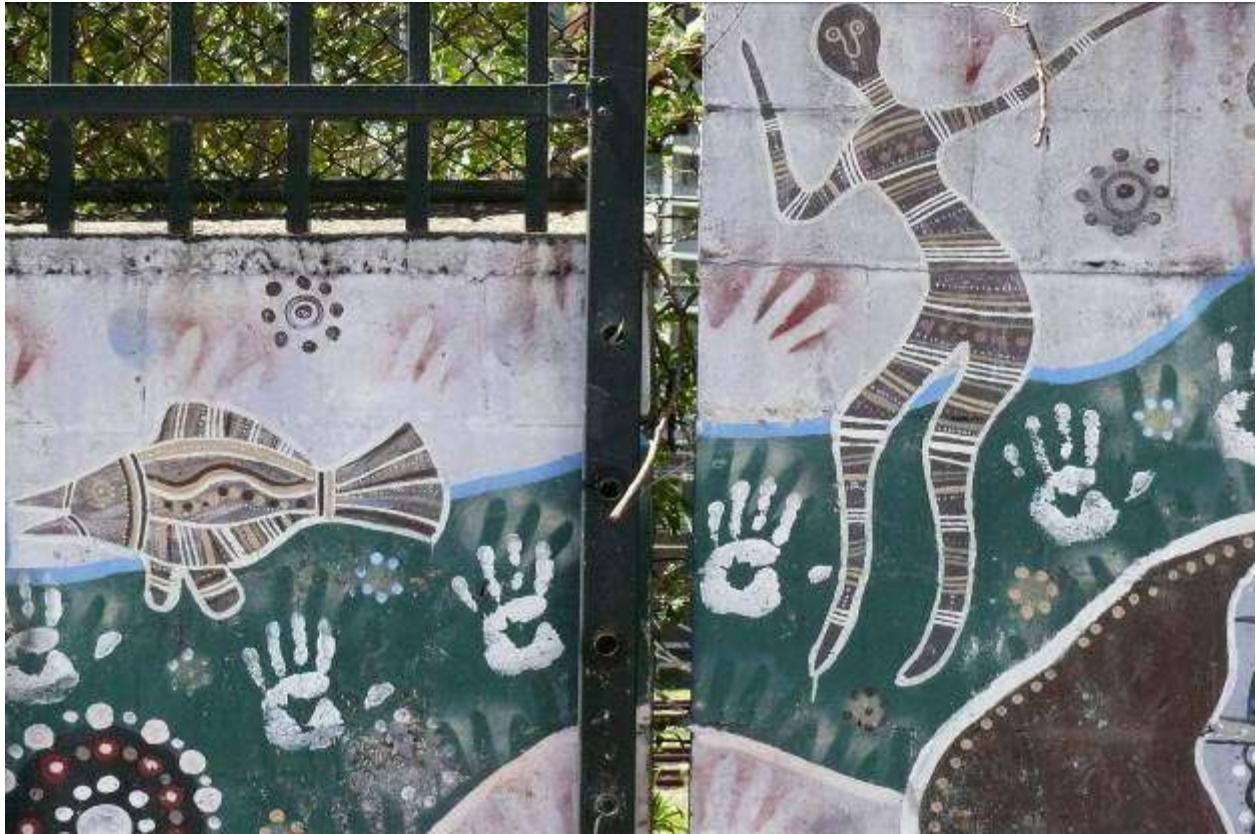
Figure 89 – Crack propagation and separation through boundary wall observed from Eveleigh Street

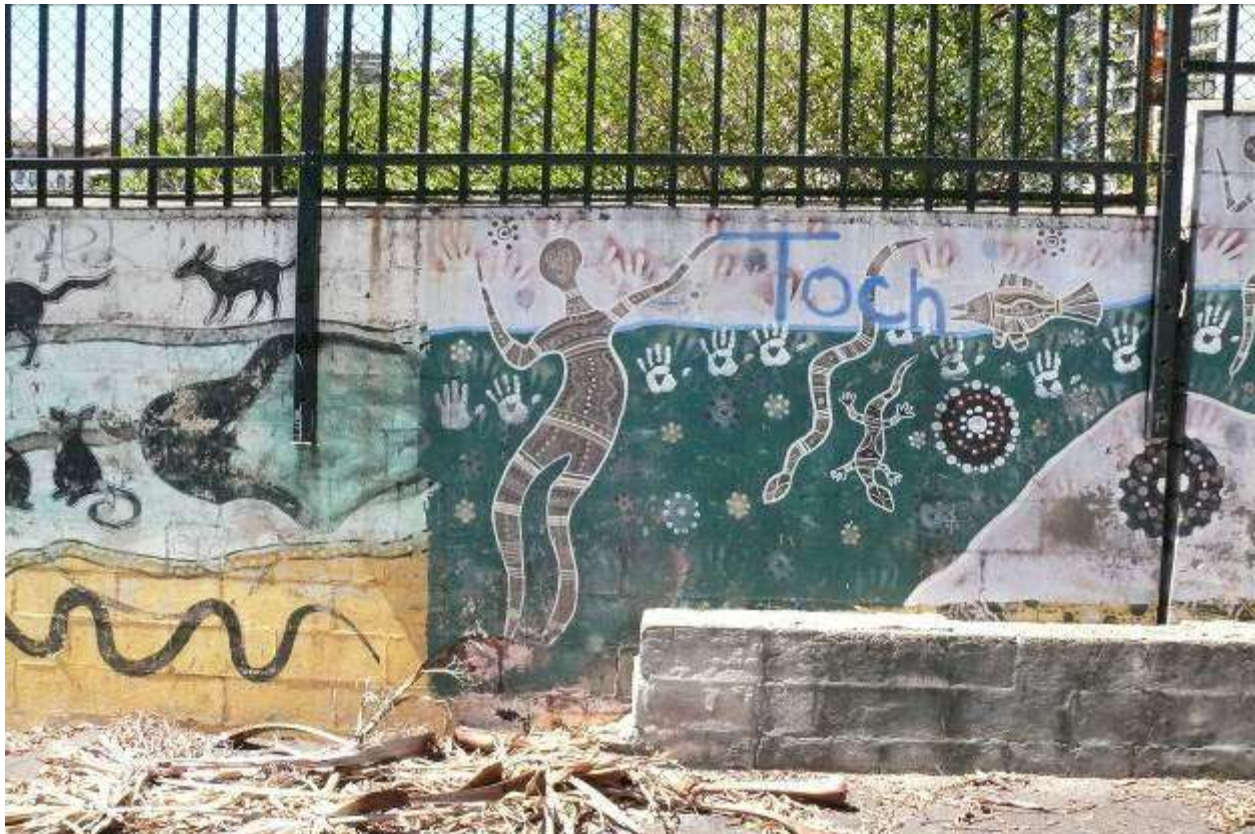
Figure 91 – General condition of RailCorp boundary wall observed from Eveleigh Street

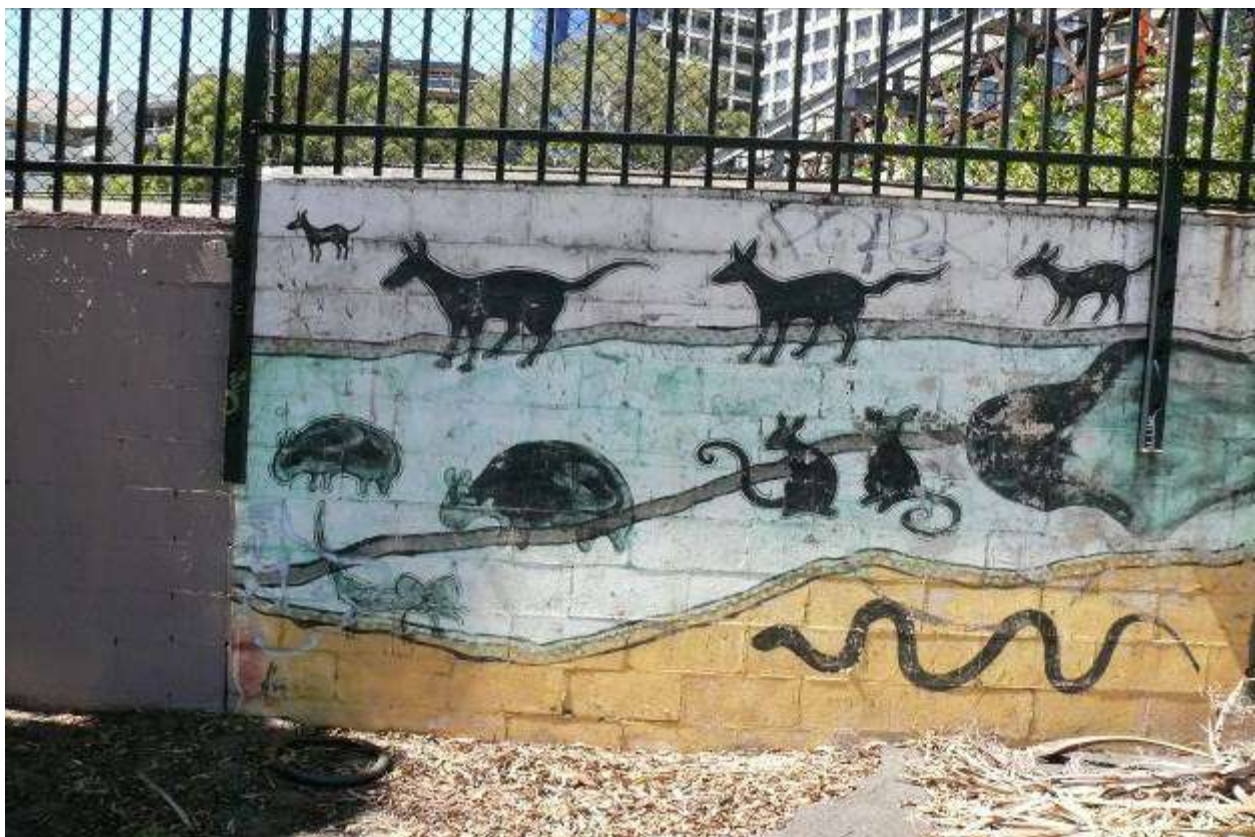
Figure 92 – General condition of RailCorp boundary wall observed from Eveleigh Street

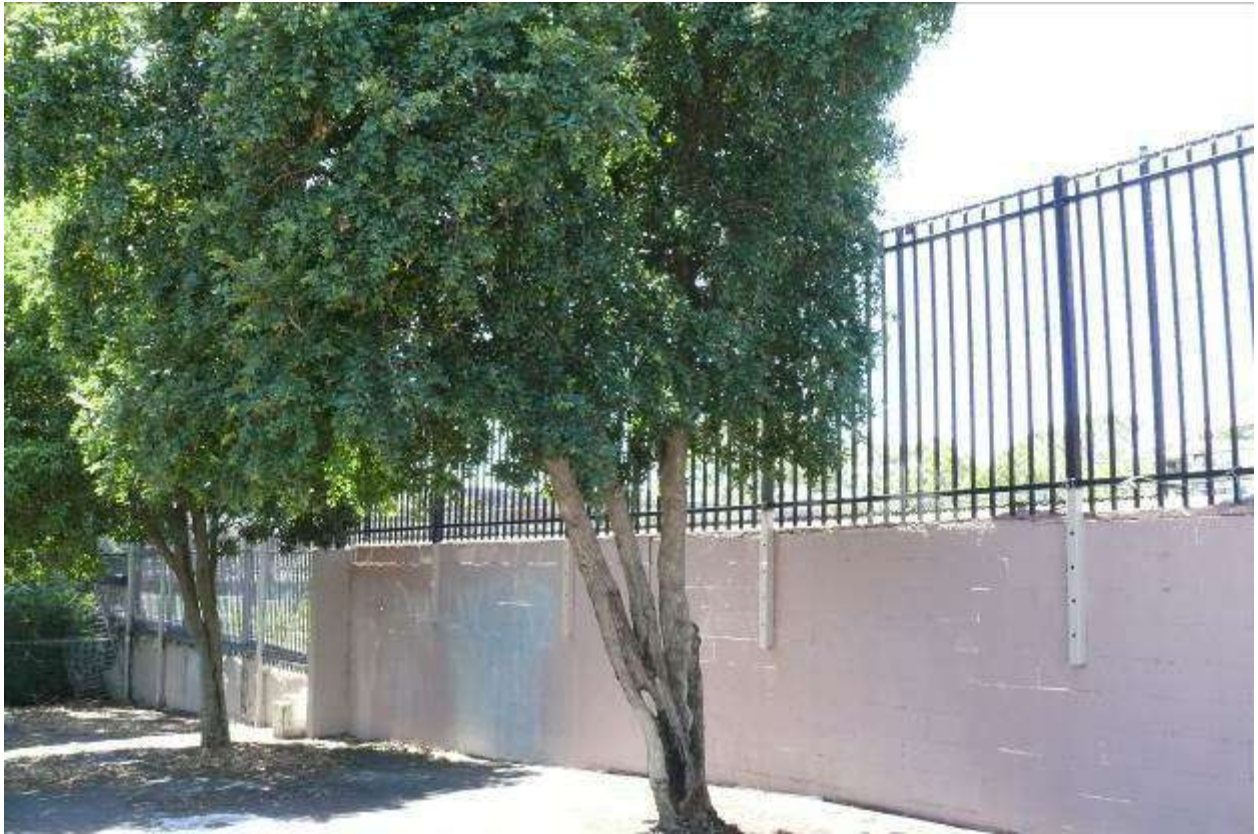
Figure 93 – General condition of RailCorp boundary wall observed from Eveleigh Street

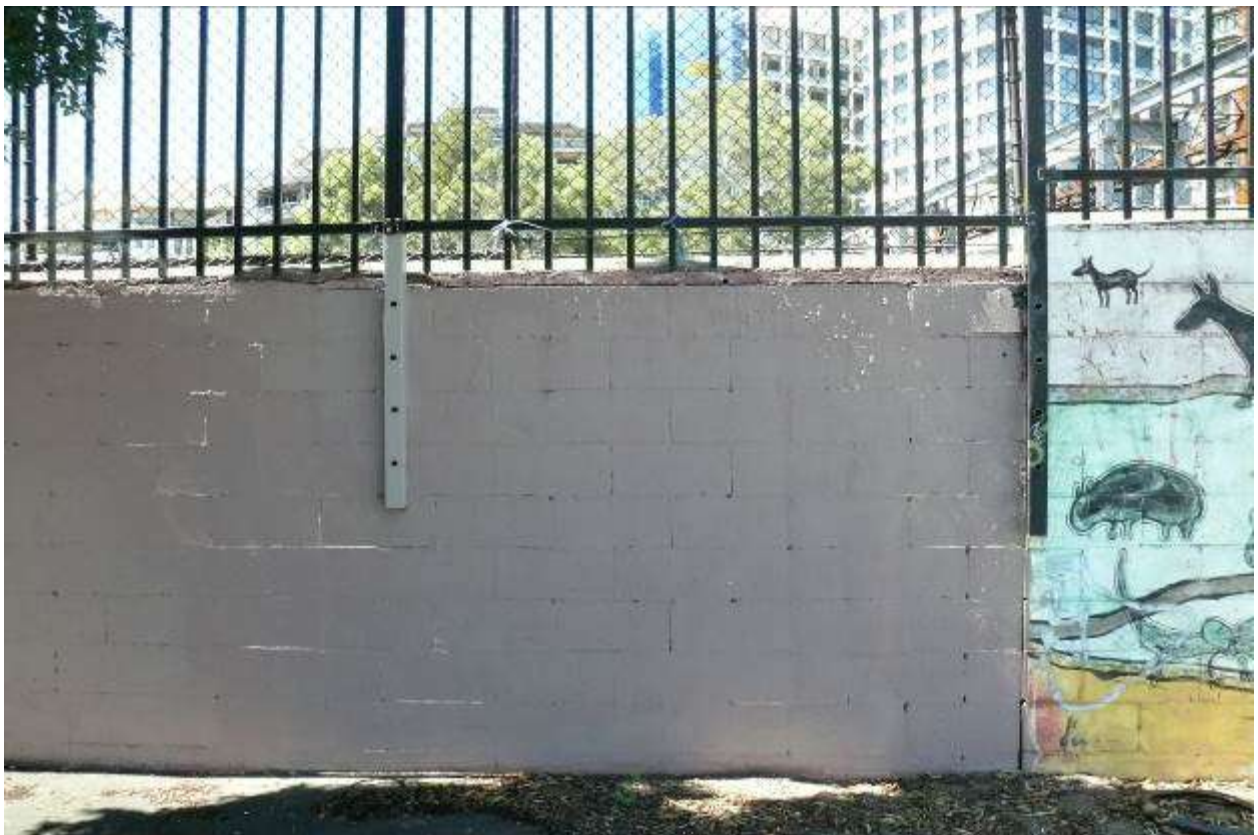
Figure 94 – General condition of RailCorp boundary wall observed from Eveleigh Street

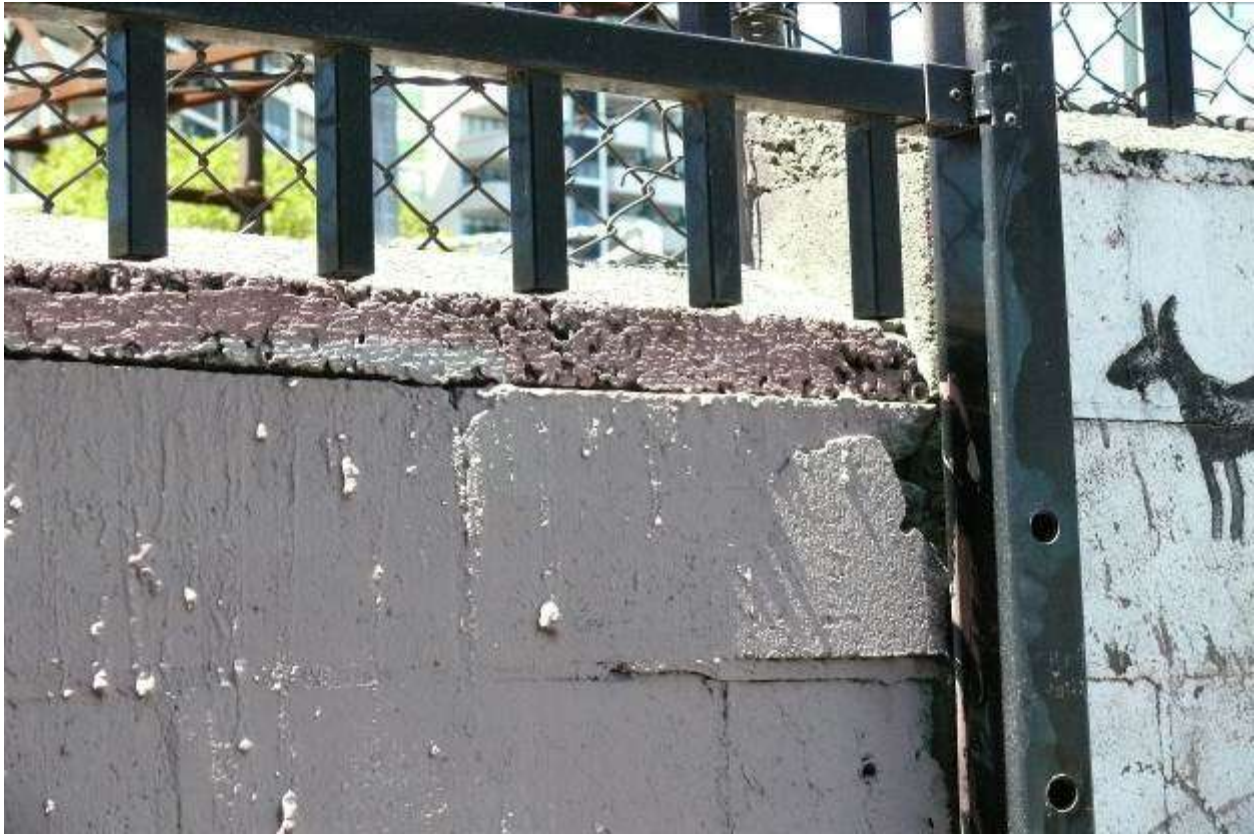
Figure 95 – Crack propagation and loss of material through boundary wall observed from Eveleigh Street

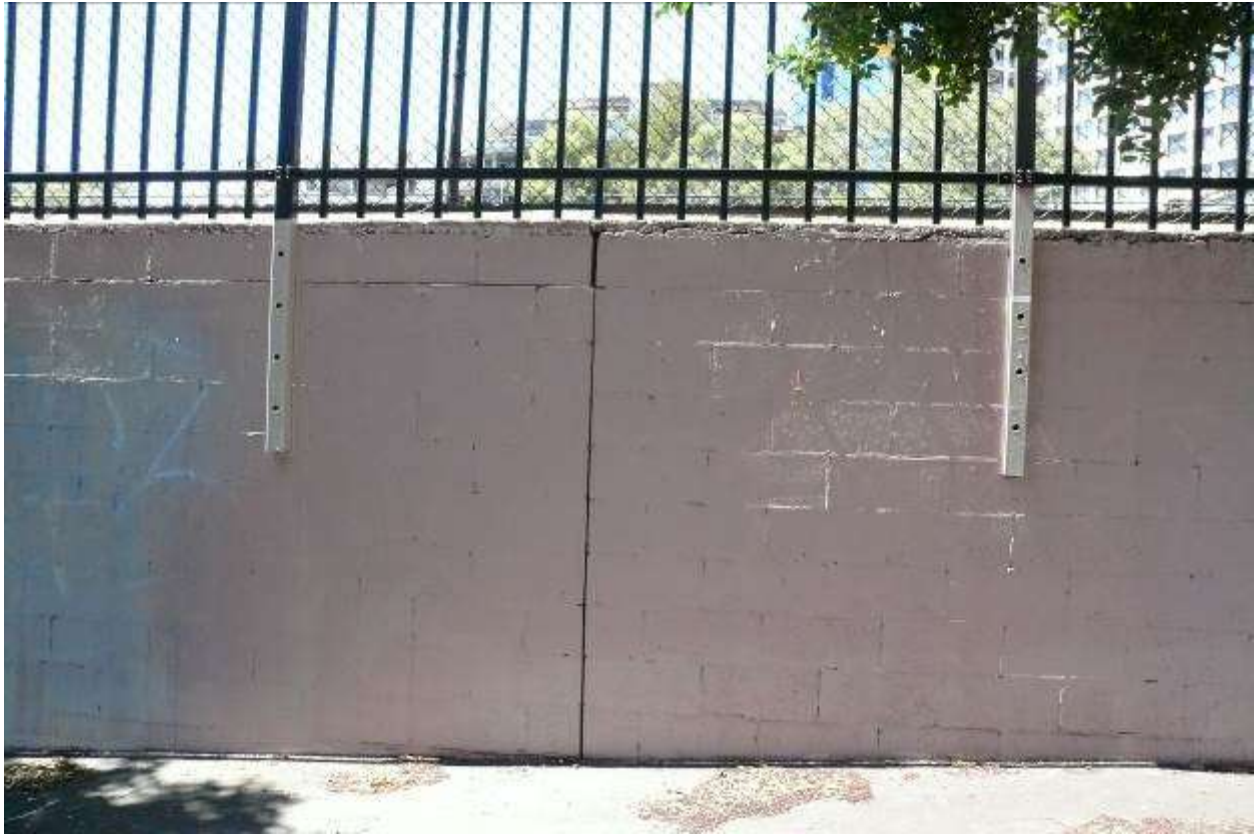
Figure 97 – General condition of RailCorp boundary wall observed from Eveleigh Street
