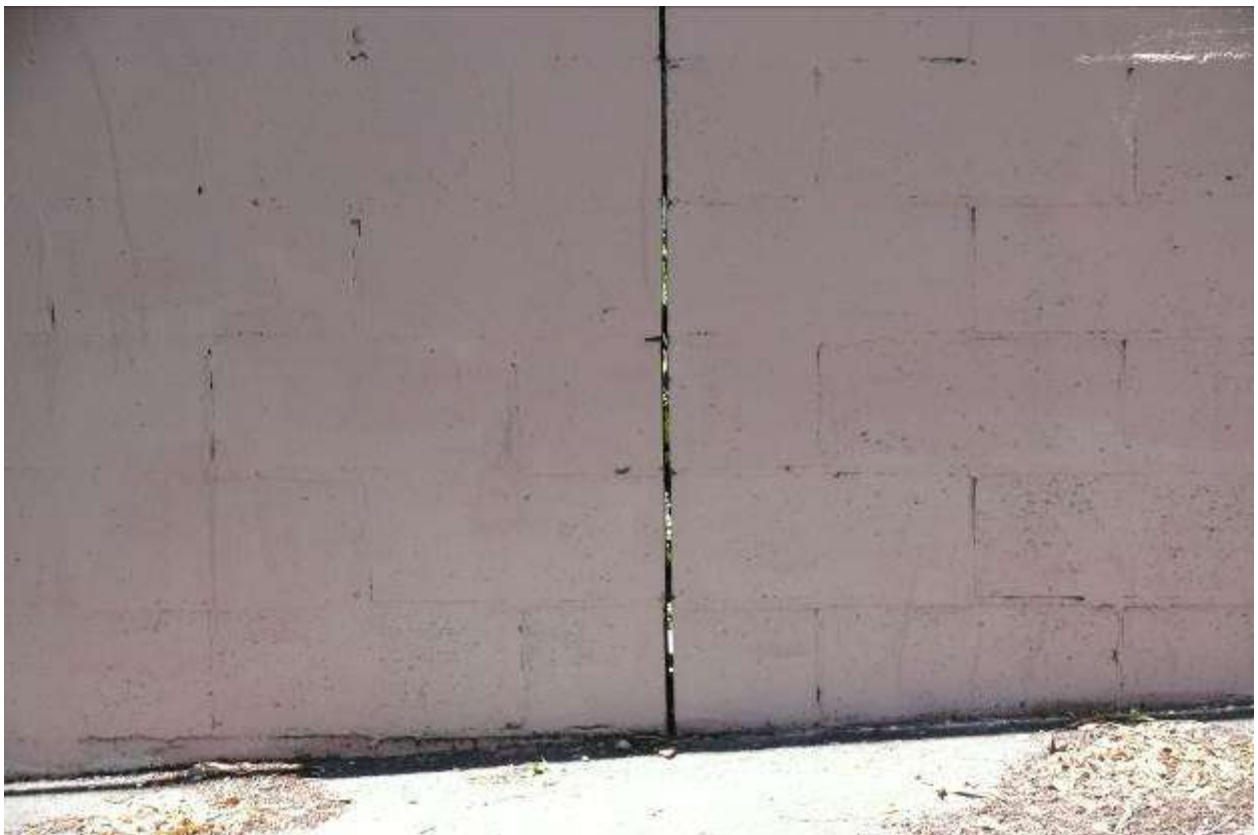
Figure 98 – Crack propagation and separation through boundary wall observed from Eveleigh Street

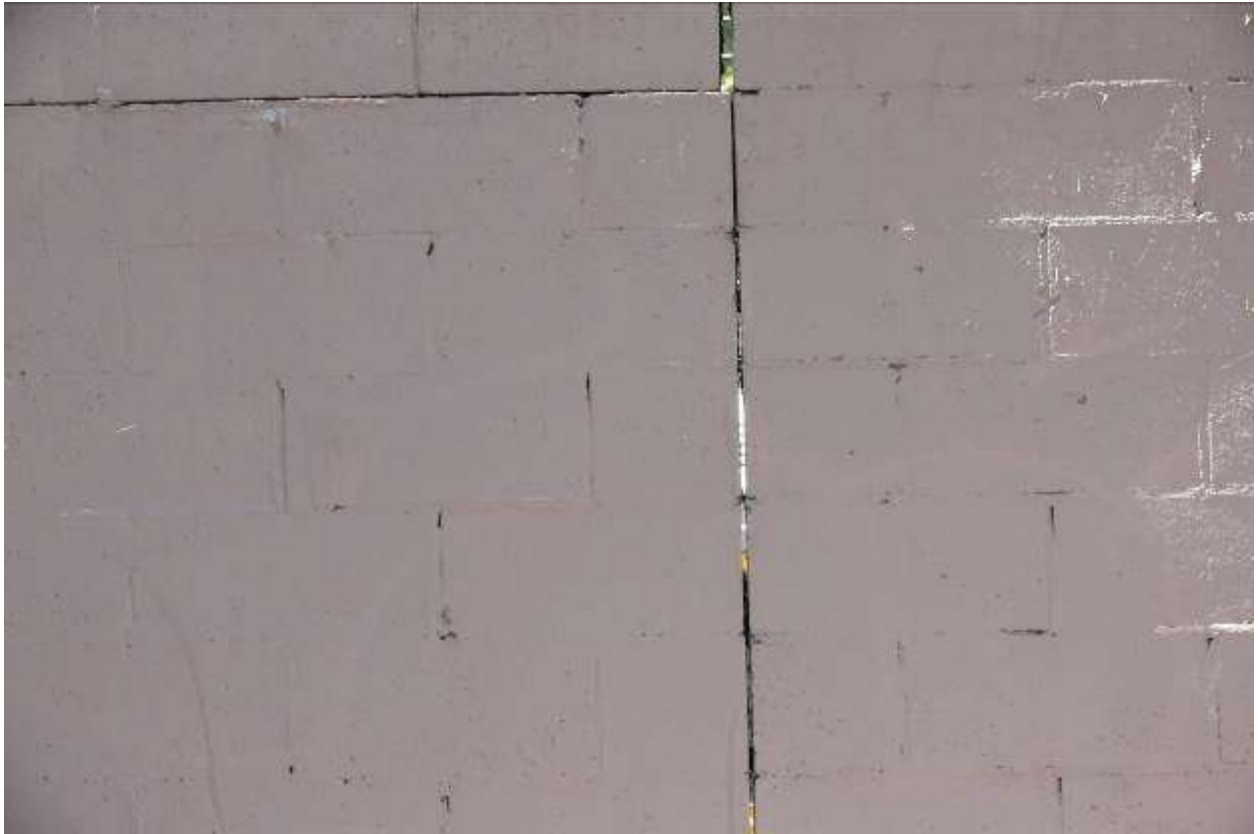
Figure 99 – Crack propagation and separation through boundary wall observed from Eveleigh Street

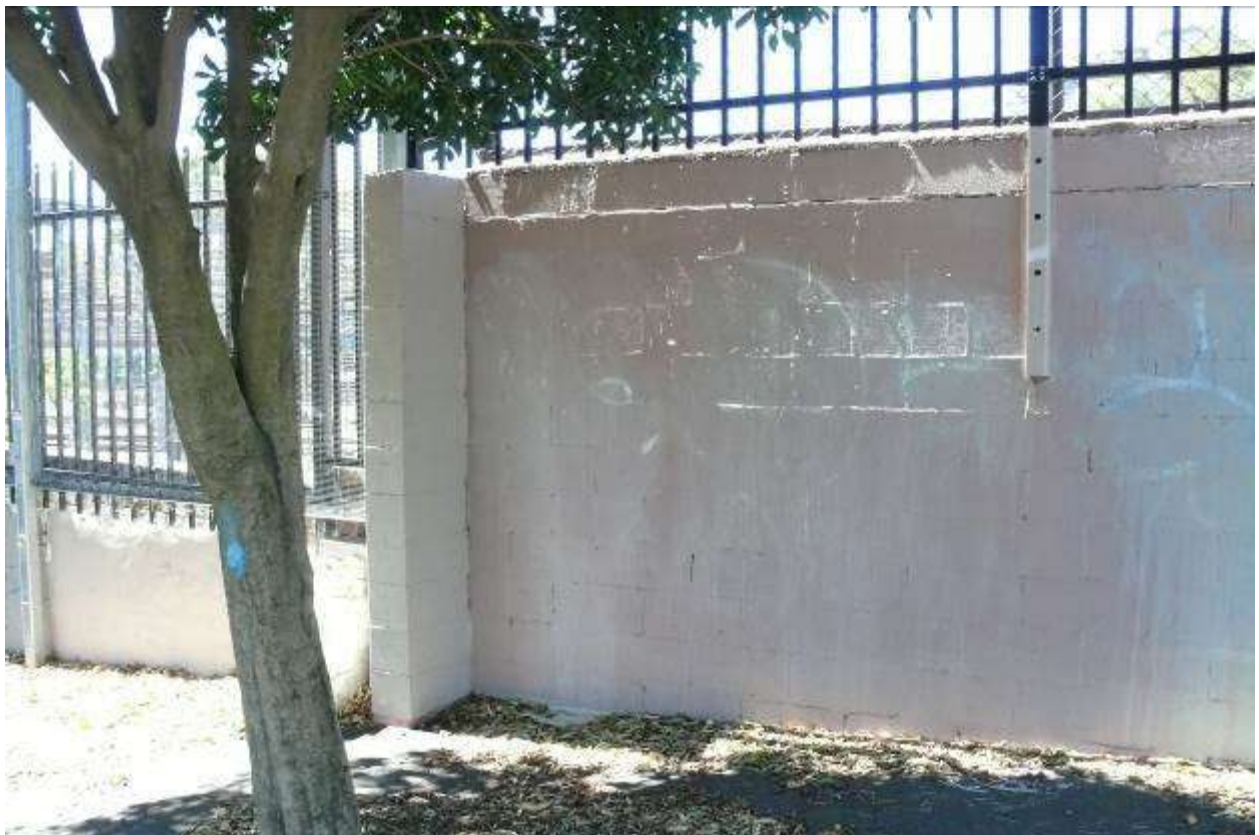
Figure 102 – General condition of RailCorp boundary wall observed from Eveleigh Street

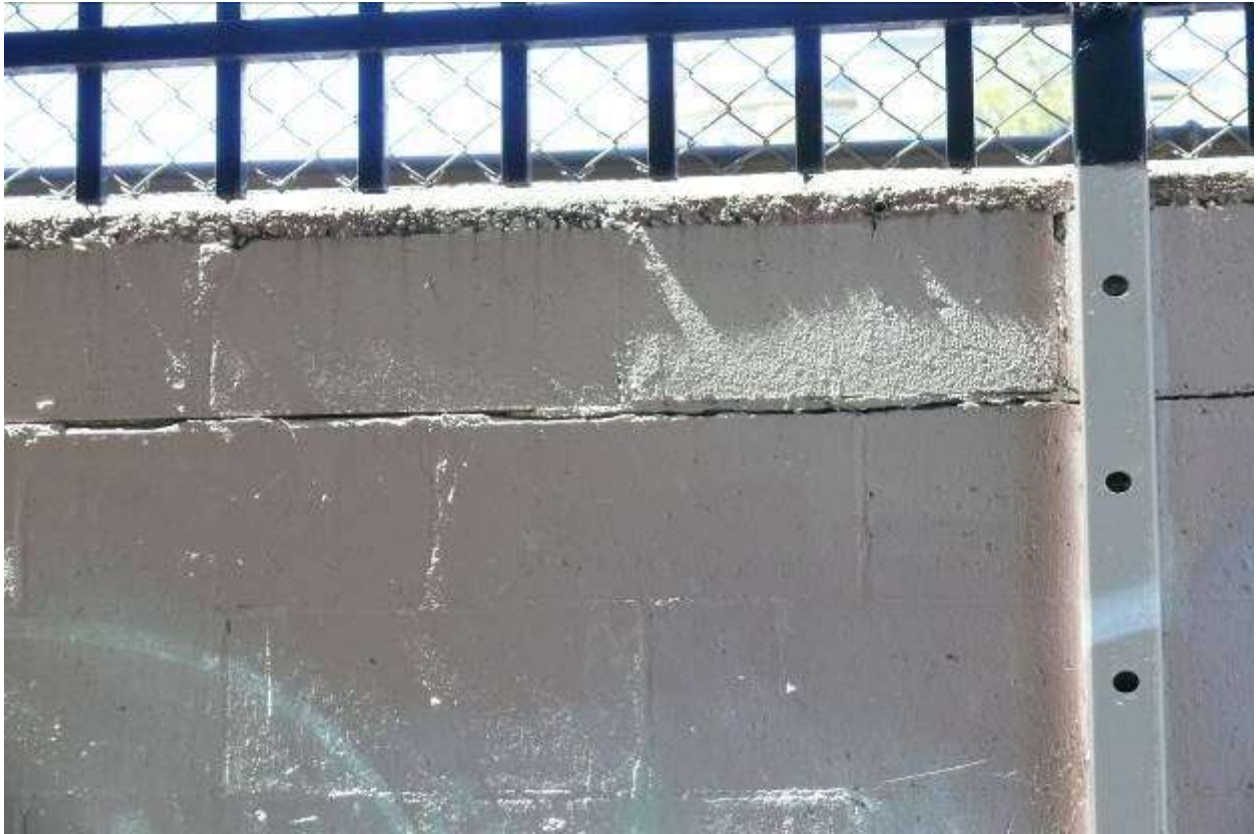
Figure 103 – Crack propagation through boundary wall observed from Eveleigh Street

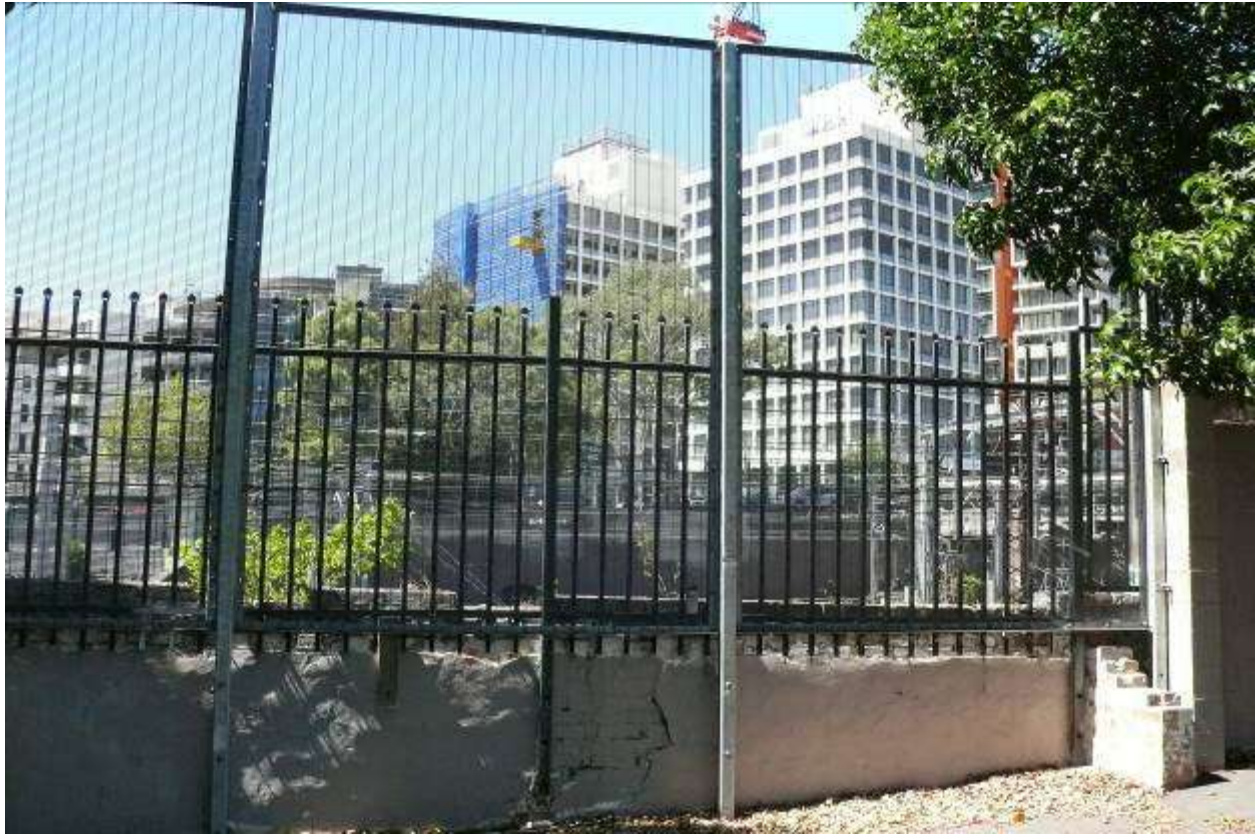
Figure 105 – General condition of RailCorp boundary wall observed from Eveleigh Street

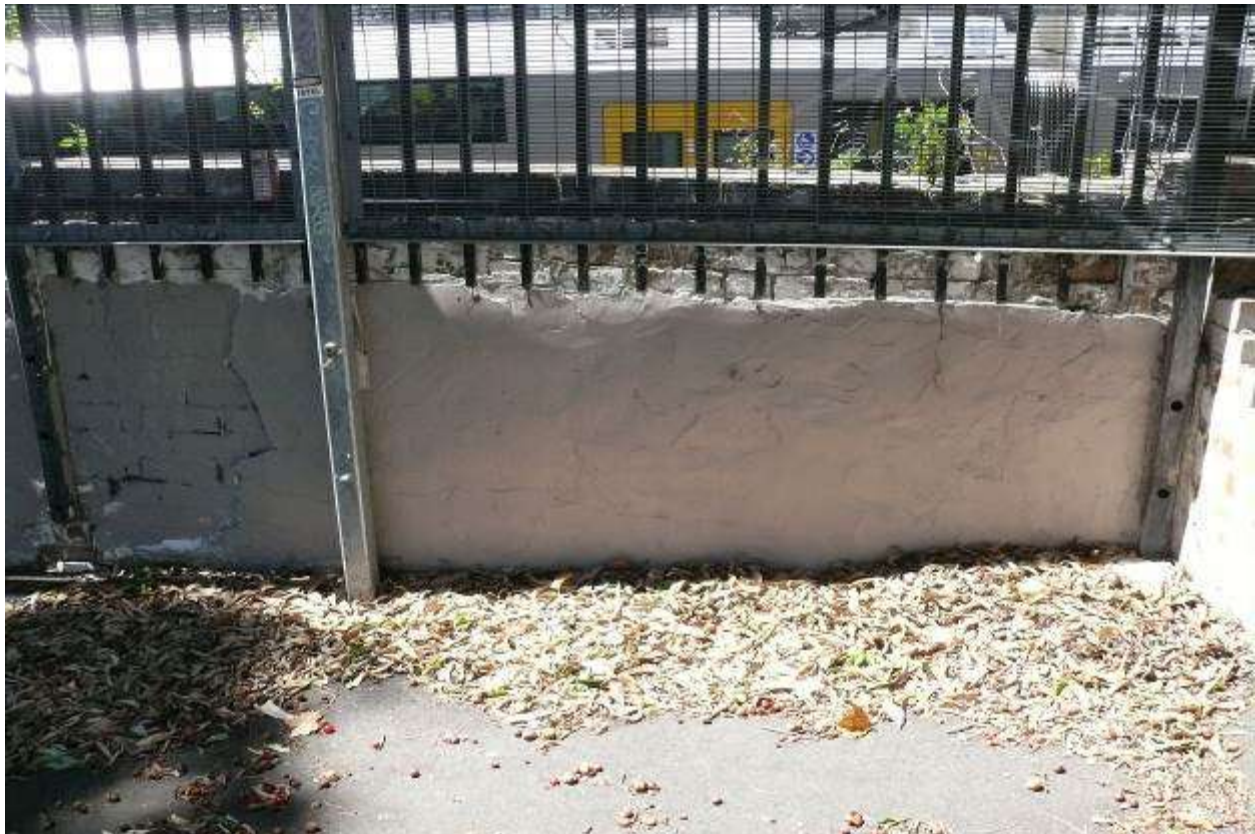
Figure 107 – Crack propagation and loss of material through boundary wall observed from Eveleigh Street

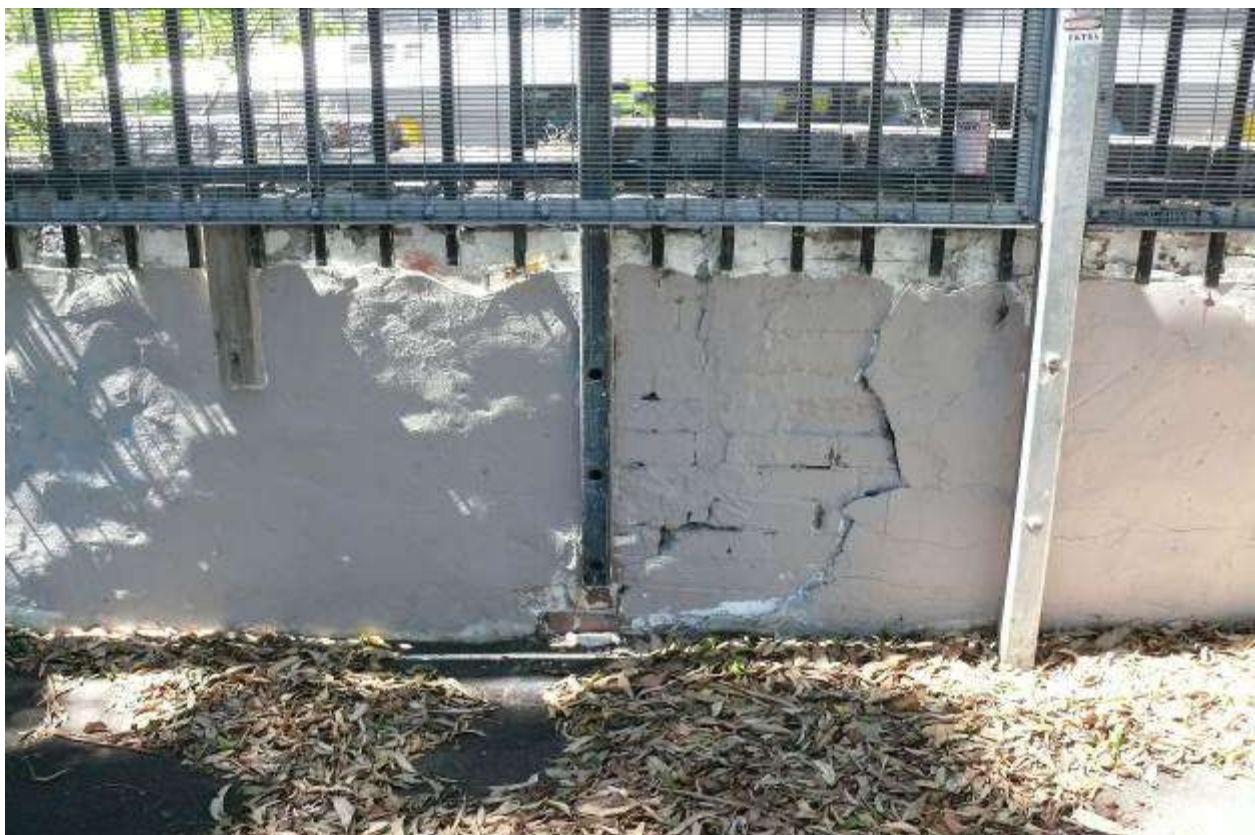
Figure 108 – Crack propagation and loss of material through boundary wall observed from Eveleigh Street

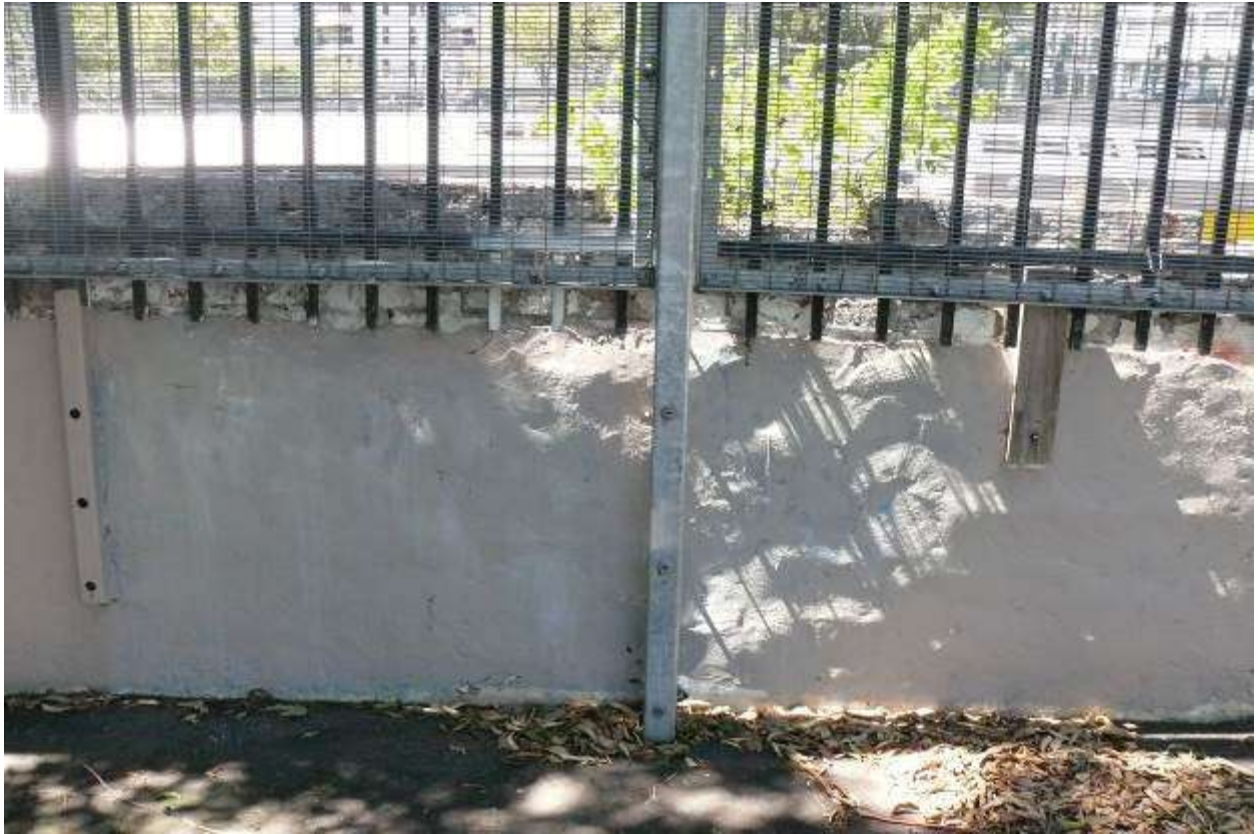
Figure 109 – General condition of RailCorp boundary wall observed from Eveleigh Street

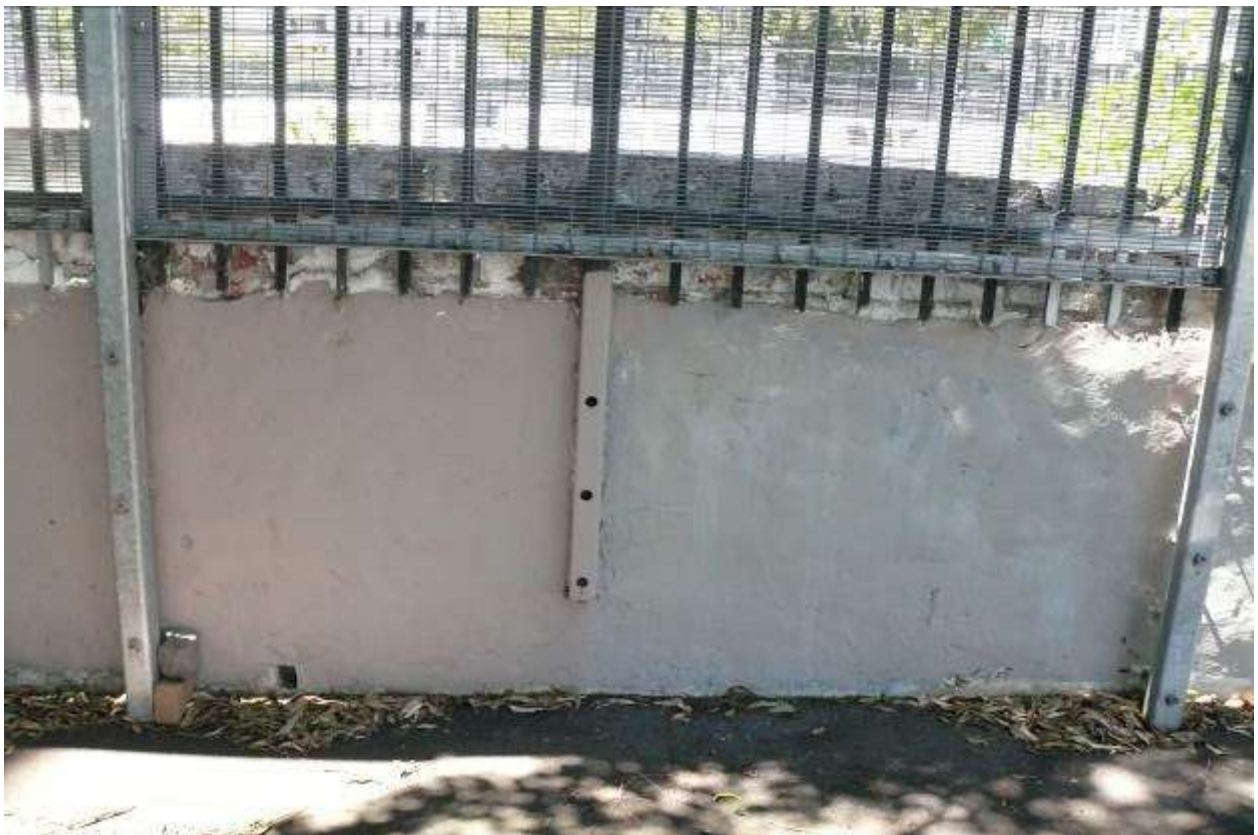
Figure 110 – General condition of RailCorp boundary wall observed from Eveleigh Street

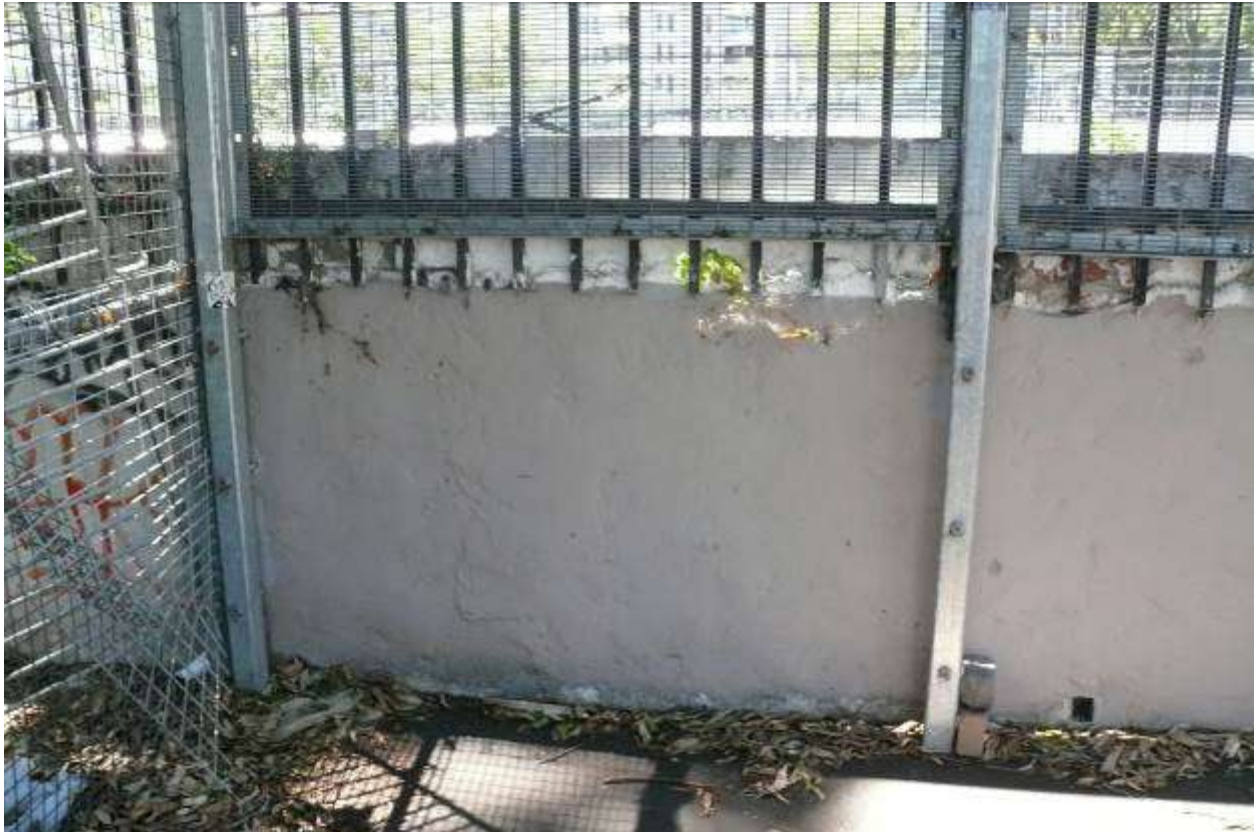
Figure 111 – General condition of RailCorp boundary wall observed from Eveleigh Street

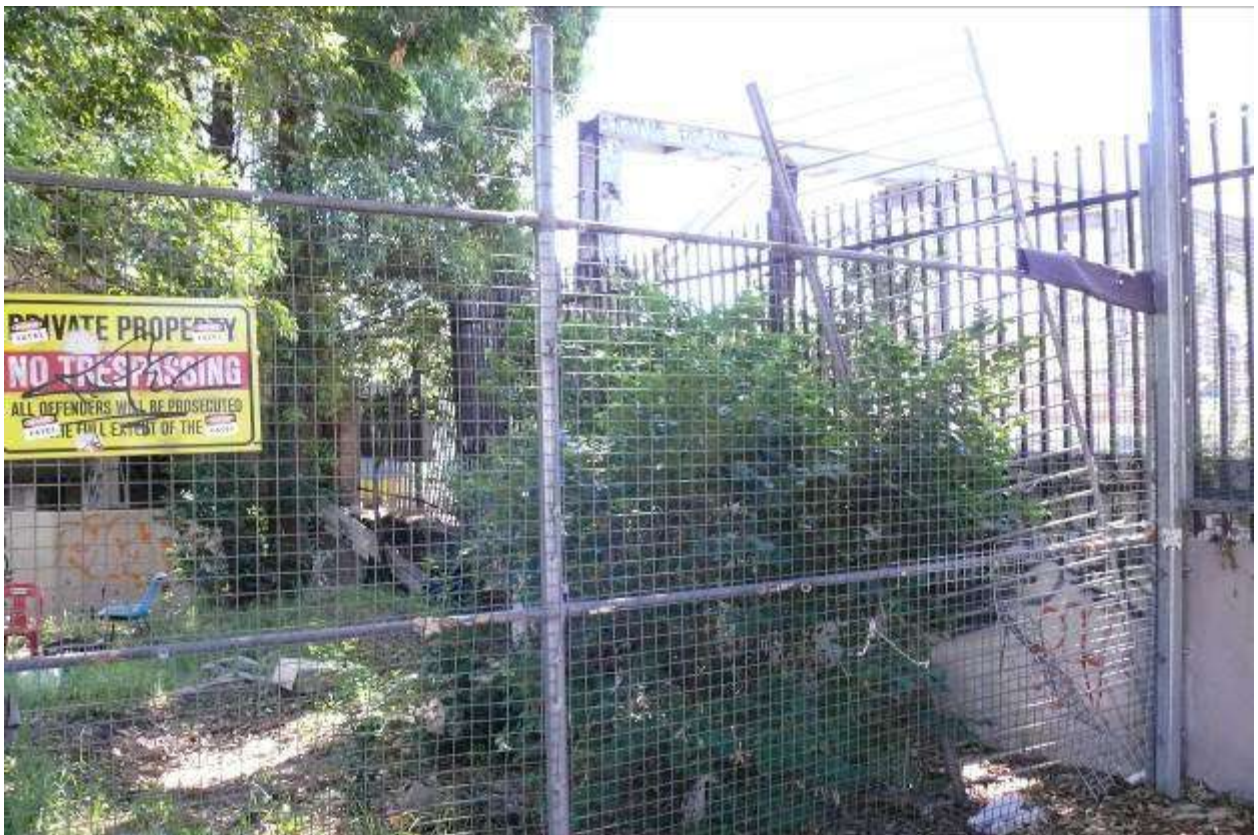
Figure 112 – General condition of RailCorp boundary wall observed from Eveleigh Street

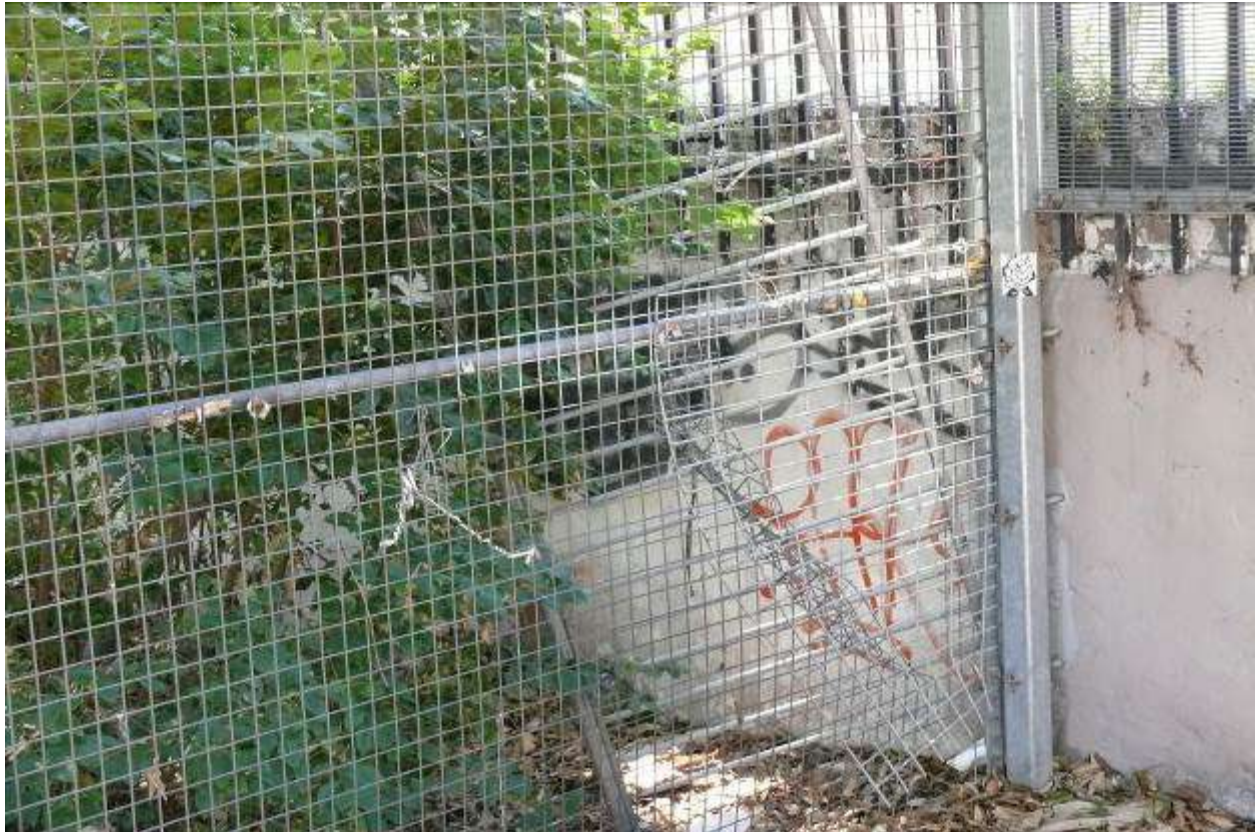
Figure 113 – Physical damage to boundary fence observed from Eveleigh Street

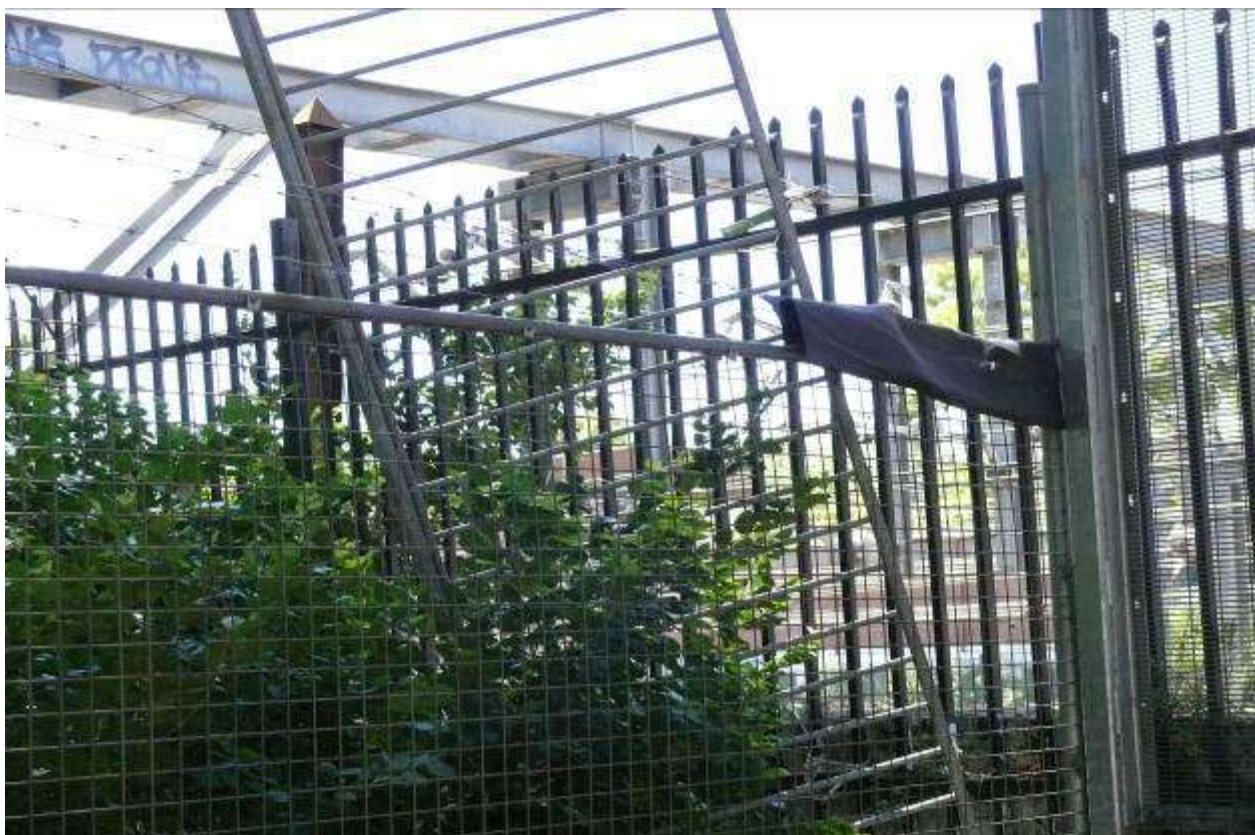
Figure 114 – Physical damage to boundary fence observed from Eveleigh Street

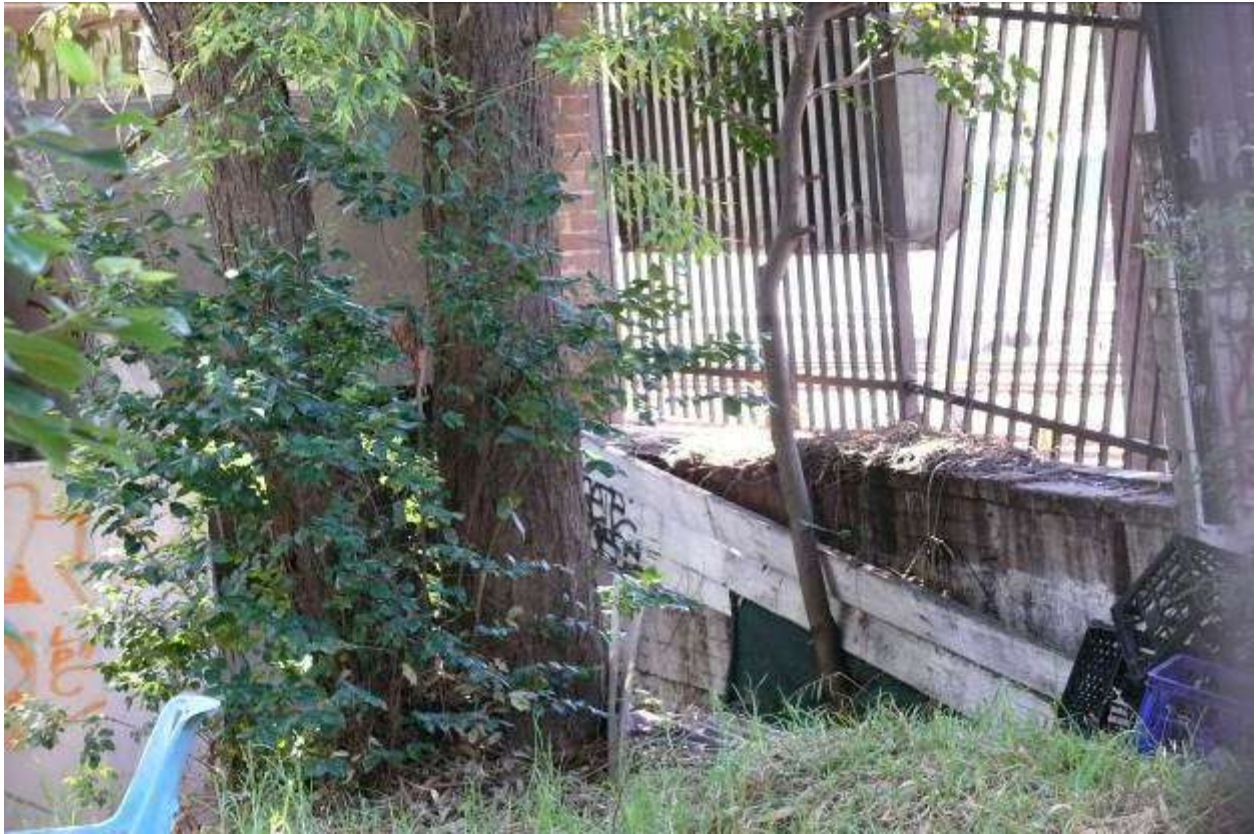
Figure 115 – Physical damage to boundary fence observed from Eveleigh Street

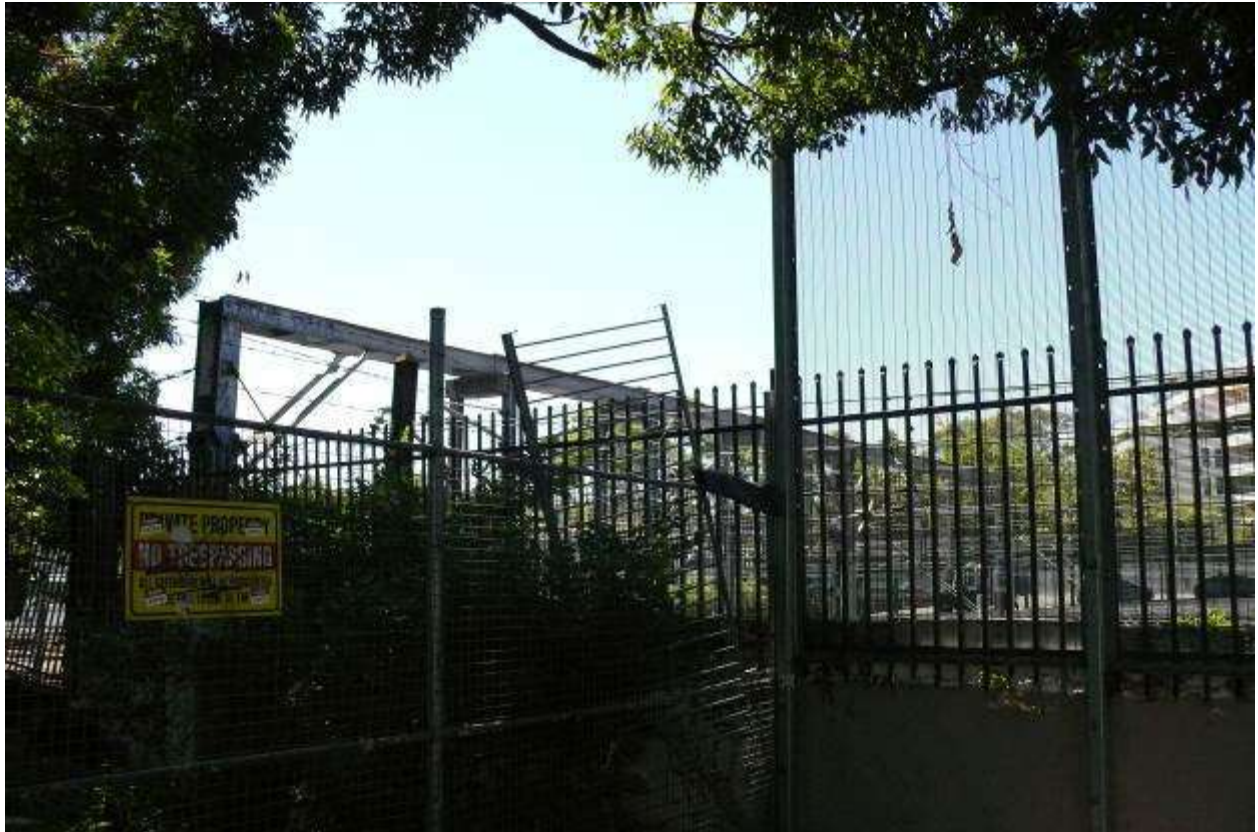
Figure 117 – Physical damage to boundary fence observed from Eveleigh Street

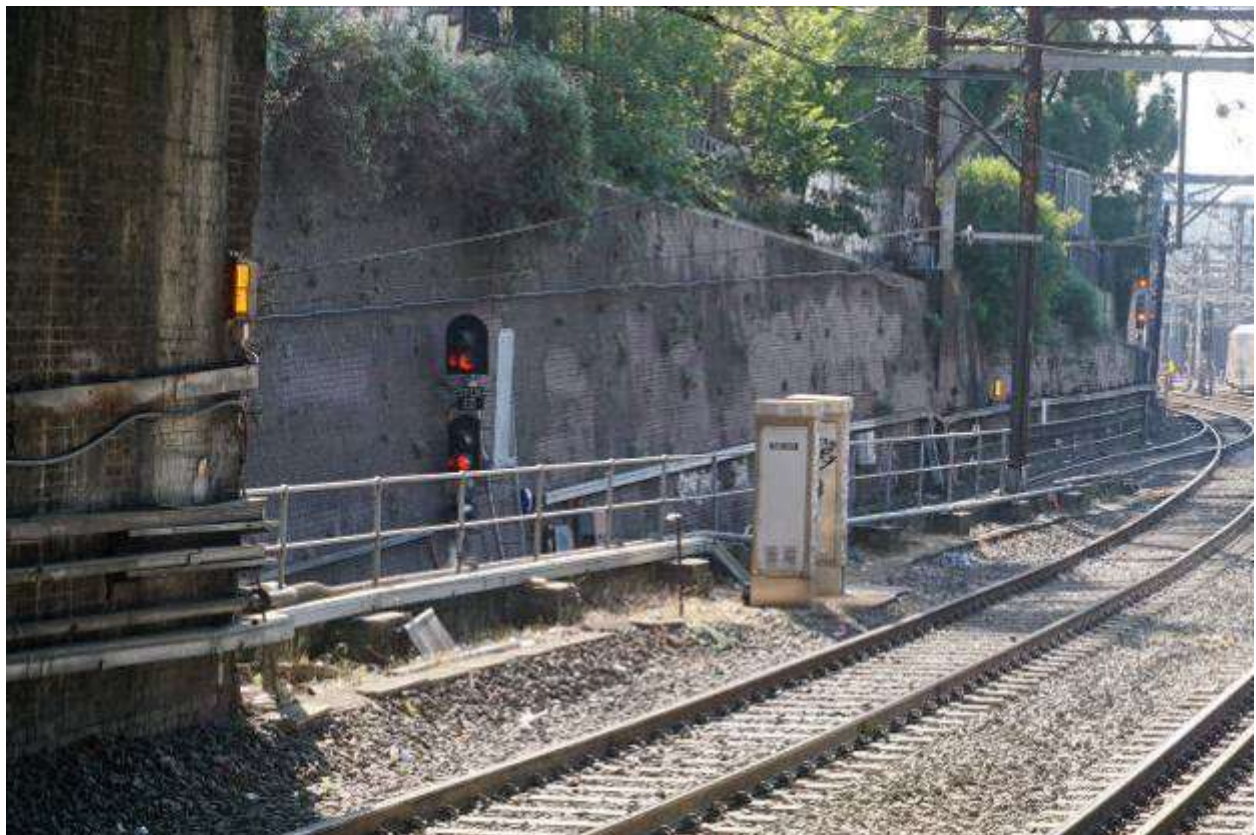
Figure 120 – General condition of RailCorp boundary wall observed from Railway Corridor

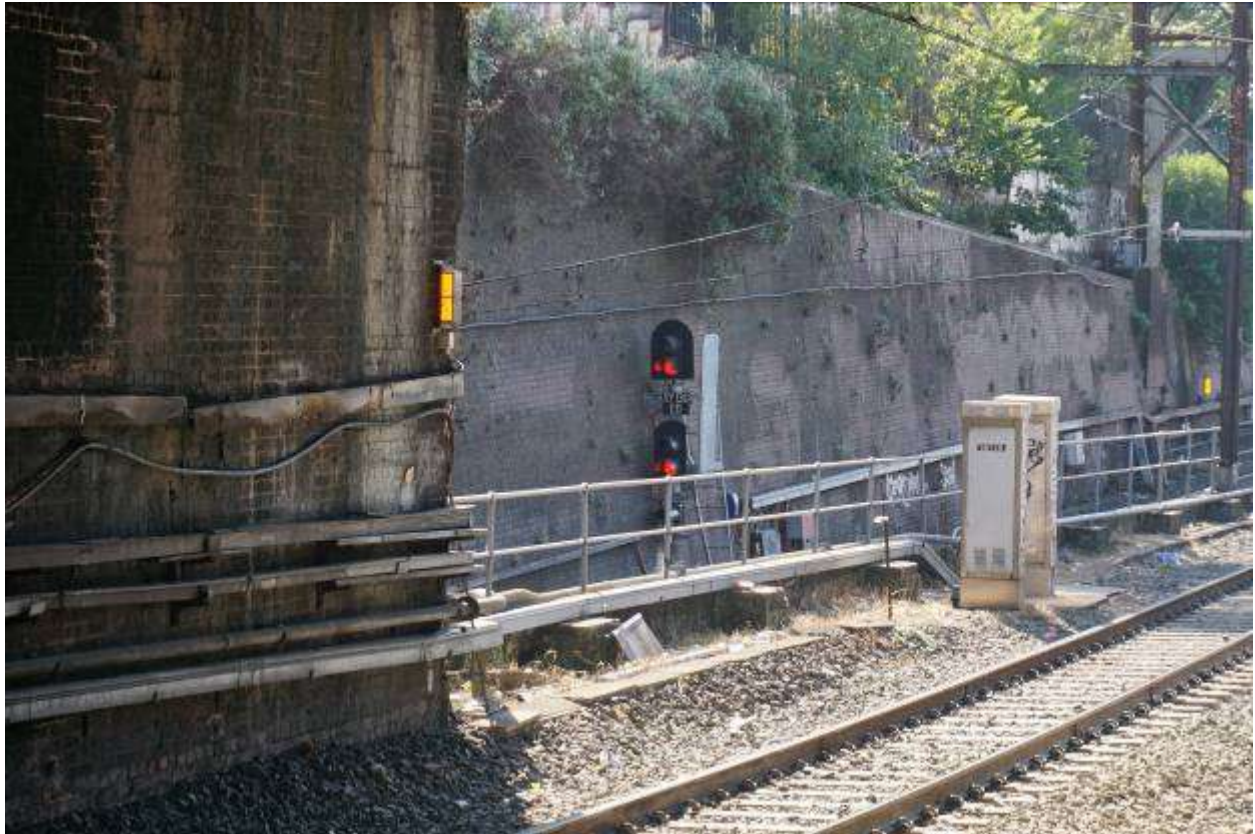
Figure 121 – General condition of RailCorp boundary wall observed from Railway Corridor

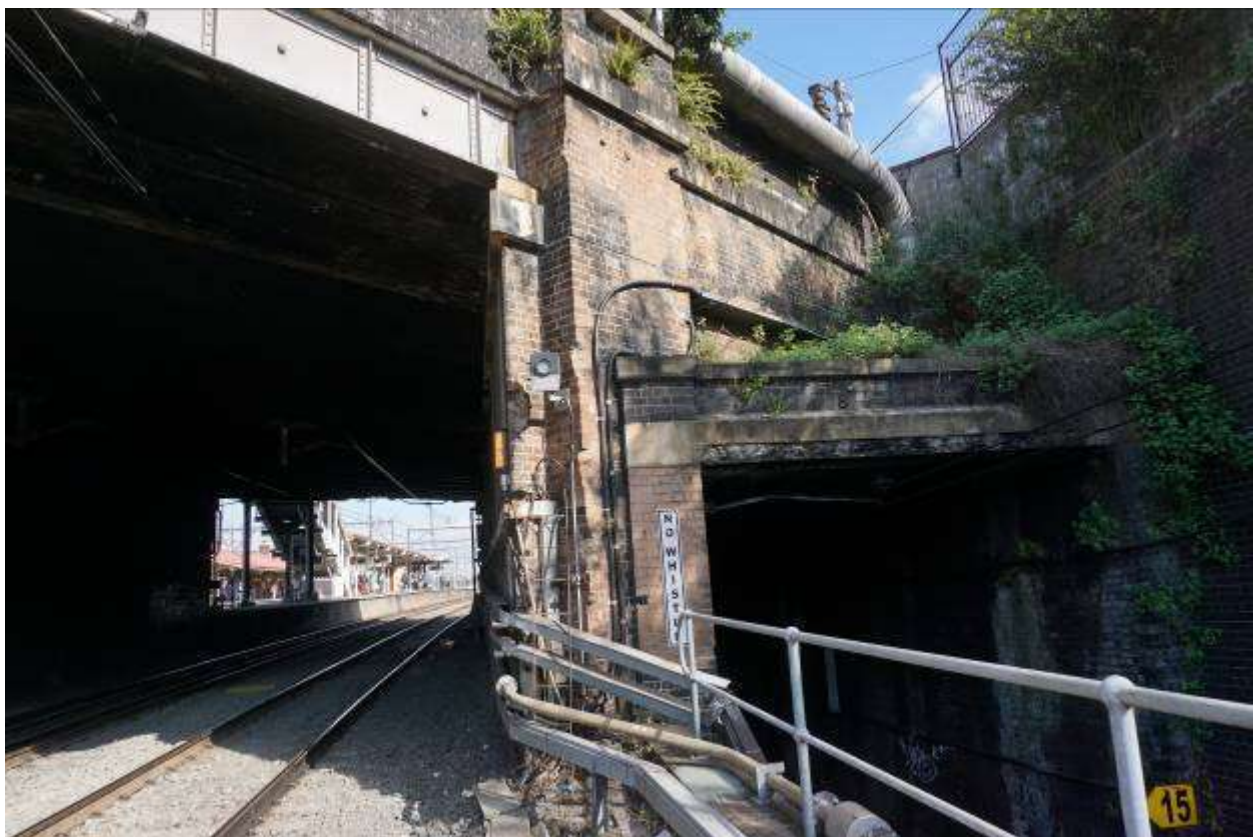
Figure 122 – General condition of RailCorp underpass observed from Railway Corridor

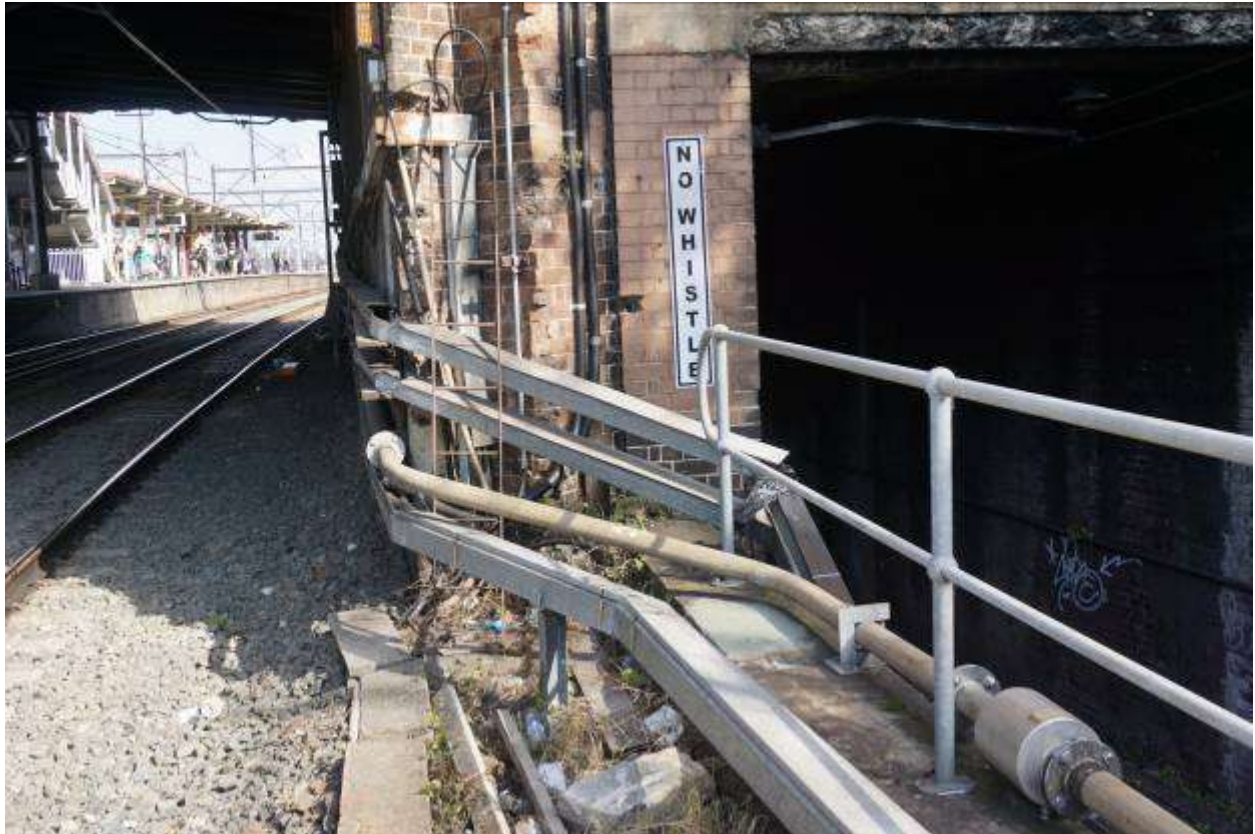
Figure 123 – General condition of RailCorp underpass observed from Railway Corridor

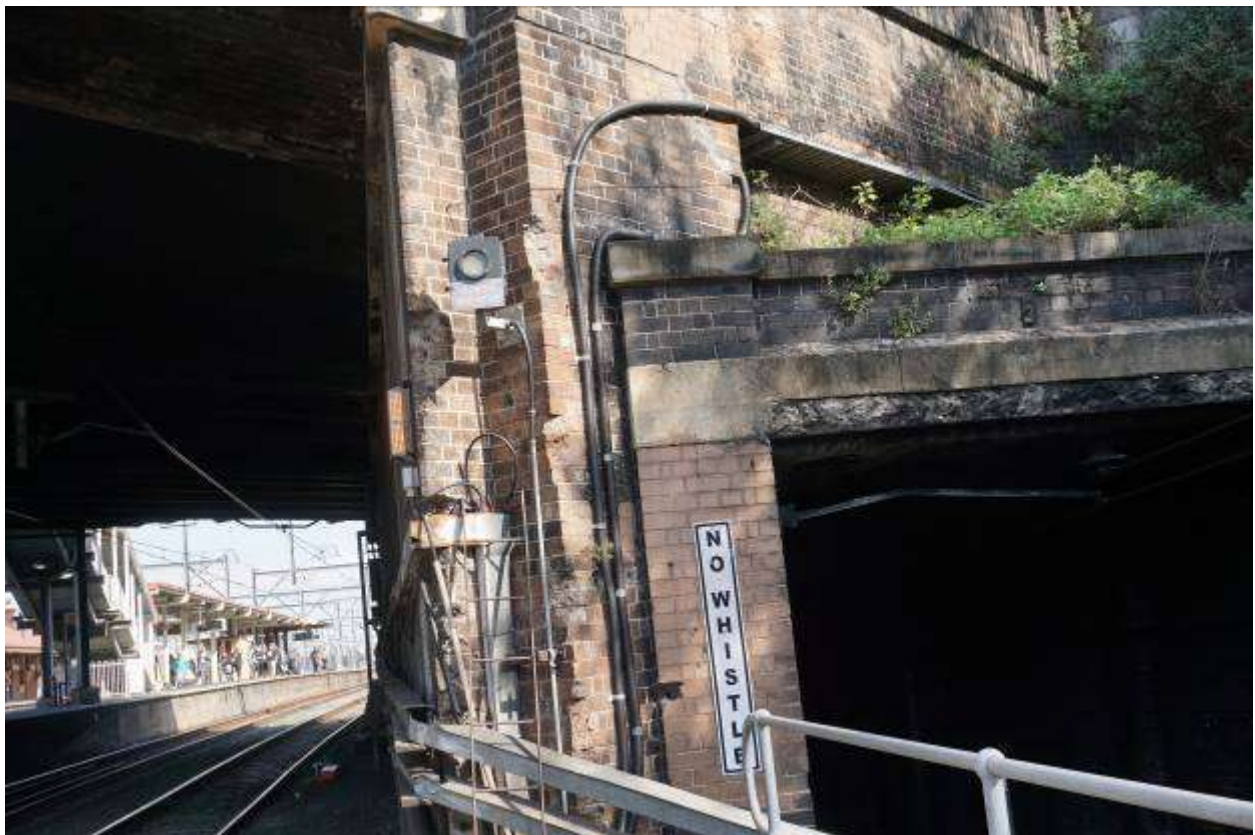
Figure 124 – General condition of RailCorp underpass observed from Railway Corridor

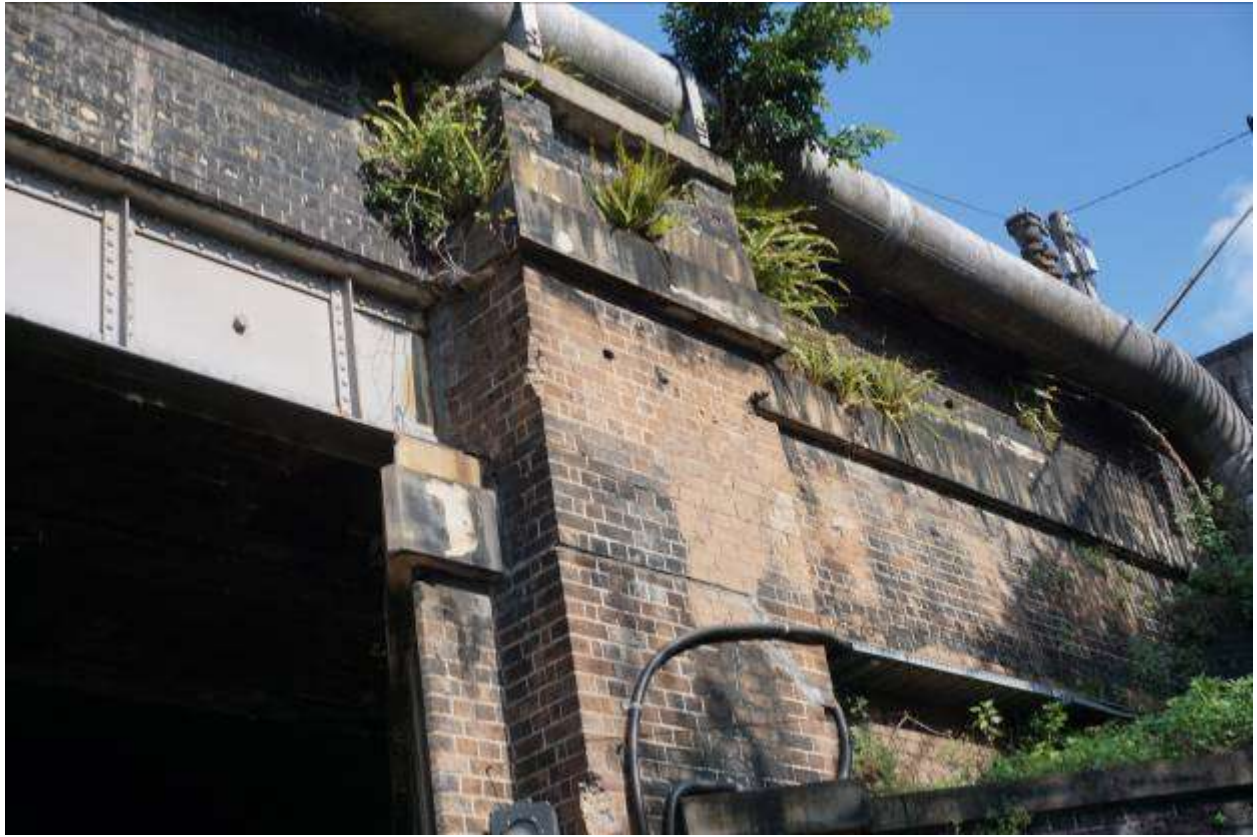
Figure 125 – General condition of RailCorp underpass observed from Railway Corridor
