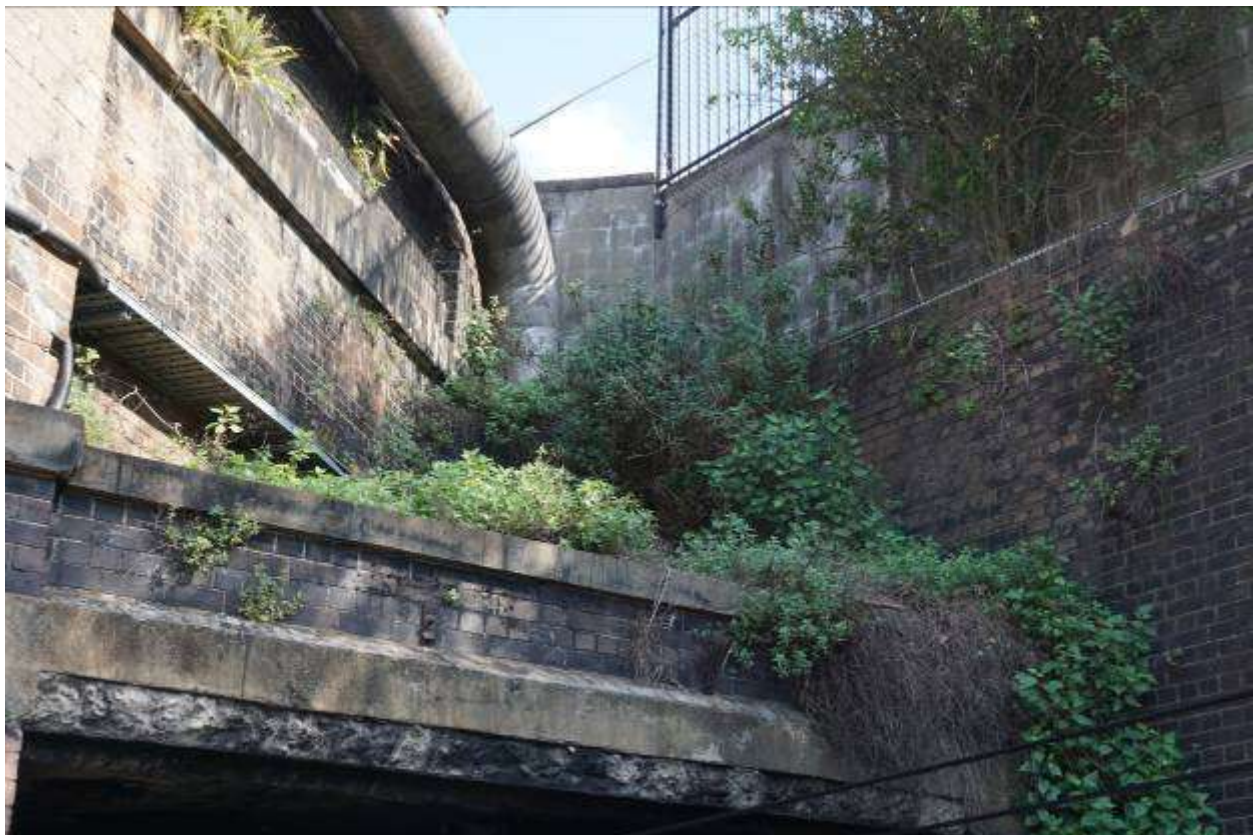
Figure 126 – General condition of RailCorp underpass observed from Railway Corridor

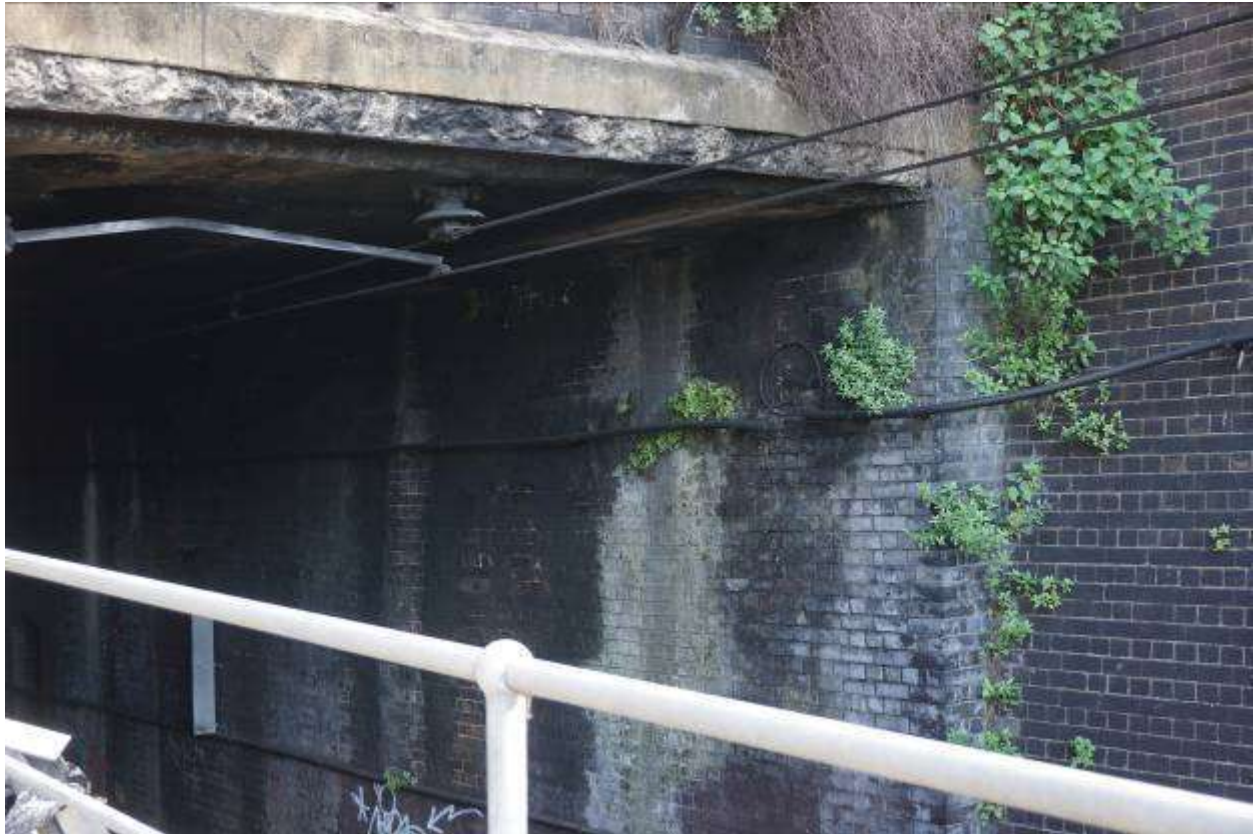
Figure 127 – General condition of RailCorp underpass observed from Railway Corridor

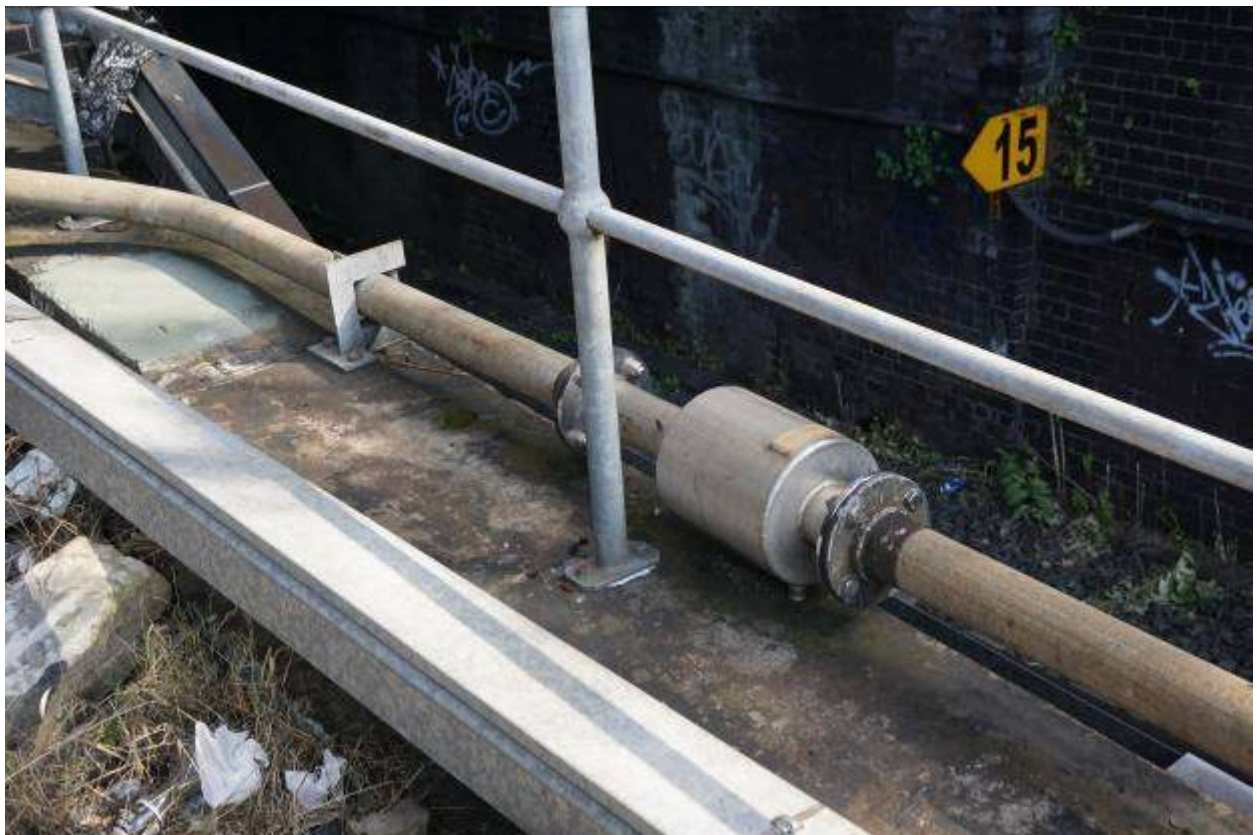
Figure 128 – General condition of RailCorp boundary wall observed from Railway Corridor

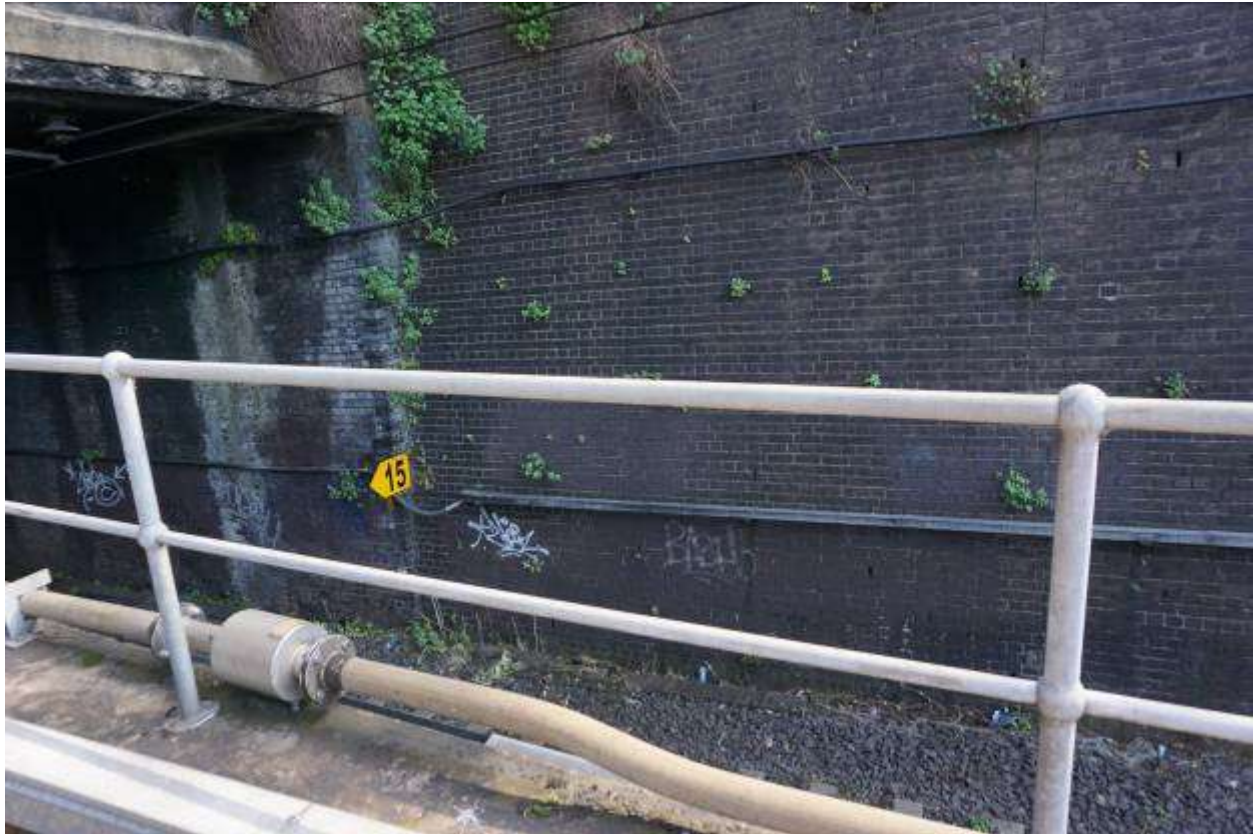
Figure 129 – General condition of RailCorp boundary wall observed from Railway Corridor

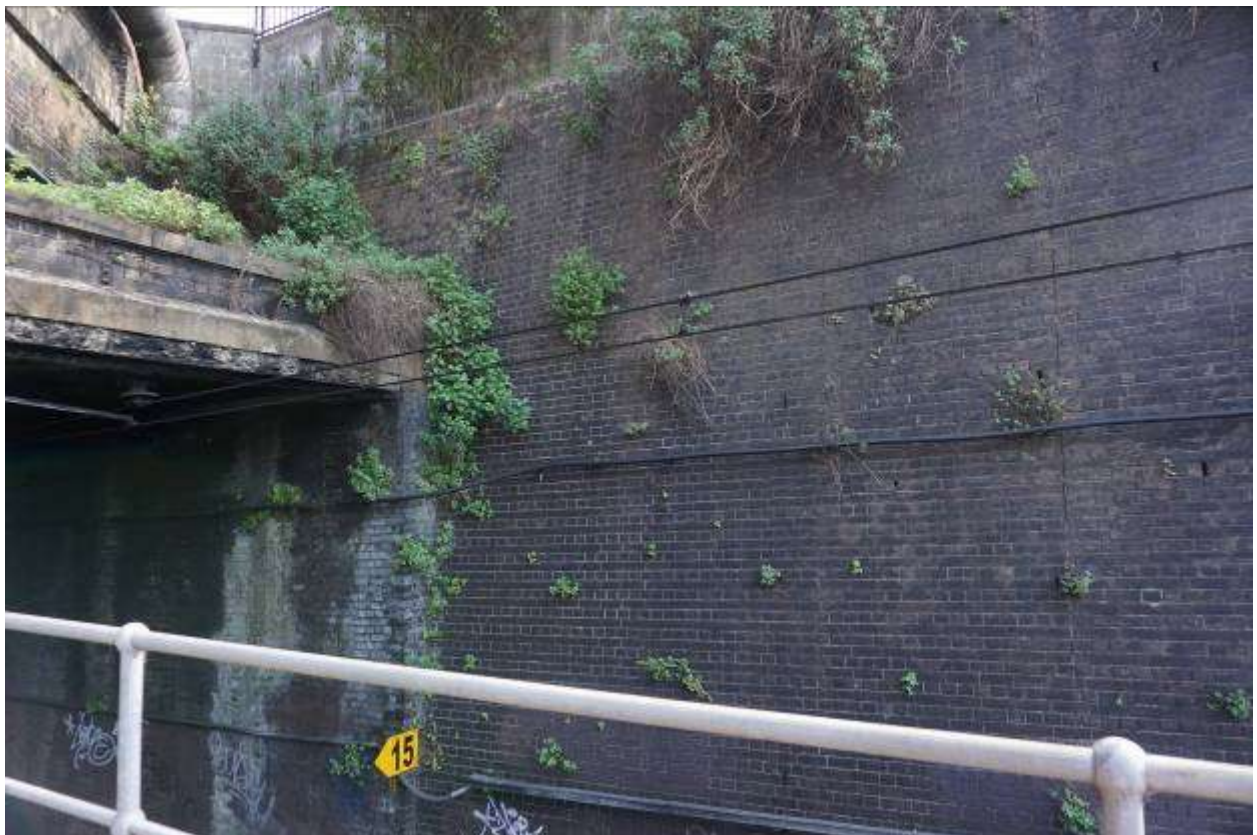
Figure 130 – General condition of RailCorp boundary wall observed from Railway Corridor

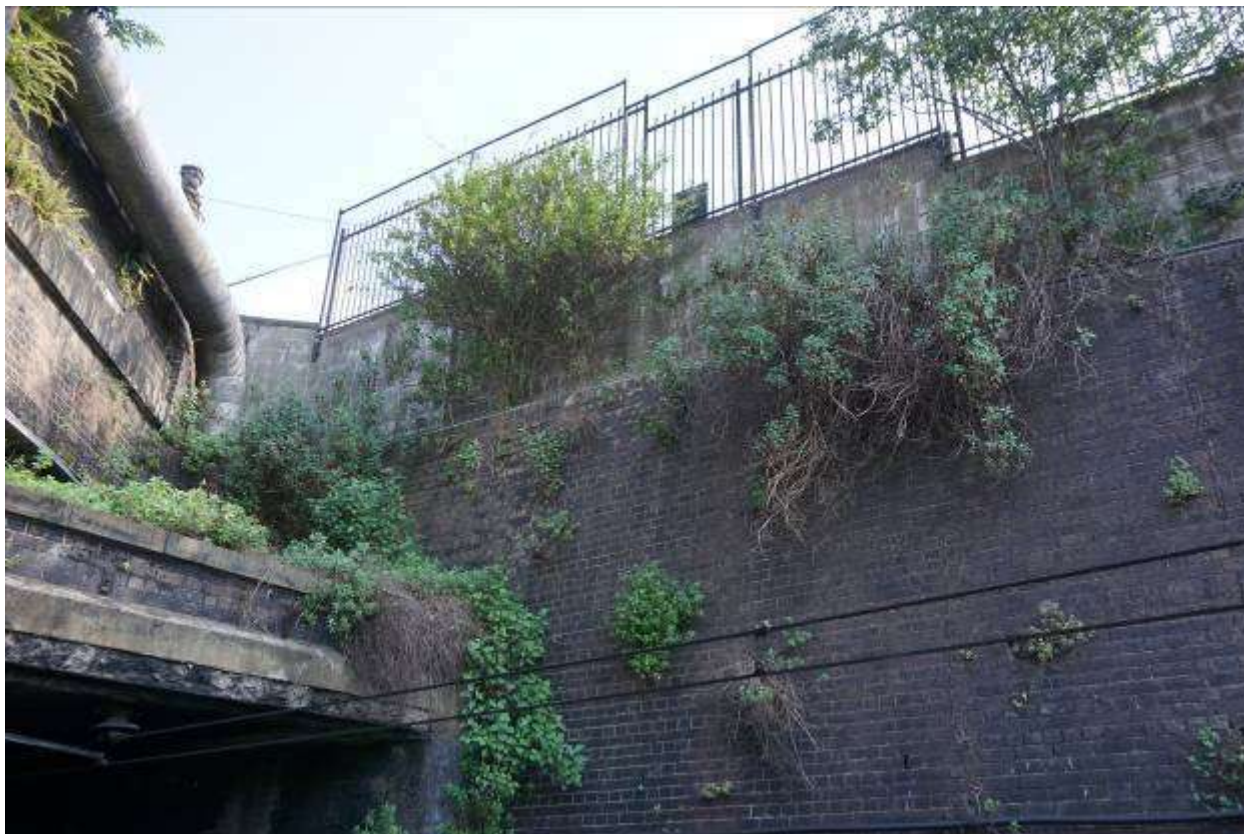
Figure 131 – General condition of RailCorp boundary wall and fence observed from Railway Corridor

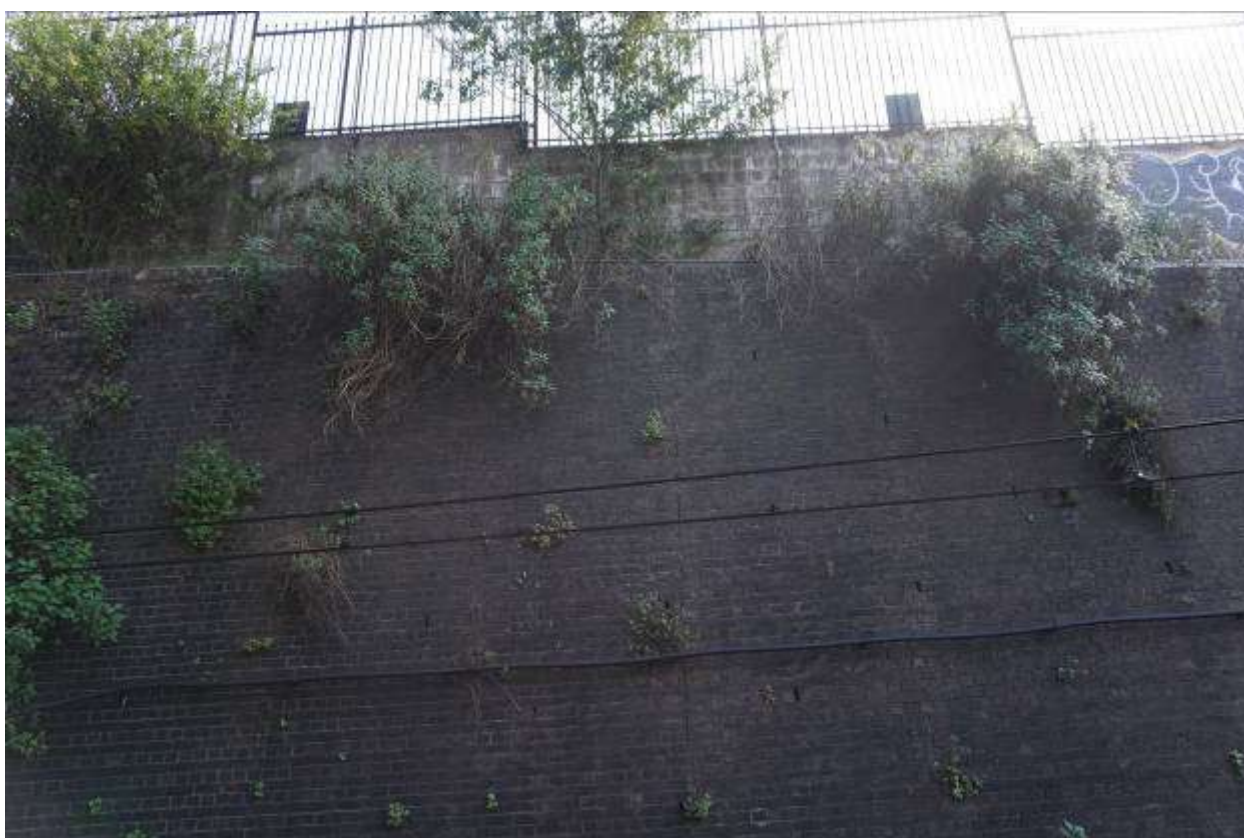
Figure 132 – General condition of RailCorp boundary wall and fence observed from Railway Corridor

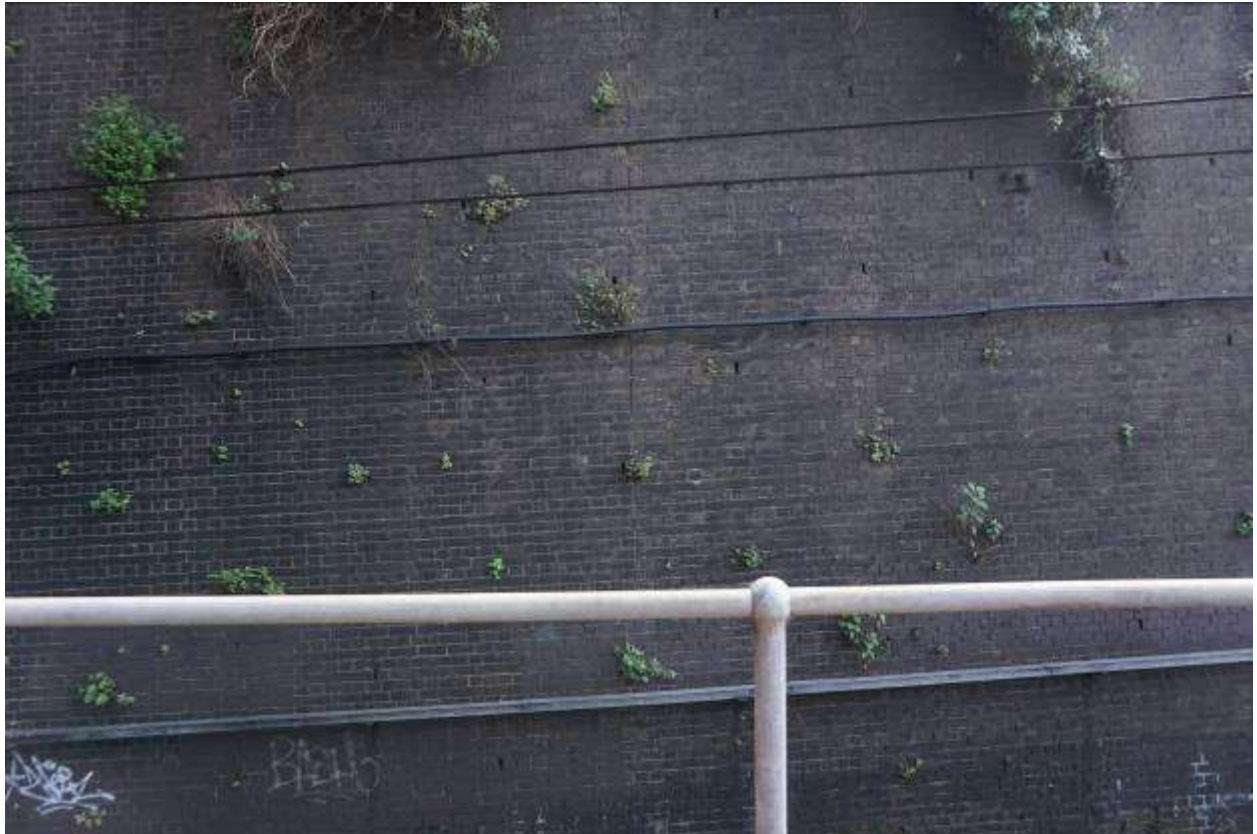
Figure 133 – General condition of RailCorp boundary wall observed from Railway Corridor

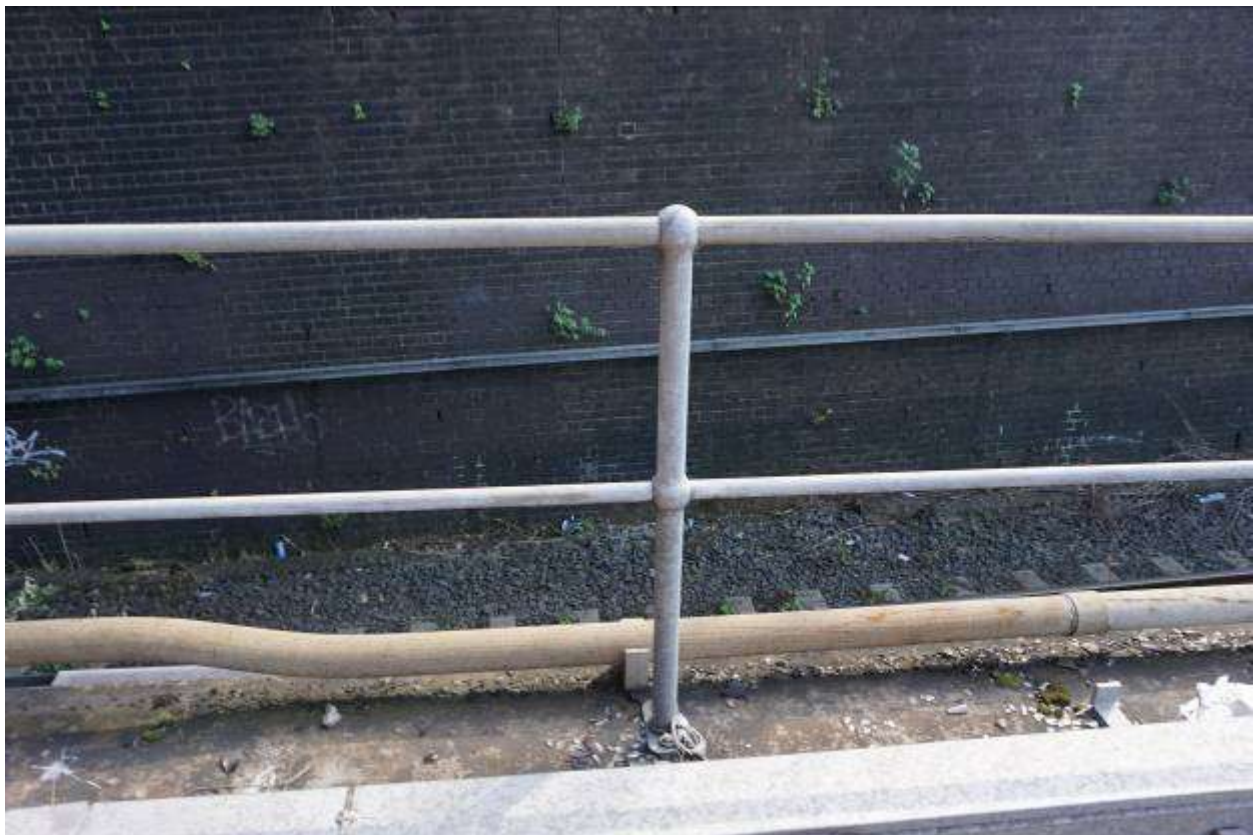
Figure 134 – General condition of RailCorp boundary wall observed from Railway Corridor

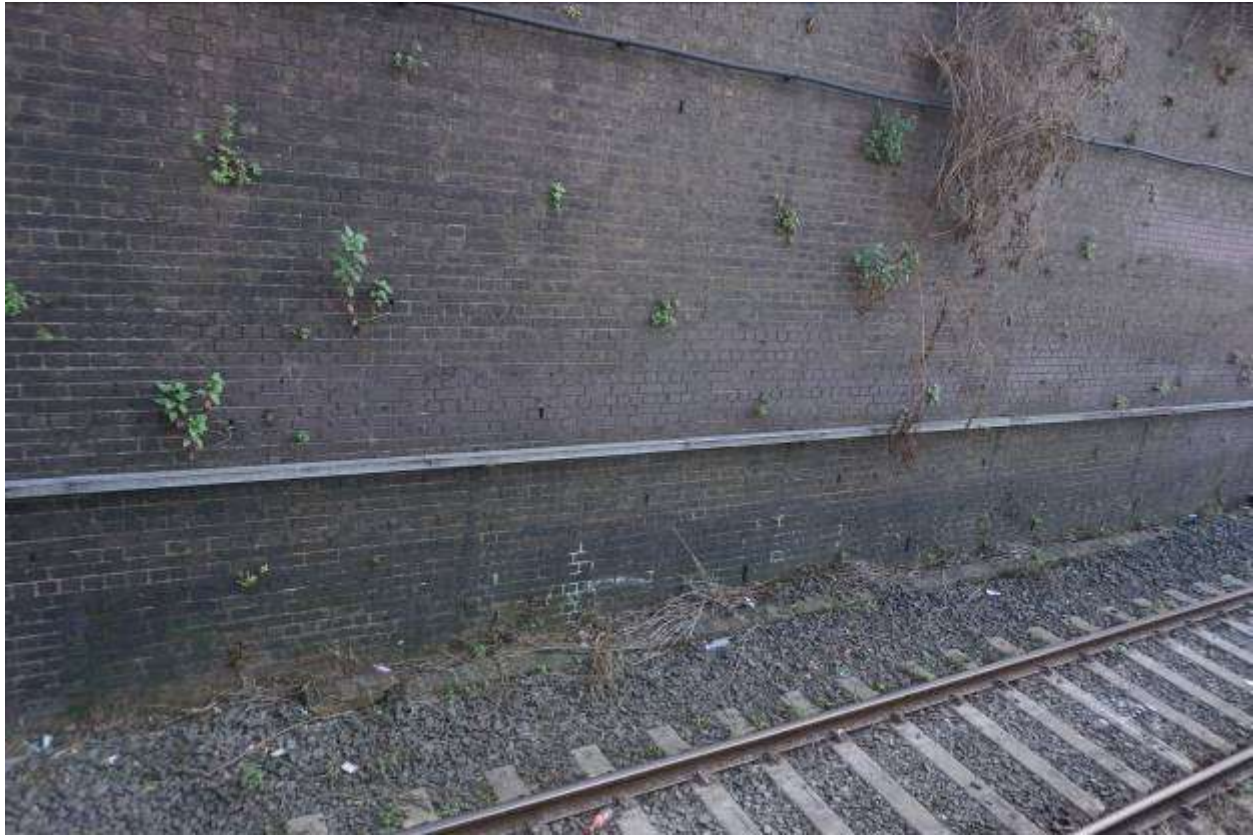
Figure 135 – General condition of RailCorp boundary wall observed from Railway Corridor

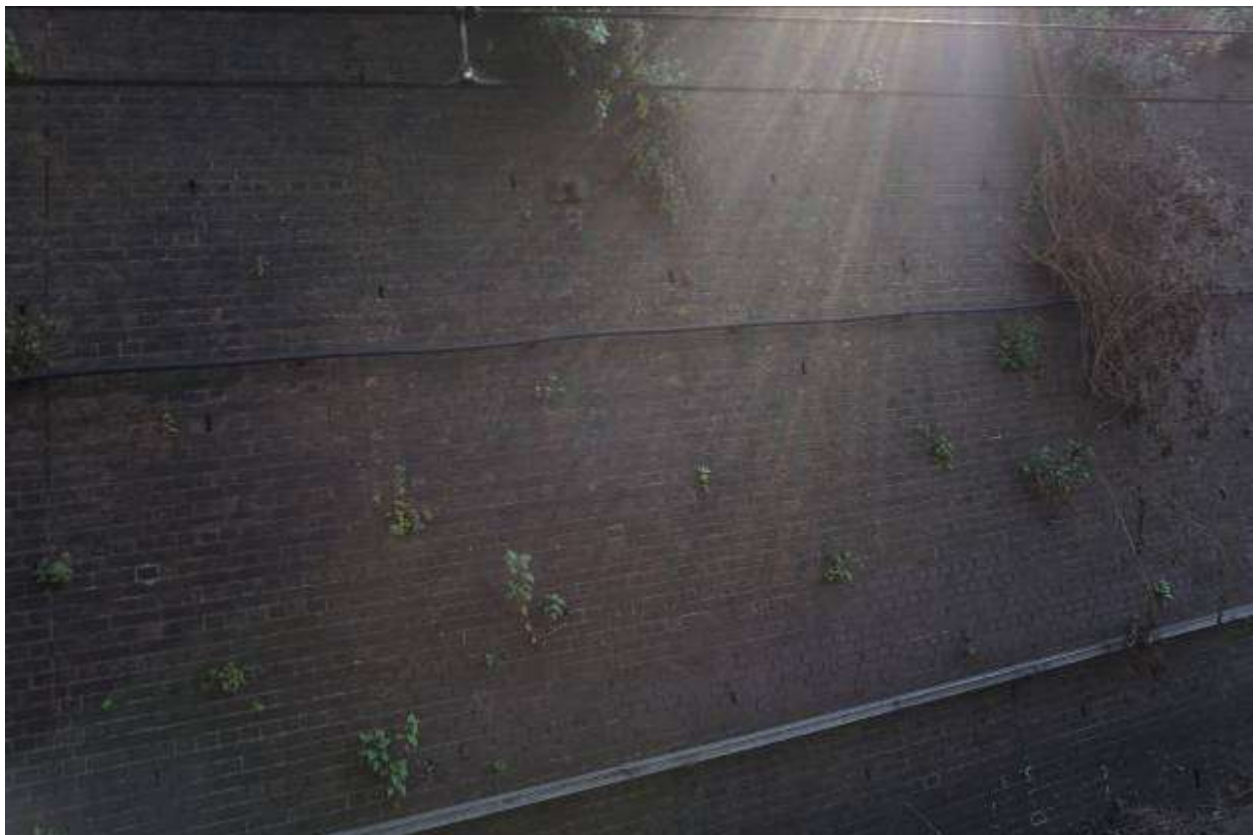
Figure 136 – General condition of RailCorp boundary wall observed from Railway Corridor

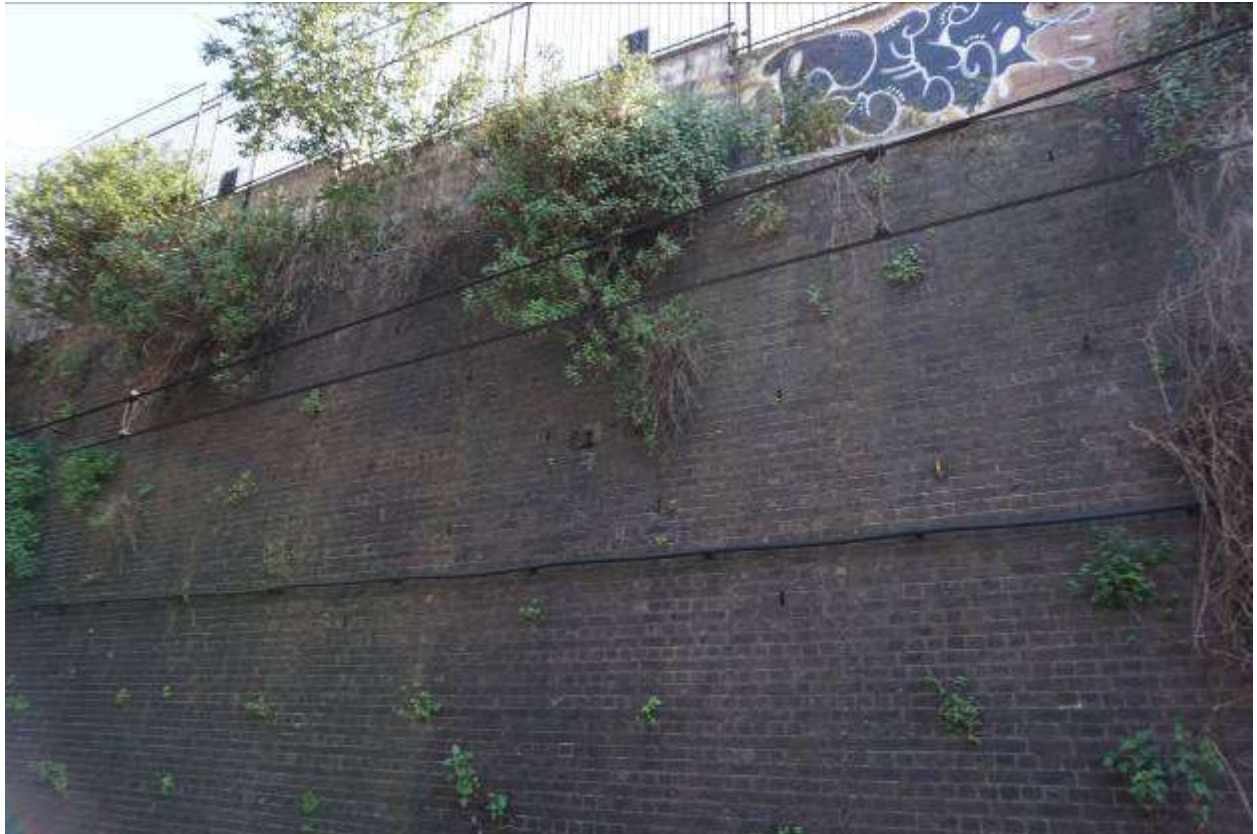
Figure 137 – General condition of RailCorp boundary wall observed from Railway Corridor

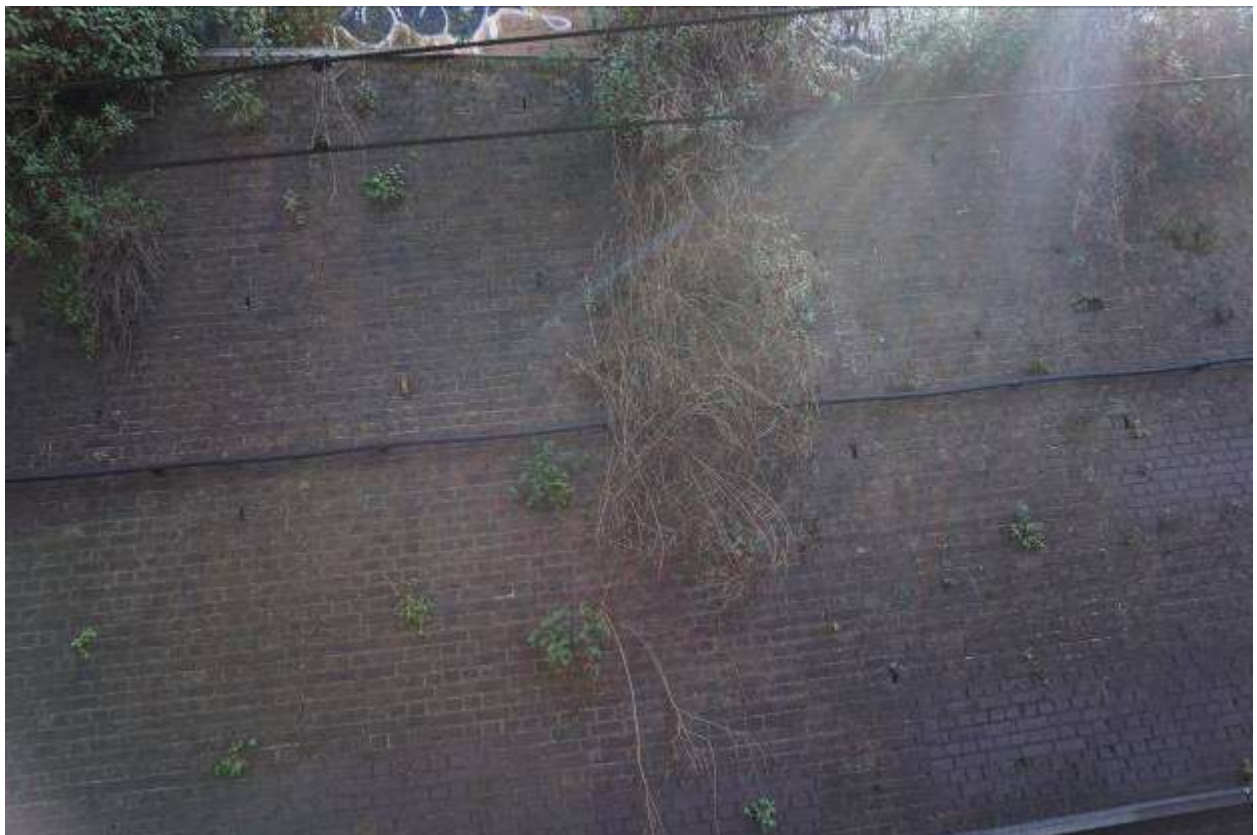
Figure 138 – General condition of RailCorp boundary wall observed from Railway Corridor

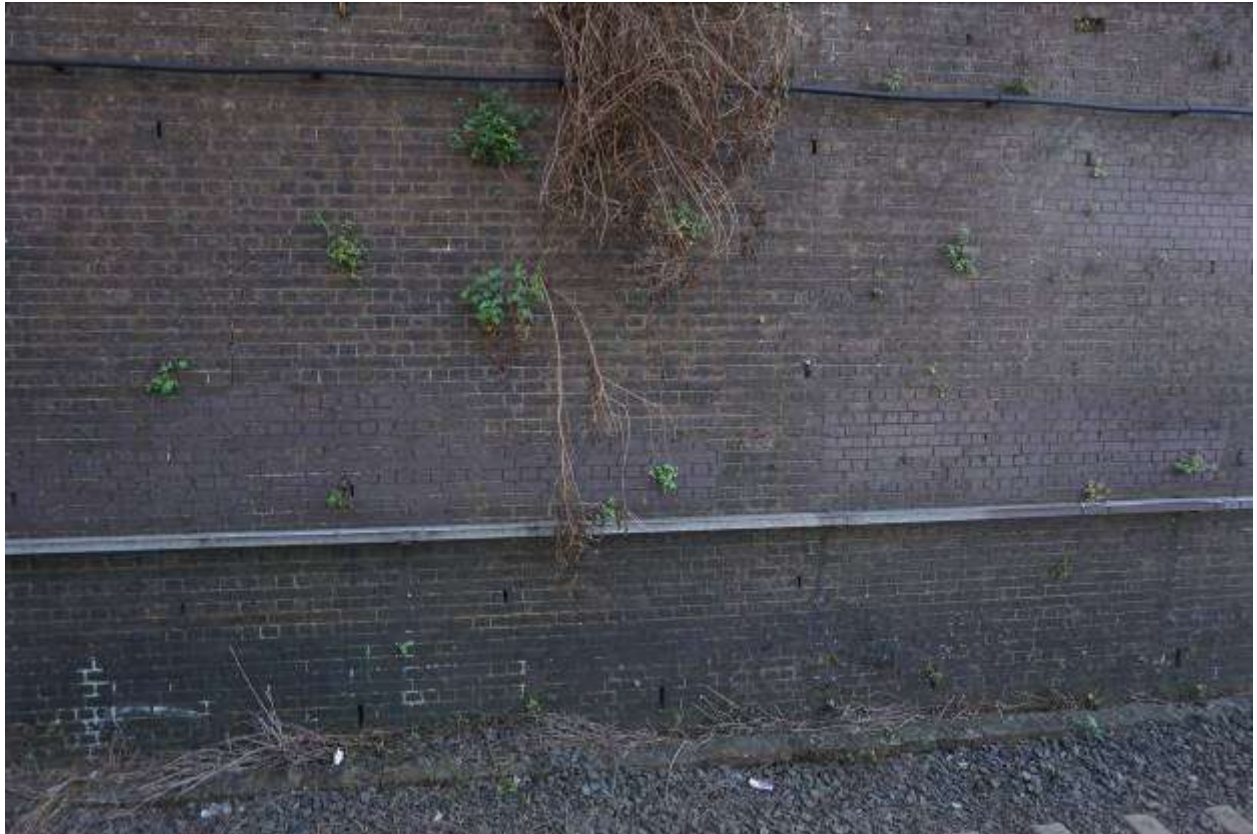
Figure 139 – General condition of RailCorp boundary wall observed from Railway Corridor

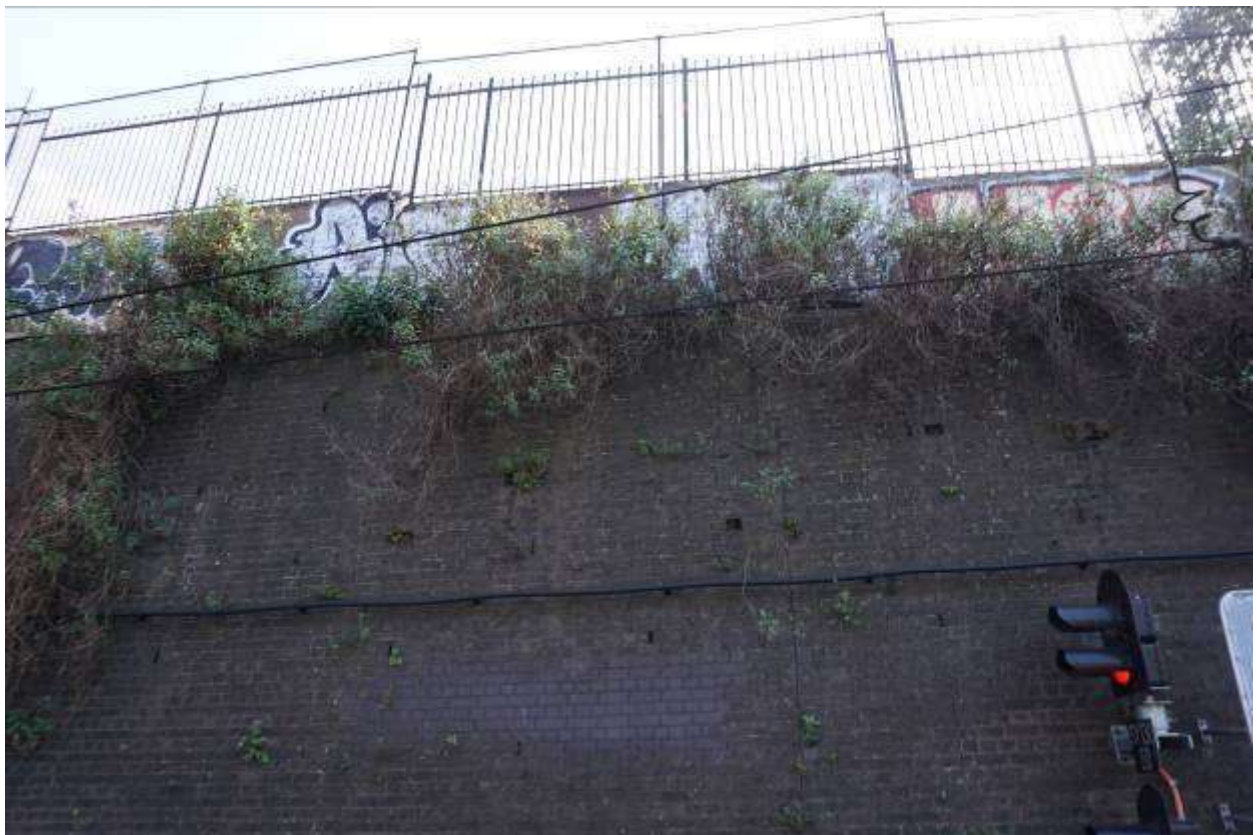
Figure 140 – General condition of RailCorp boundary wall and fence observed from Railway Corridor

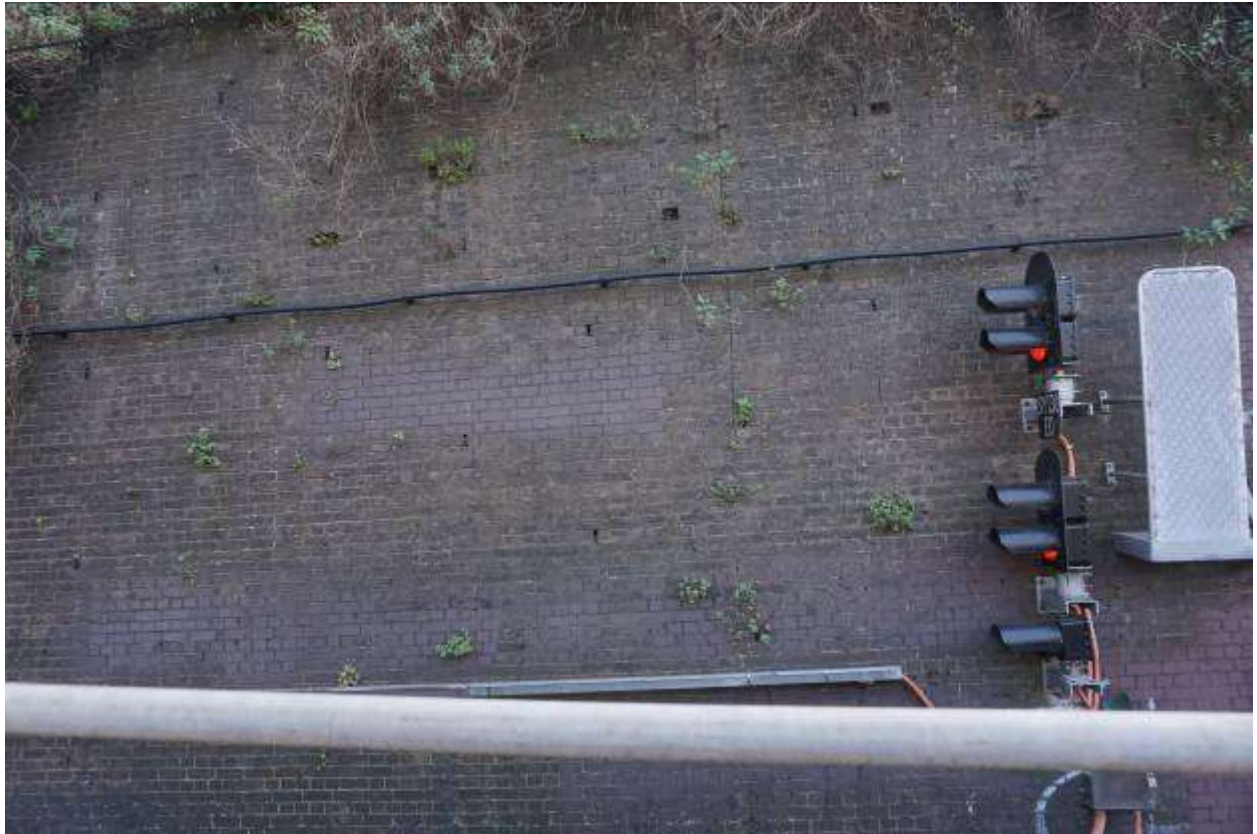
Figure 141 – General condition of RailCorp boundary wall observed from Railway Corridor

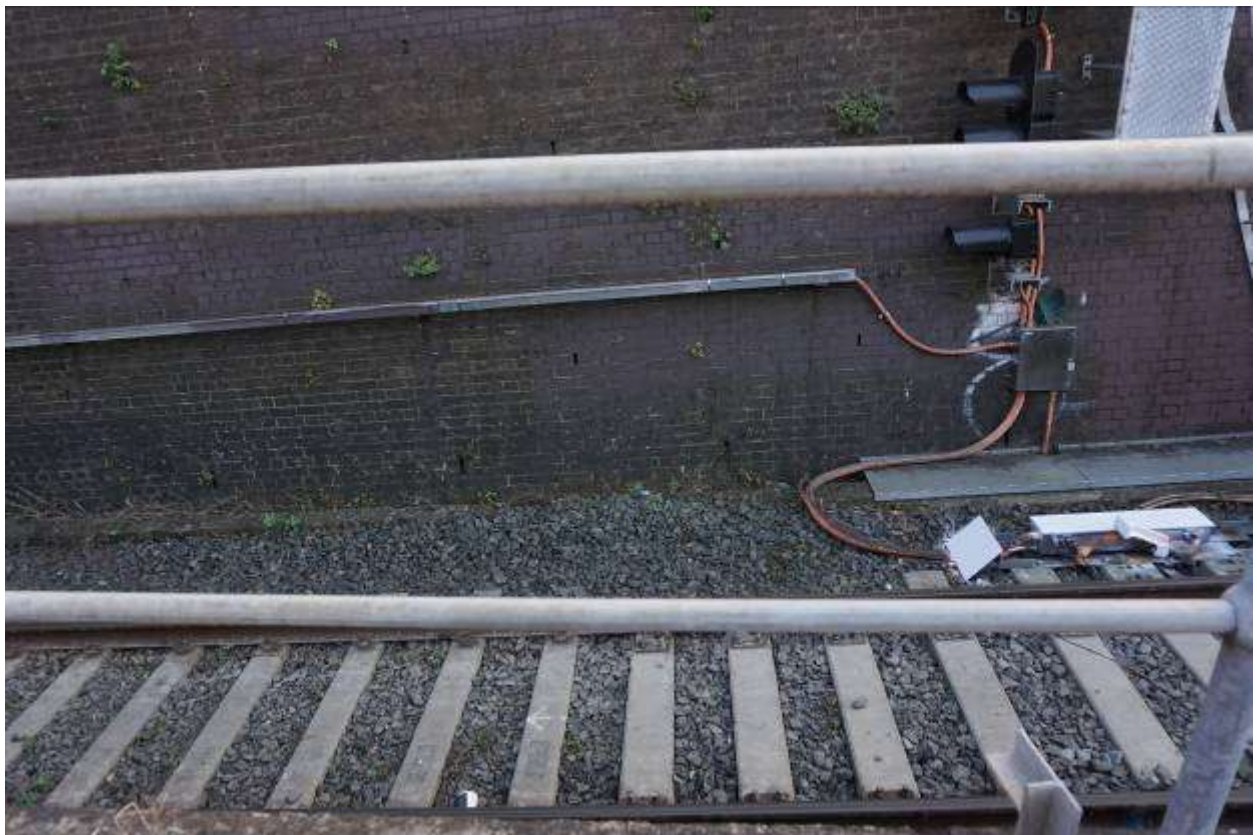
Figure 142 – General condition of RailCorp boundary wall observed from Railway Corridor

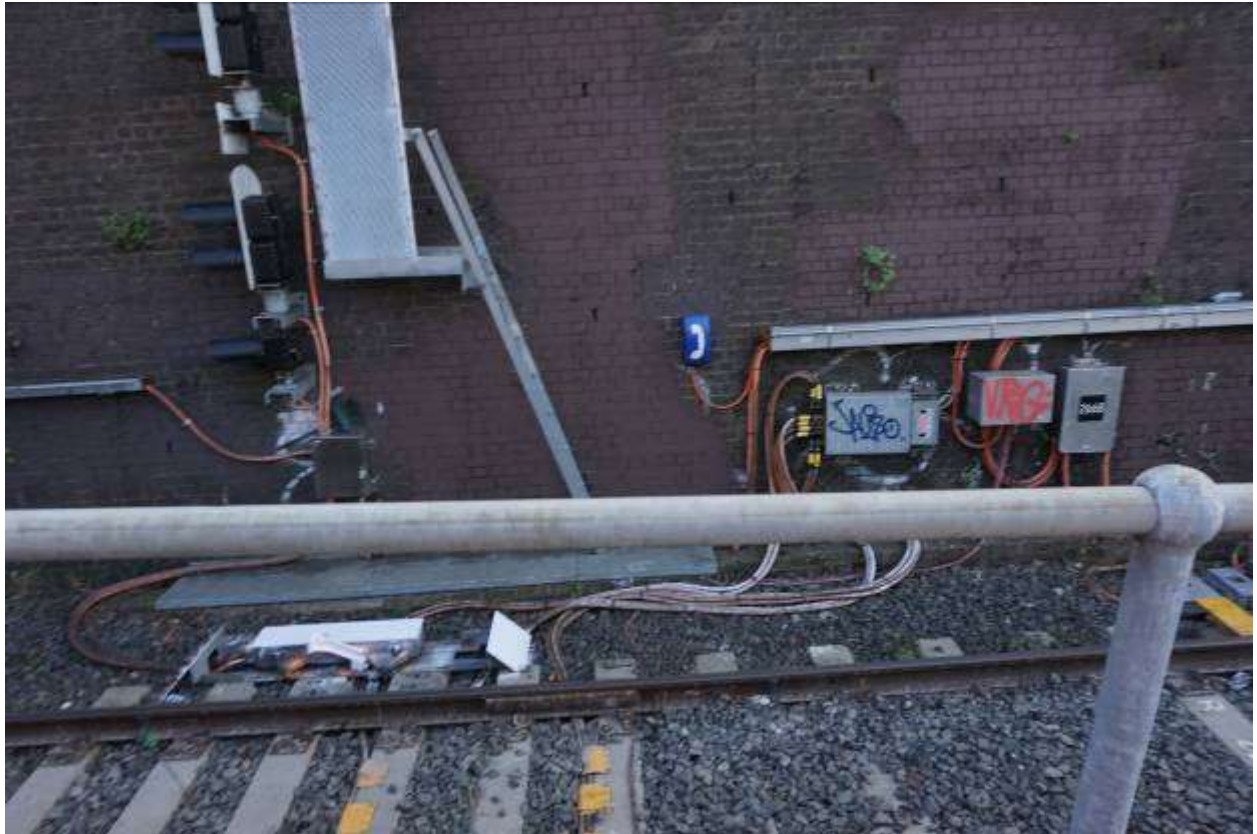
Figure 143 – General condition of RailCorp boundary wall observed from Railway Corridor

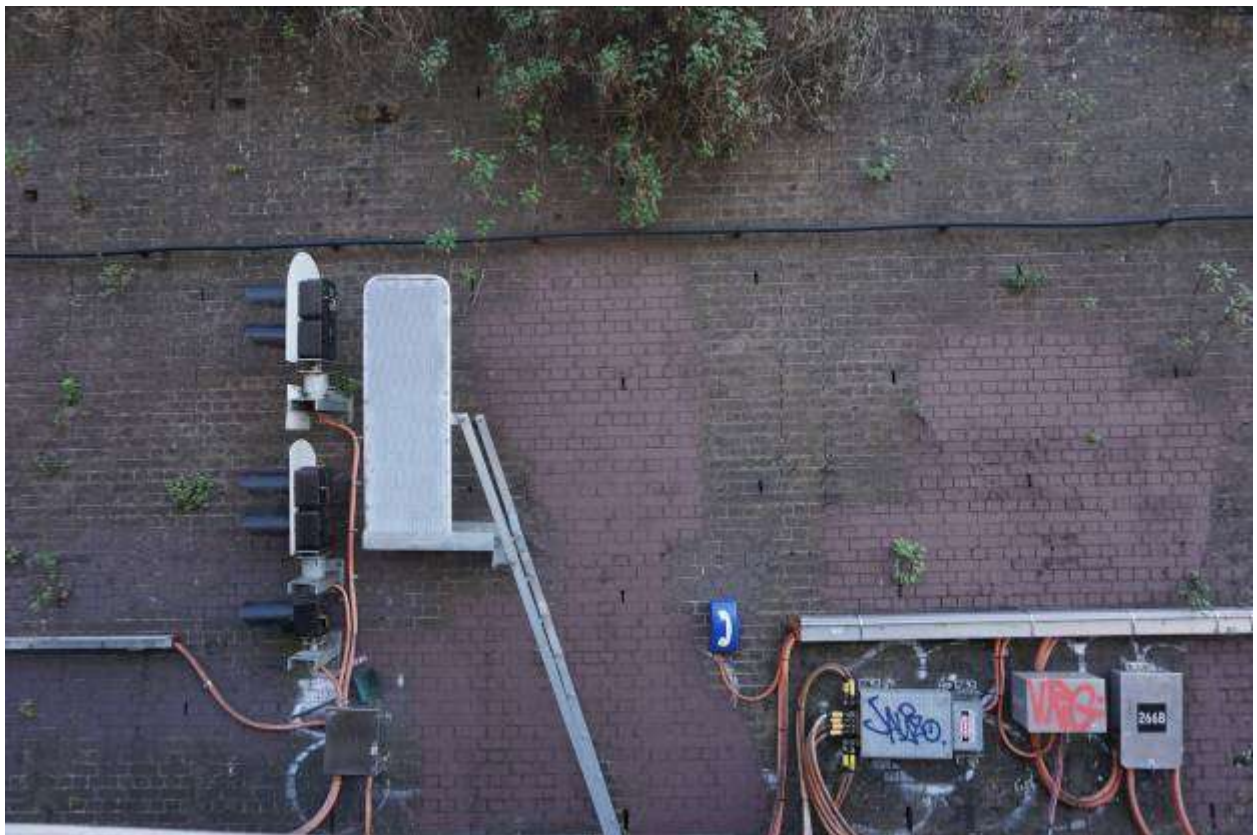
Figure 144 – General condition of RailCorp boundary wall observed from Railway Corridor

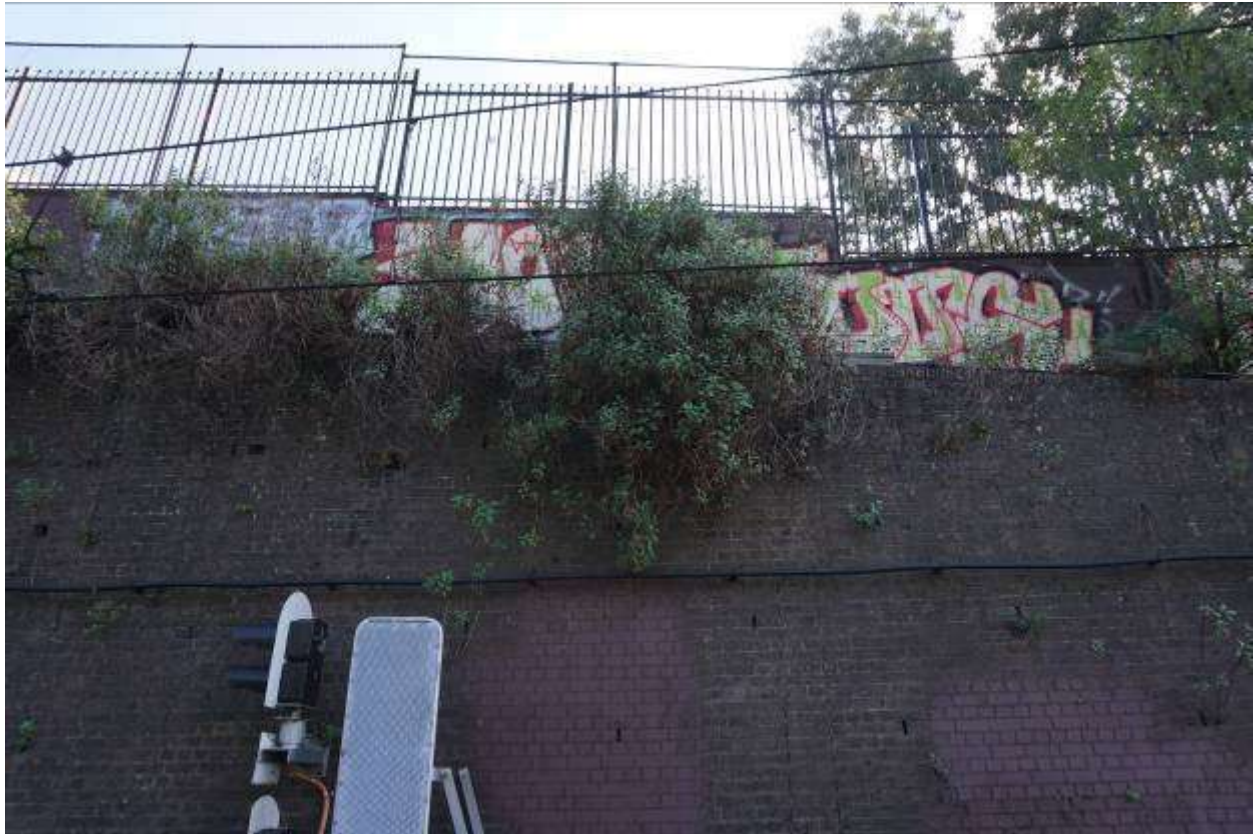
Figure 145 – General condition of RailCorp boundary wall and fence observed from Railway Corridor

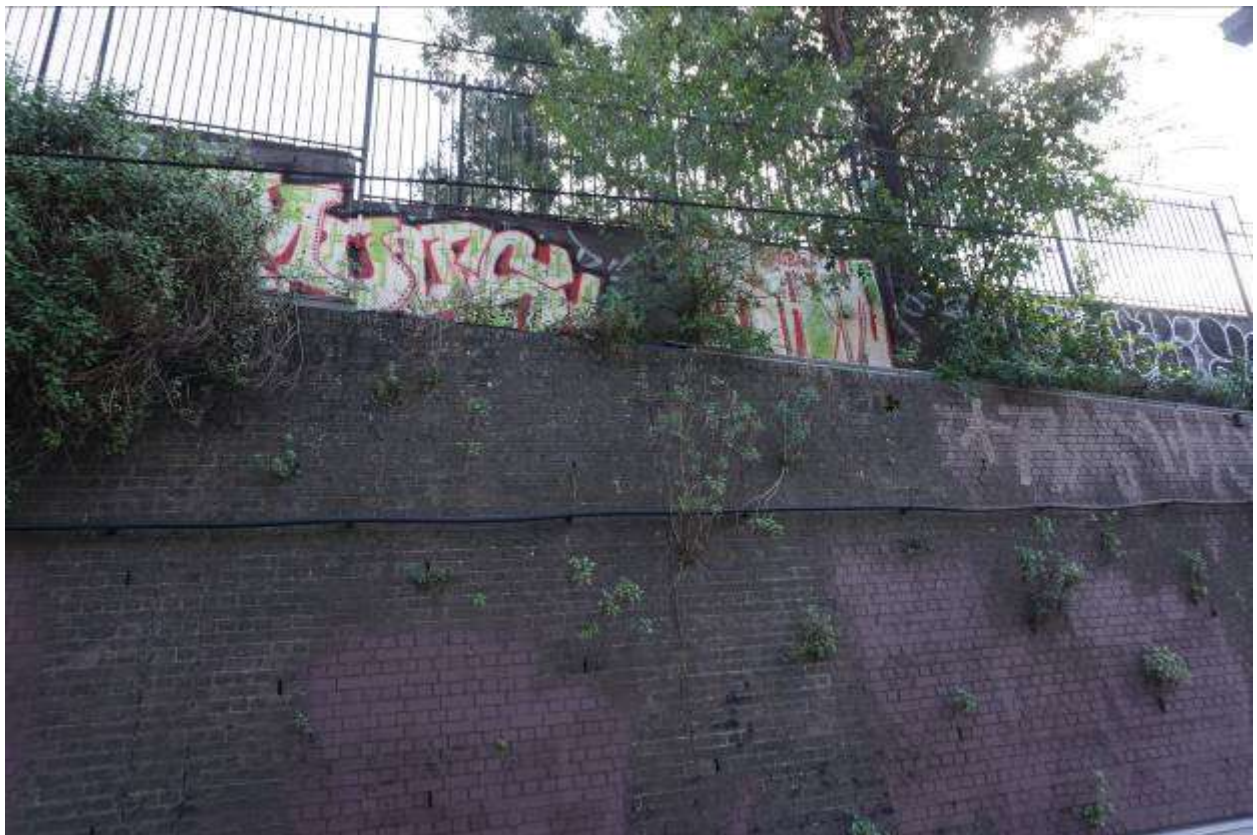
Figure 146 – General condition of RailCorp boundary wall and fence observed from Railway Corridor
