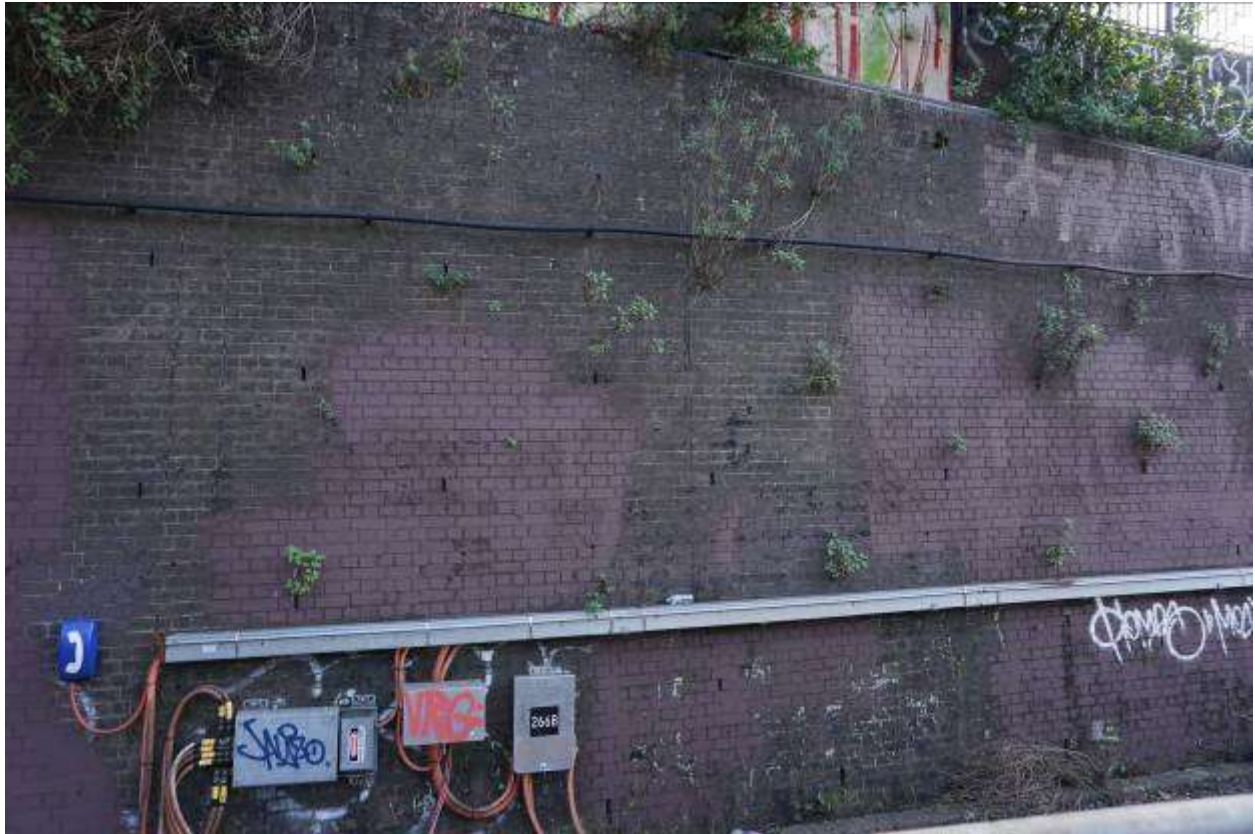
Figure 147 – General condition of RailCorp boundary wall observed from Railway Corridor

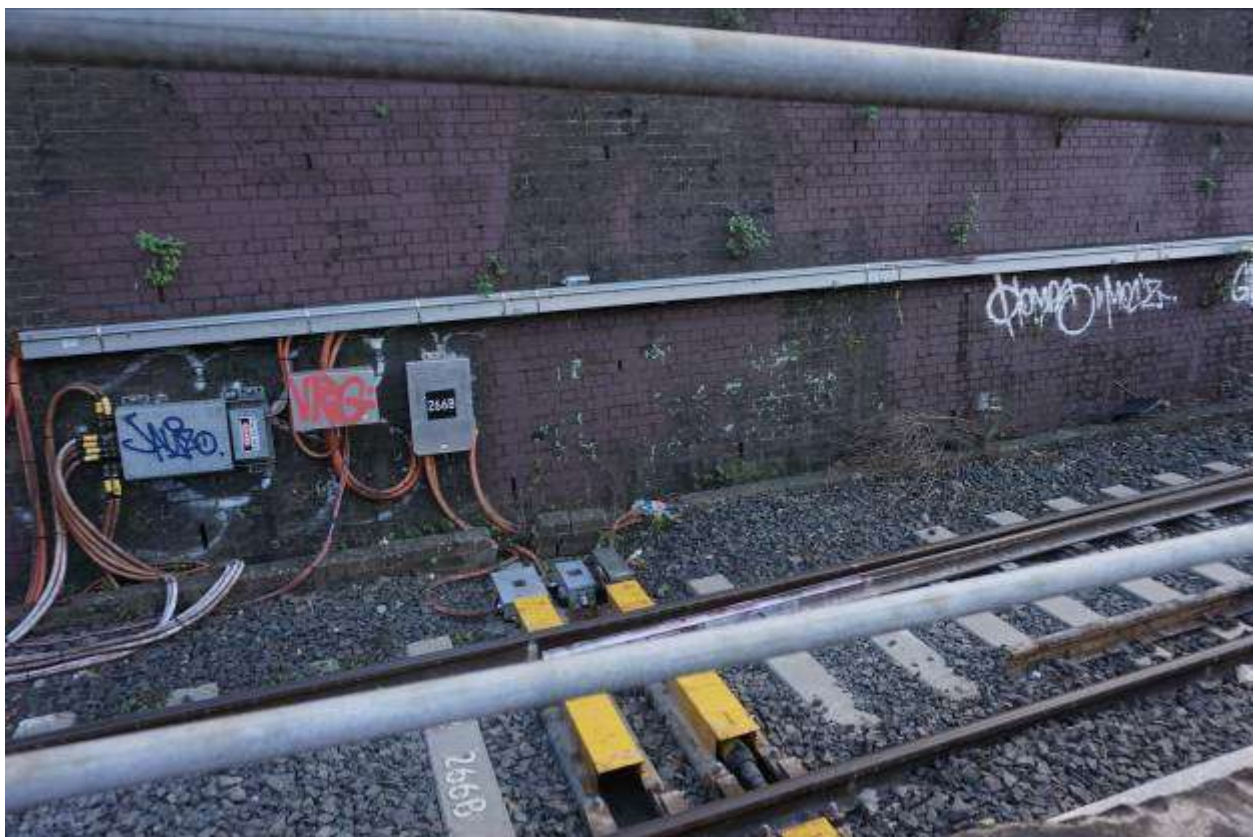
Figure 148 – General condition of RailCorp boundary wall observed from Railway Corridor

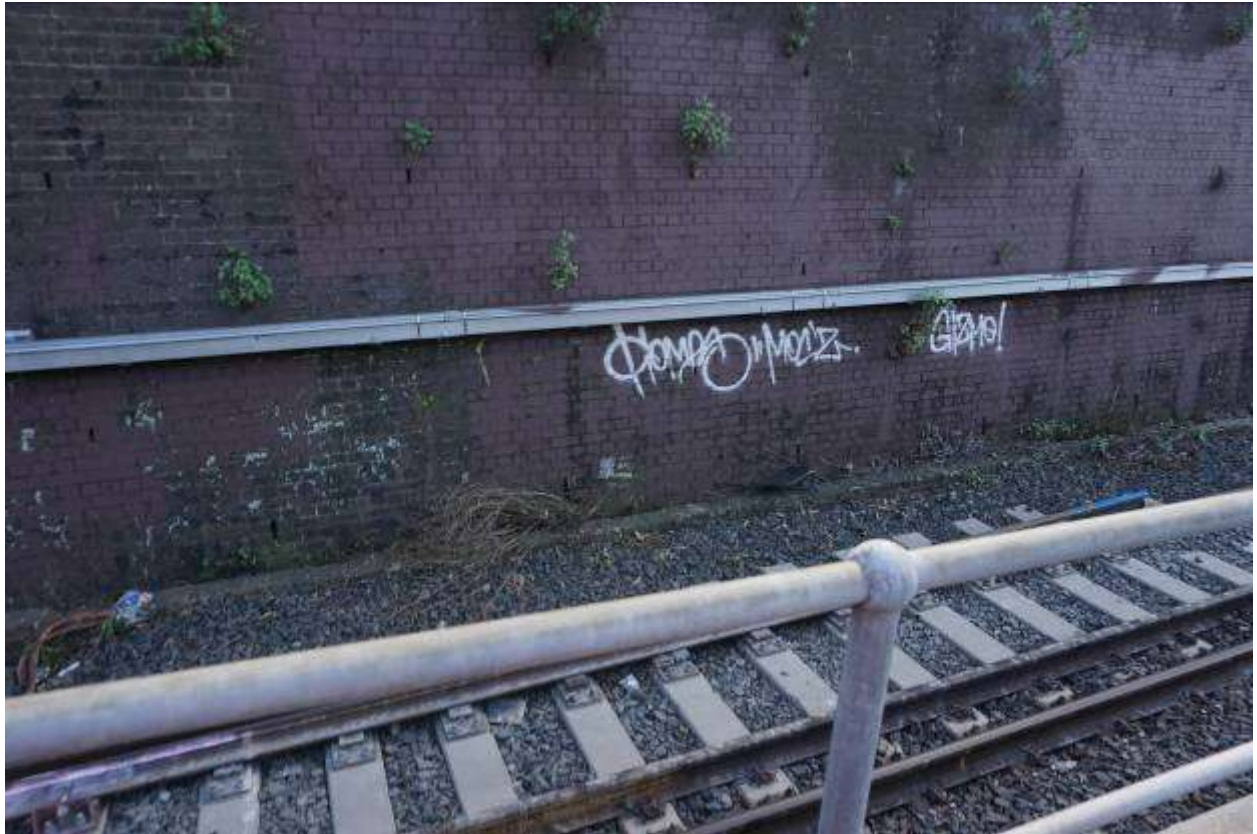
Figure 149 – General condition of RailCorp boundary wall observed from Railway Corridor

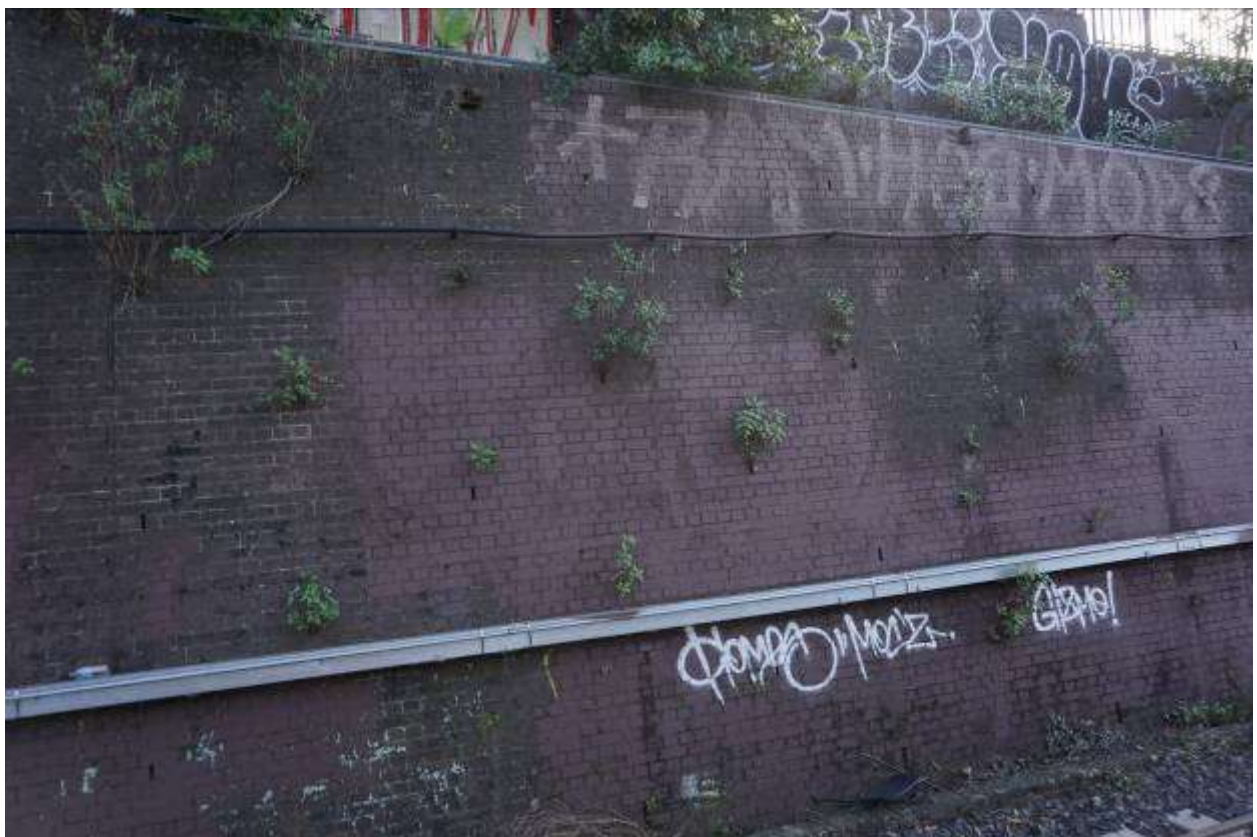
Figure 150 – General condition of RailCorp boundary wall observed from Railway Corridor

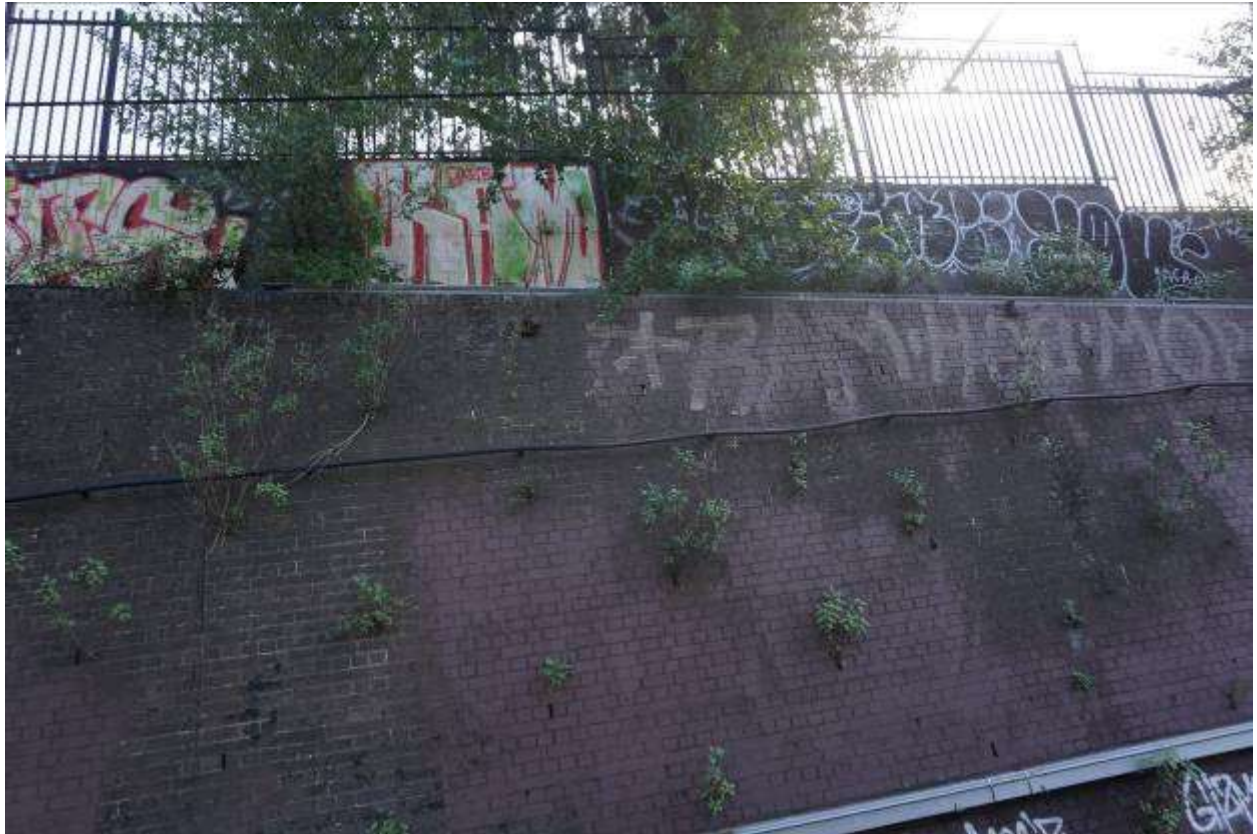
Figure 151 – General condition of RailCorp boundary wall and fence observed from Railway Corridor

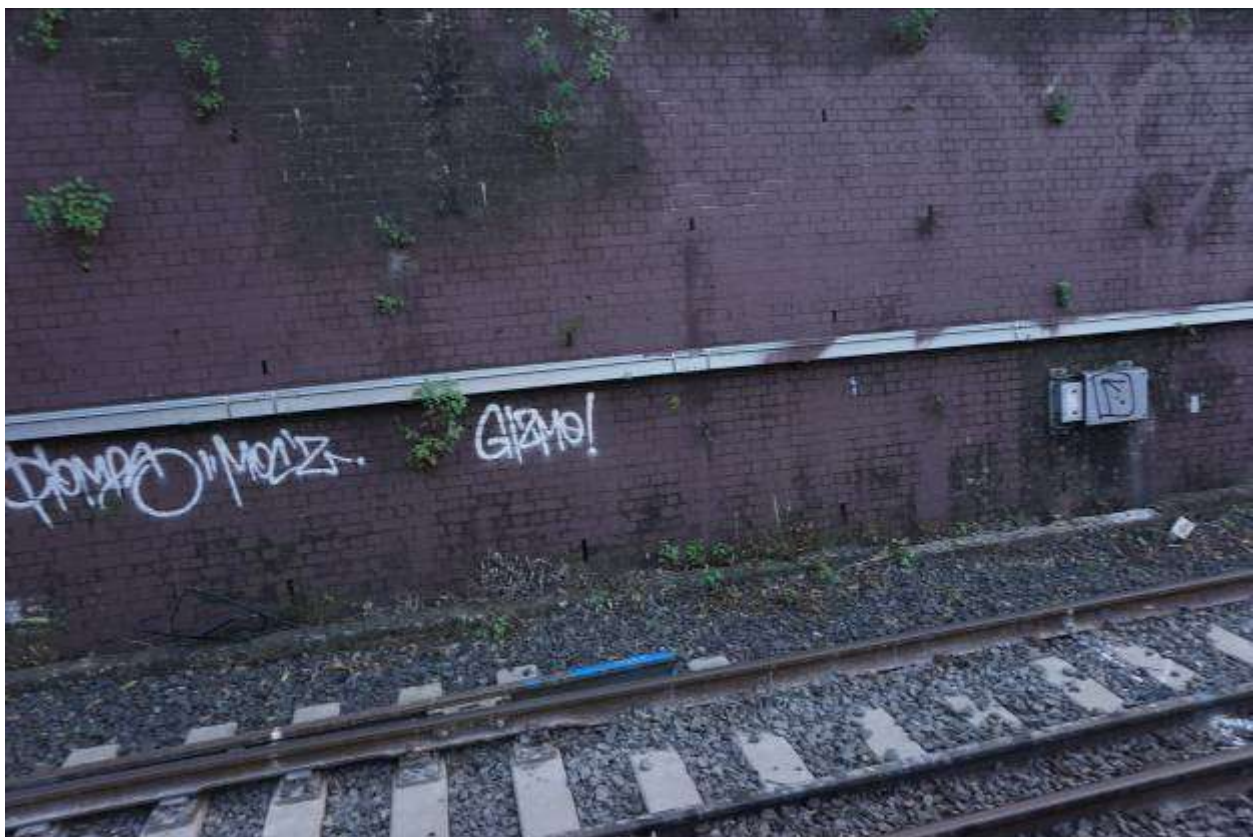
Figure 152 – General condition of RailCorp boundary wall observed from Railway Corridor

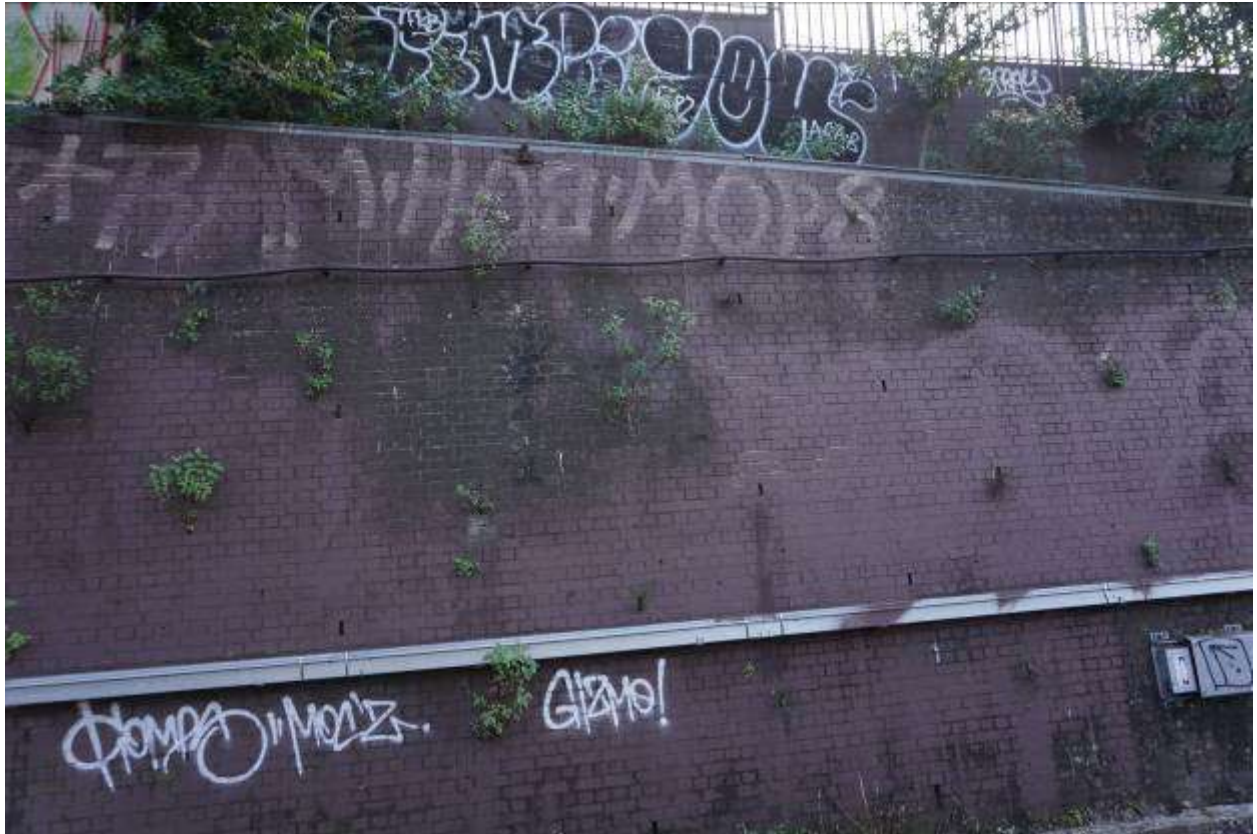
Figure 153 – General condition of RailCorp boundary wall observed from Railway Corridor

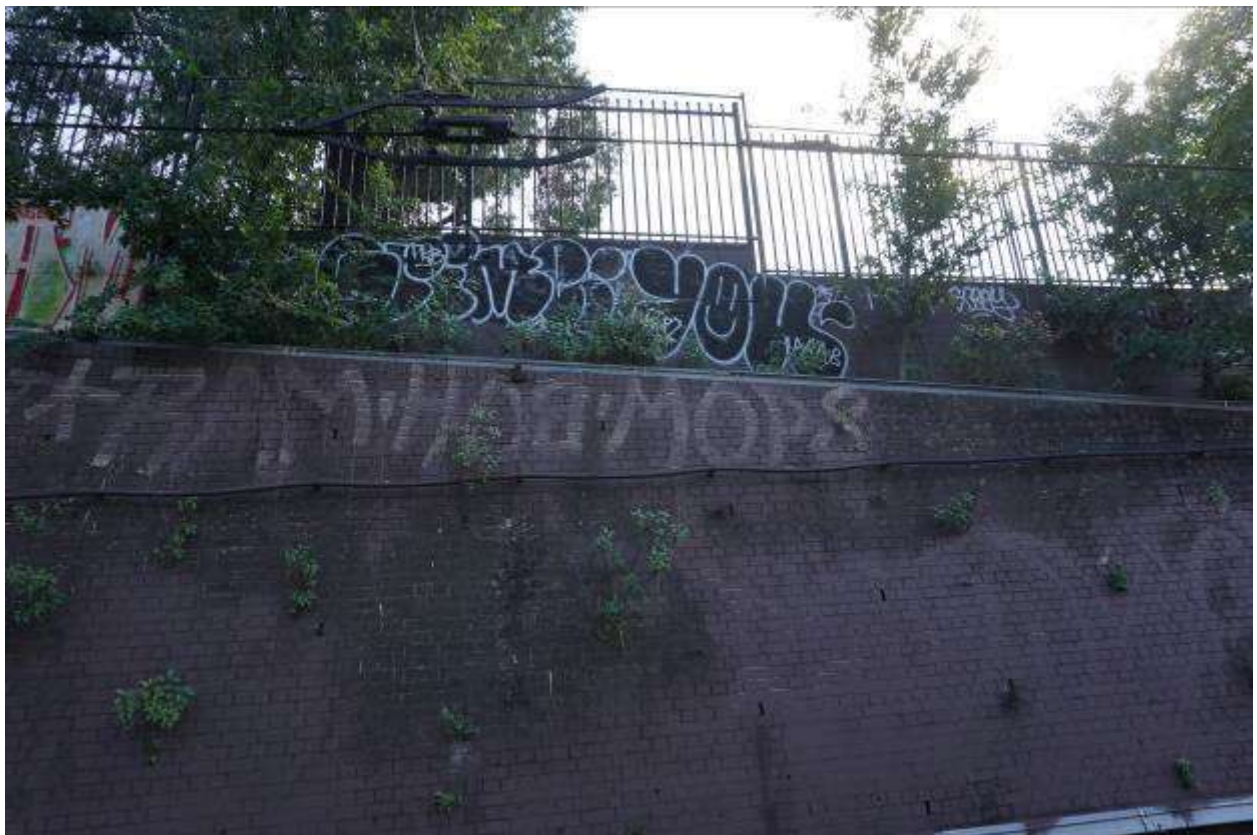
Figure 154 – General condition of RailCorp boundary wall and fence observed from Railway Corridor

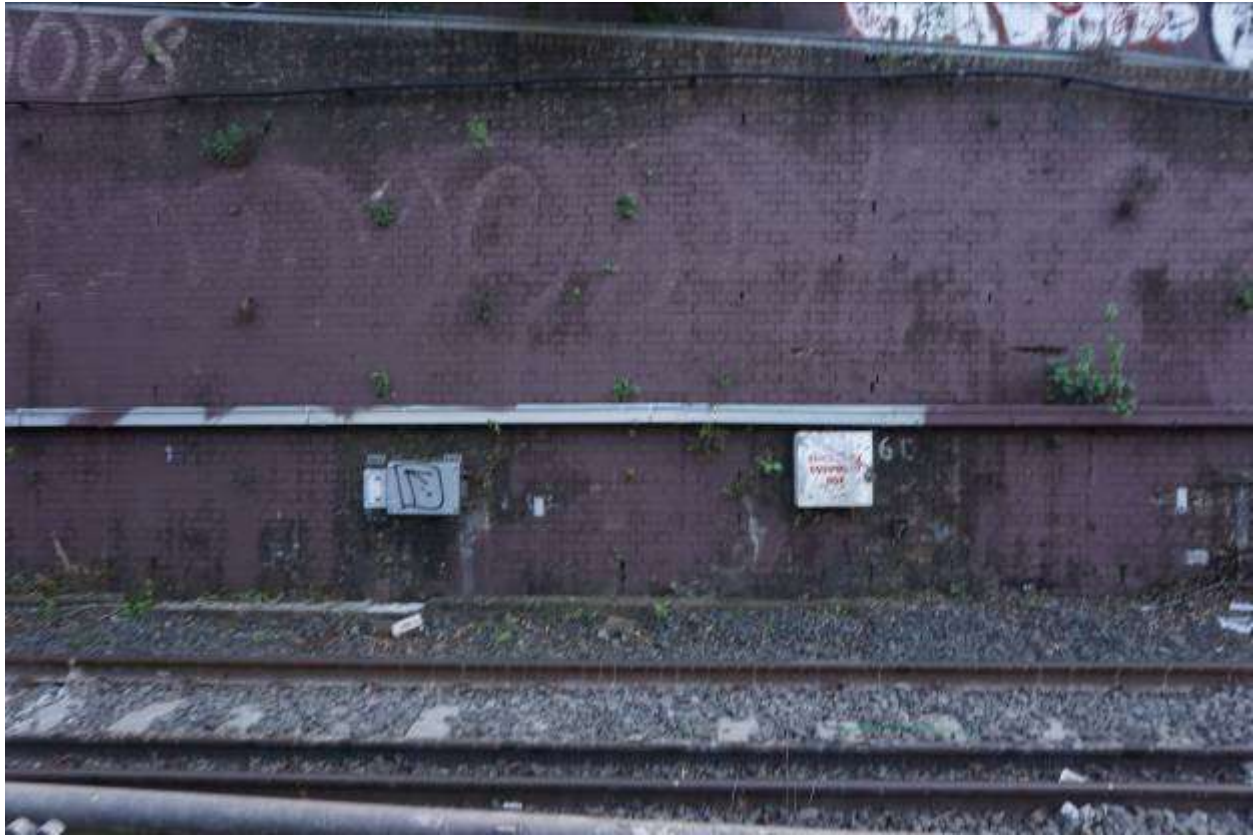
Figure 155 – General condition of RailCorp boundary wall observed from Railway Corridor

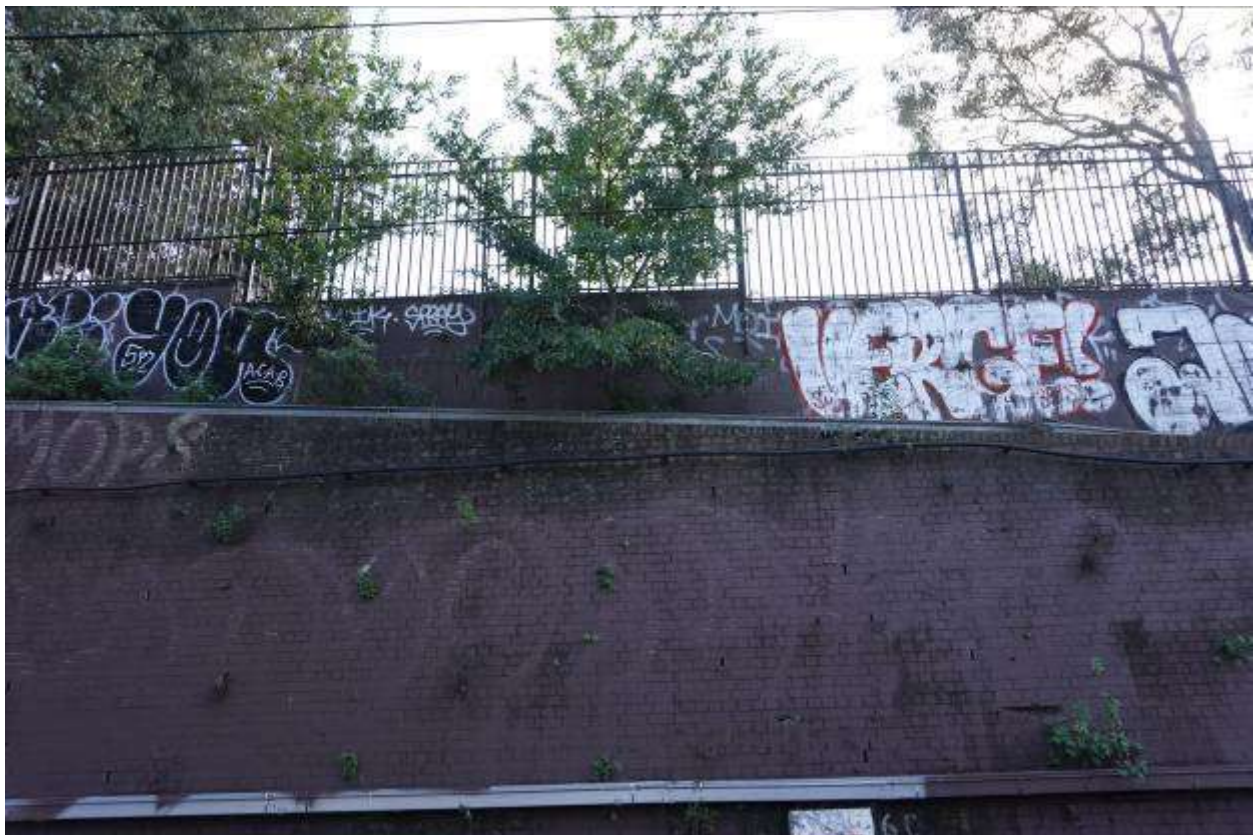
Figure 156 – General condition of RailCorp boundary wall and fence observed from Railway Corridor

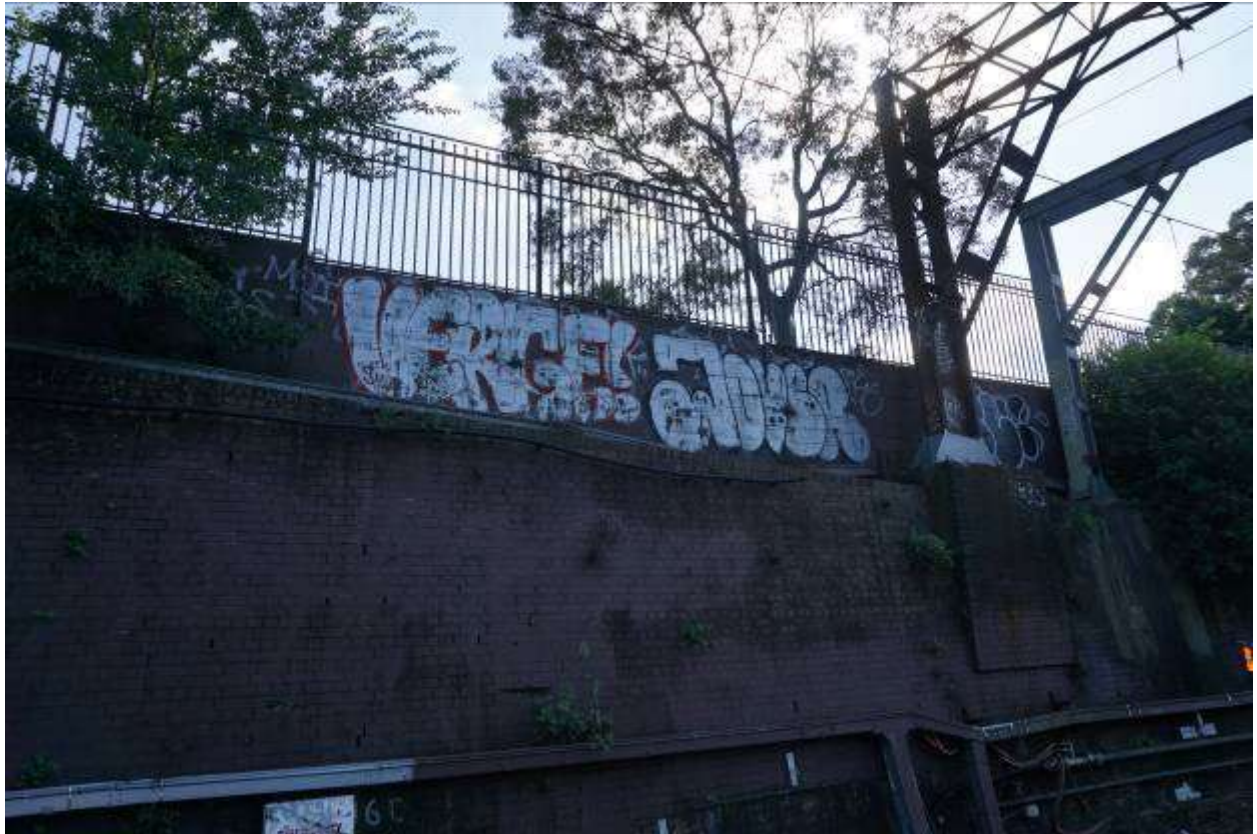
Figure 157 – General condition of RailCorp boundary wall and fence observed from Railway Corridor

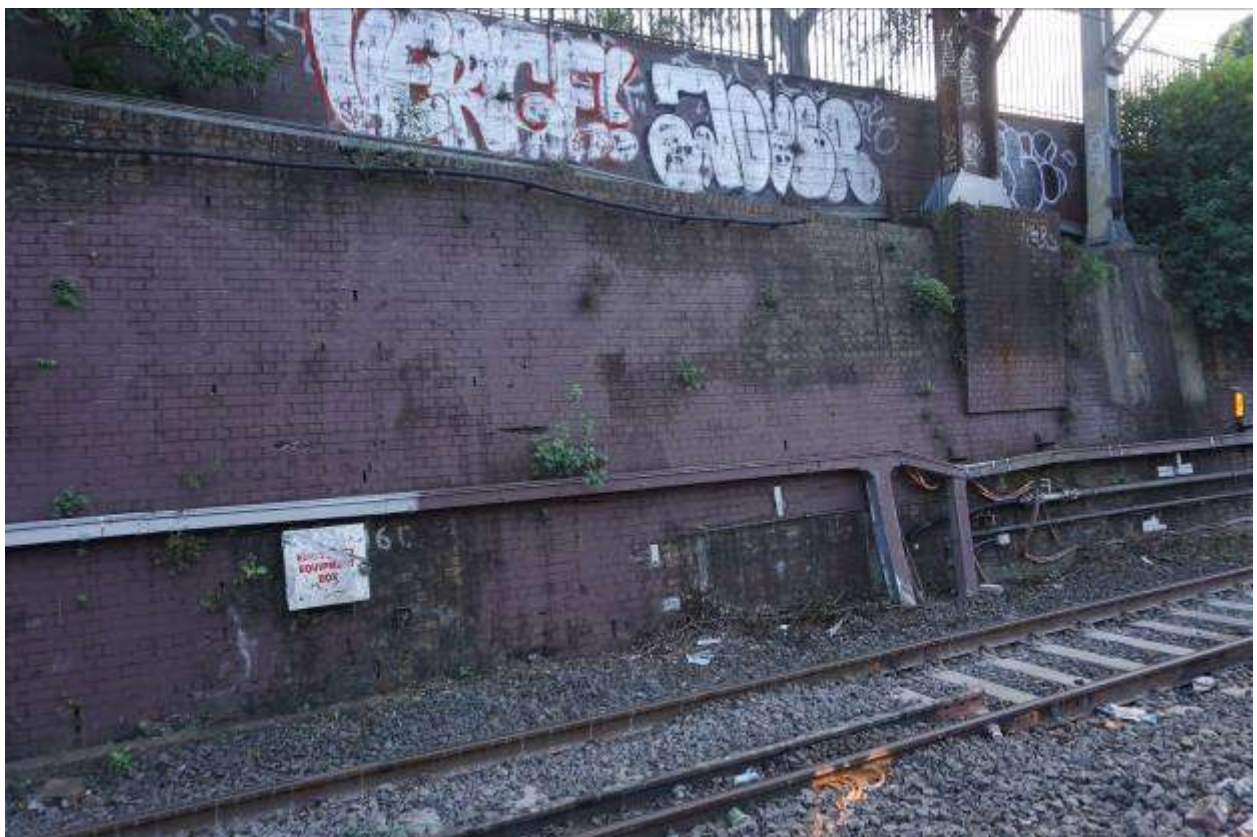
Figure 158 – General condition of RailCorp boundary wall observed from Railway Corridor

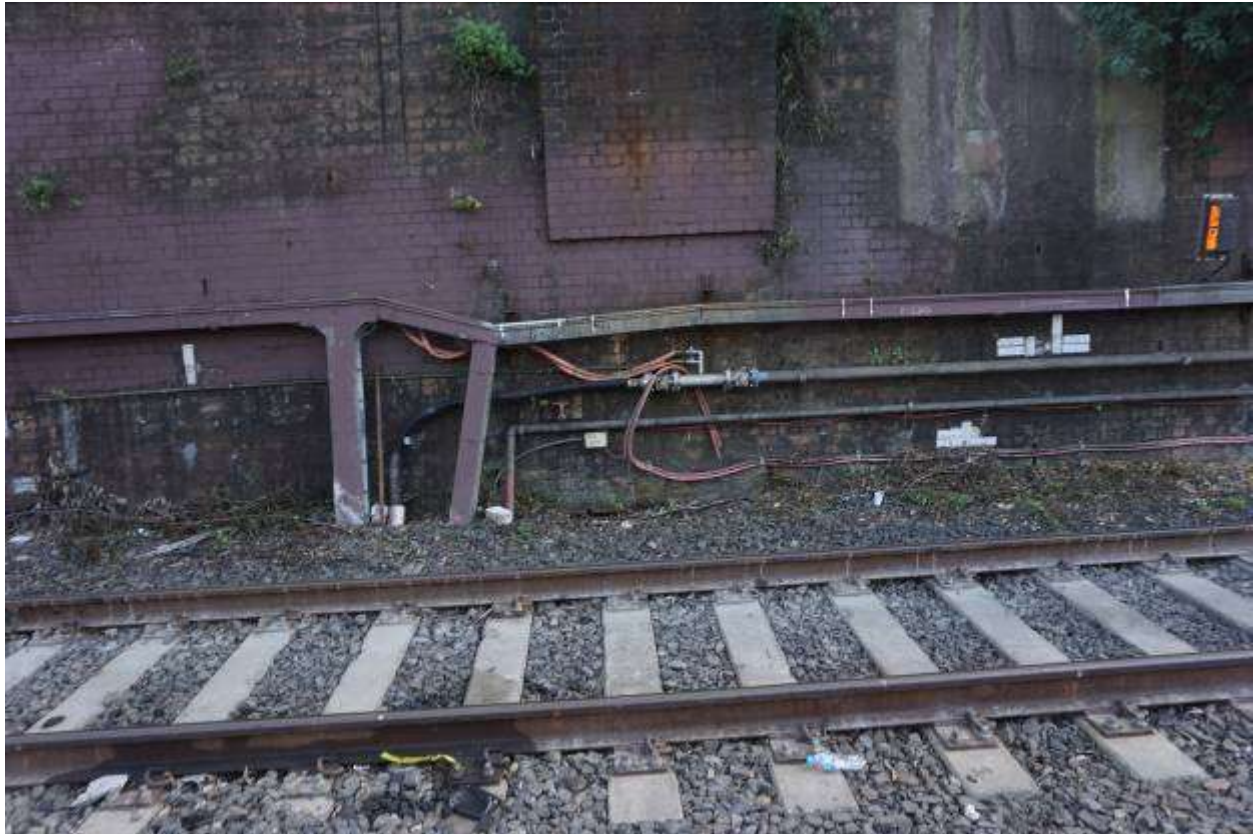
Figure 159 – General condition of RailCorp boundary wall observed from Railway Corridor

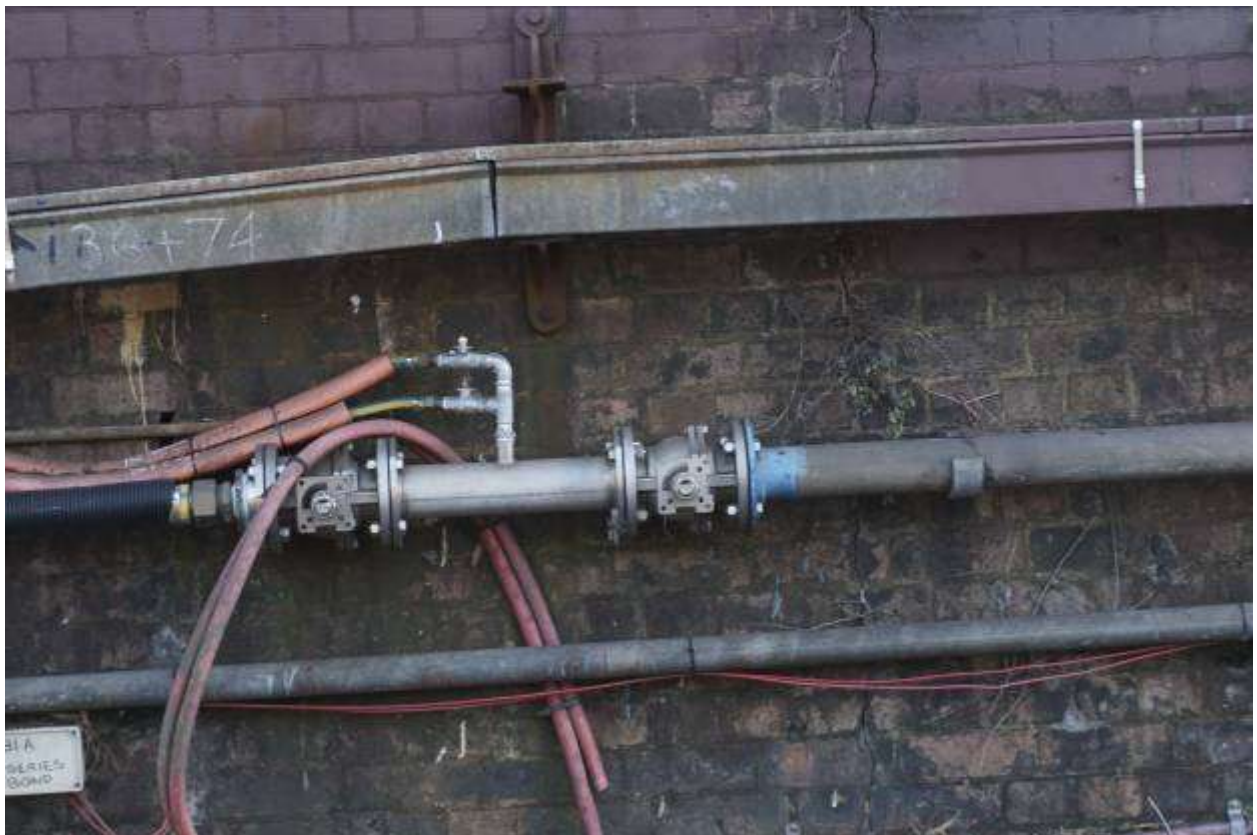
Figure 160 – Crack propagation through RailCorp boundary wall observed from Railway Corridor

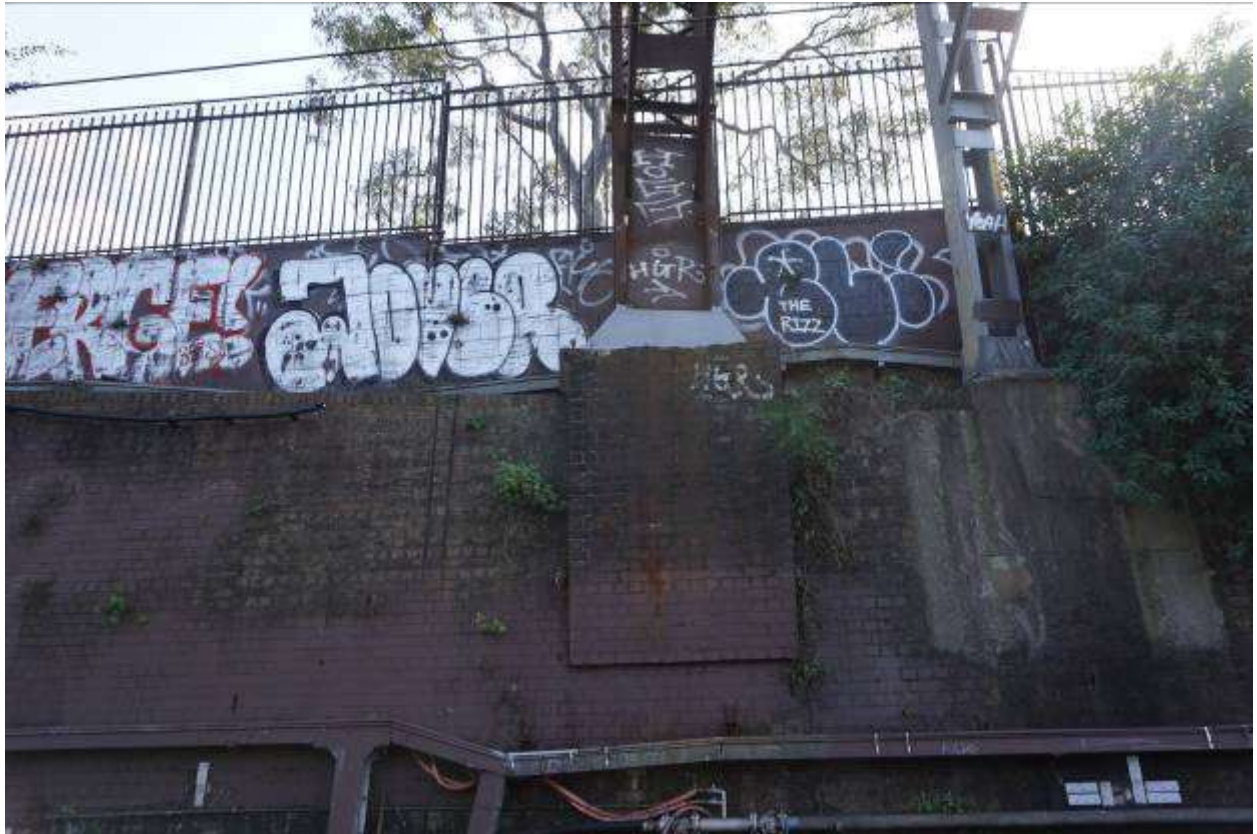
Figure 161 – General condition of RailCorp boundary wall and fence observed from Railway Corridor

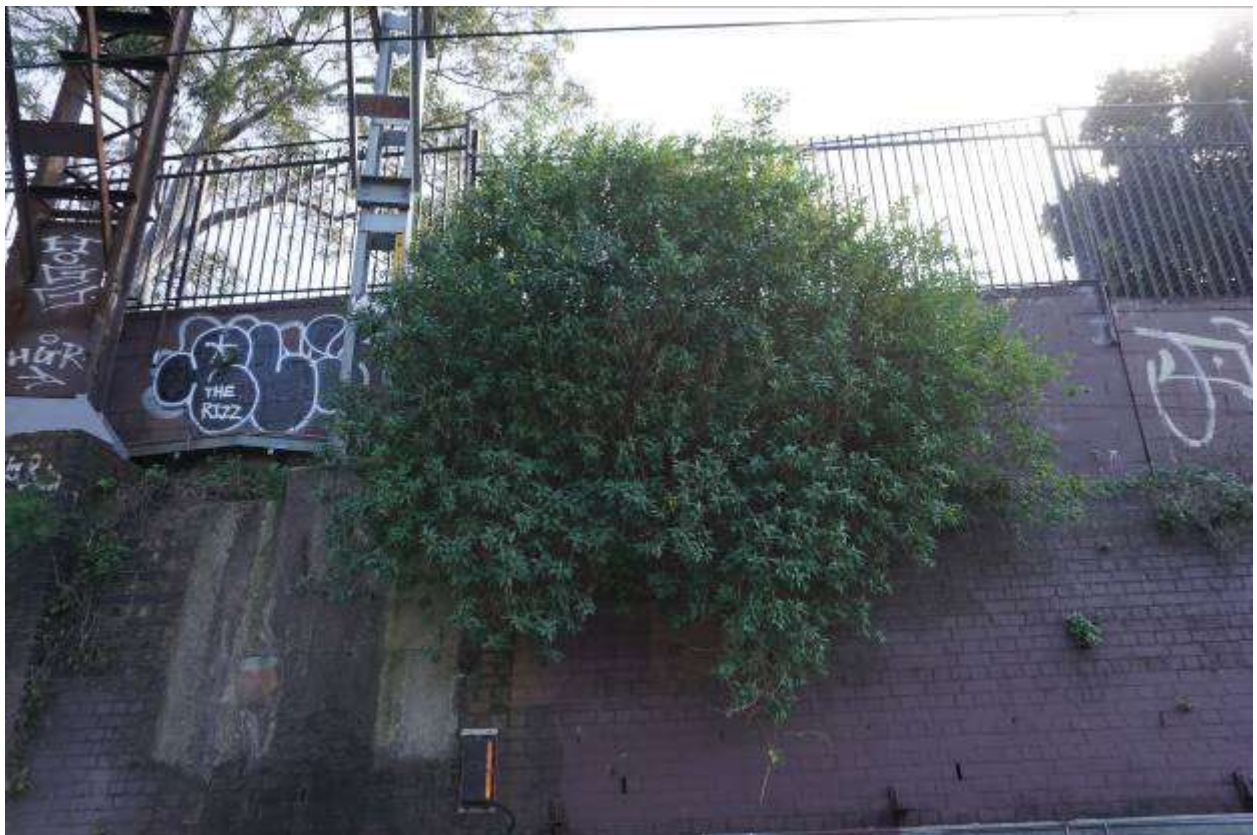
Figure 162 – General condition of RailCorp boundary wall and fence observed from Railway Corridor

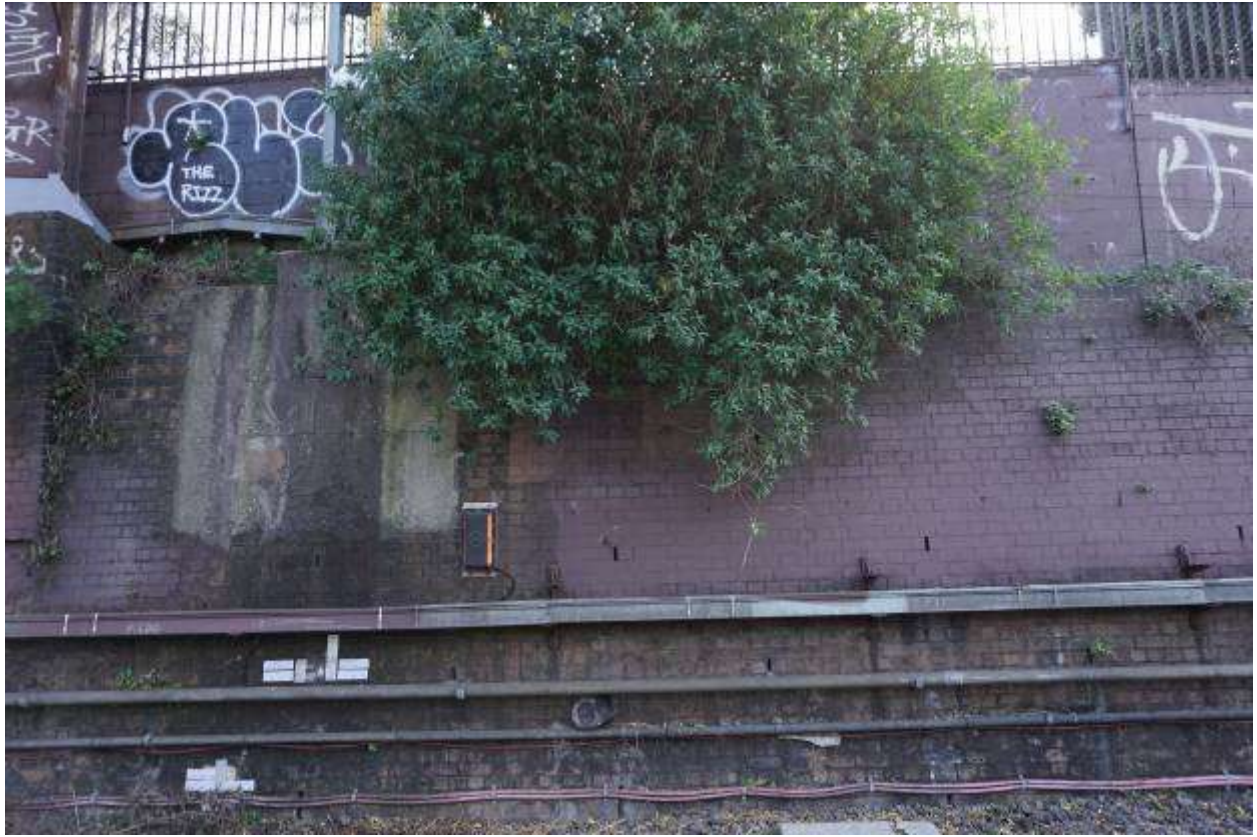
Figure 163 – General condition of RailCorp boundary wall observed from Railway Corridor

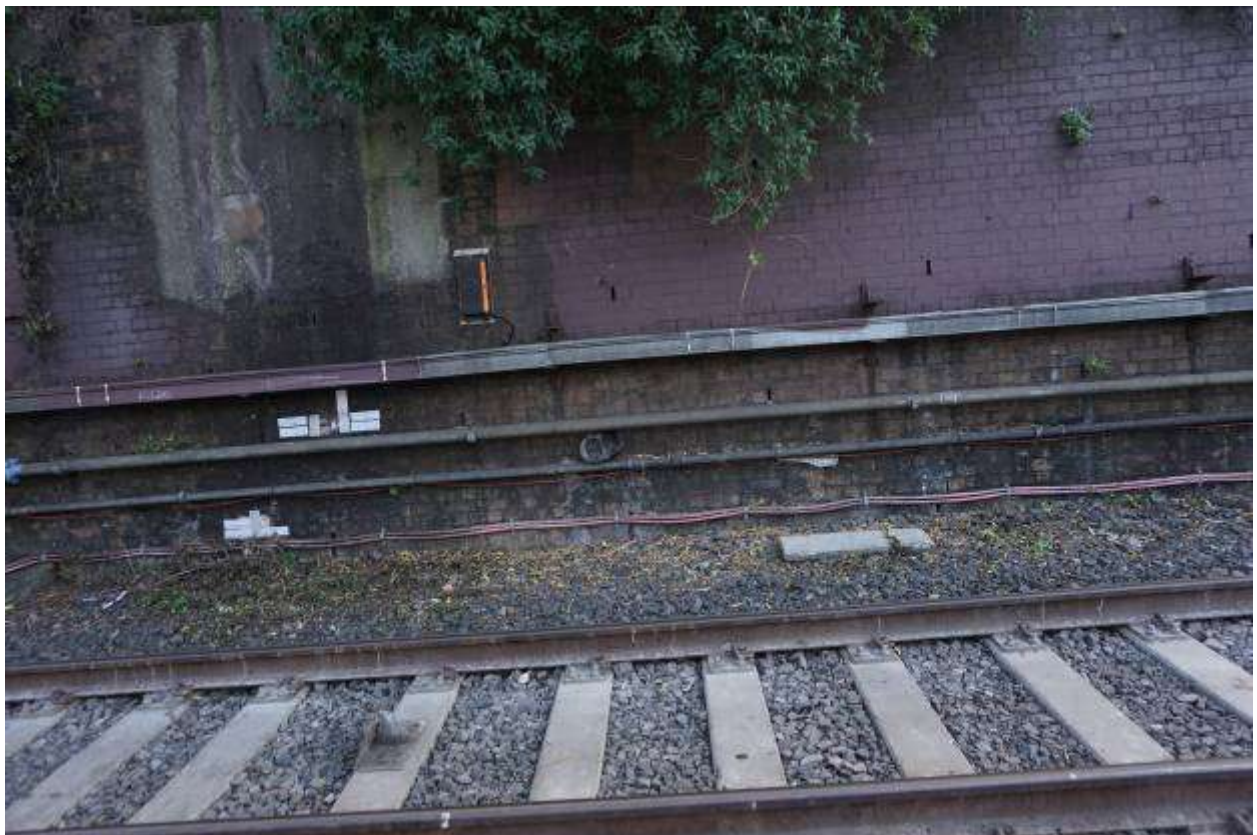
Figure 164 – General condition of RailCorp boundary wall observed from Railway Corridor

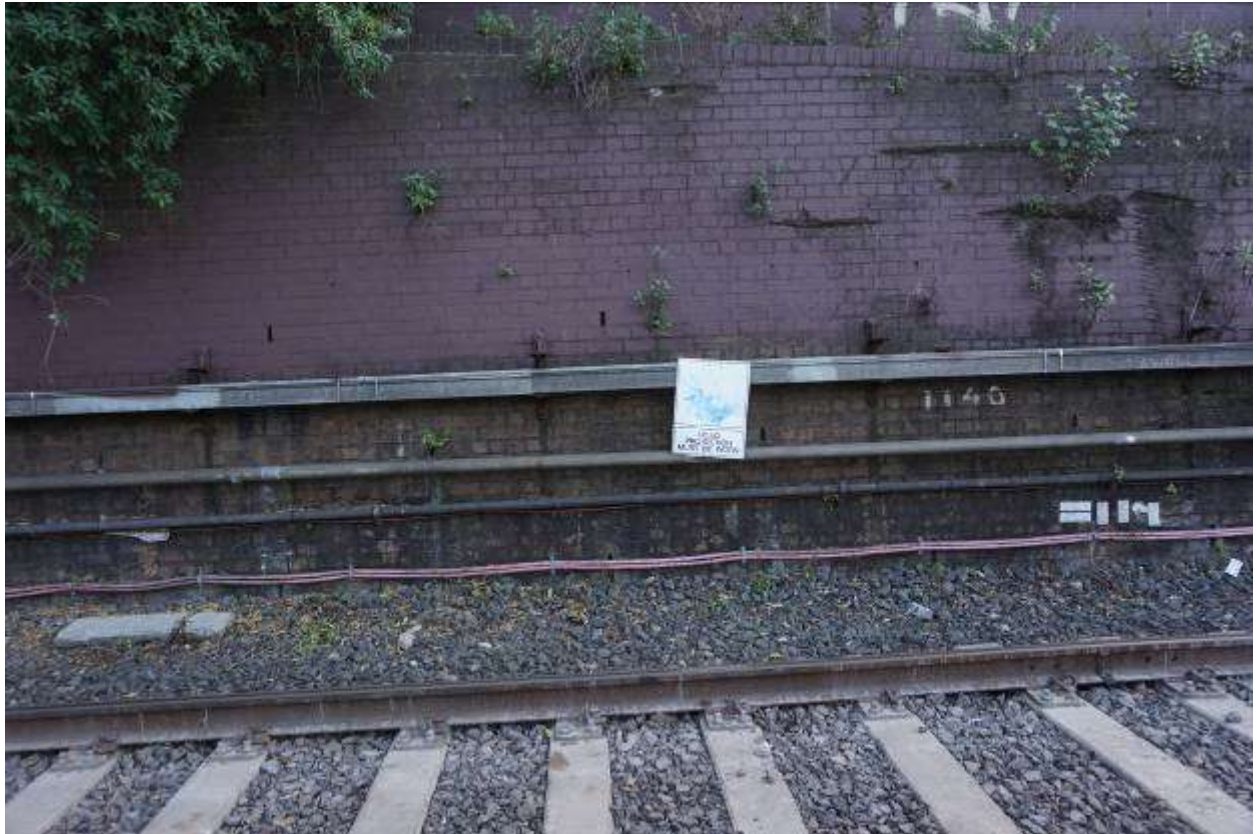
Figure 165 – General condition of RailCorp boundary wall observed from Railway Corridor

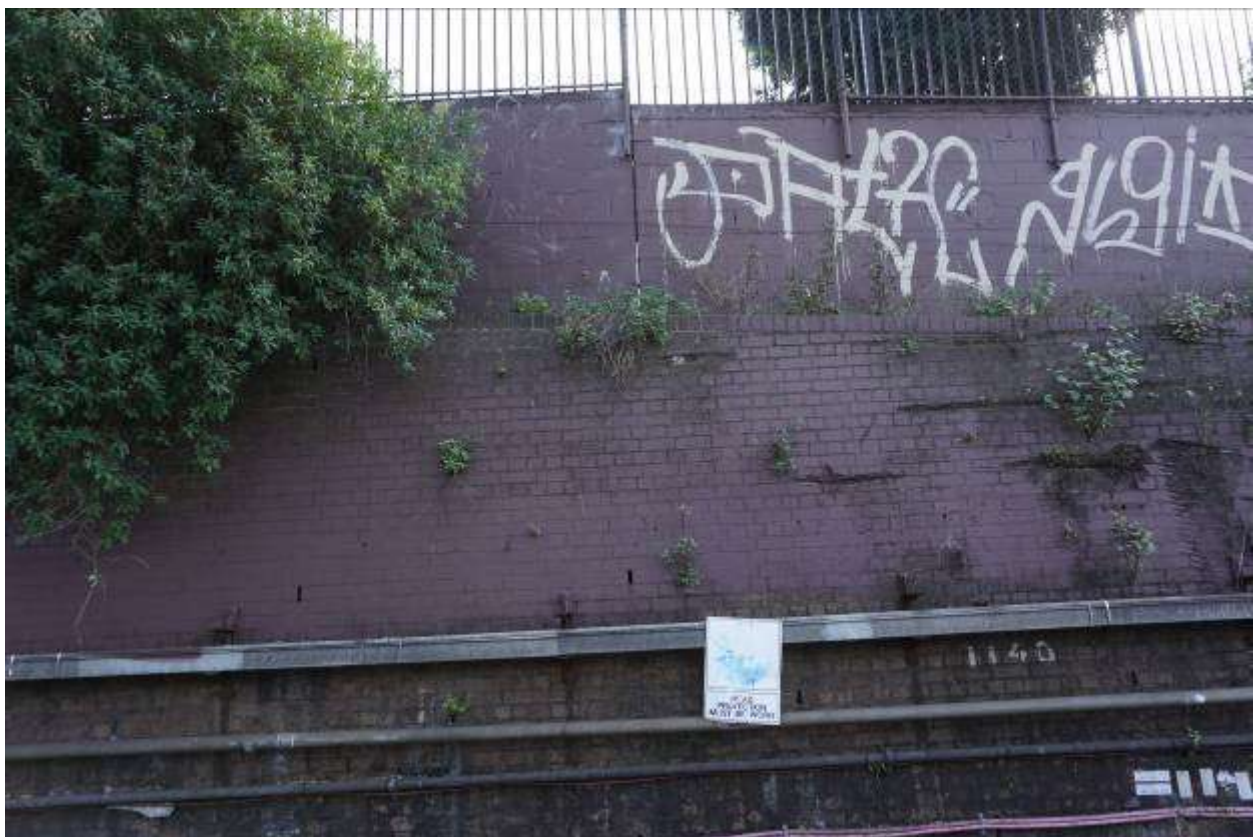
Figure 166 – General condition of RailCorp boundary wall observed from Railway Corridor

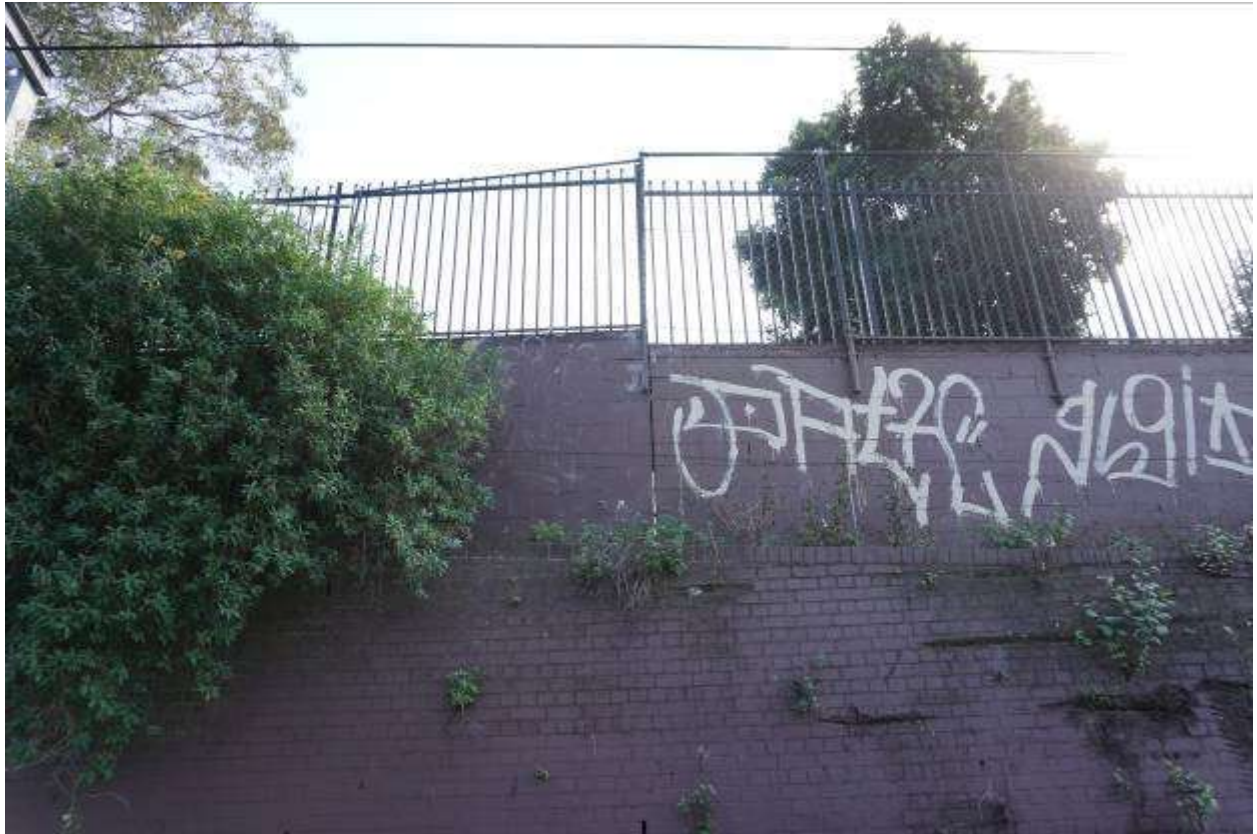
Figure 167 – General condition of RailCorp boundary wall and fence observed from Railway Corridor
