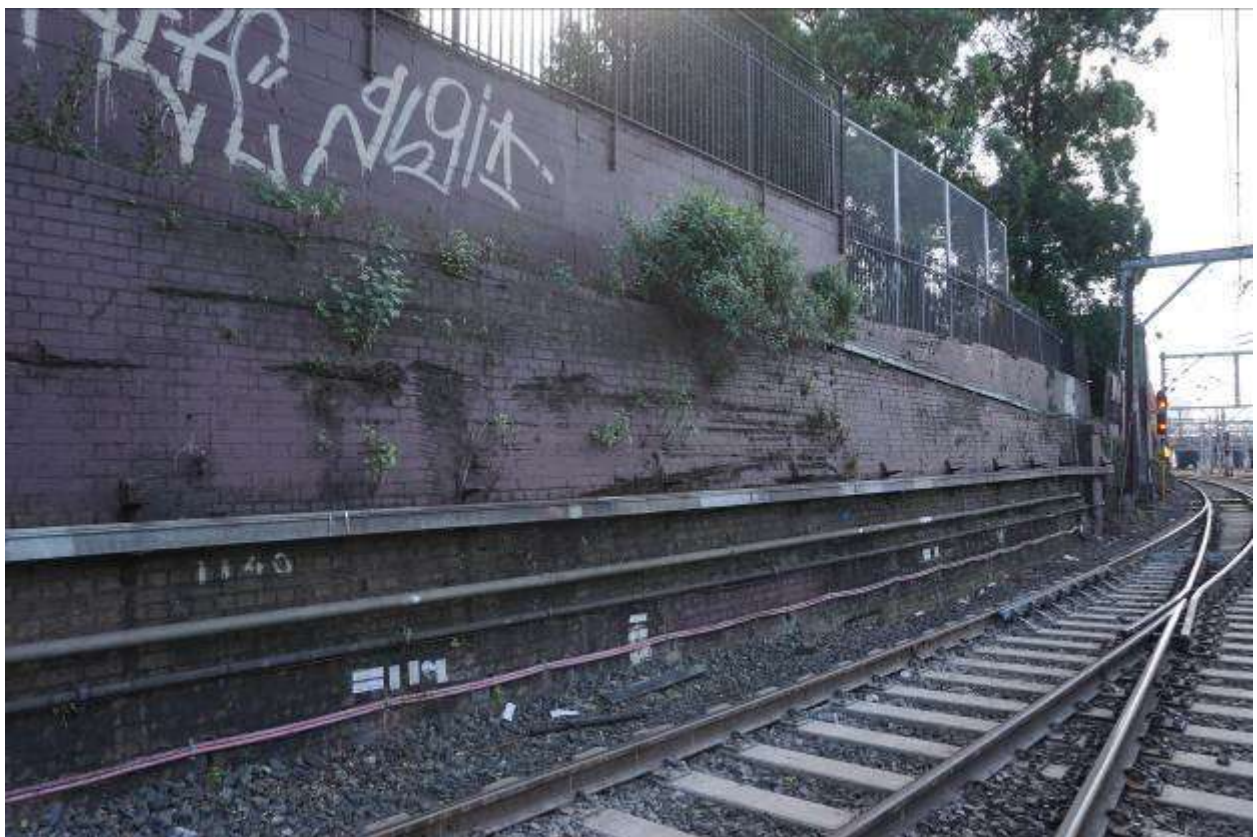
Figure 168 – General condition of RailCorp boundary wall observed from Railway Corridor

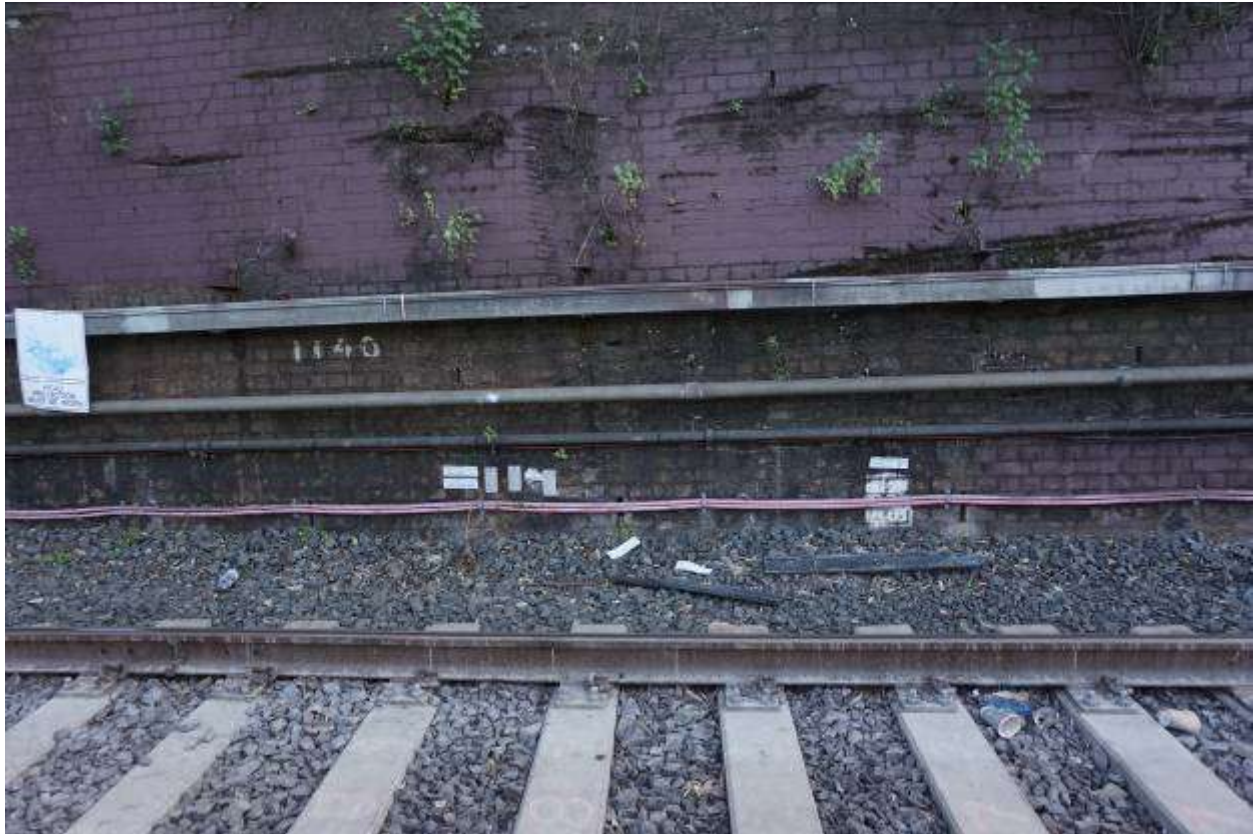
Figure 169 – General condition of RailCorp boundary wall observed from Railway Corridor

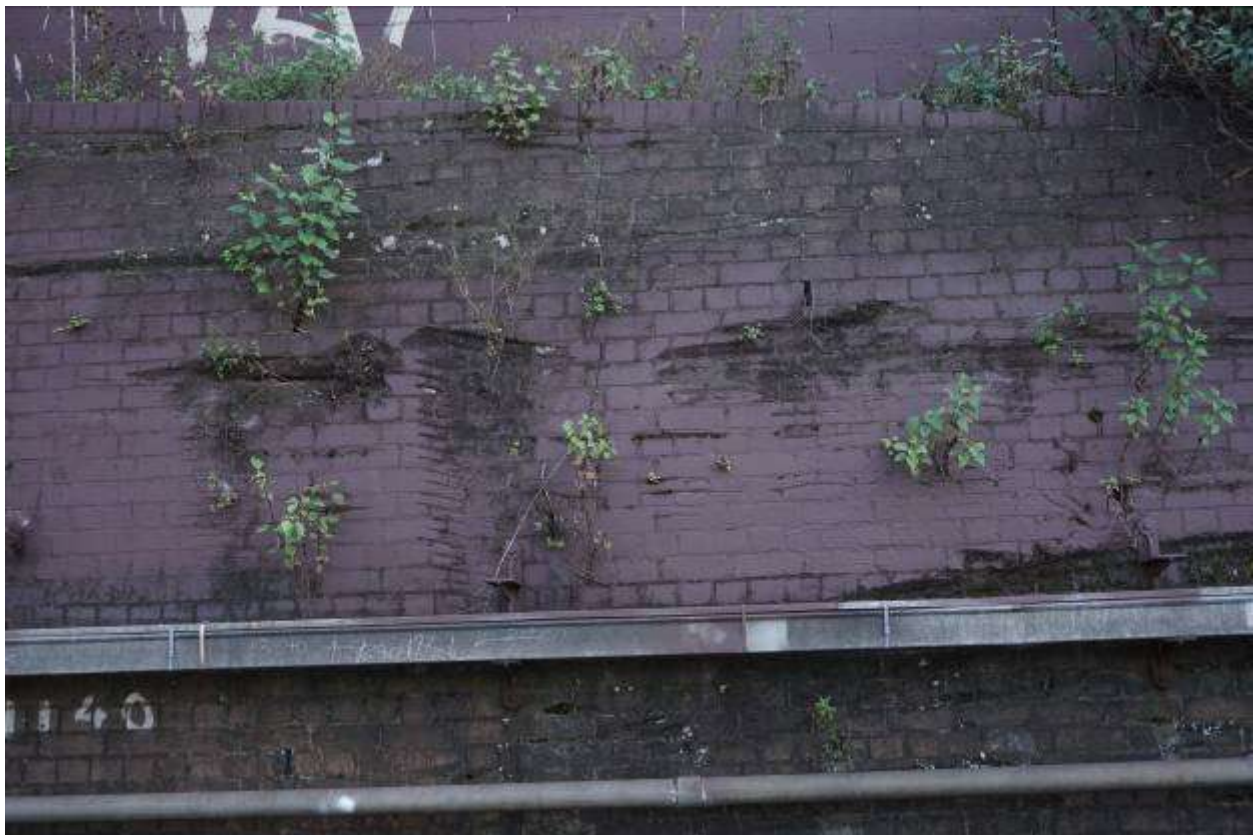
Figure 170 – Crack propagation through RailCorp boundary wall observed from Railway Corridor
