Re: Dilapidation Report for Property
No: Pemulwuy Project - Redfern NSW 2016

Job: 170037.0
Date: MAY 2017

SUMMARY

This report serves as a record of the condition of the RailCorp infrastructure assets of the "Metro Illawarra & South Coast" line, which is adjacent to the subject site, prior to the commencement of any works proposed at: Pemulwuy Project - Redfern NSW 2016.

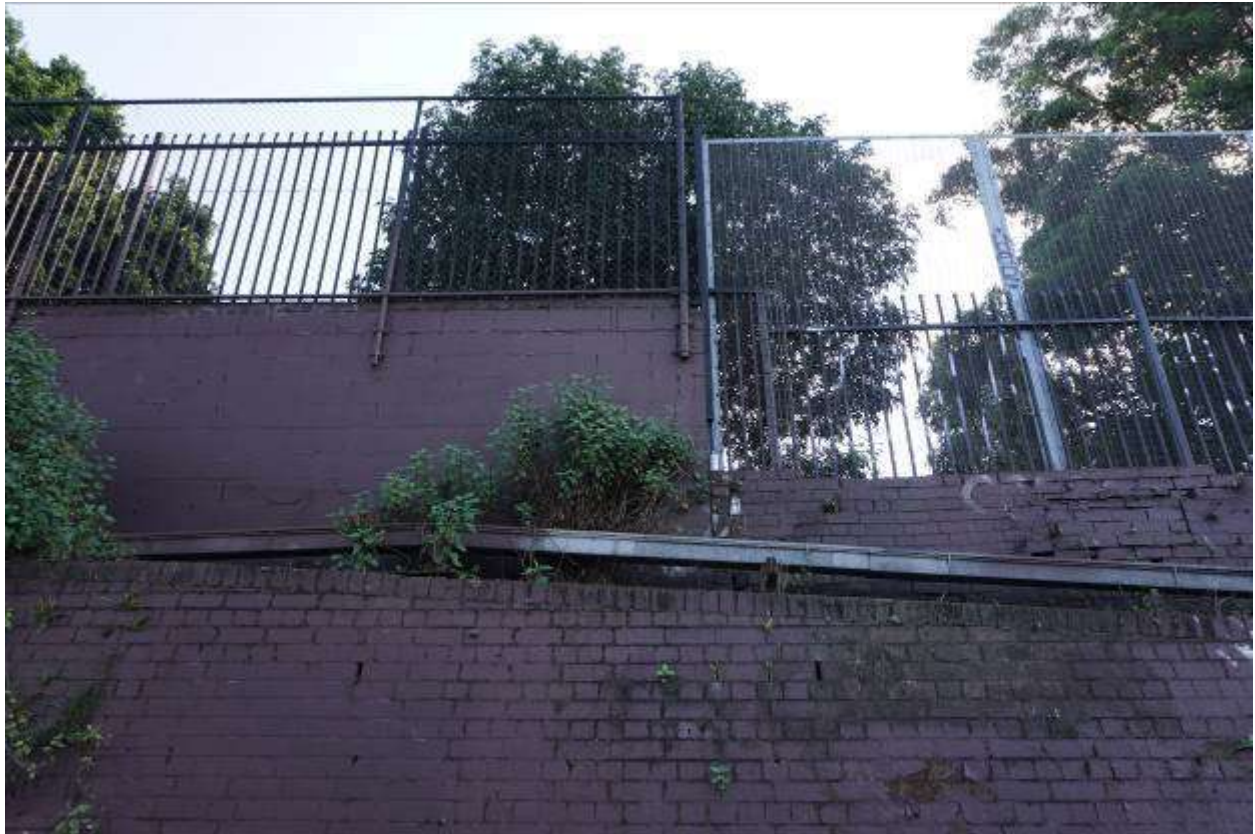
Figure 177 – General condition of RailCorp boundary wall and fence observed from Railway Corridor

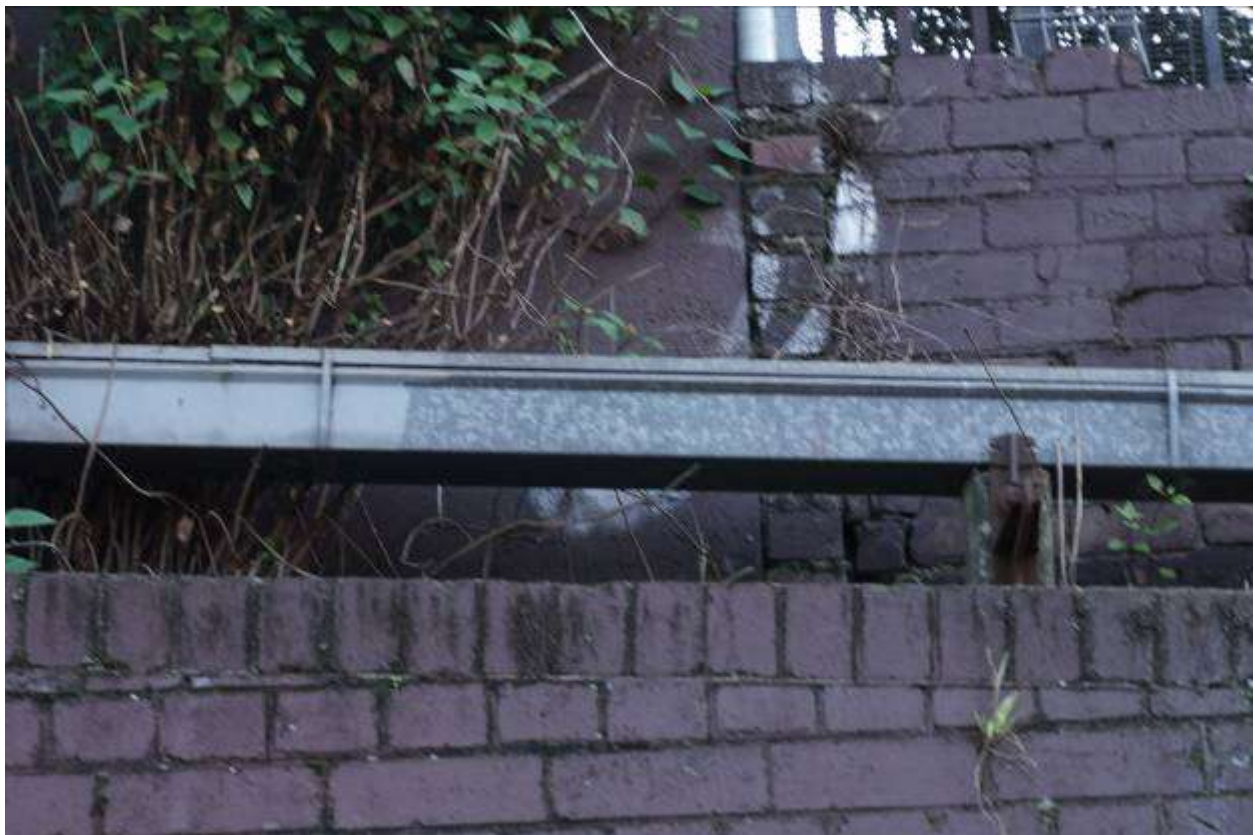
Figure 178 – Crack propagation through RailCorp boundary wall observed from Railway Corridor

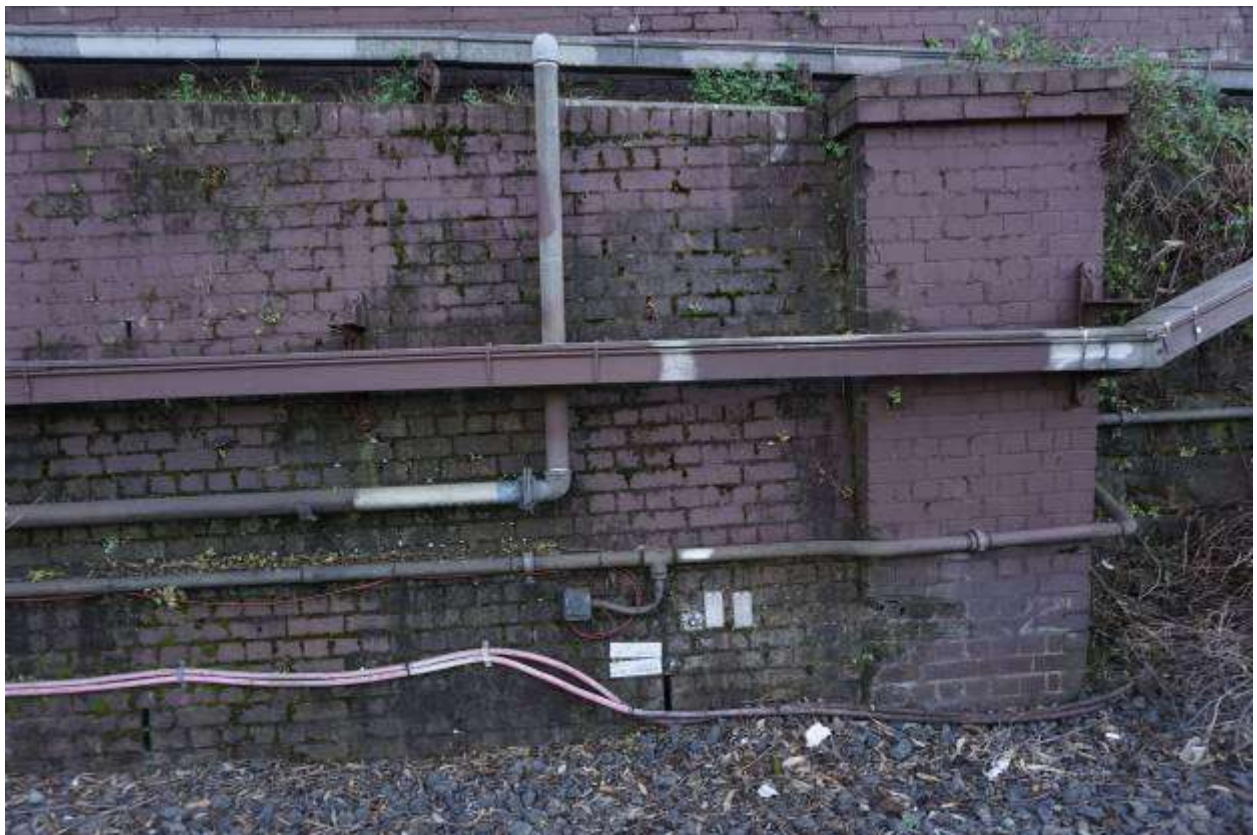
Figure 182 – General condition of RailCorp boundary wall observed from Railway Corridor

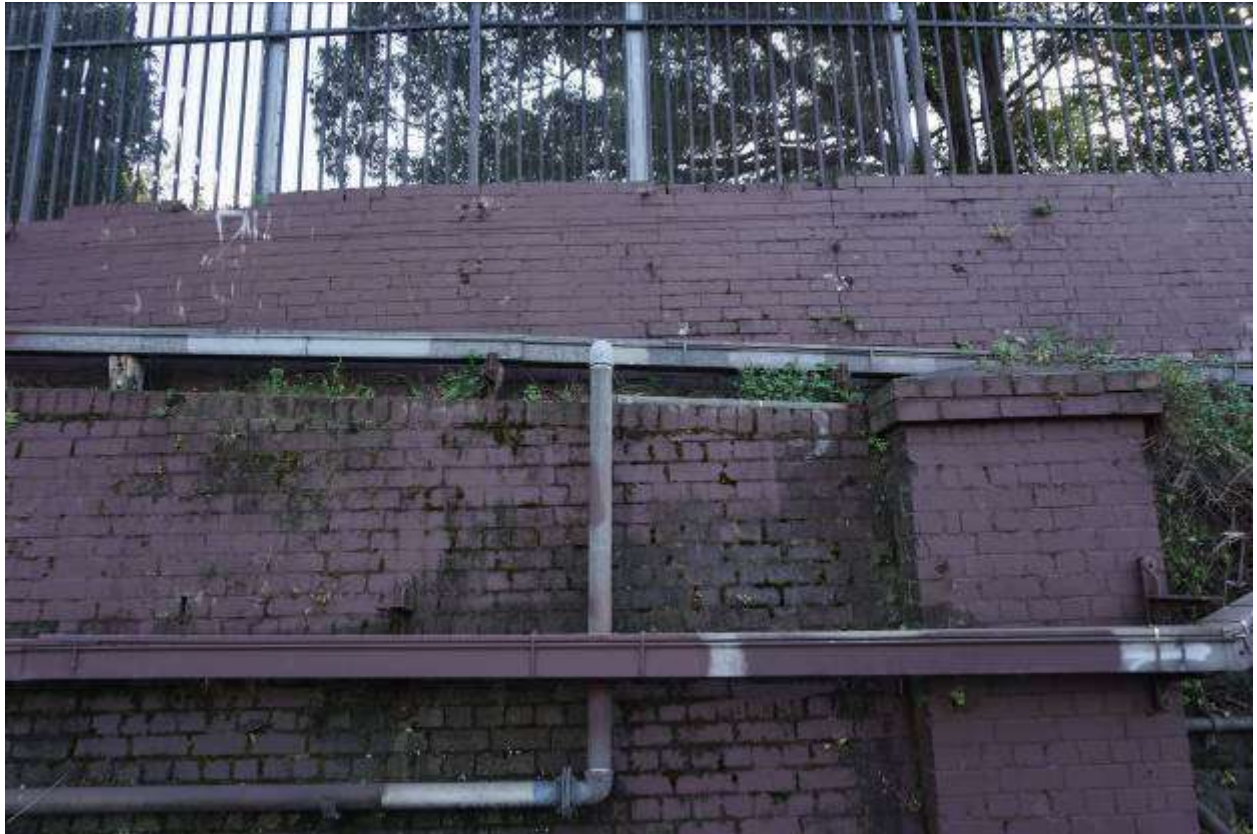
Figure 183 – General condition of RailCorp boundary wall observed from Railway Corridor

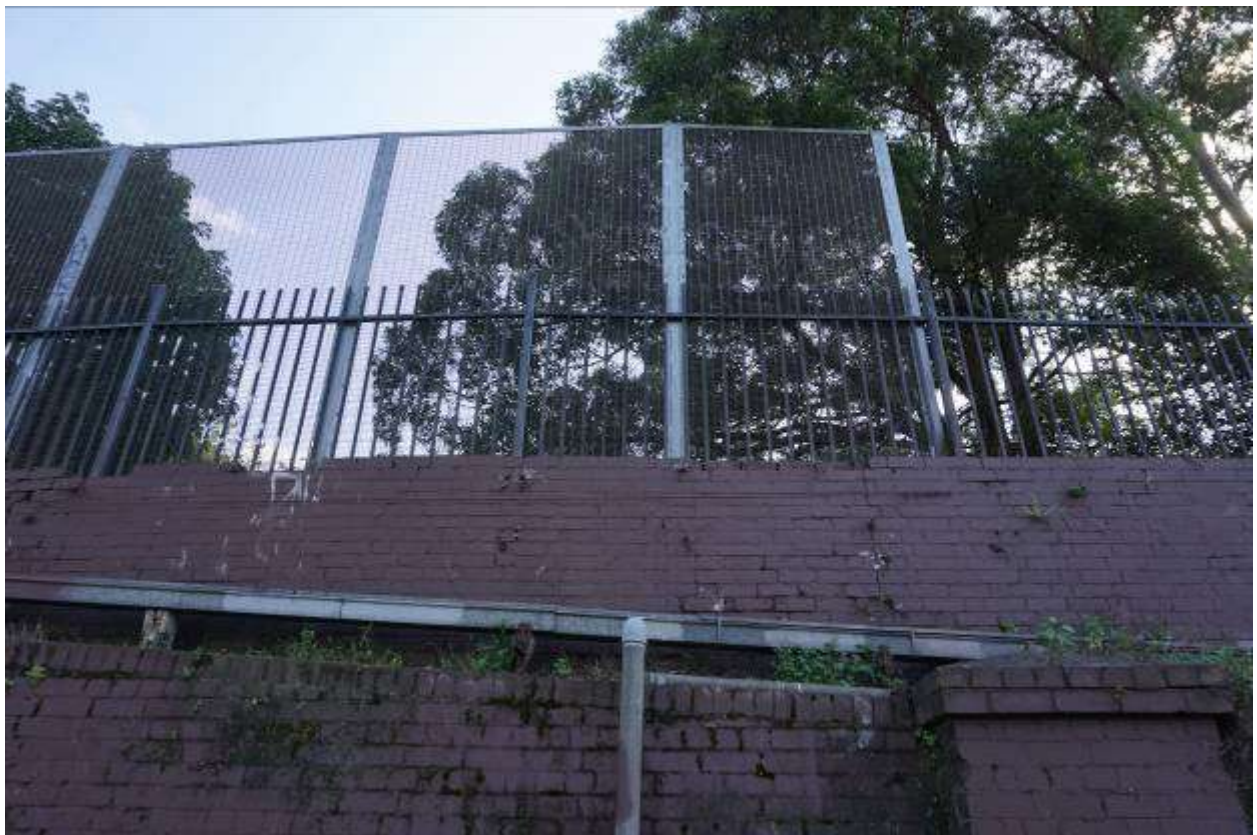
Figure 184 – General condition of RailCorp boundary wall and fence observed from Railway Corridor

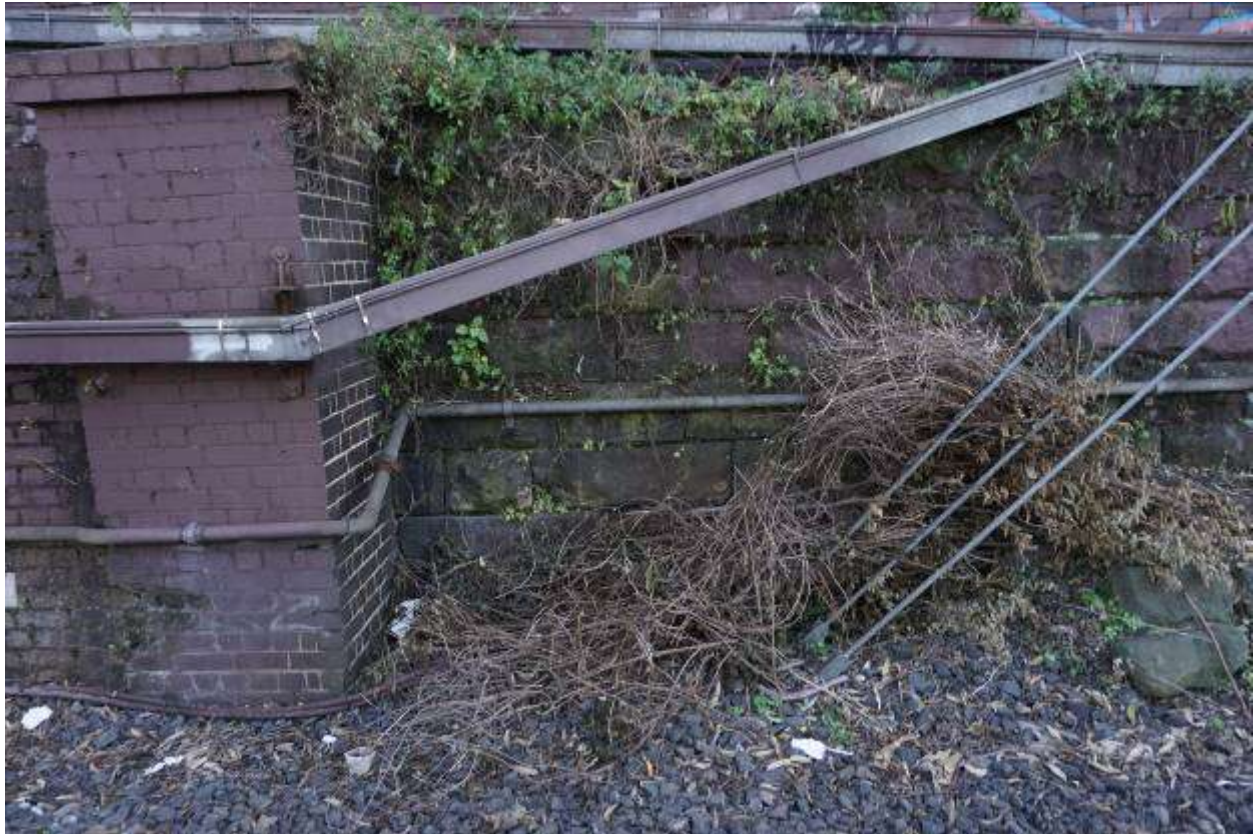
Figure 185 – General condition of RailCorp boundary wall observed from Railway Corridor

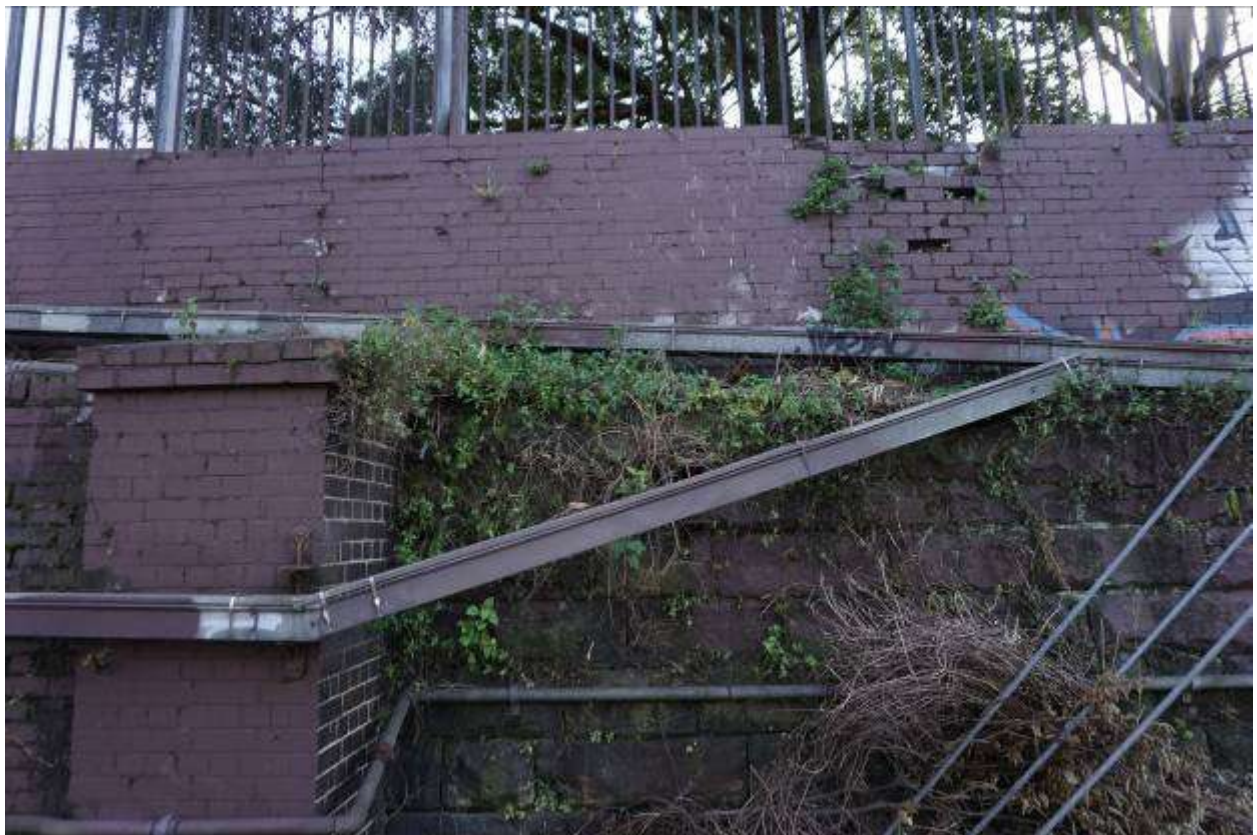
Figure 186 – General condition of RailCorp boundary wall observed from Railway Corridor

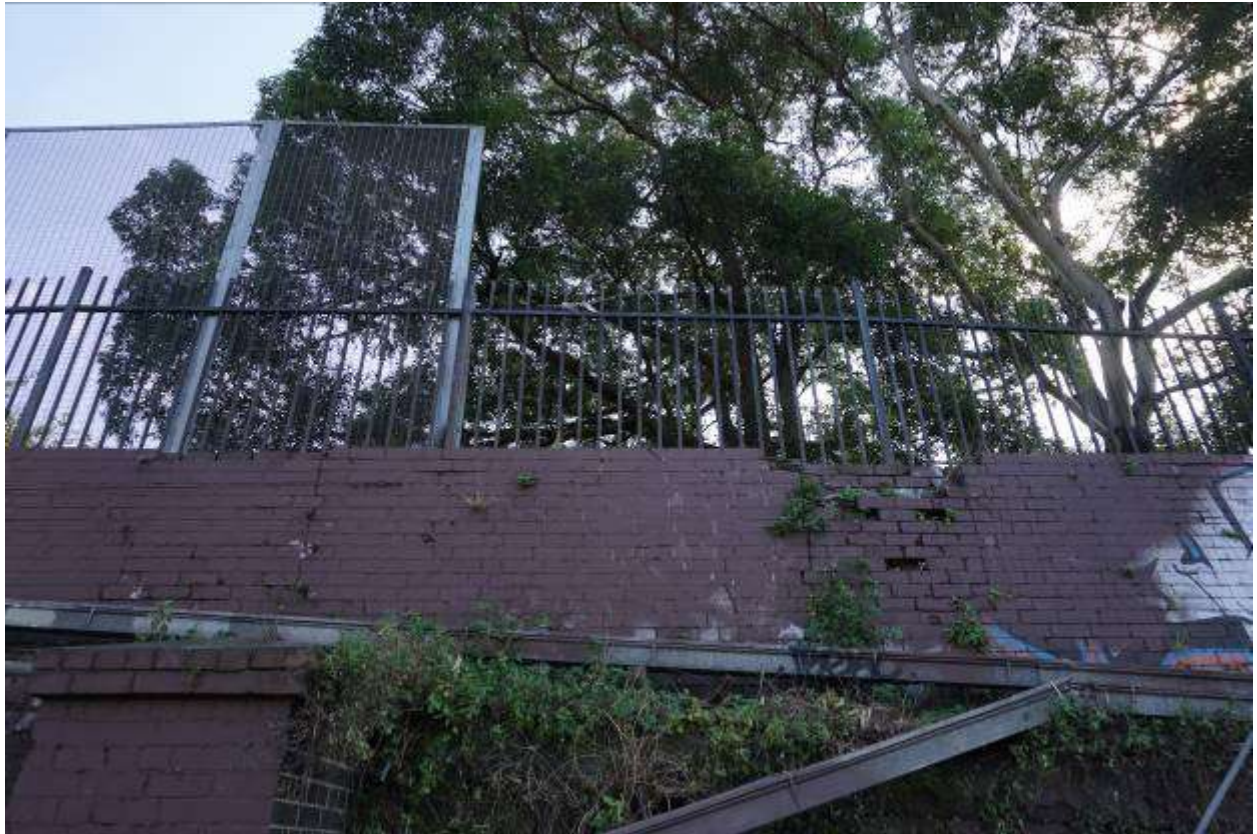
Figure 187 – General condition of RailCorp boundary wall observed from Railway Corridor

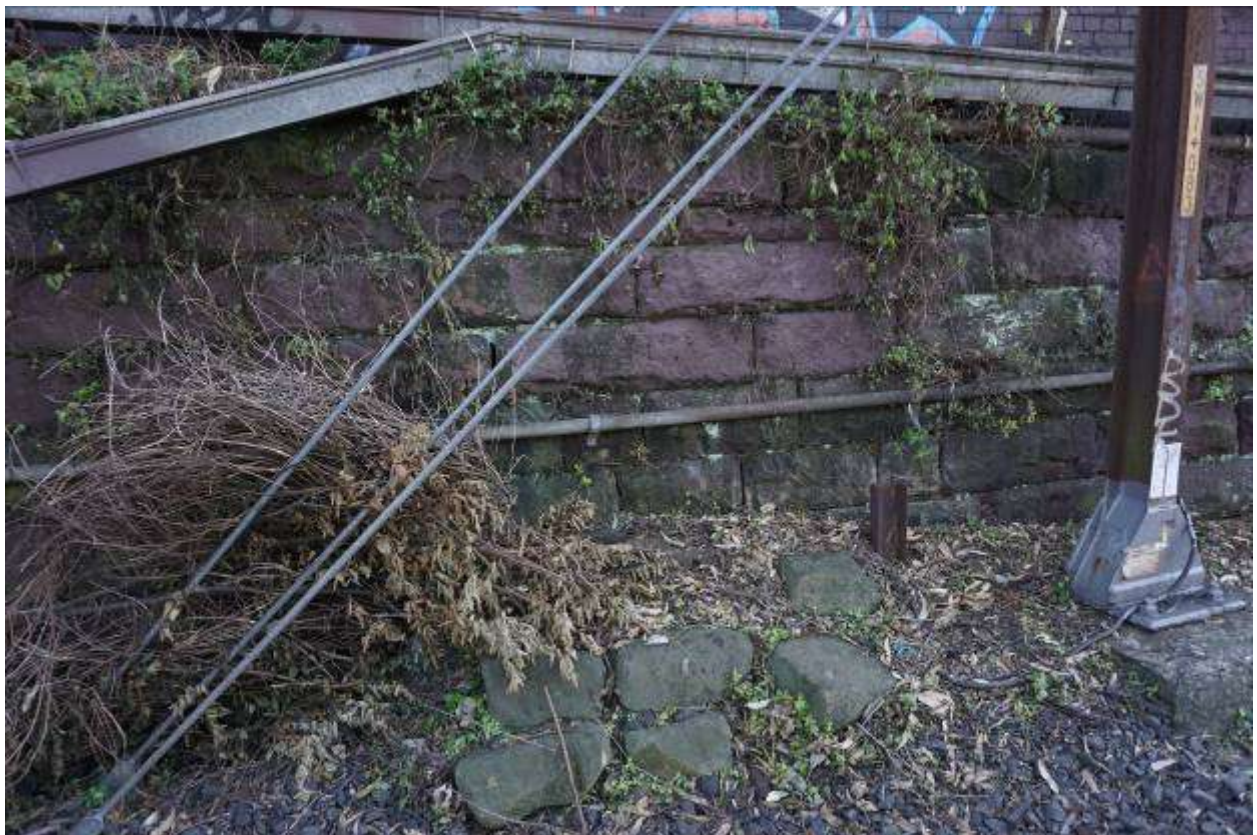
Figure 188 – General condition of RailCorp boundary wall observed from Railway Corridor

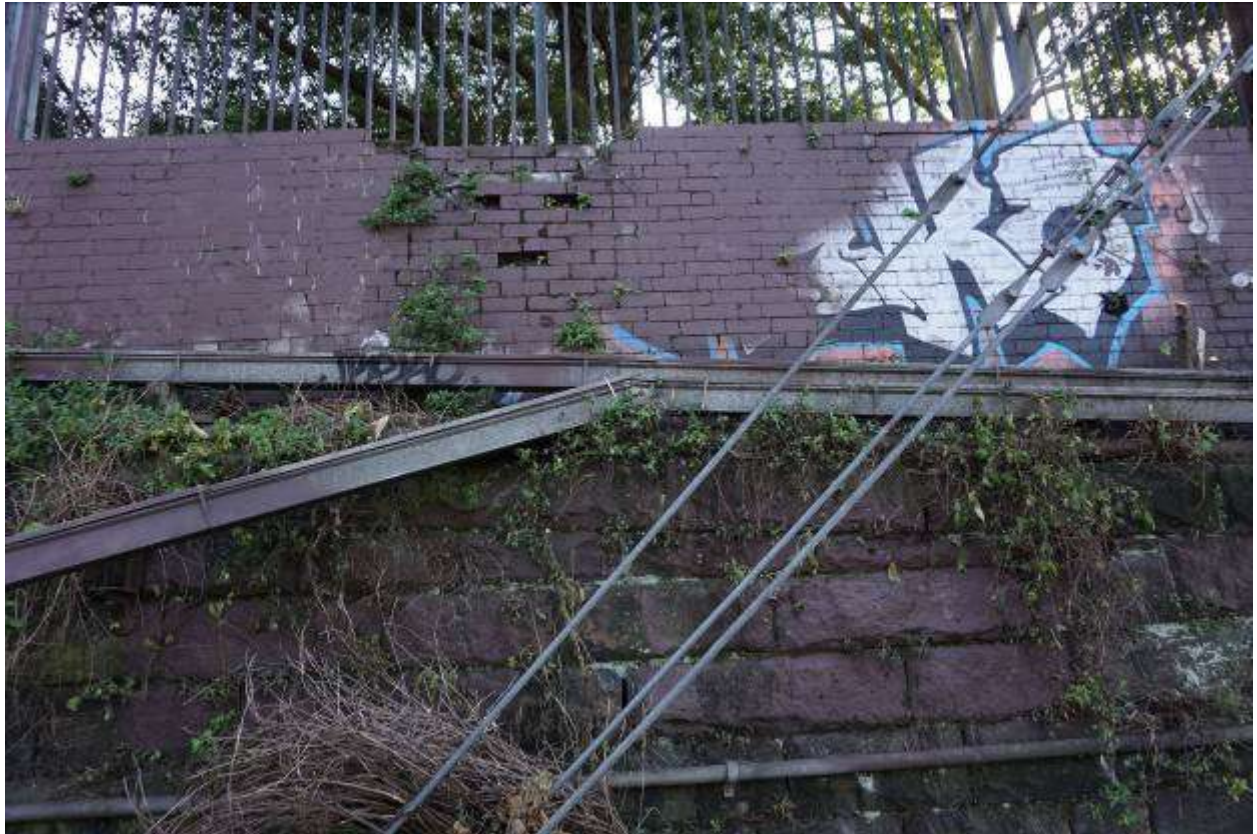
Figure 189 – General condition of RailCorp boundary wall observed from Railway Corridor

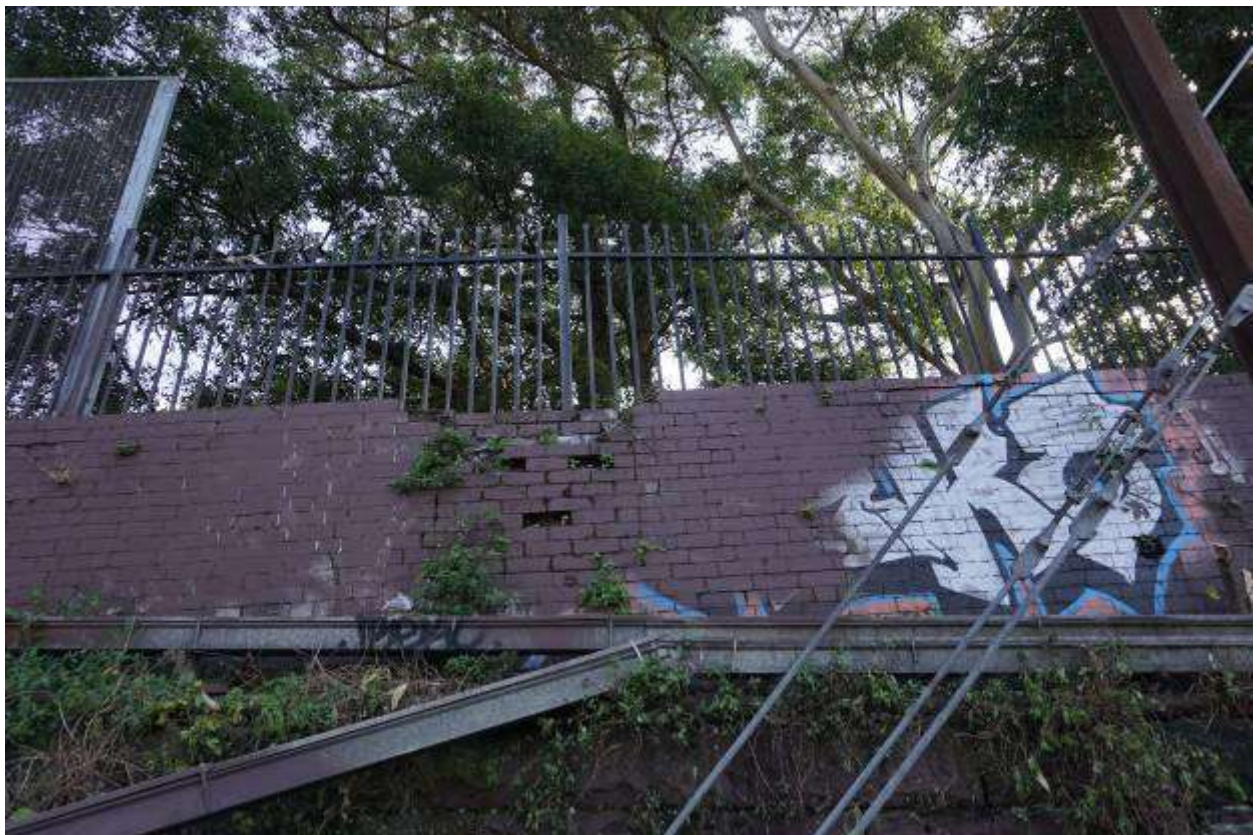
Figure 190 – General condition of RailCorp boundary wall and fence observed from Railway Corridor

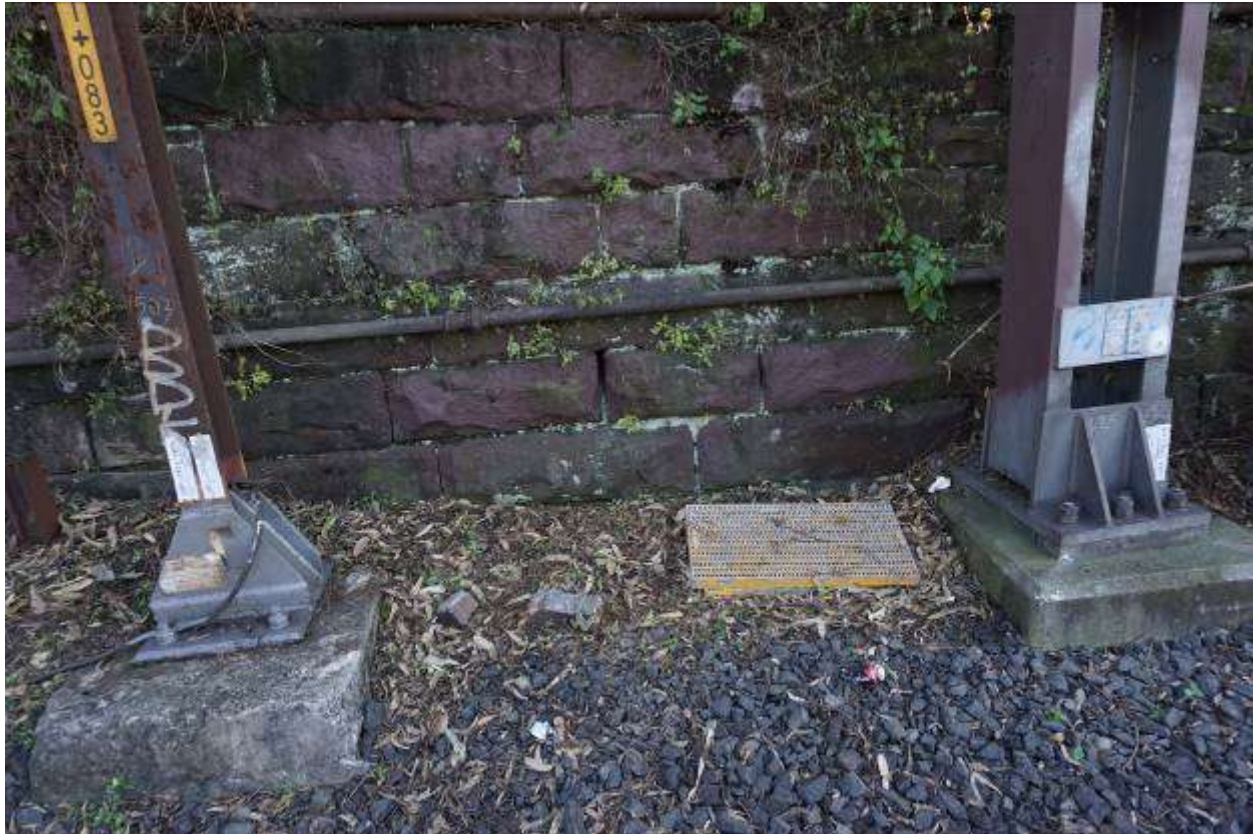
Figure 193 – General condition of RailCorp boundary wall observed from Railway Corridor

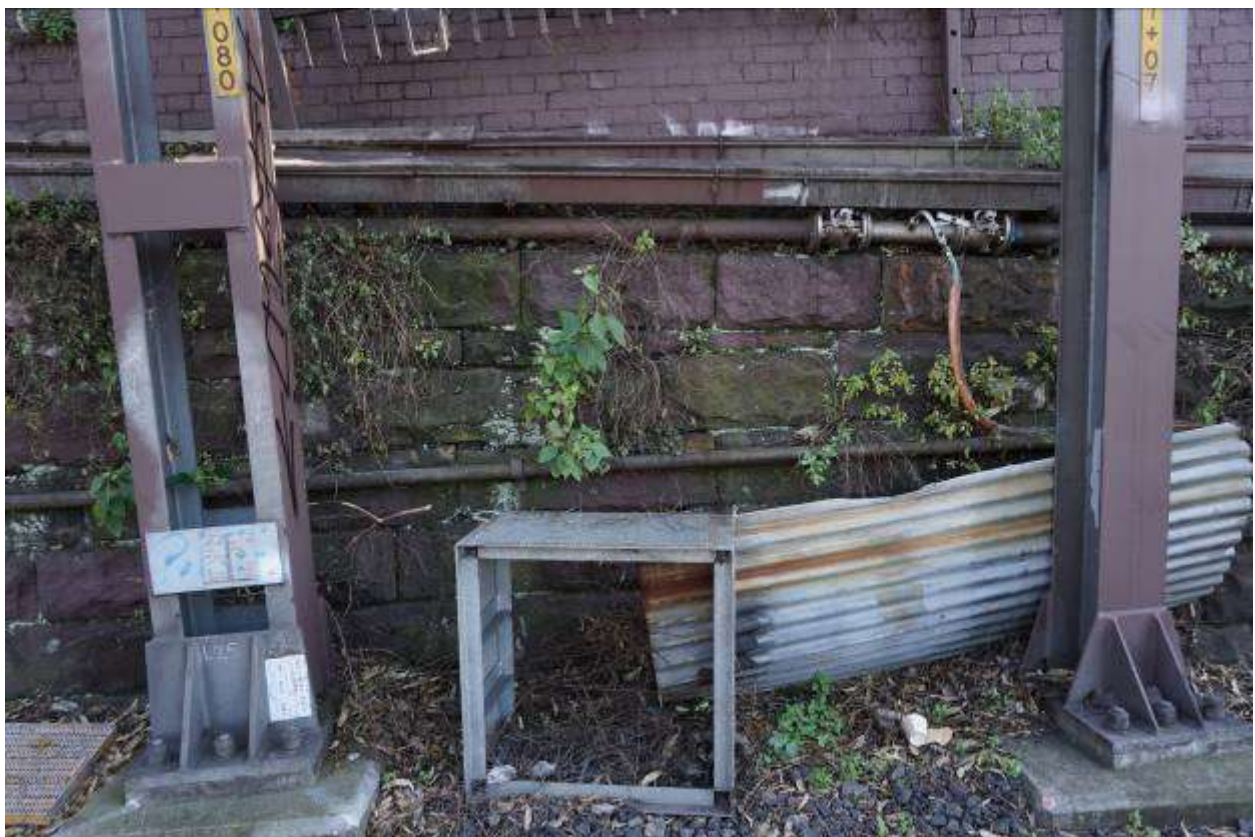
Figure 194 – General condition of RailCorp boundary wall observed from Railway Corridor

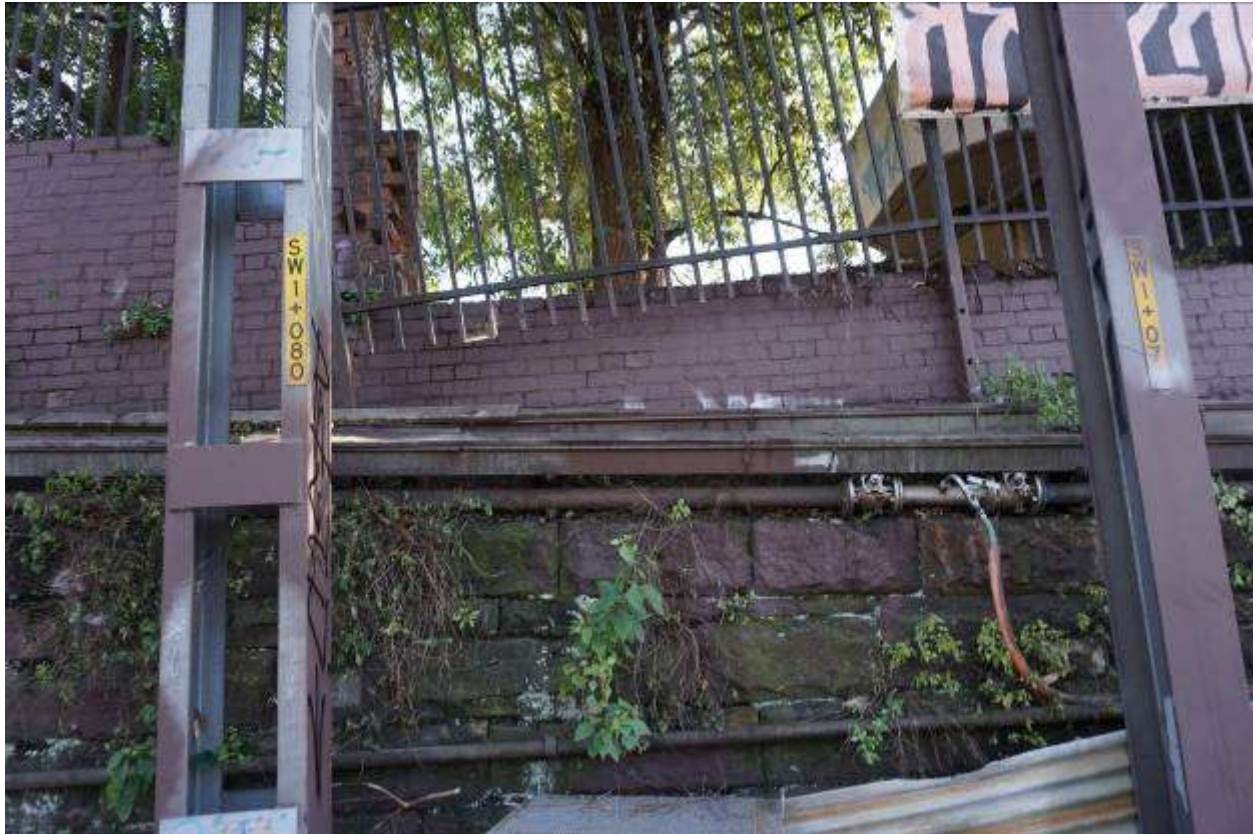
Figure 195 – General condition of RailCorp boundary wall observed from Railway Corridor

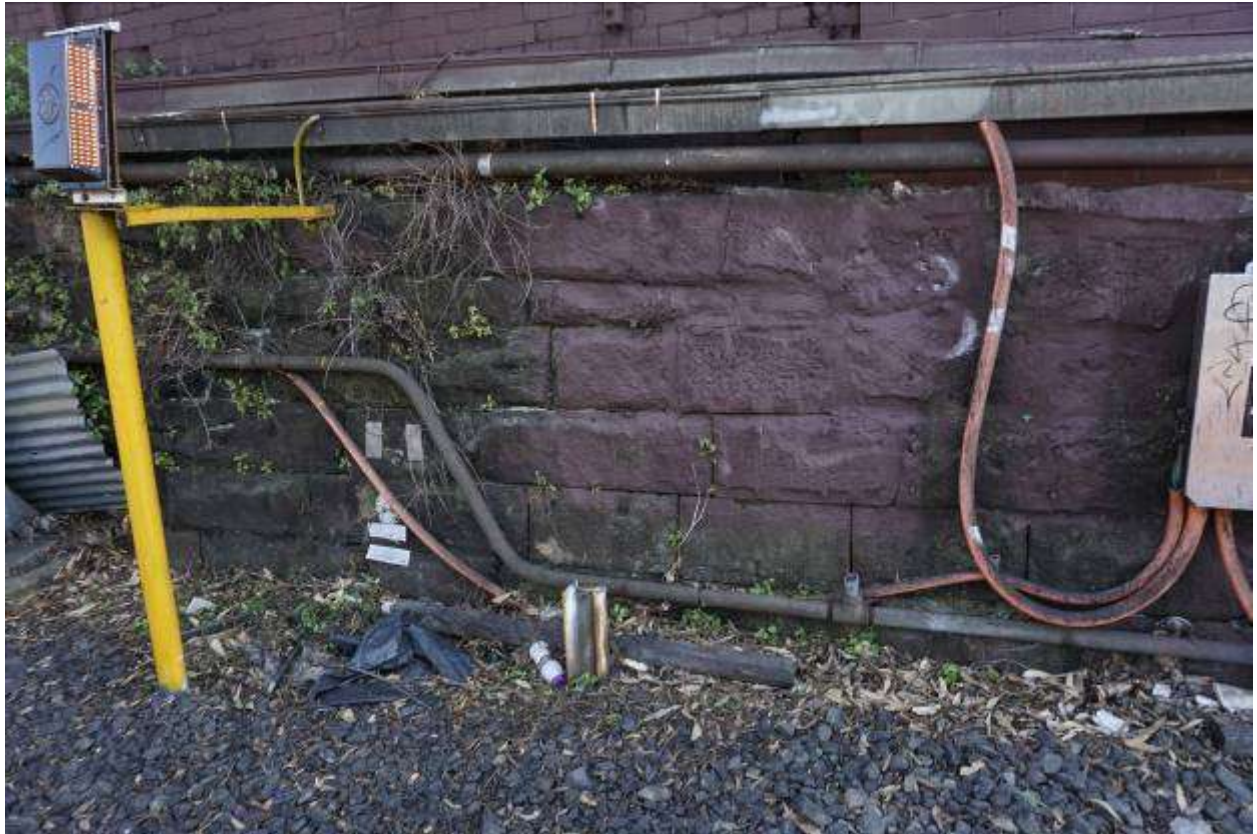
Figure 197 – General condition of RailCorp boundary wall observed from Railway Corridor

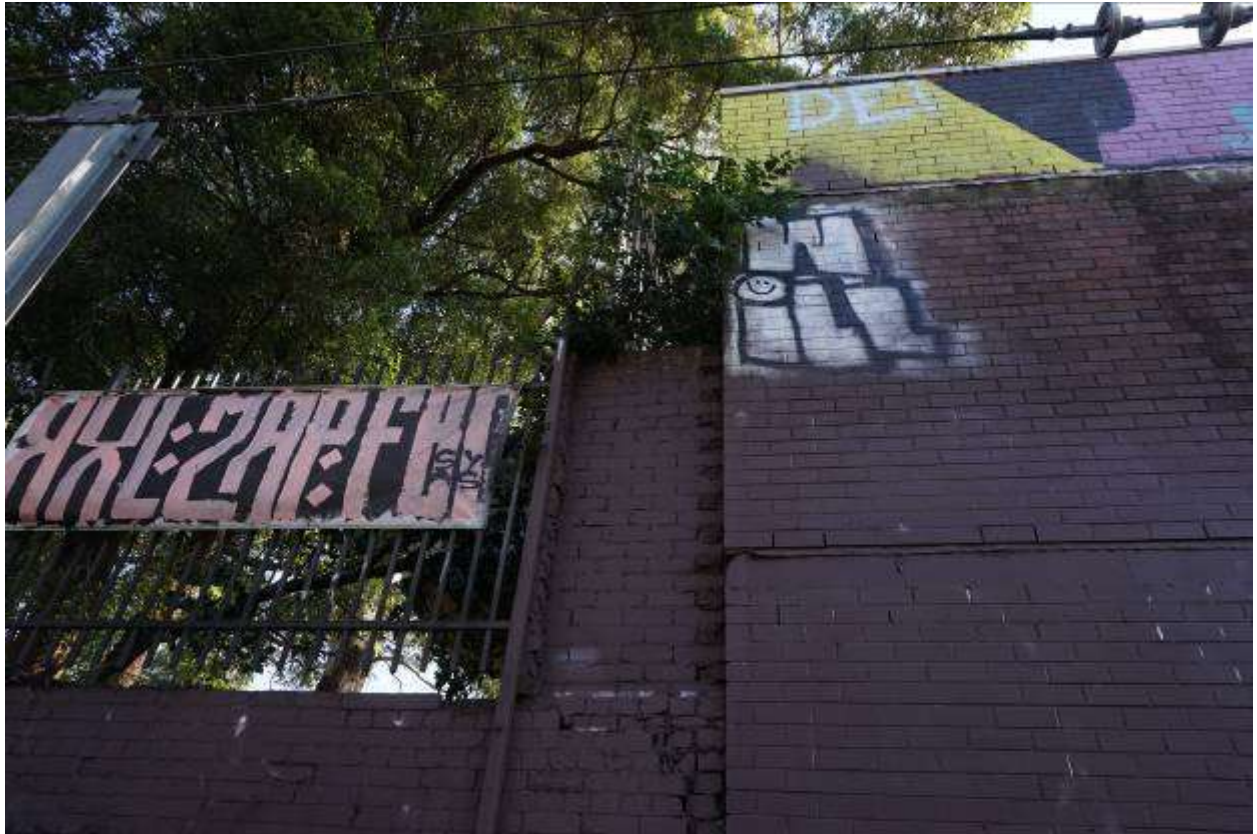
Figure 199 – General condition of RailCorp boundary wall observed from Railway Corridor

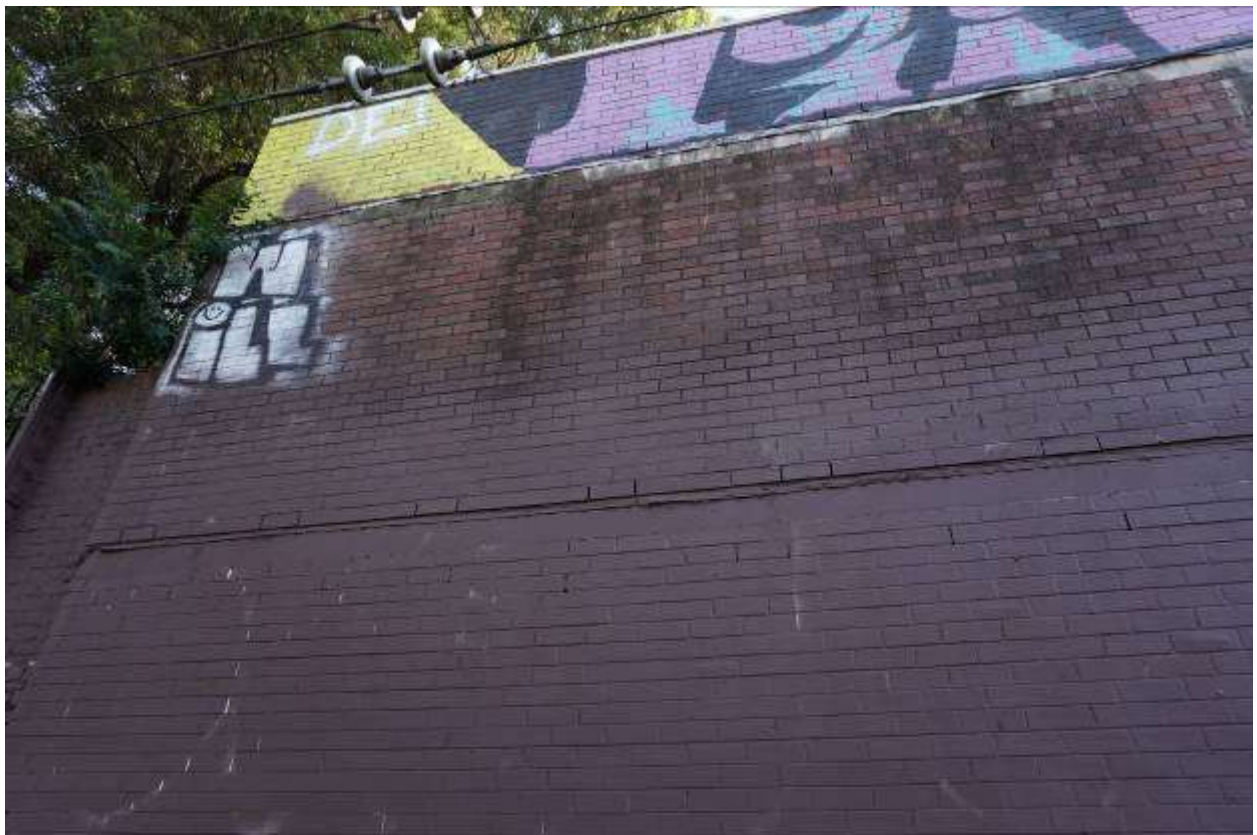
Figure 200 – General condition of RailCorp boundary wall observed from Railway Corridor

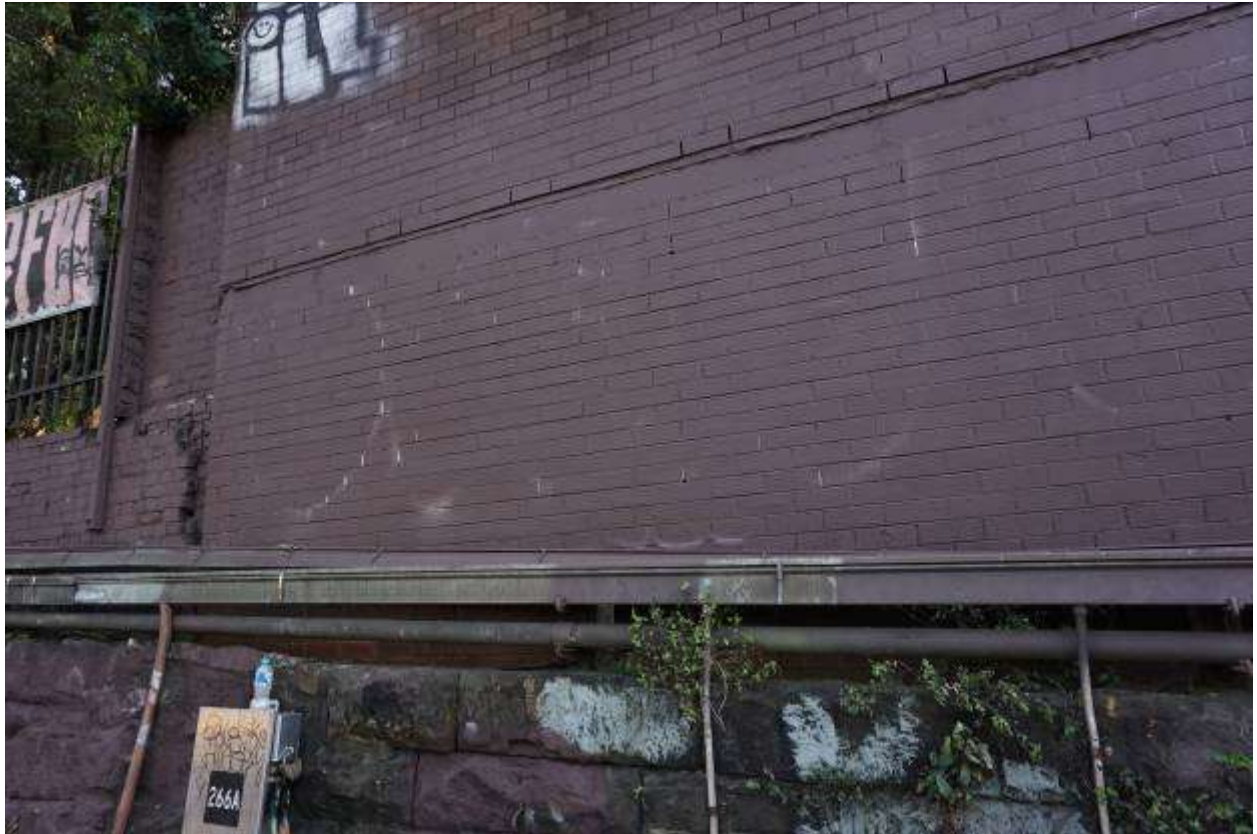
Figure 201 – General condition of RailCorp boundary wall observed from Railway Corridor

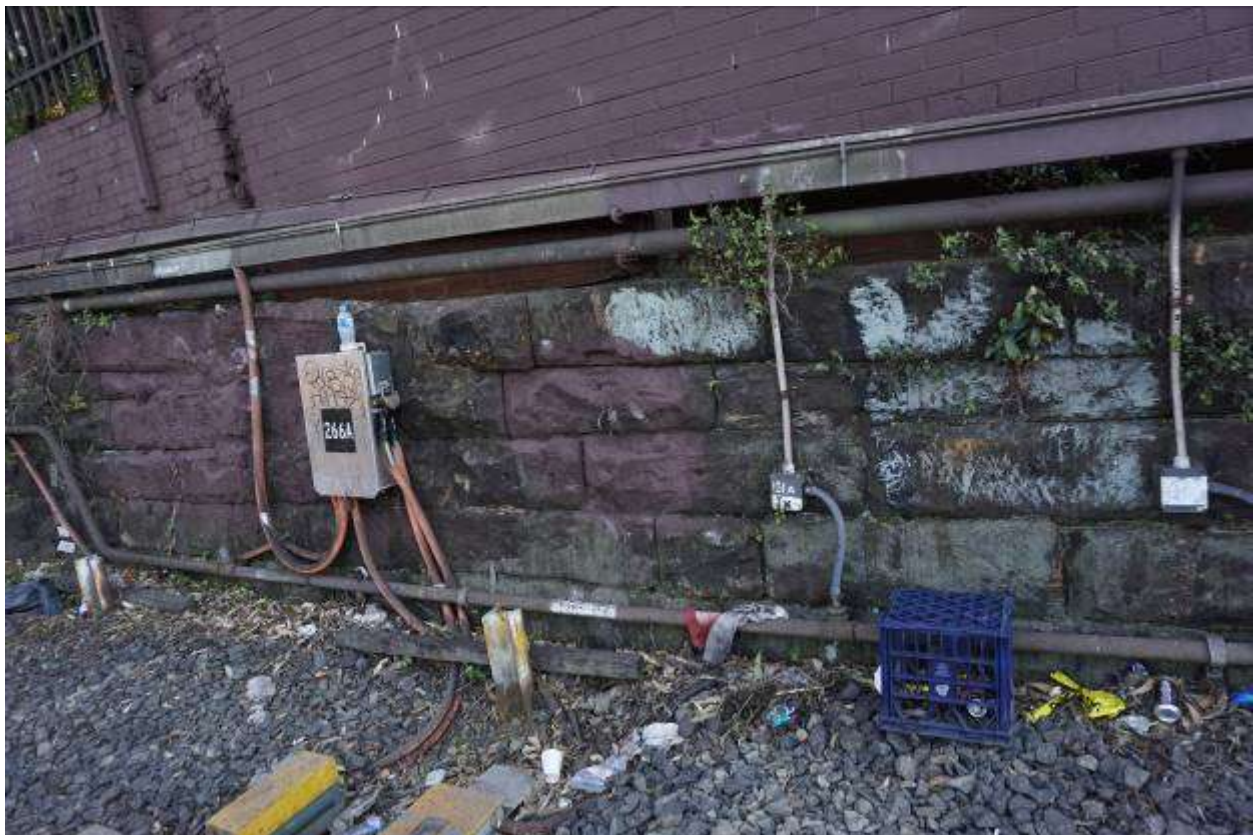
Figure 202 – General condition of RailCorp boundary wall observed from Railway Corridor

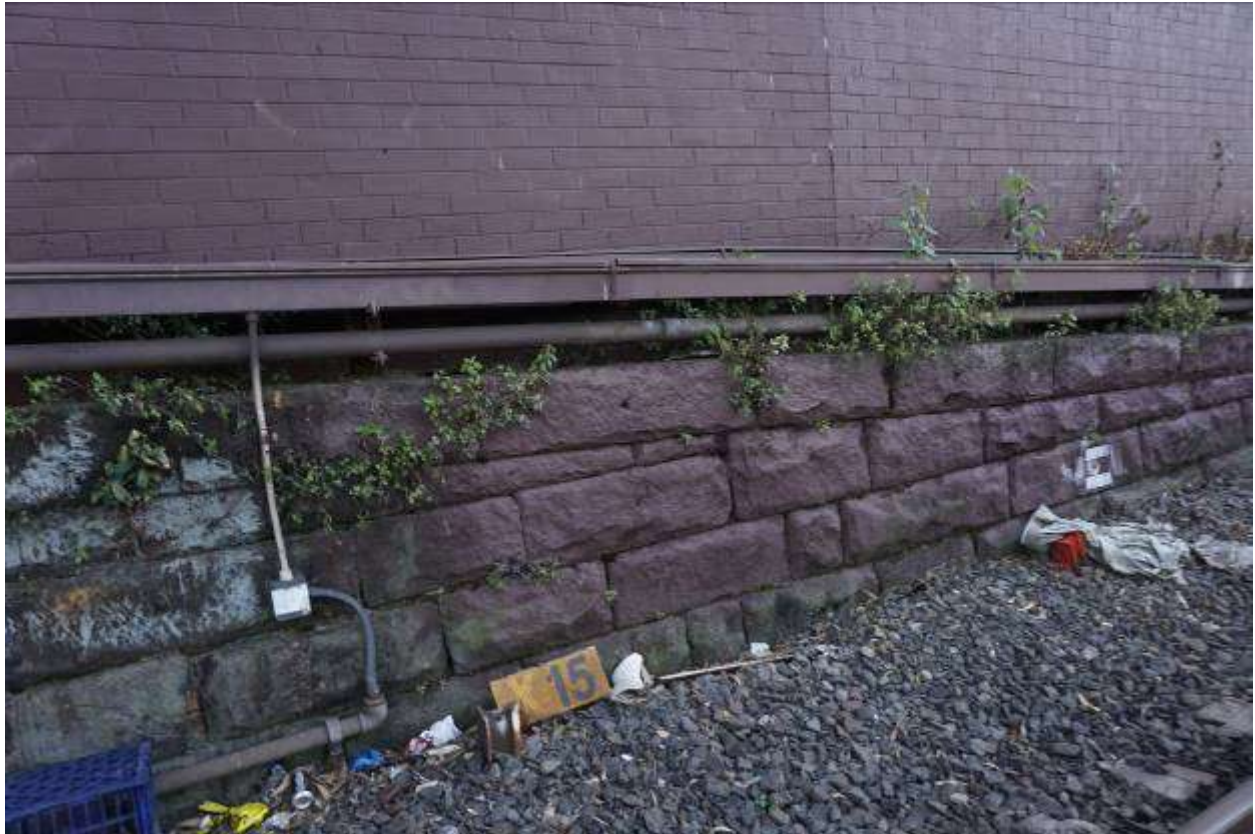
Figure 203 – General condition of RailCorp boundary wall observed from Railway Corridor

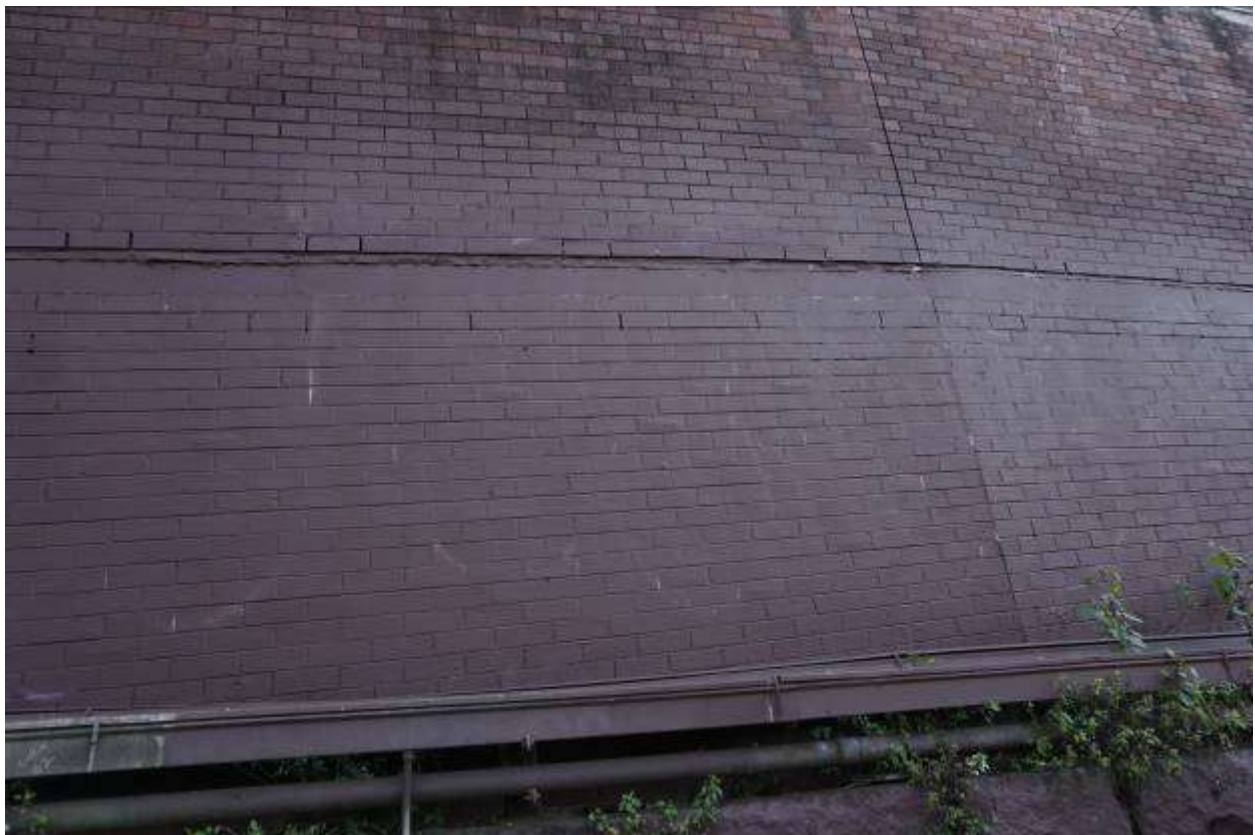
Figure 204 – General condition of RailCorp boundary wall observed from Railway Corridor
