Re: Dilapidation Report for Property
No: Pemulwuy Project - Redfern NSW 2016

Job: 170037.0
Date: MAY 2017

SUMMARY

This report serves as a record of the condition of the RailCorp infrastructure assets of the "Metro Illawarra & South Coast" line, which is adjacent to the subject site, prior to the commencement of any works proposed at: Pemulwuy Project - Redfern NSW 2016.

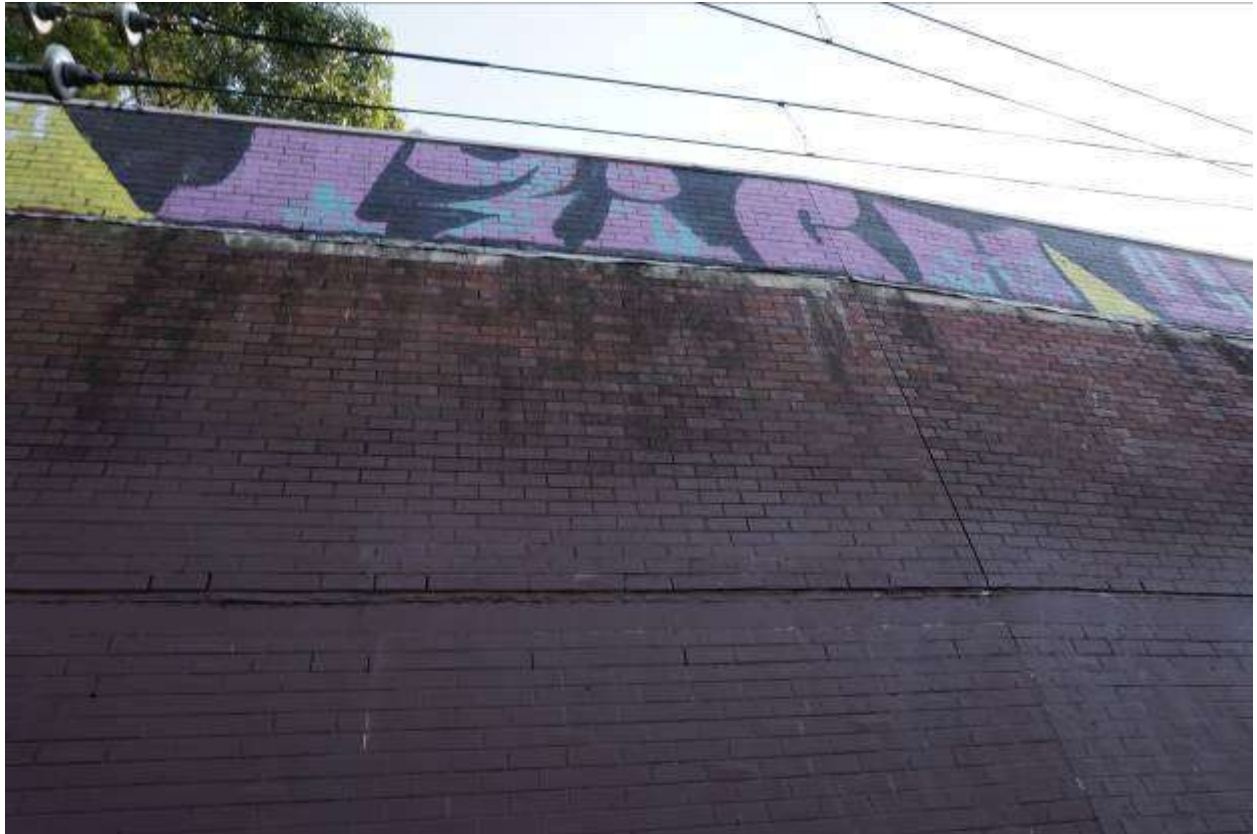
Figure 205 – General condition of RailCorp boundary wall observed from Railway Corridor

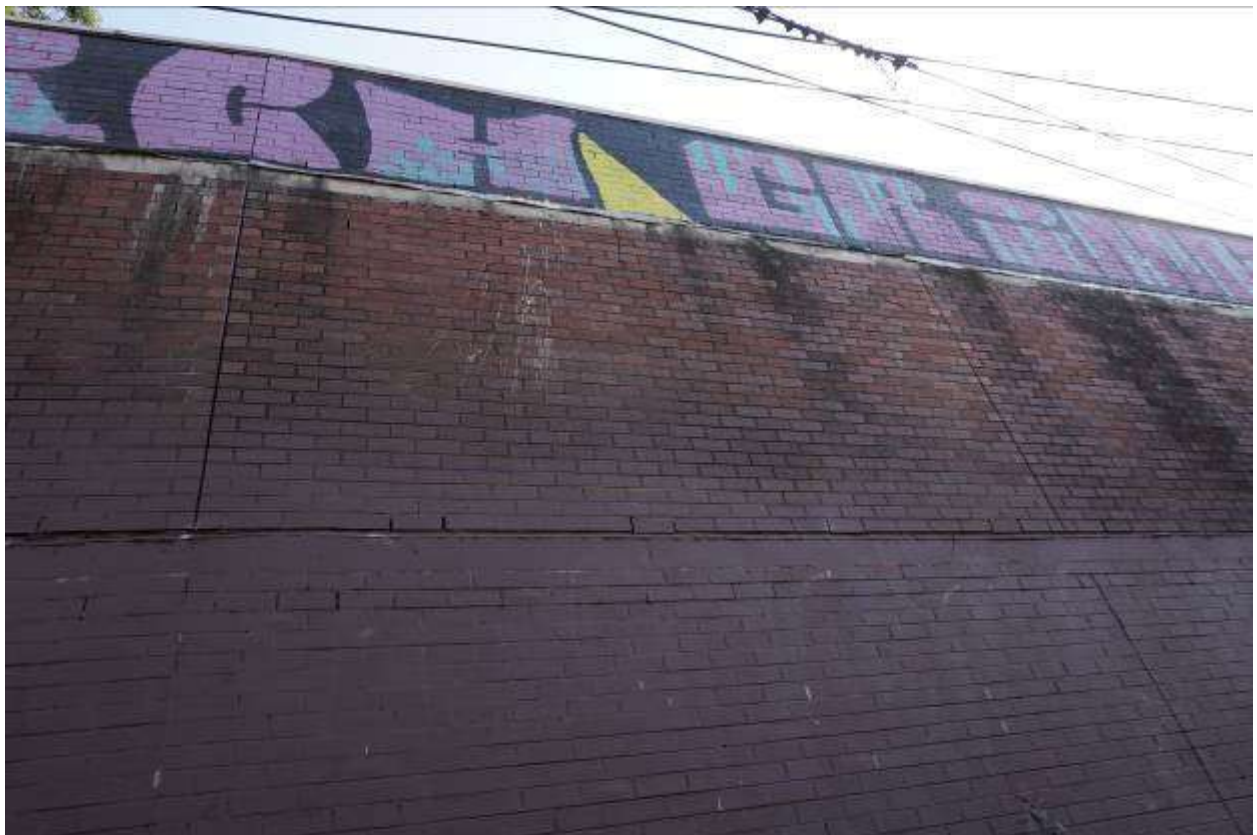
Figure 206 – General condition of RailCorp boundary wall observed from Railway Corridor

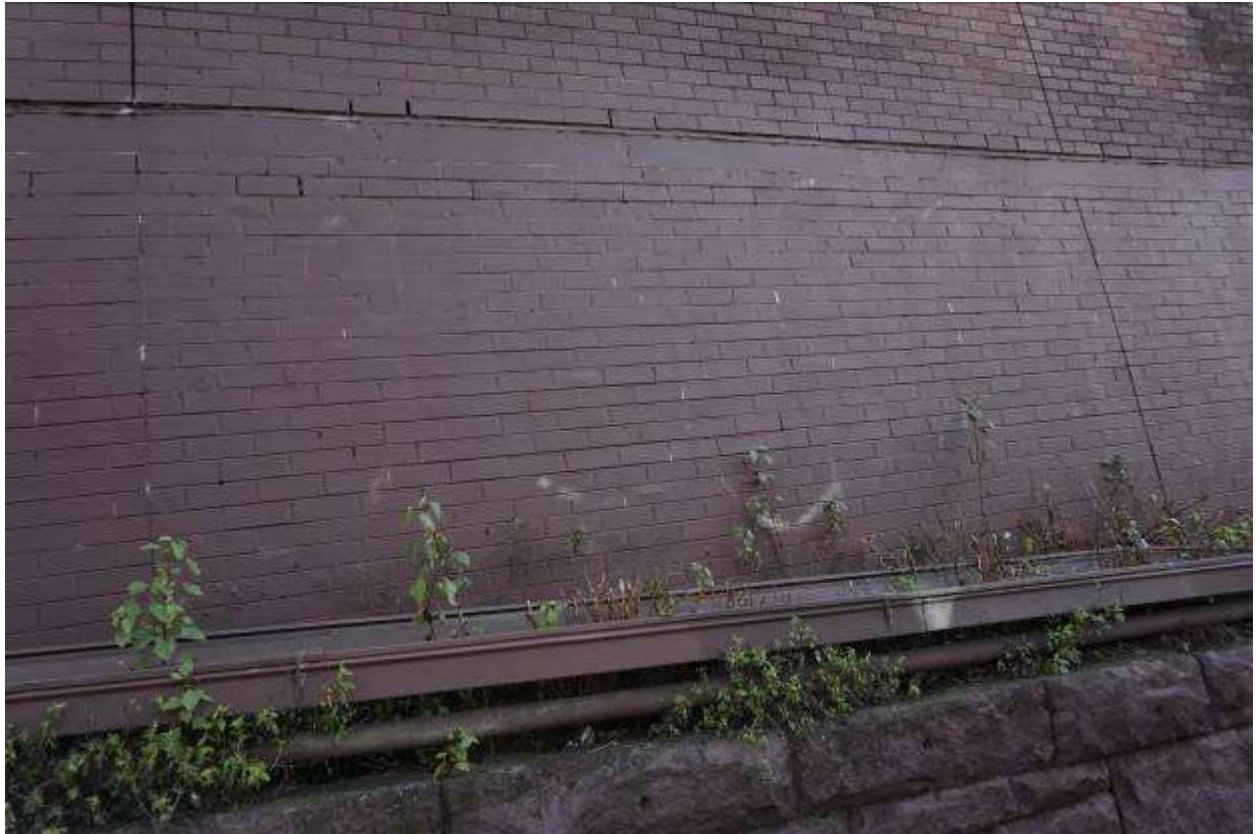
Figure 207 – General condition of RailCorp boundary wall observed from Railway Corridor

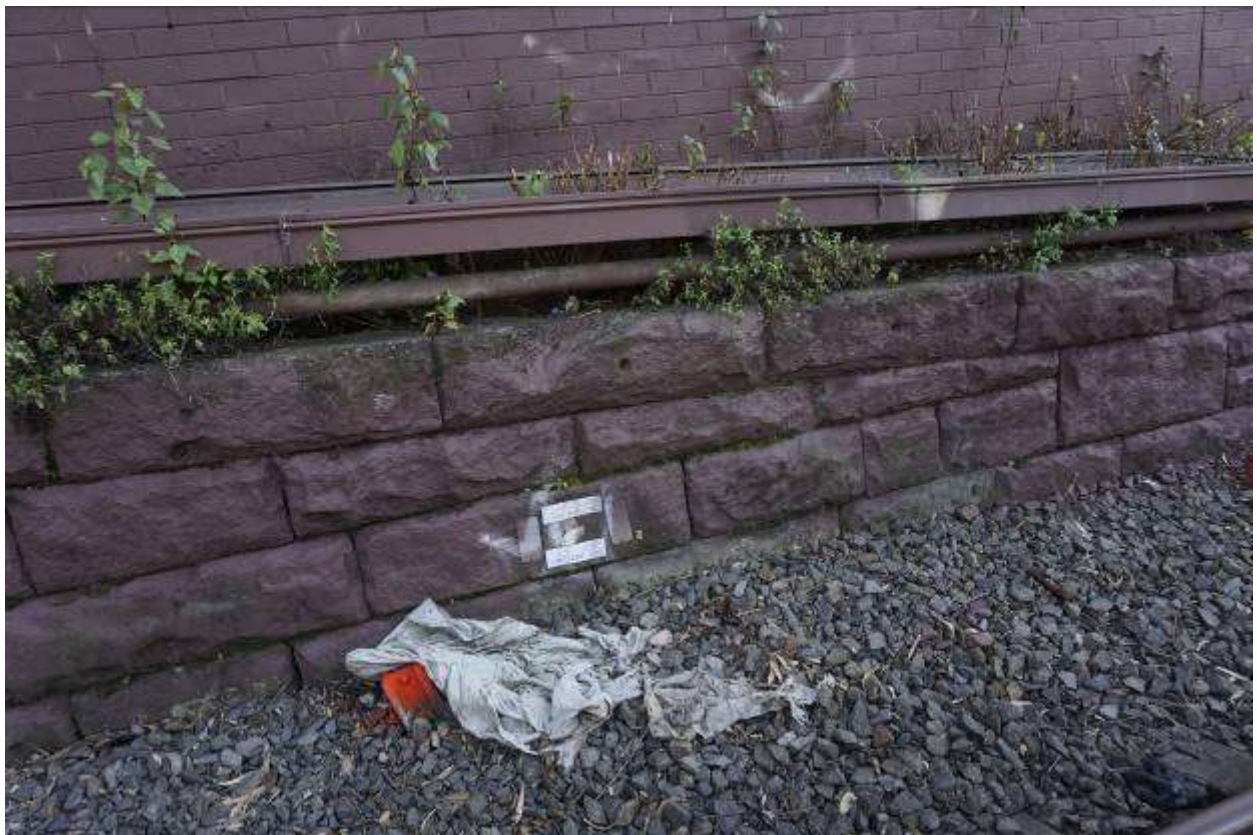
Figure 208 – General condition of RailCorp boundary wall observed from Railway Corridor

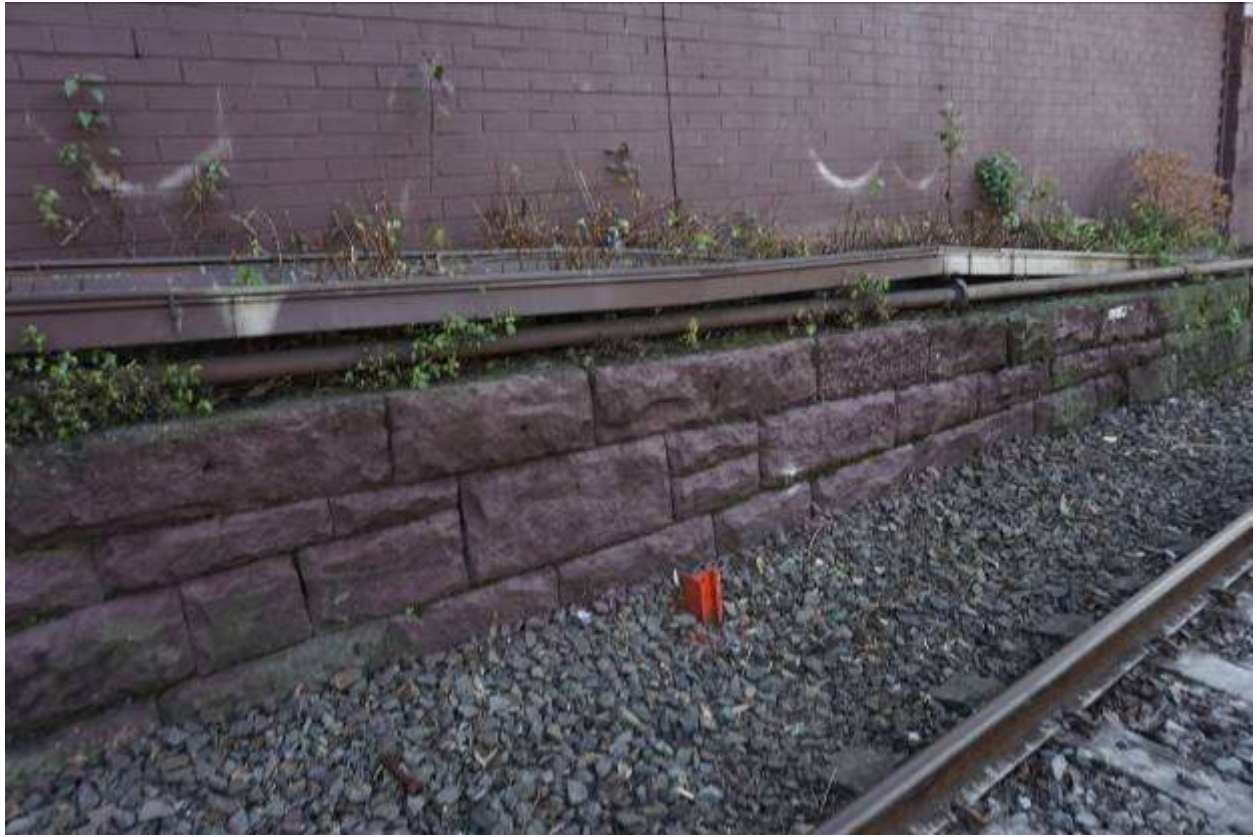
Figure 209 – General condition of RailCorp boundary wall observed from Railway Corridor

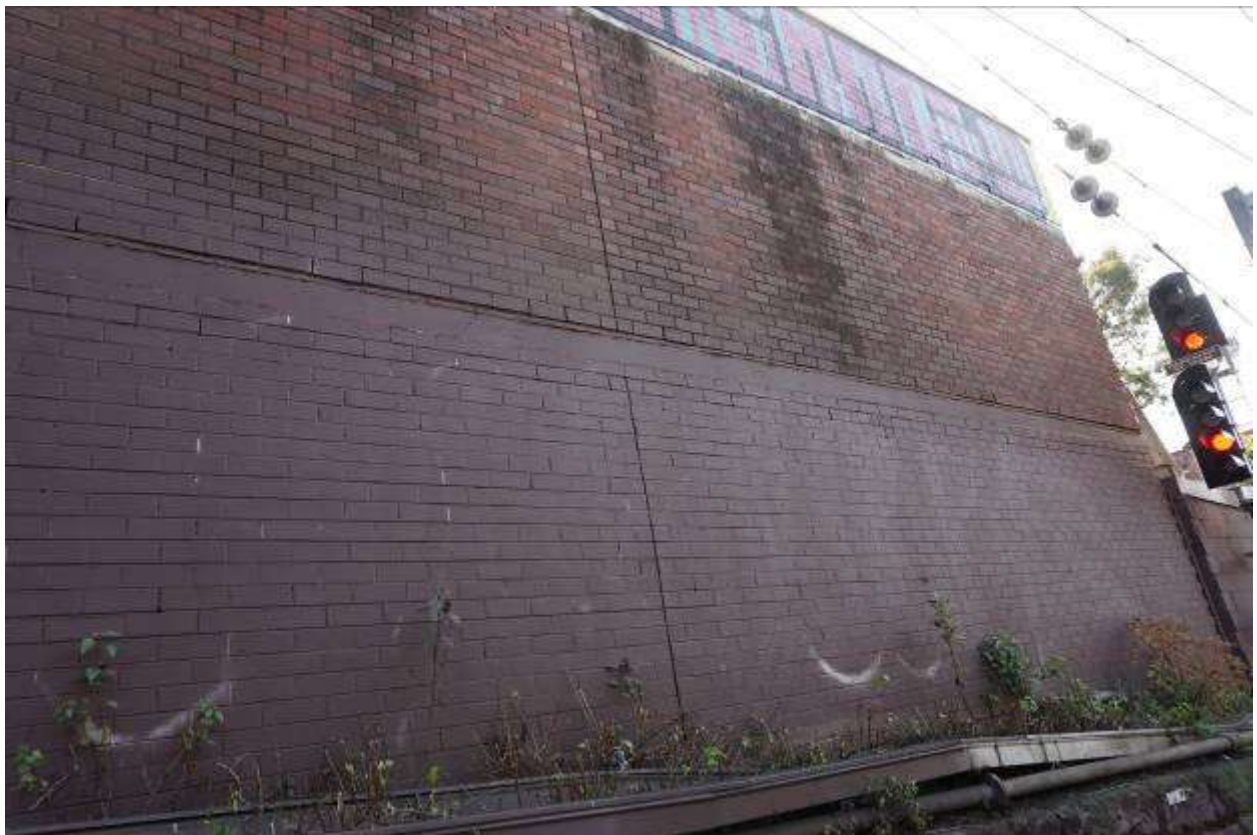
Figure 210 – General condition of RailCorp boundary wall observed from Railway Corridor

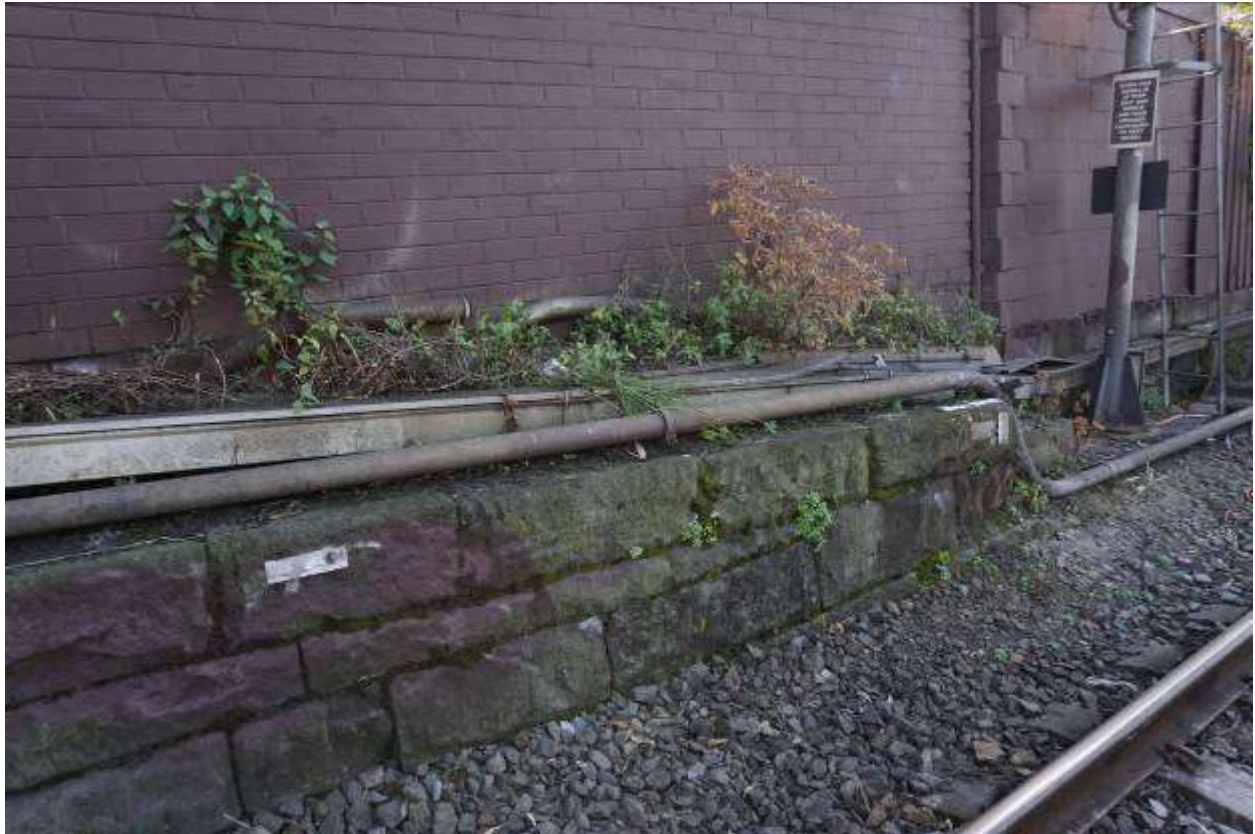
Figure 211 – General condition of RailCorp boundary wall observed from Railway Corridor

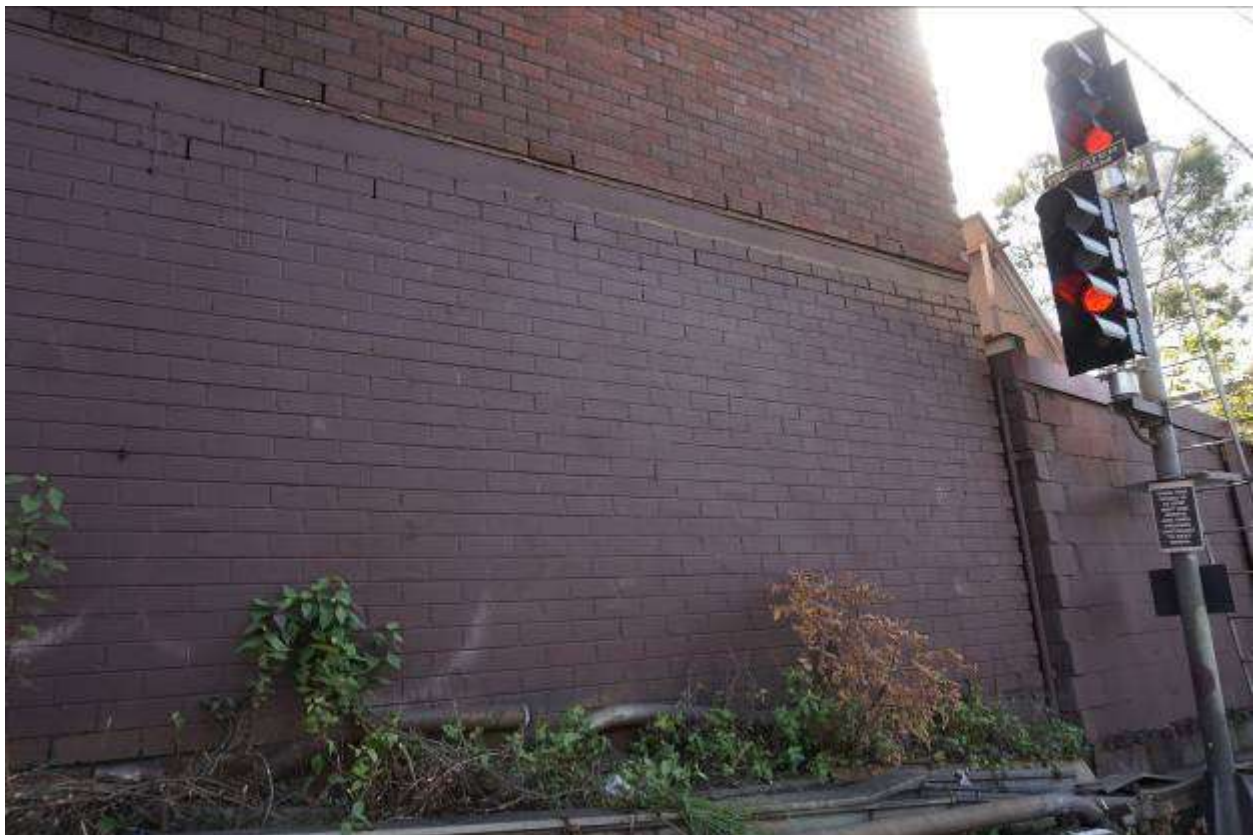
Figure 212 – General condition of RailCorp boundary wall observed from Railway Corridor

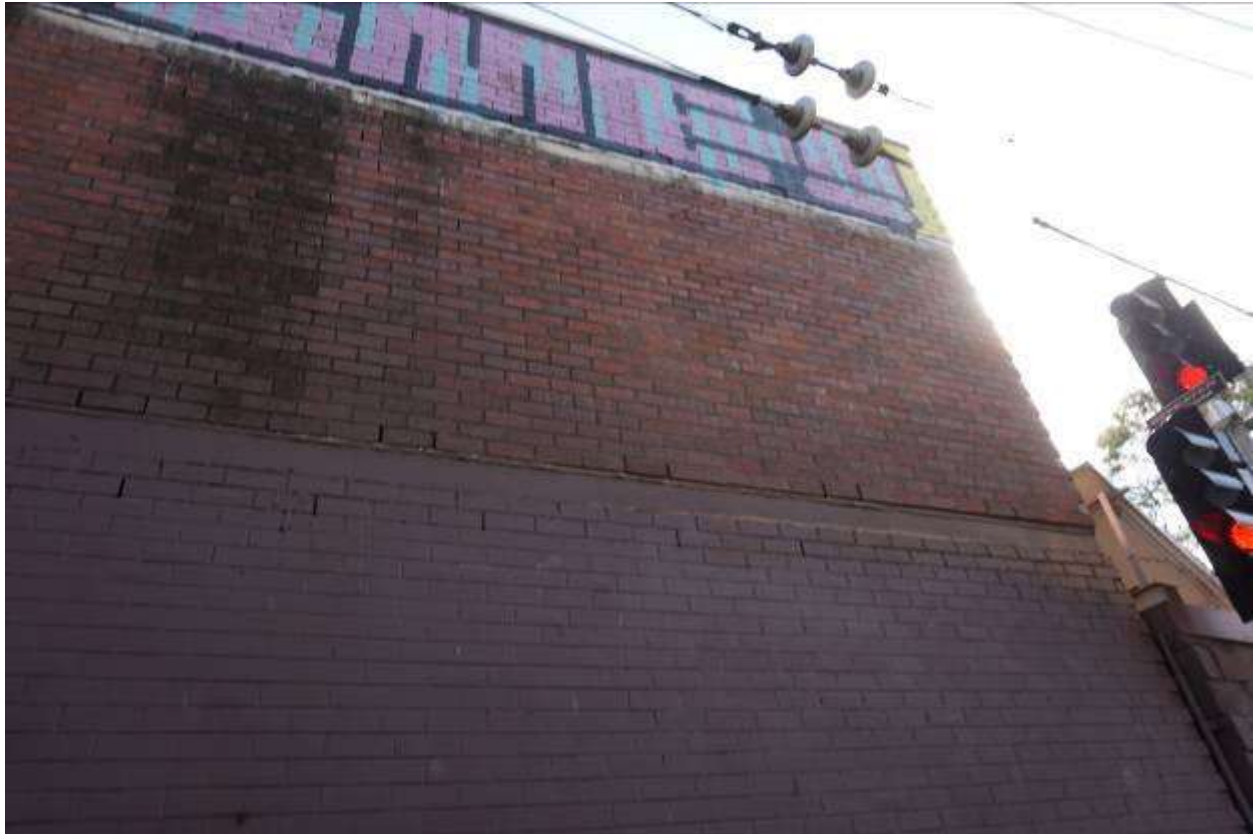
Figure 213 – General condition of RailCorp boundary wall observed from Railway Corridor

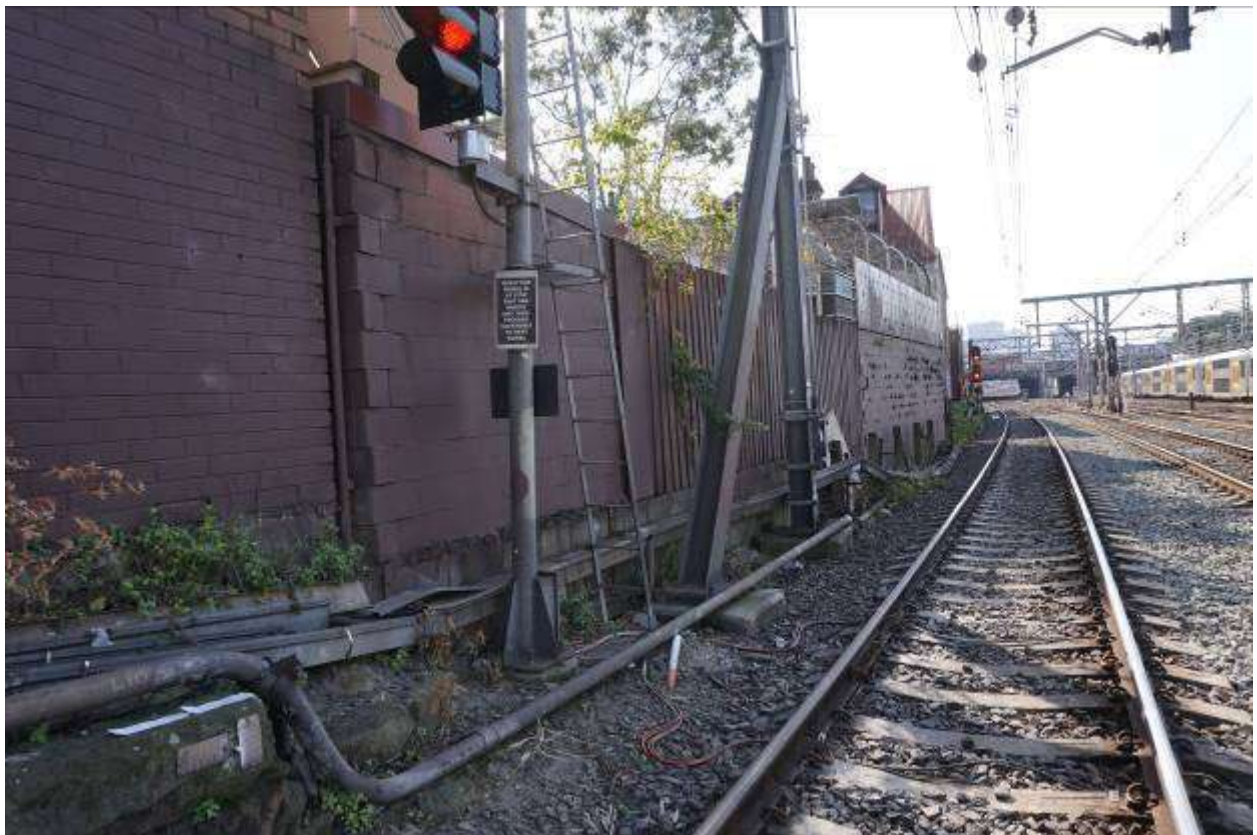
Figure 214 – General condition of RailCorp boundary wall observed from Railway Corridor

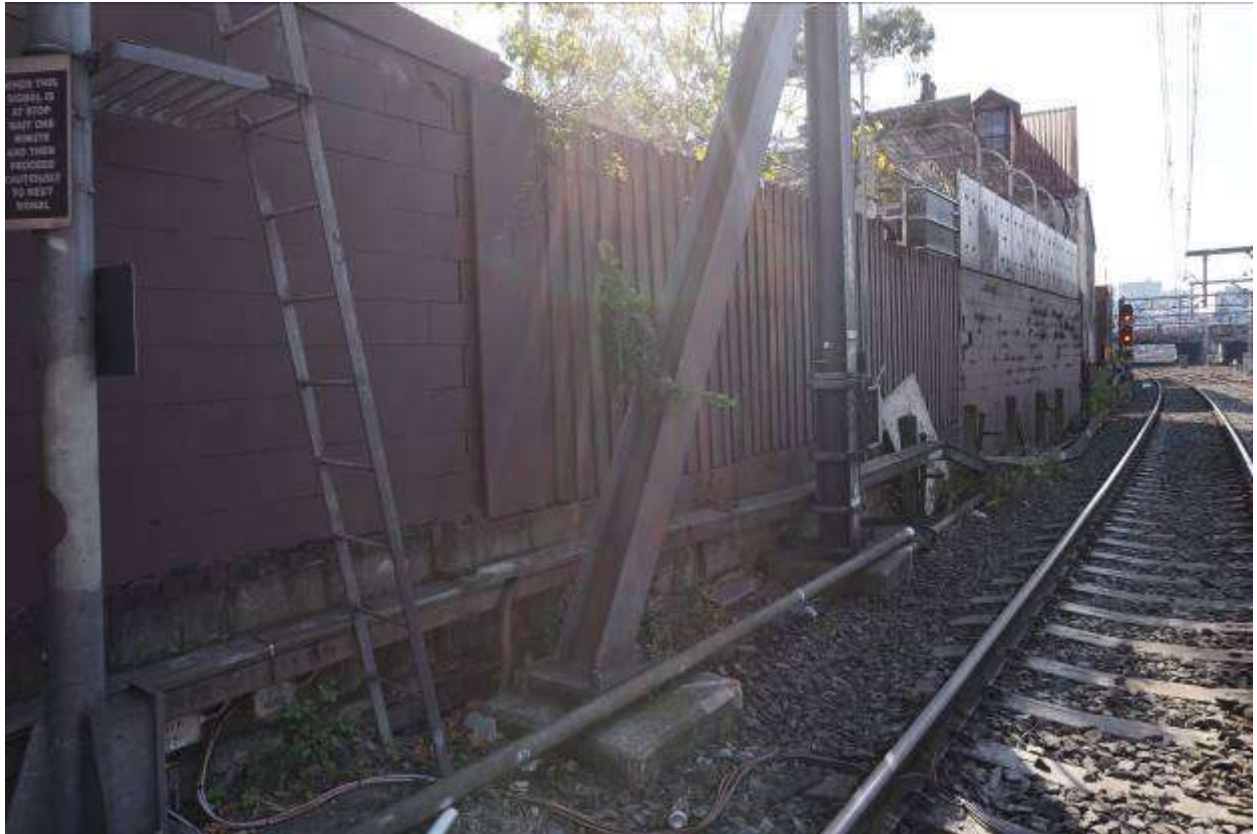
Figure 215 – General condition of RailCorp boundary wall observed from Railway Corridor

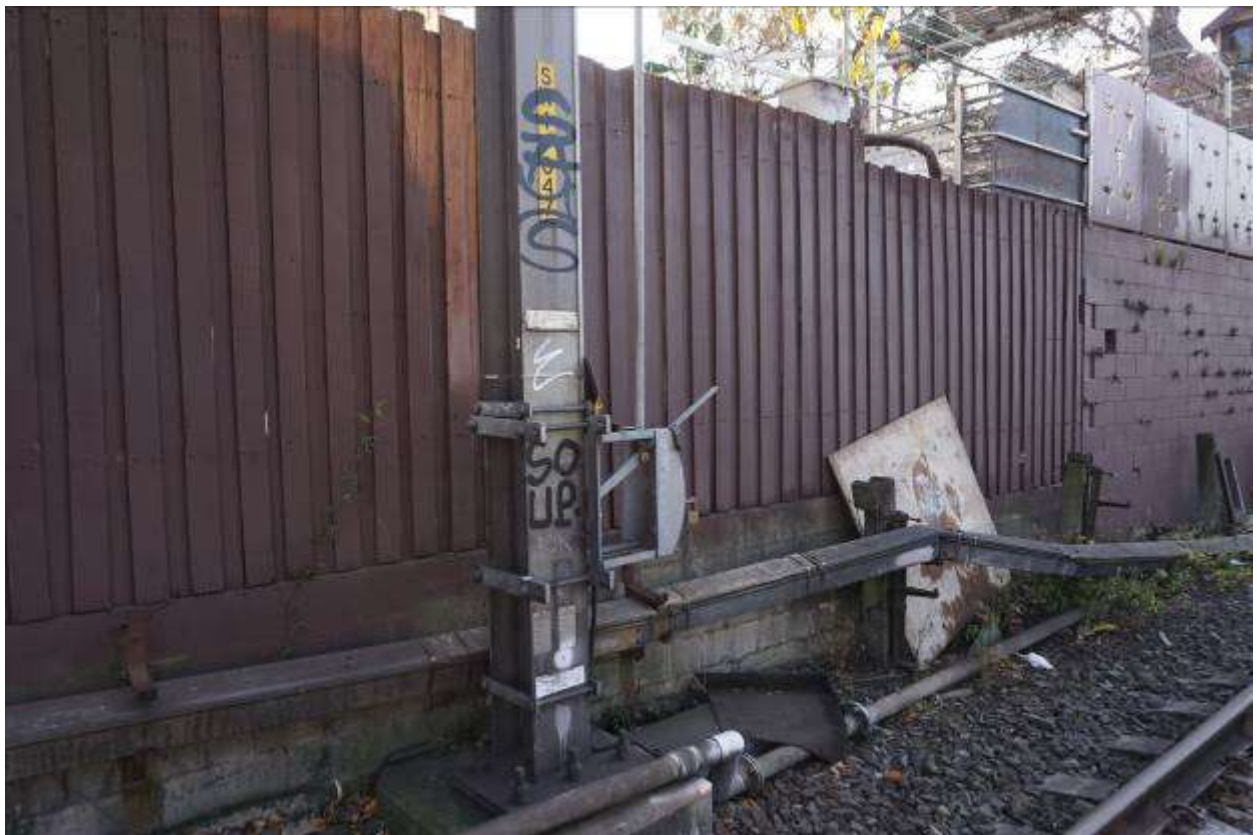
Figure 216 – General condition of RailCorp boundary wall observed from Railway Corridor

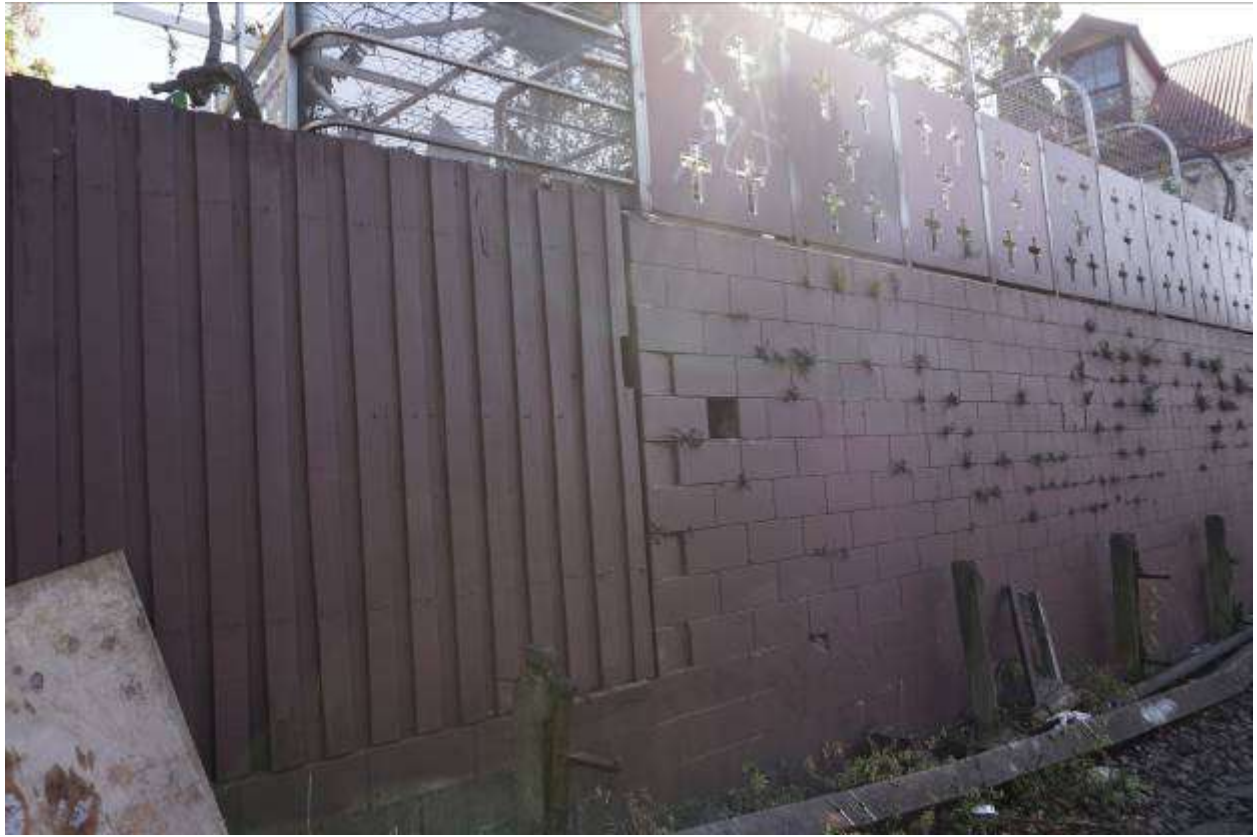
Figure 217 – General condition of RailCorp boundary wall observed from Railway Corridor

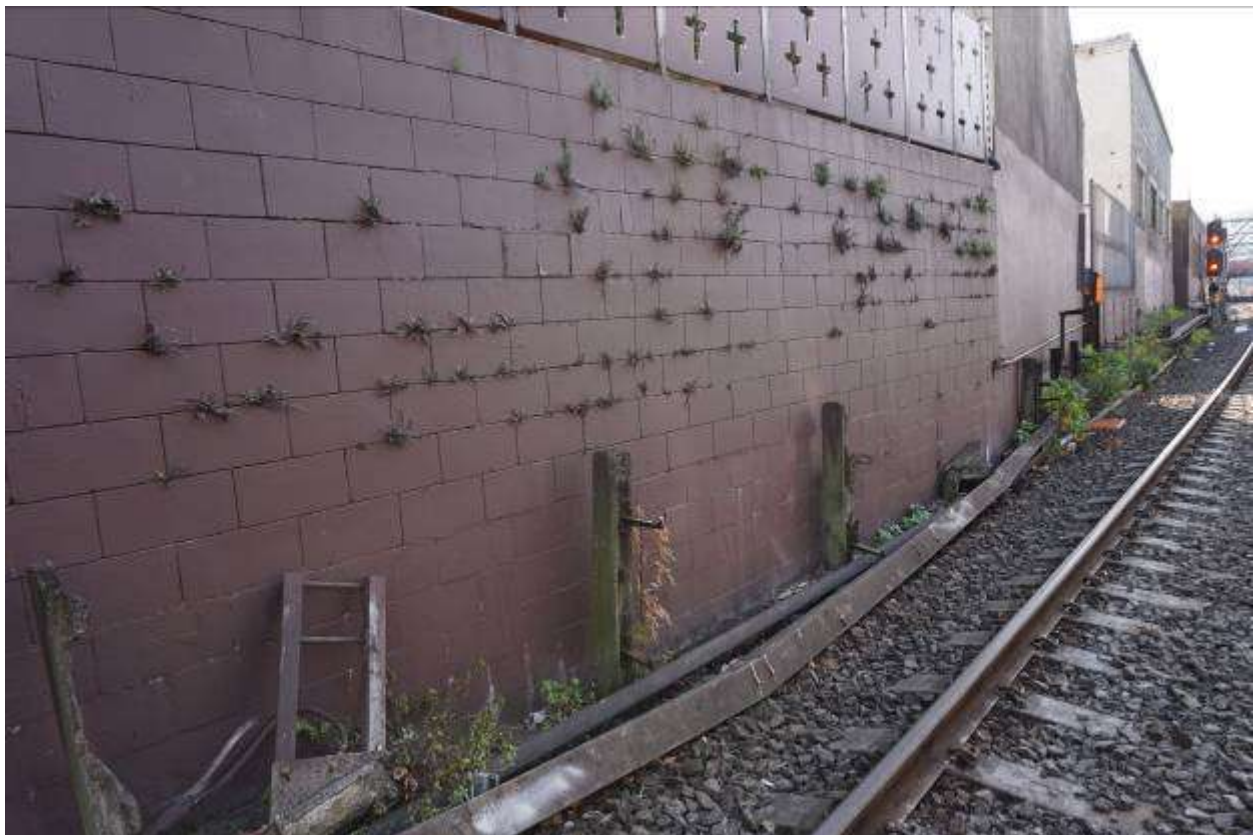
Figure 218 – General condition of RailCorp boundary wall observed from Railway Corridor

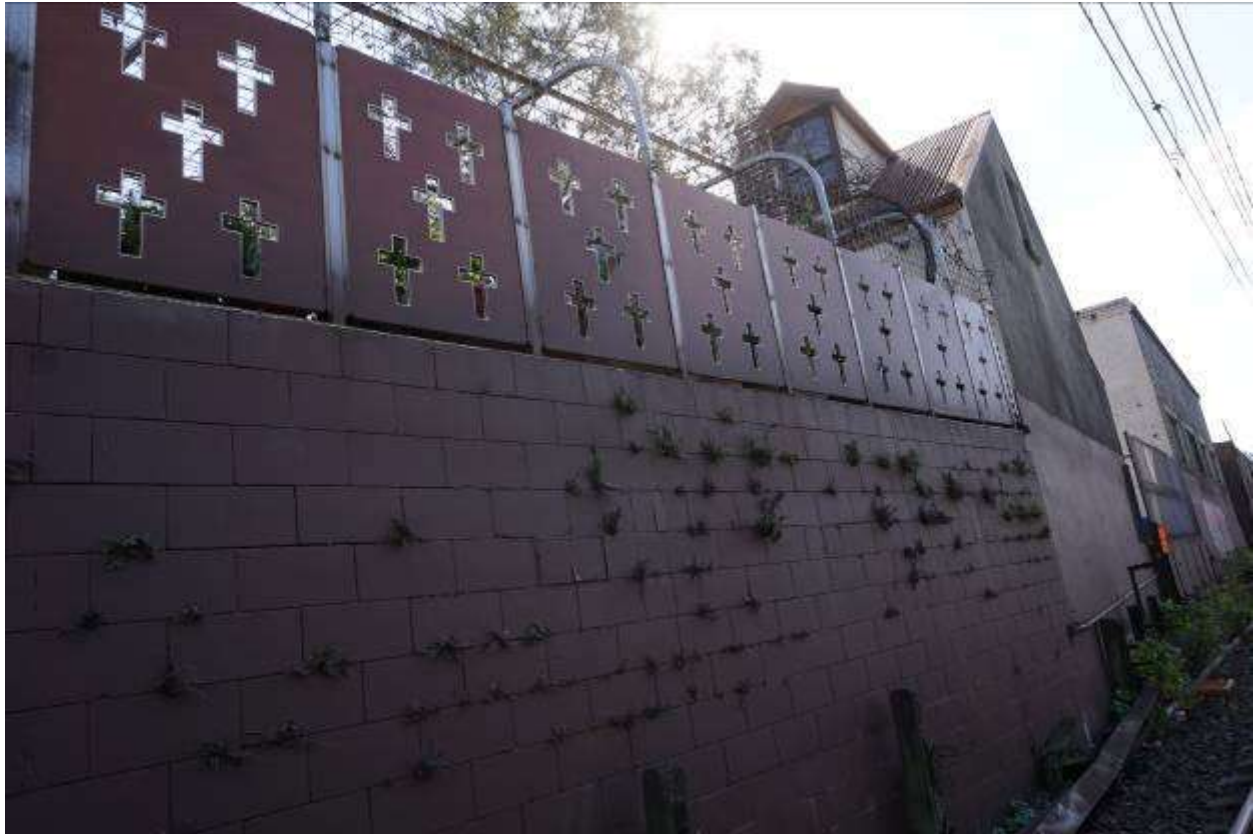
Figure 219 – General condition of RailCorp boundary wall observed from Railway Corridor

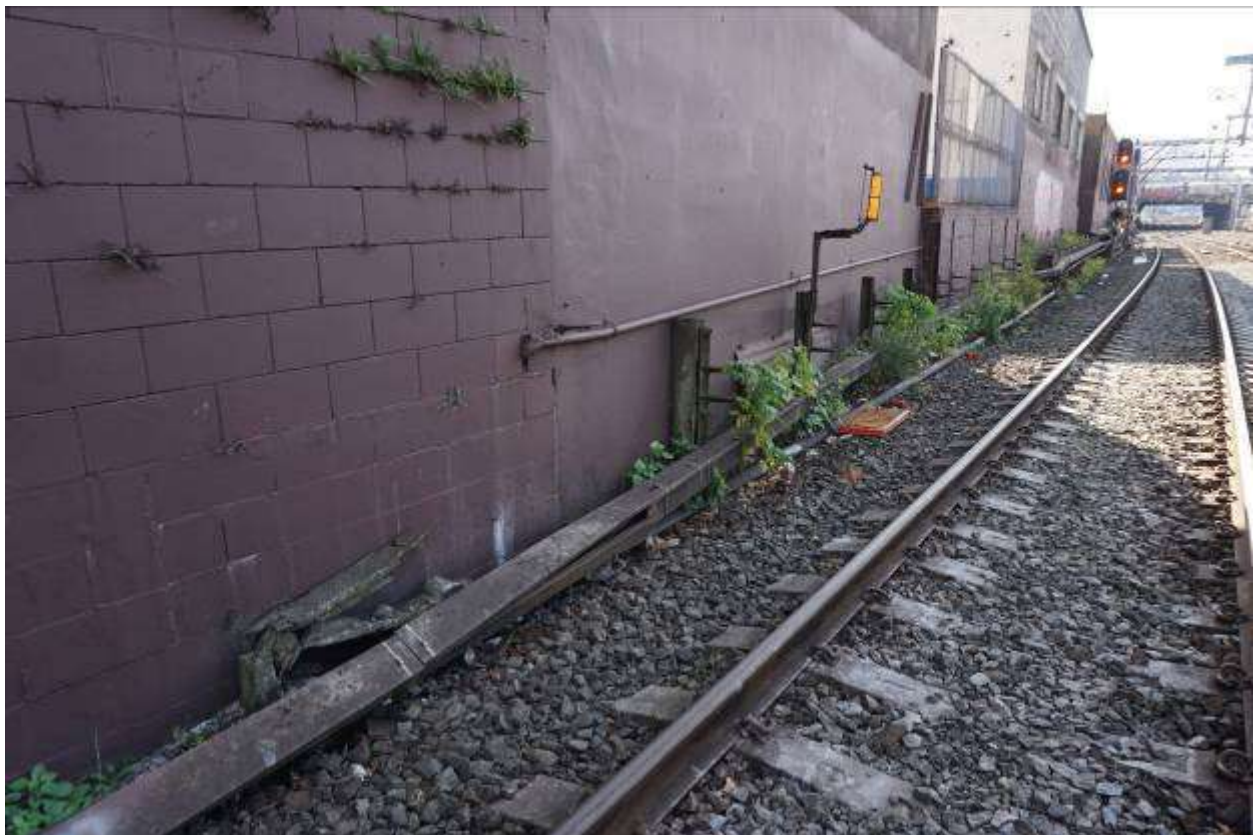
Figure 220 – General condition of RailCorp boundary wall observed from Railway Corridor

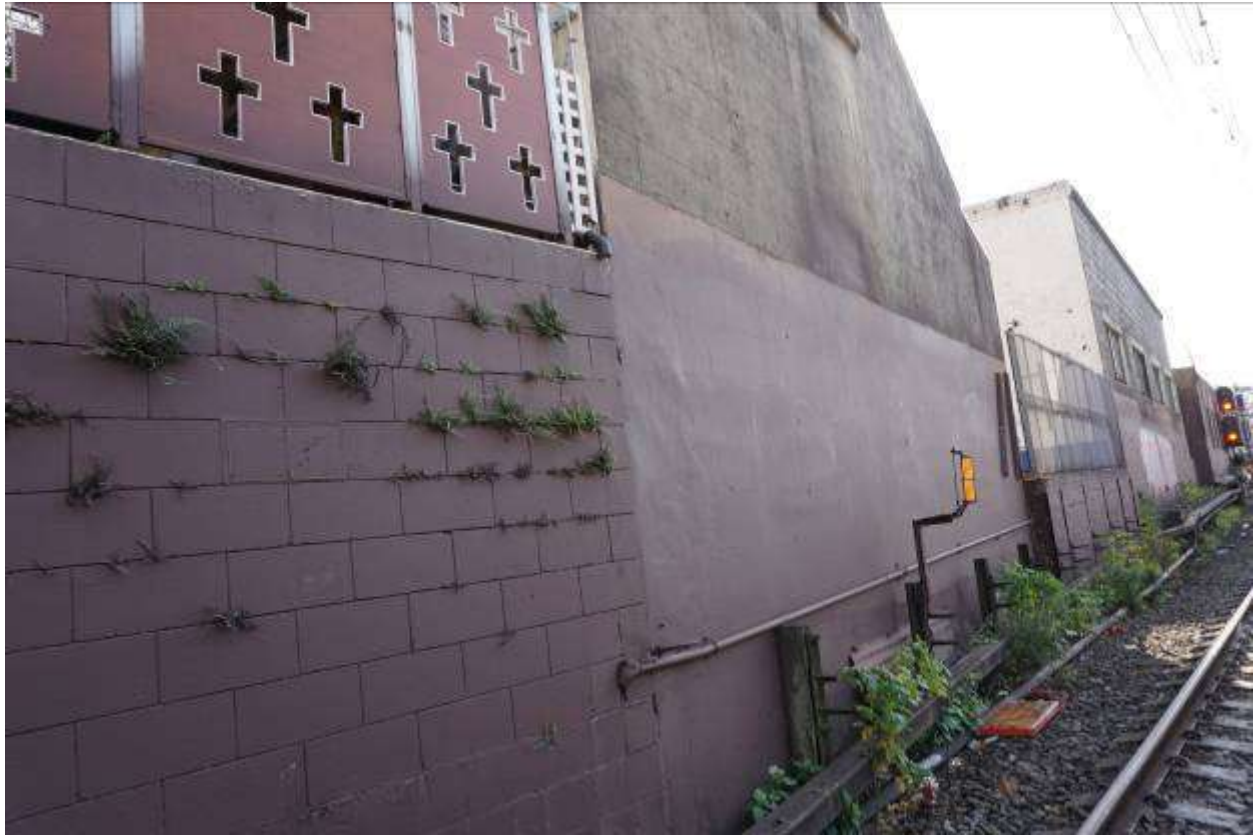
Figure 221 – General condition of RailCorp boundary wall observed from Railway Corridor

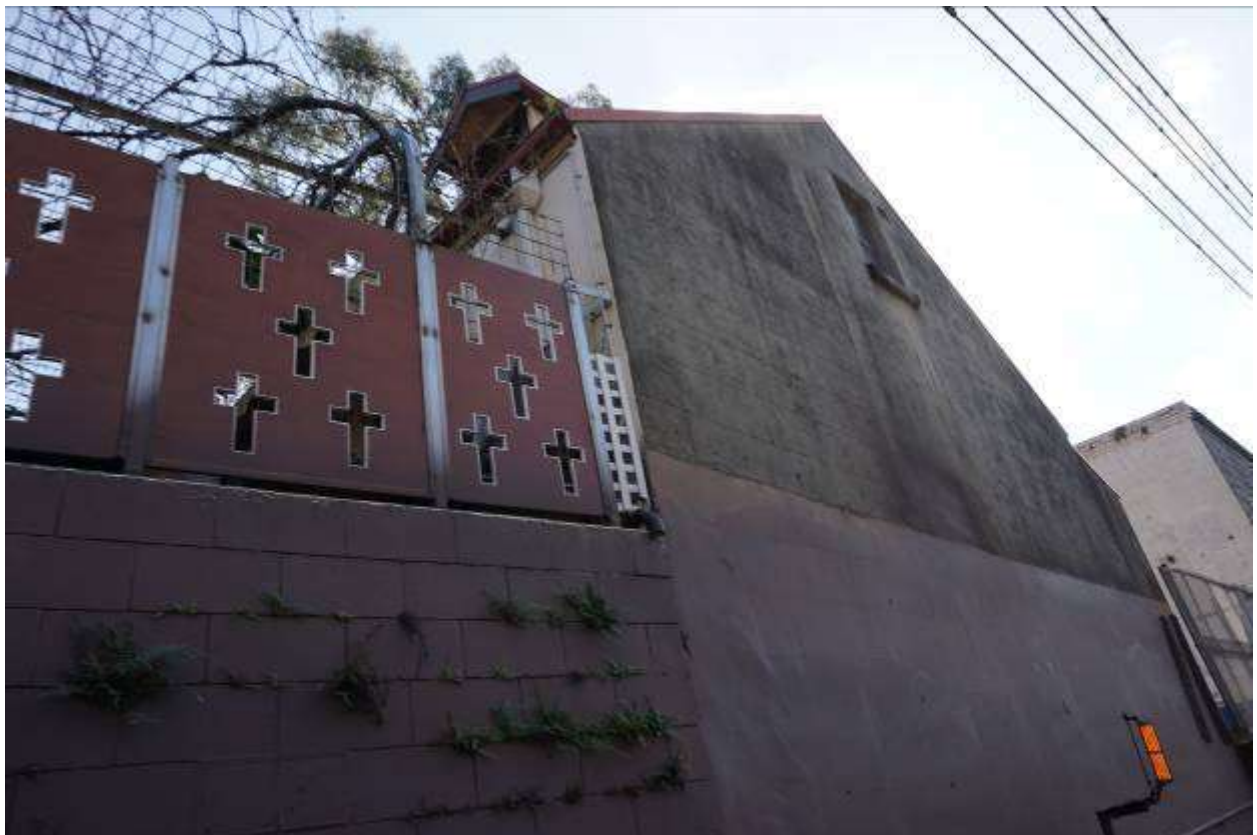
Figure 222 – General condition of RailCorp boundary wall observed from Railway Corridor

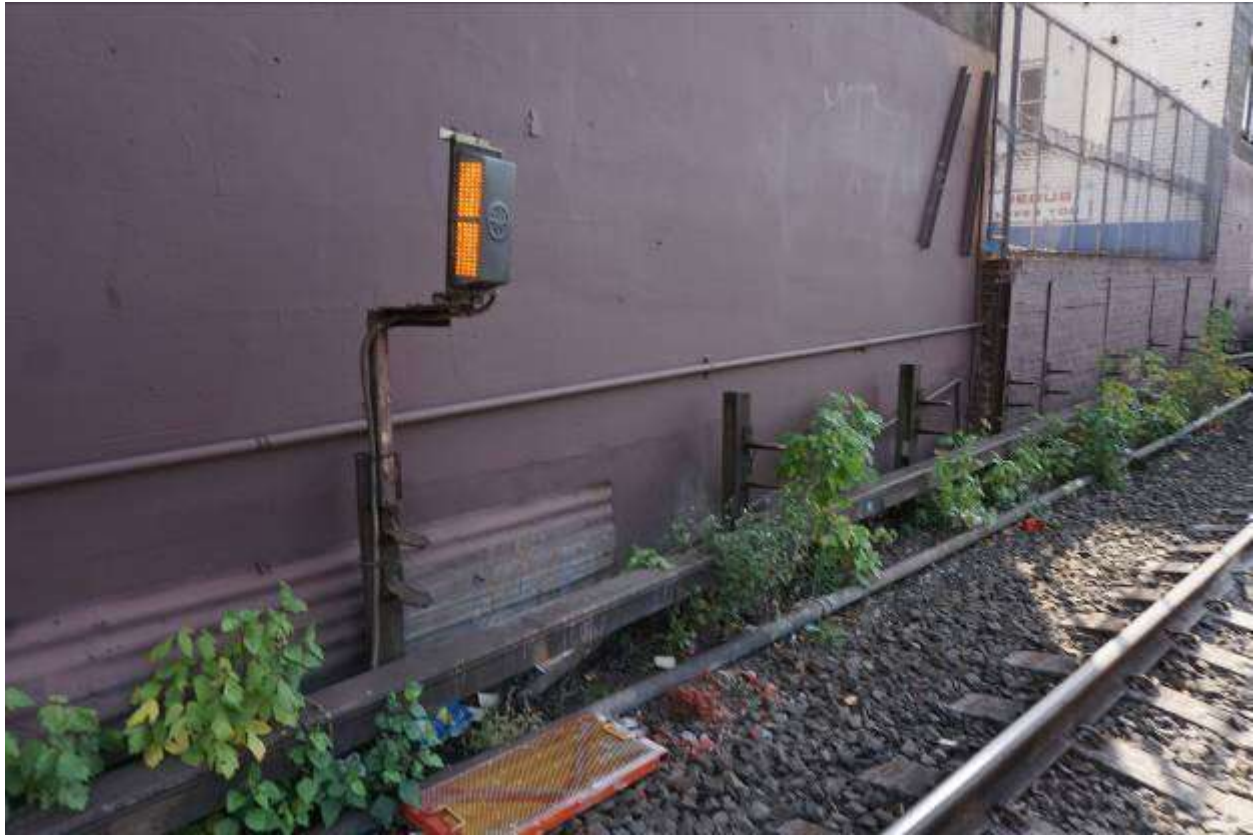
Figure 223 – General condition of RailCorp boundary wall observed from Railway Corridor

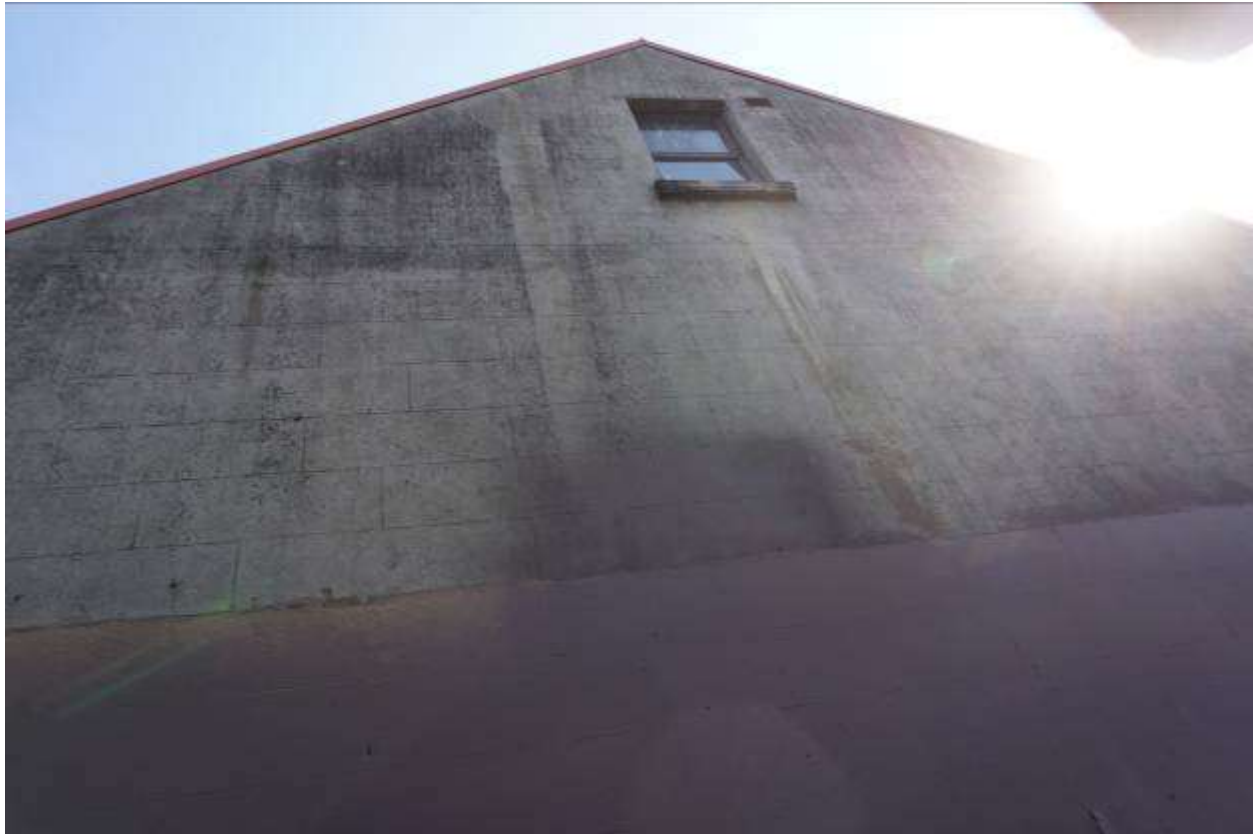
Figure 225 – General condition of RailCorp boundary wall observed from Railway Corridor

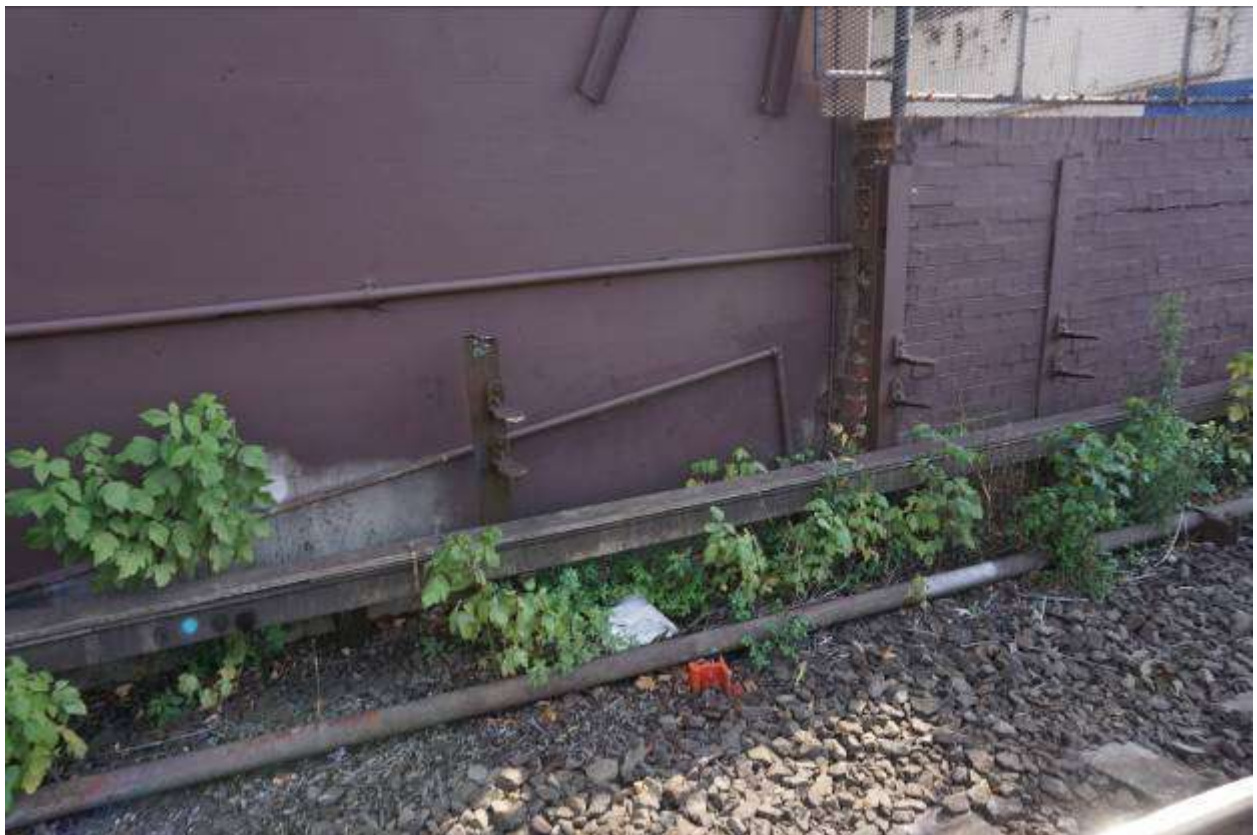
Figure 226 – General condition of RailCorp boundary wall observed from Railway Corridor
