Re: Dilapidation Report for Property
No: Pemulwuy Project - Redfern NSW 2016

Job: 170037.0
Date: MAY 2017

SUMMARY

This report serves as a record of the condition of the RailCorp infrastructure assets of the "Metro Illawarra & South Coast" line, which is adjacent to the subject site, prior to the commencement of any works proposed at: Pemulwuy Project - Redfern NSW 2016.

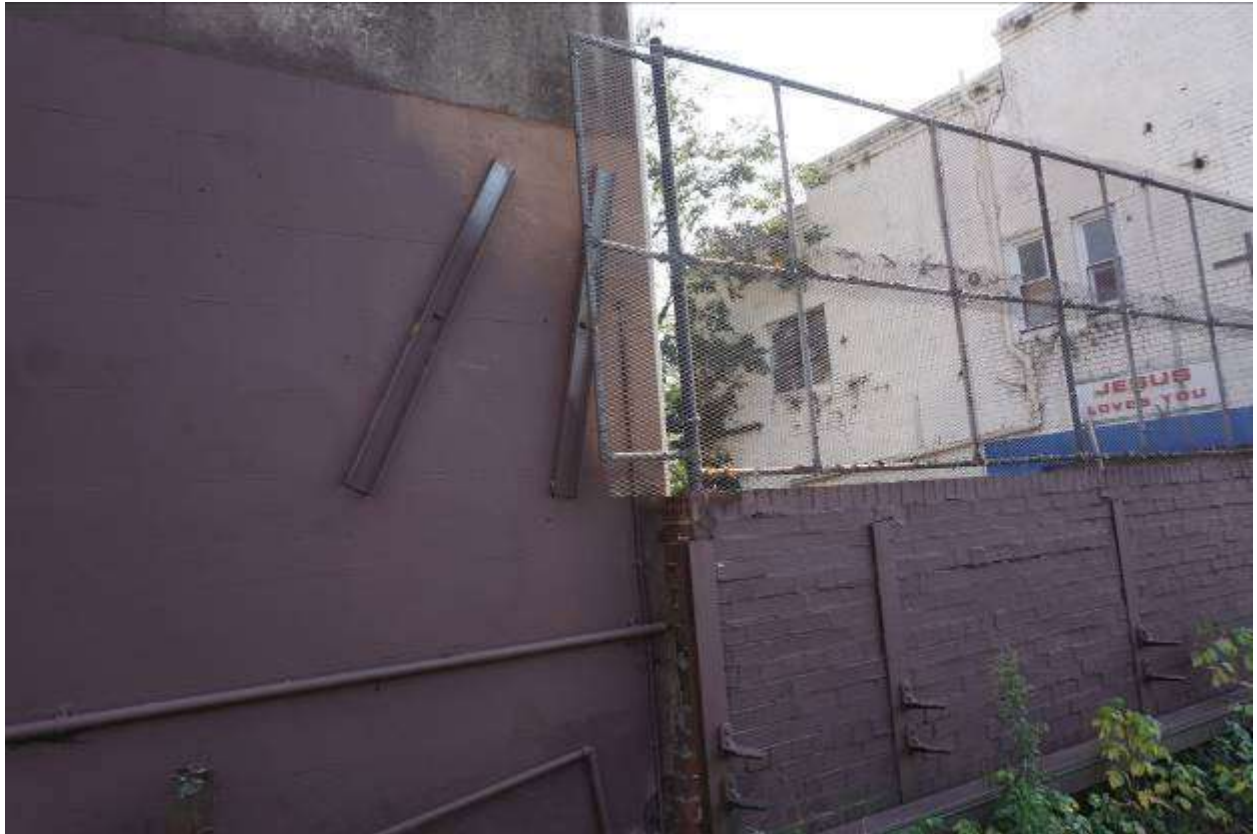
Figure 227 – General condition of RailCorp boundary wall observed from Railway Corridor

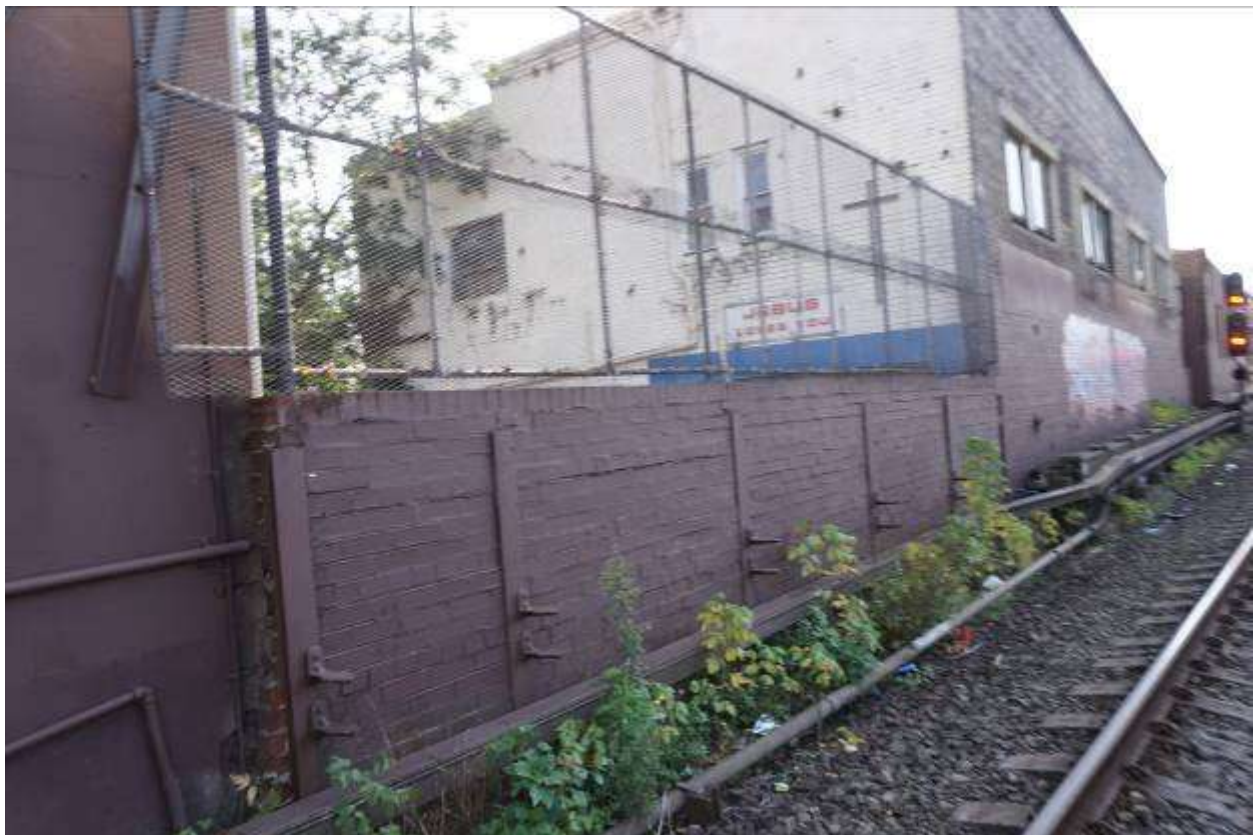
Figure 228 – General condition of RailCorp boundary wall observed from Railway Corridor

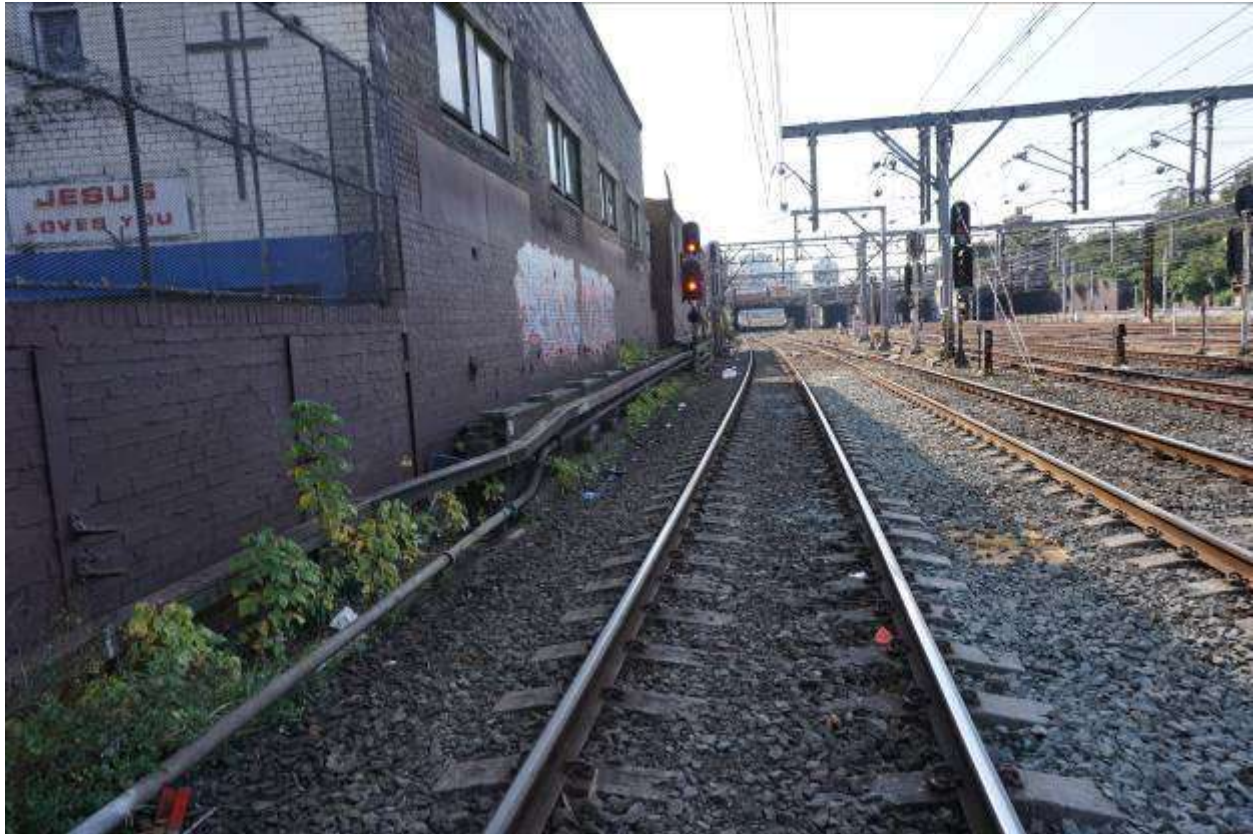
Figure 229 – General condition of RailCorp boundary wall observed from Railway Corridor

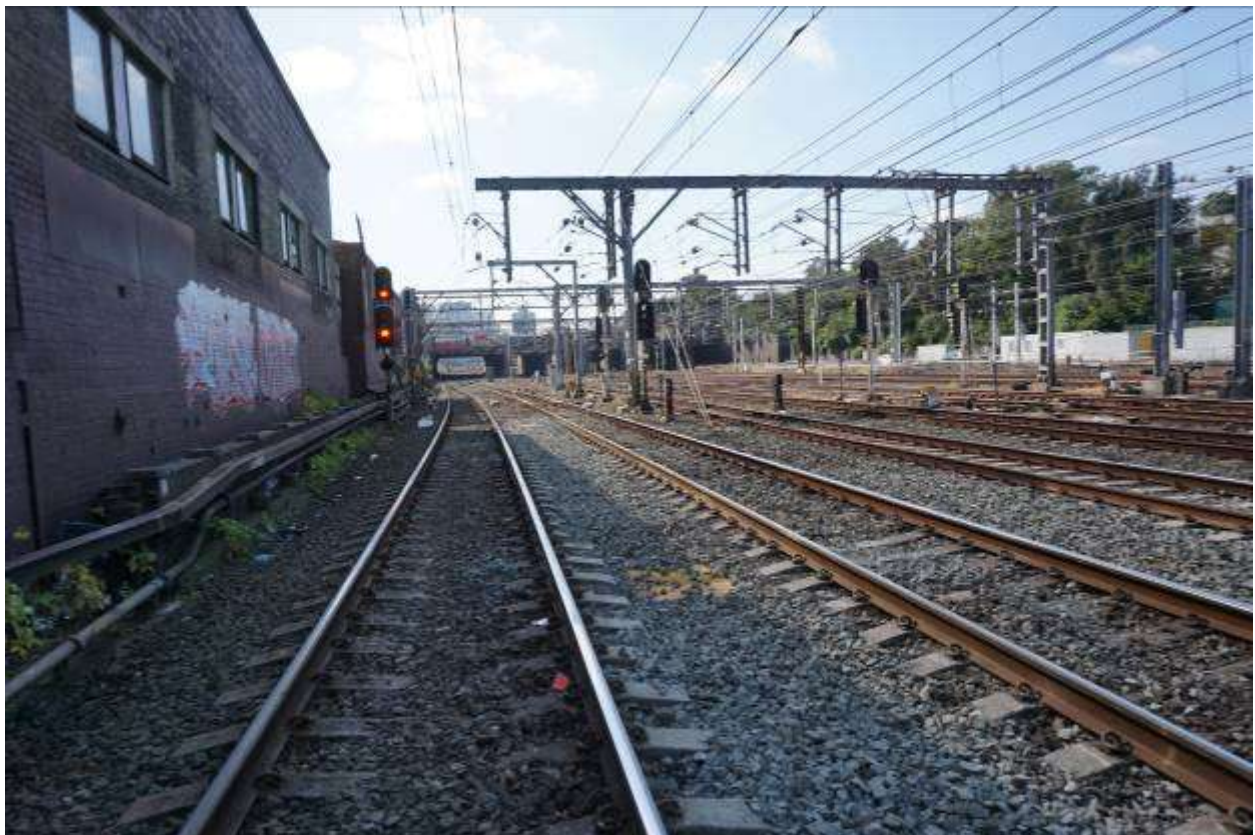
Figure 230 – General condition of RailCorp boundary wall observed from Railway Corridor

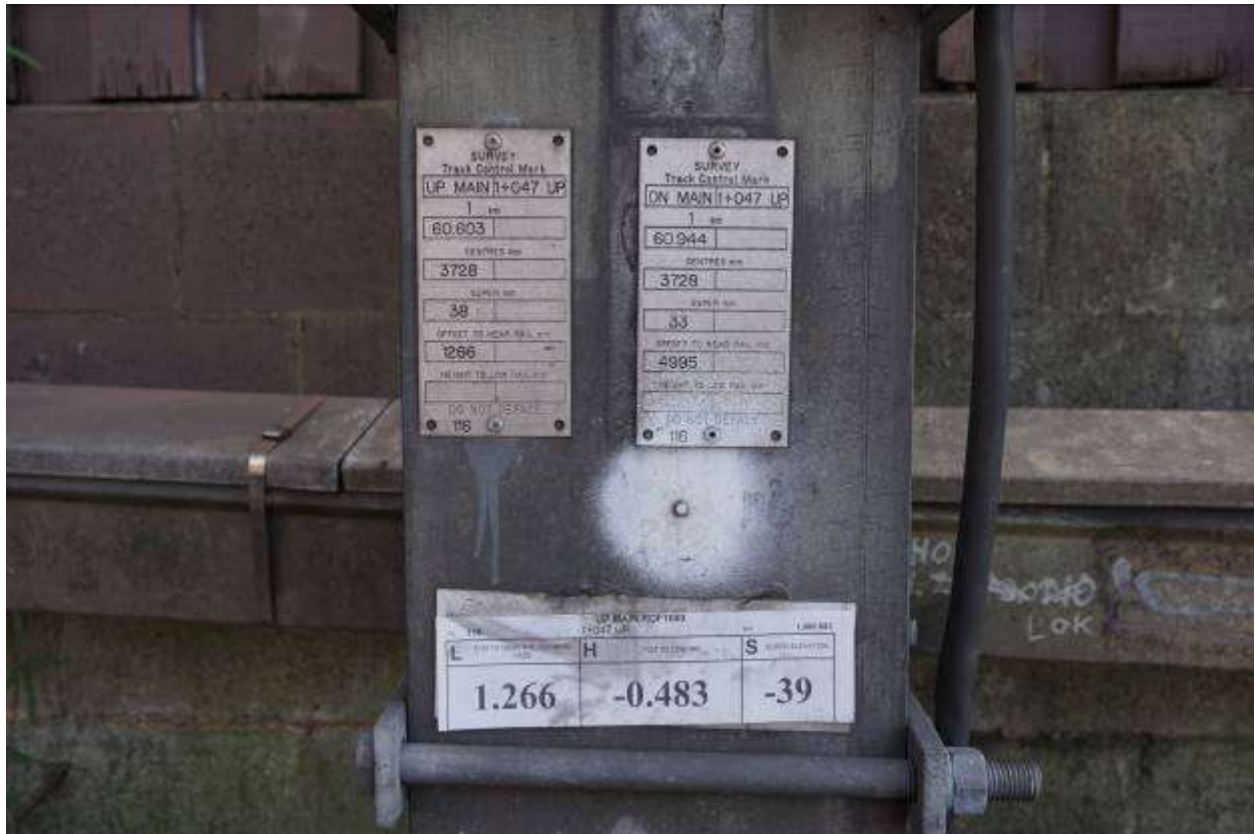
Figure 231 – General condition of Survey Track Control Mark observed from Railway Corridor

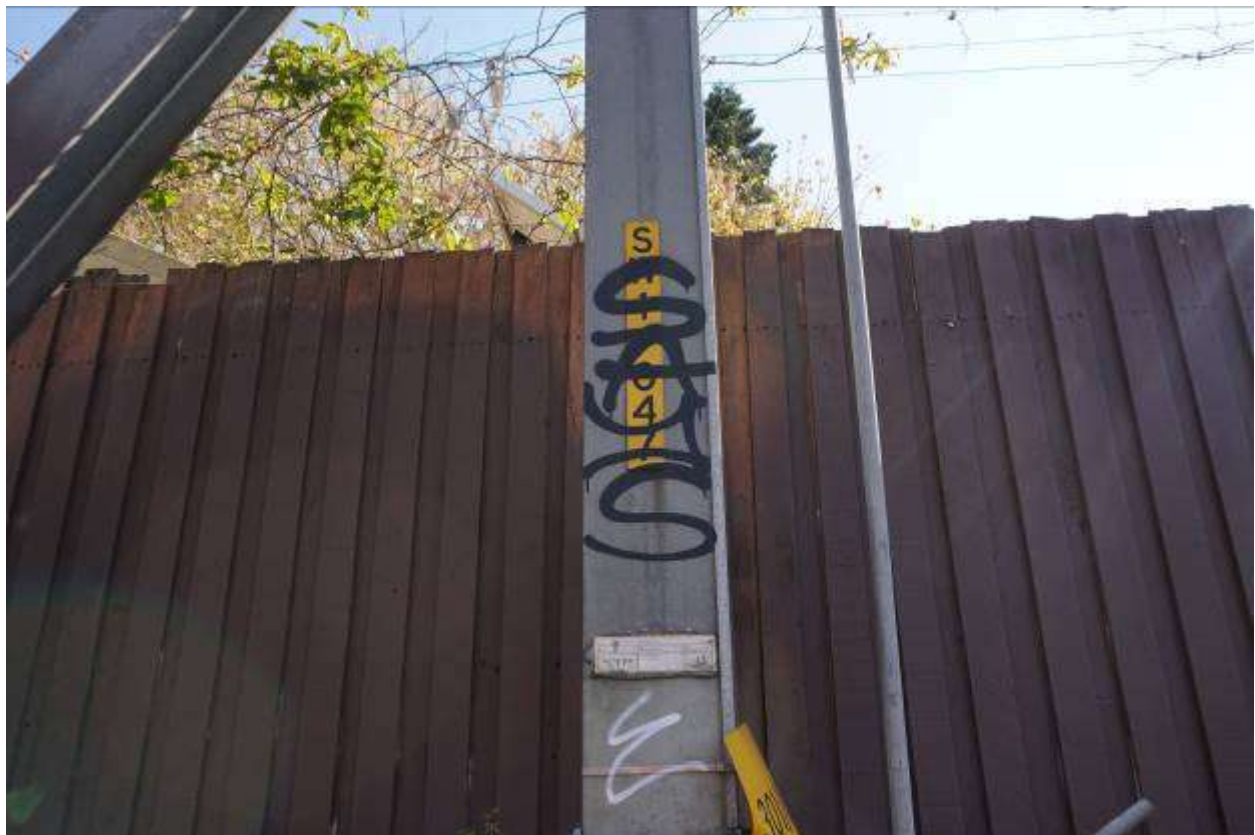
Figure 232 – General condition of steel portal haunch Identification No. SW1+047 observed from Railway Corridor

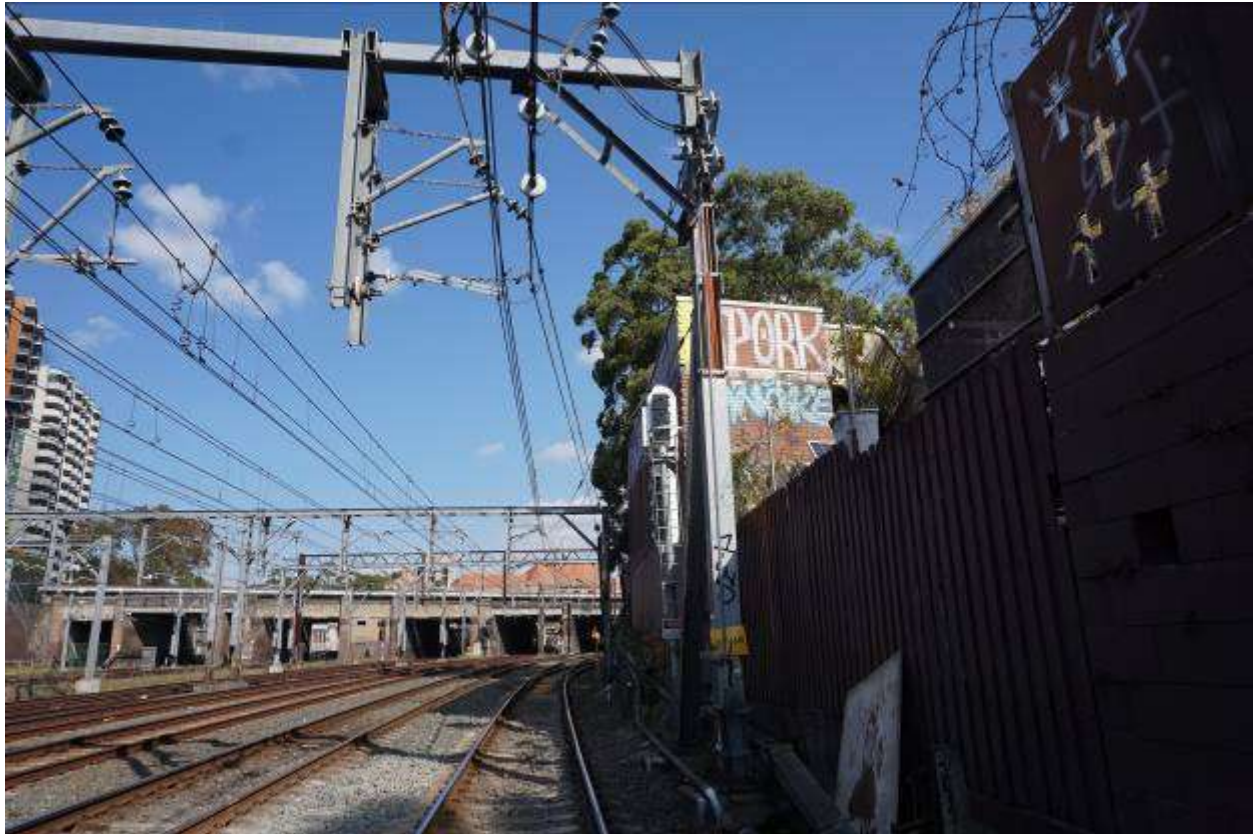
Figure 233 – General condition of steel portal haunch Identification No. SW1+047 and overhead power supply system observed from Railway Corridor

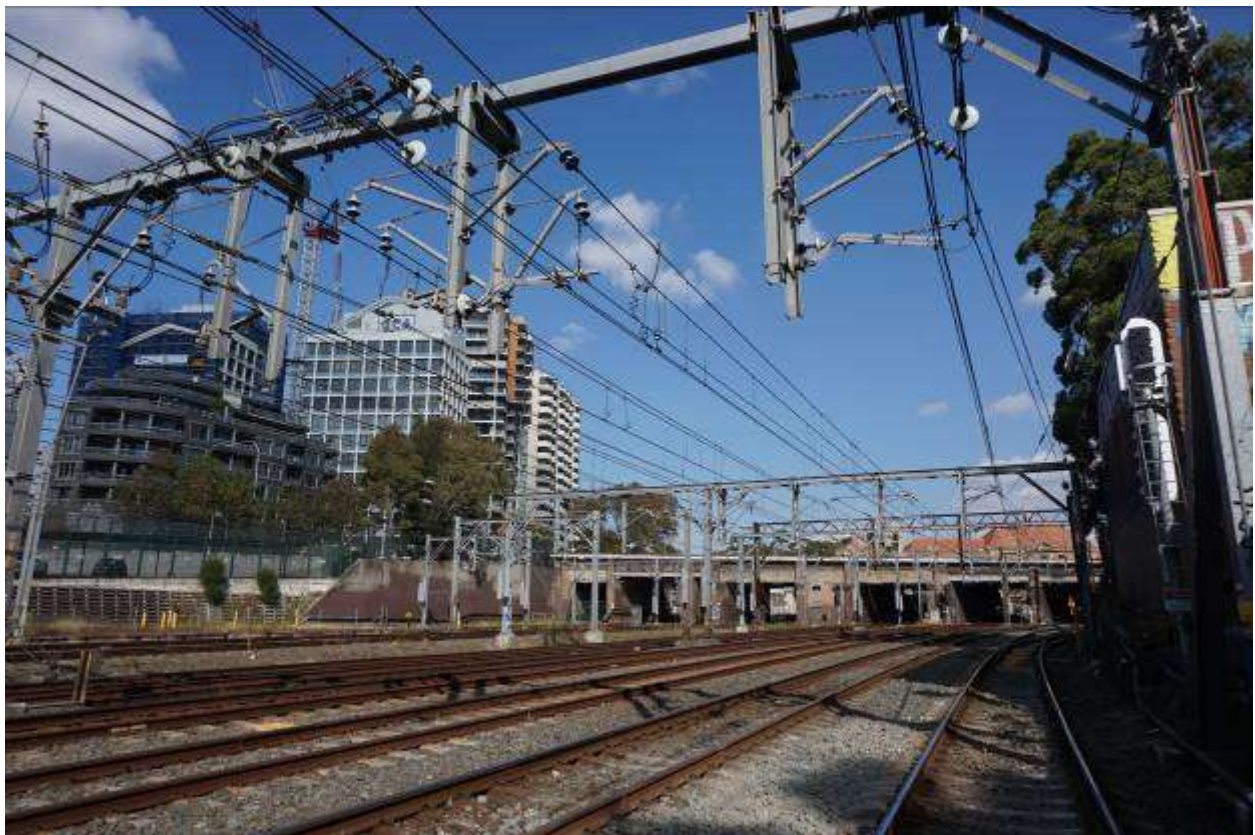
Figure 234 – General condition of steel portal haunch Identification No. SW1+047 and overhead power supply system observed from Railway Corridor

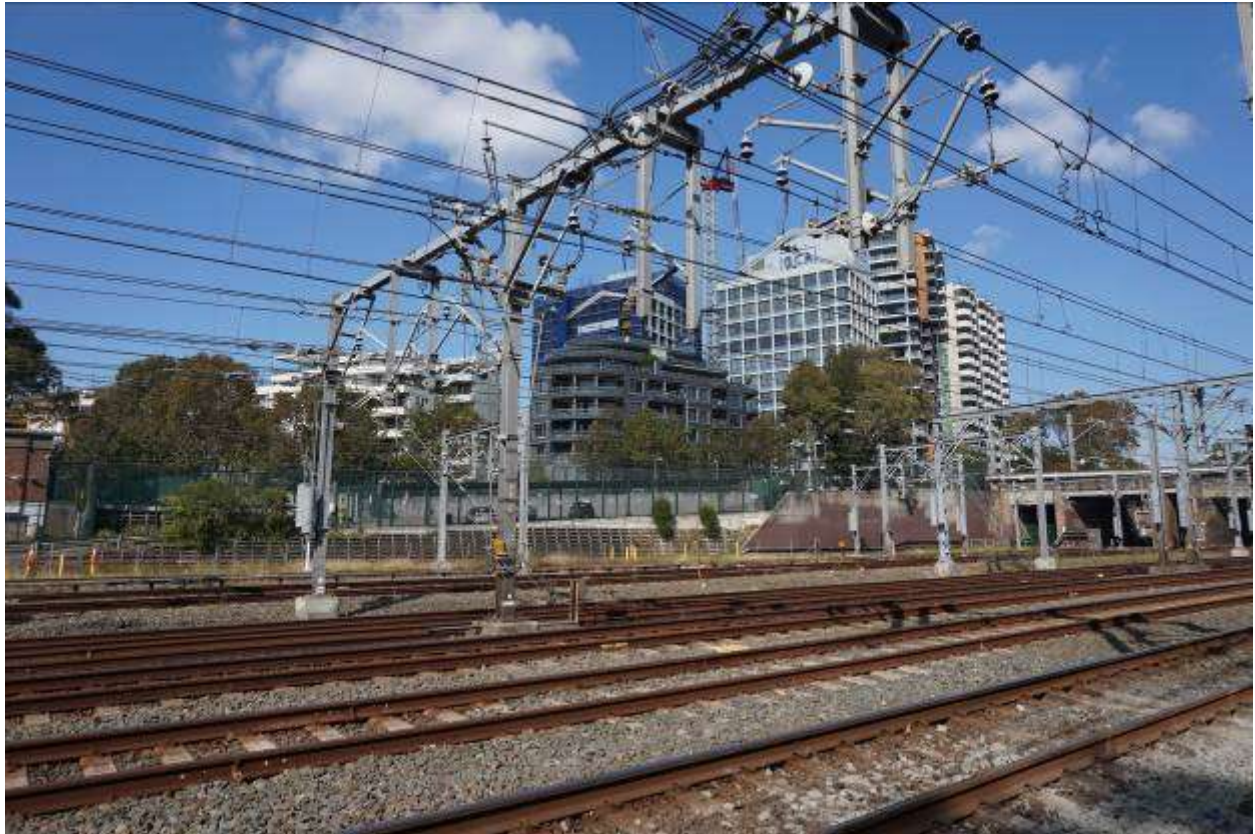
Figure 235 – General condition of steel portal haunch Identification No. SW1+047 and overhead power supply system observed from Railway Corridor

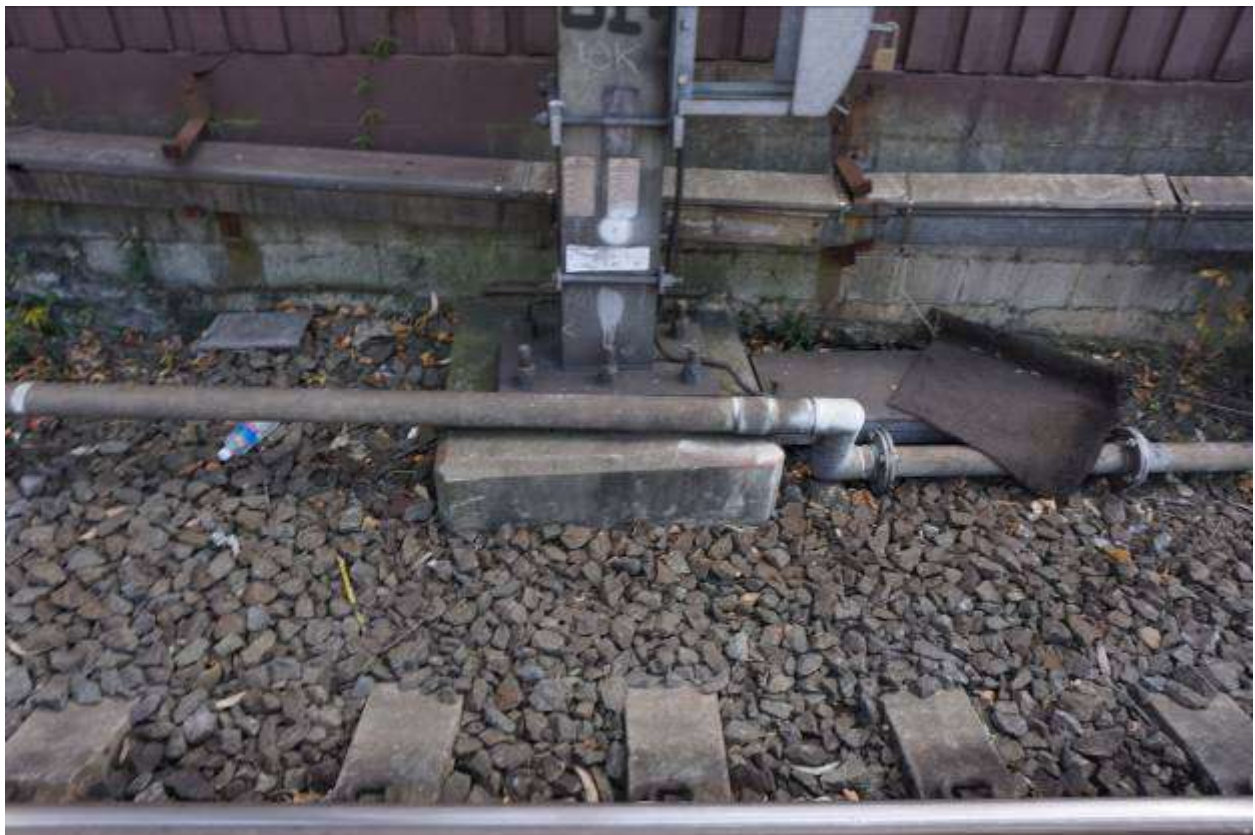
Figure 236 – General condition of concrete footing observed from Railway Corridor

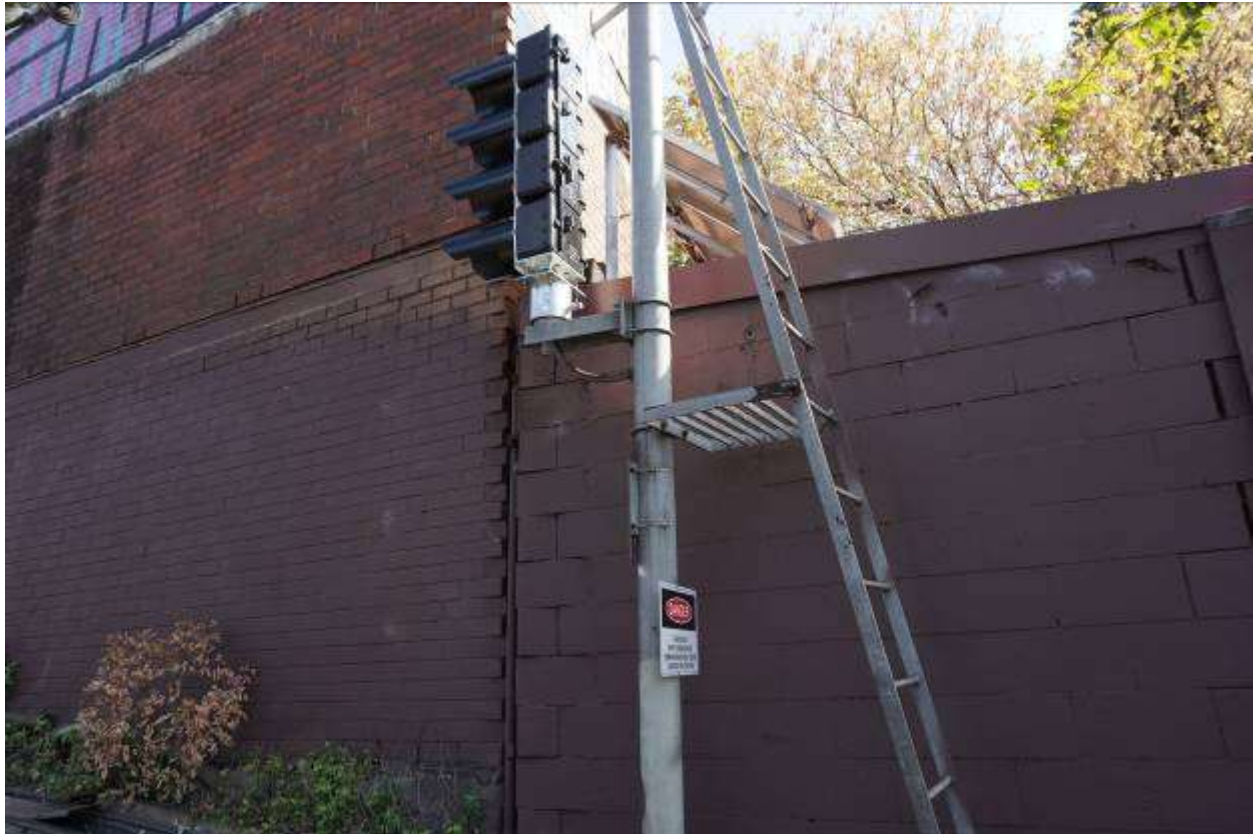
Figure 239 – General condition of RailCorp traffic signal observed from Railway Corridor

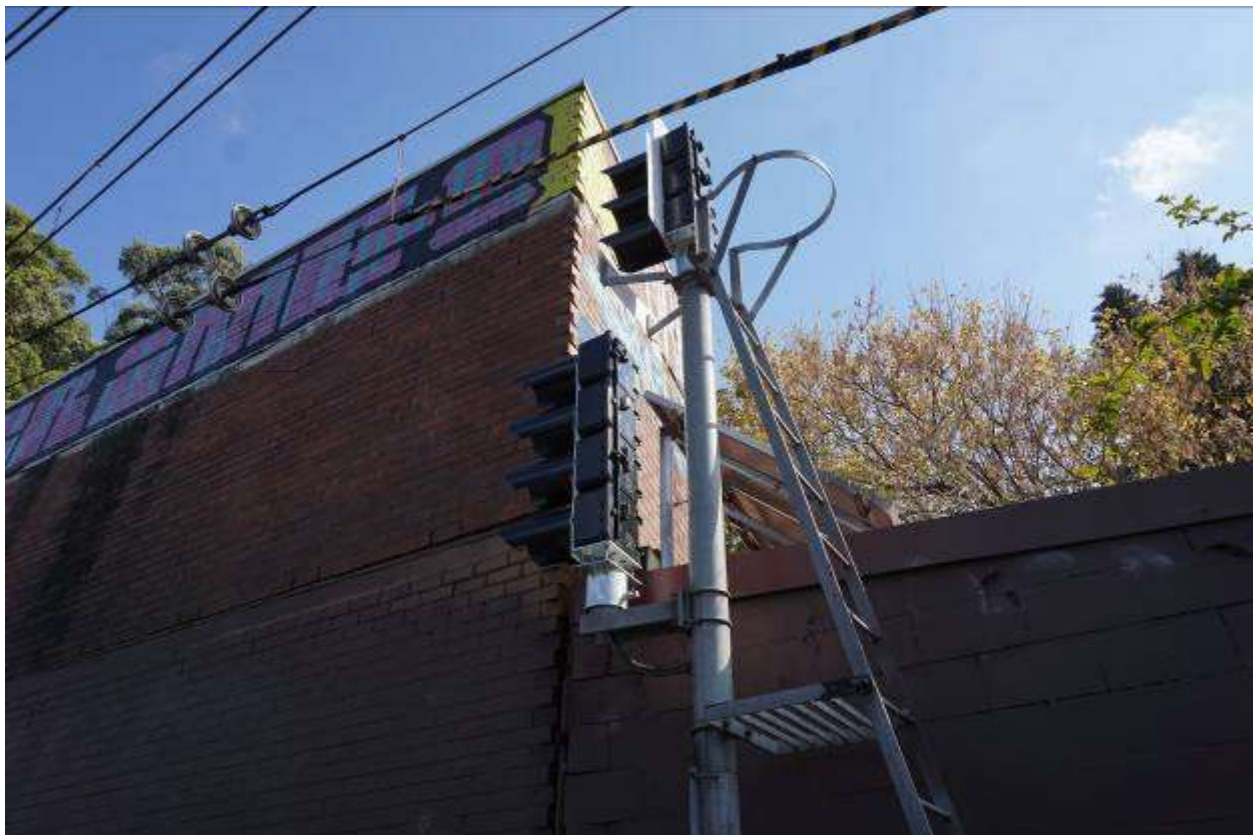
Figure 240 – General condition of RailCorp traffic signal observed from Railway Corridor

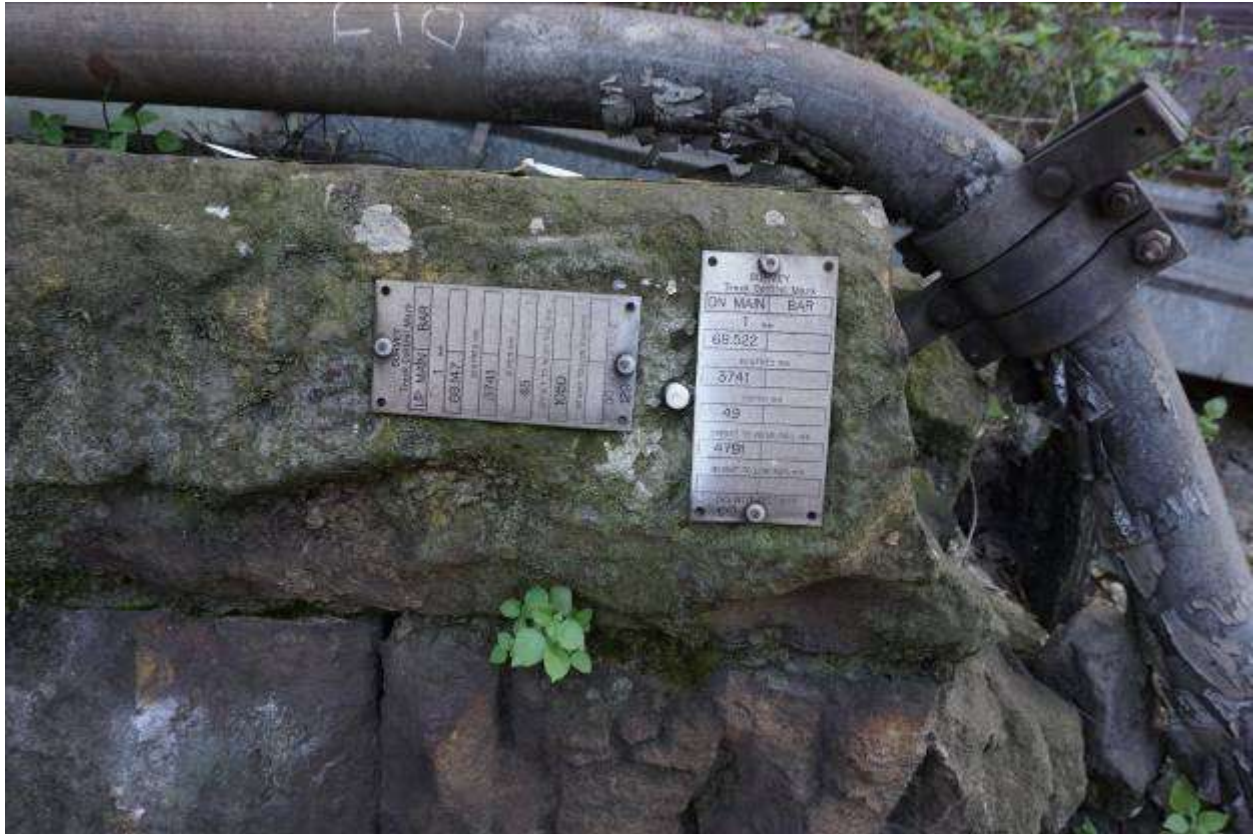
Figure 241 – General condition of Survey Track Control Mark observed from Railway Corridor

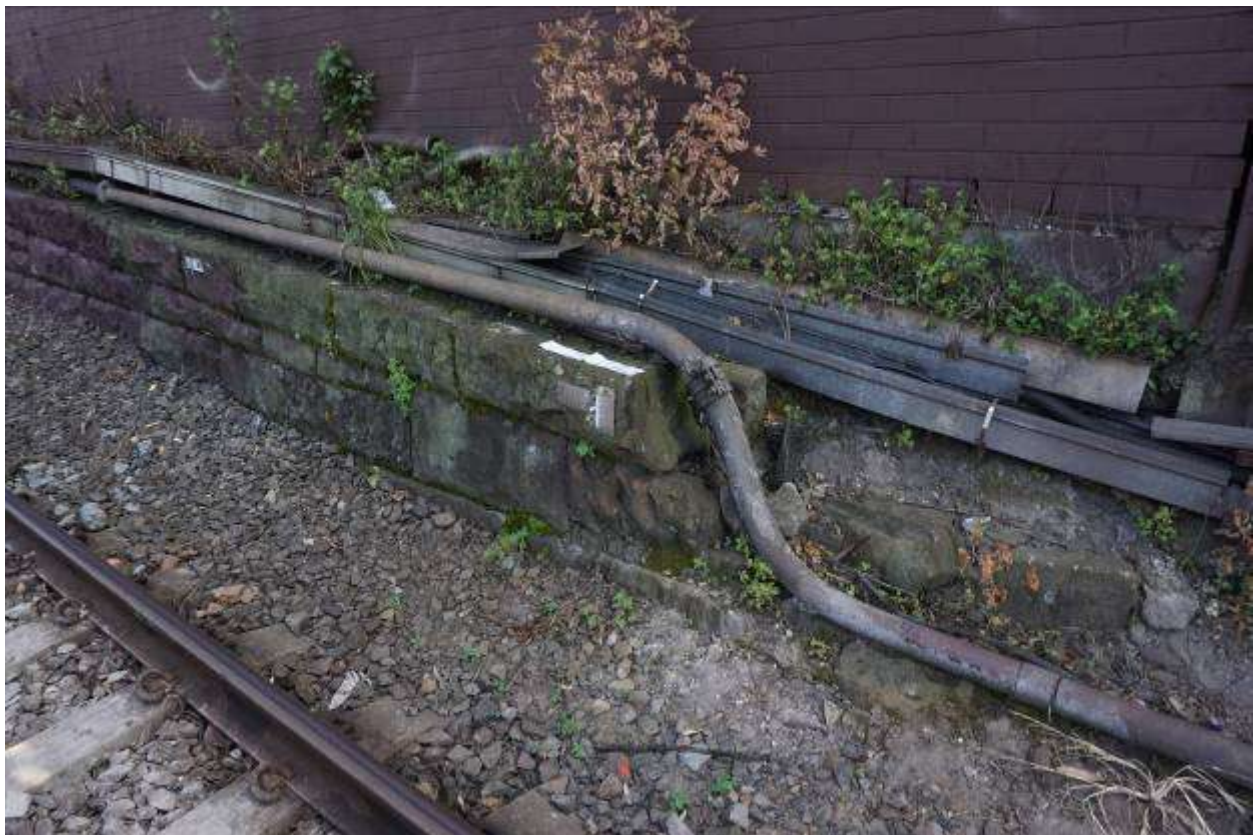
Figure 242 – General condition of RailCorp signal troughing observed from Railway Corridor

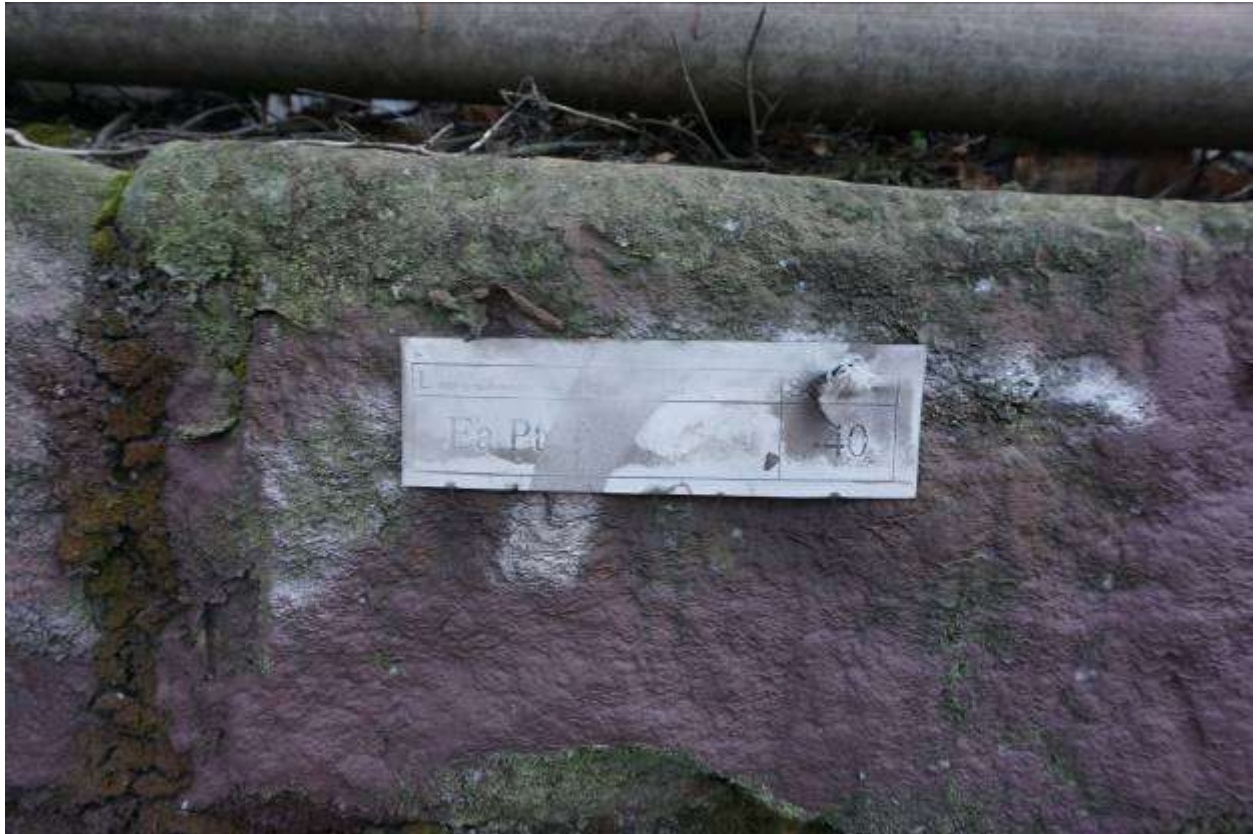
Figure 243 – General condition of Survey Track Control Mark observed from Railway Corridor

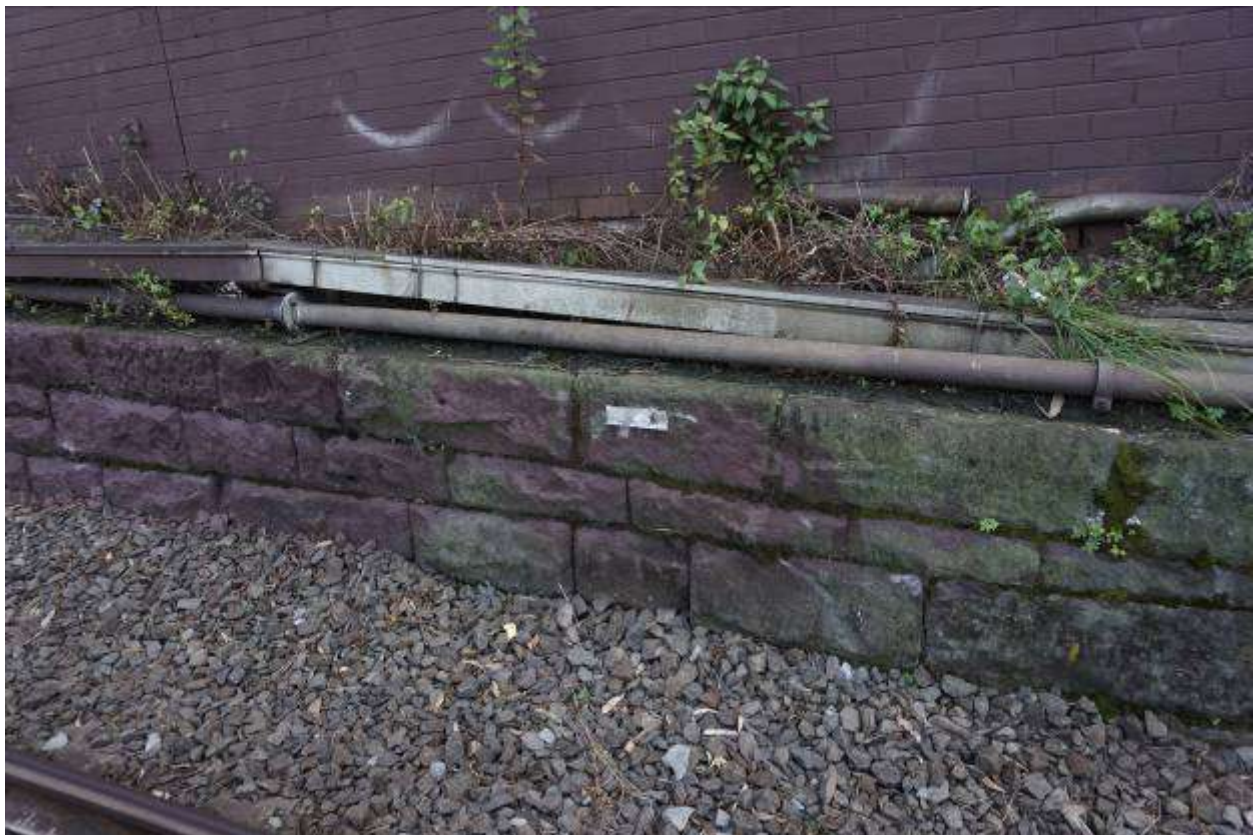
Figure 244 – General condition of RailCorp signal troughing observed from Railway Corridor

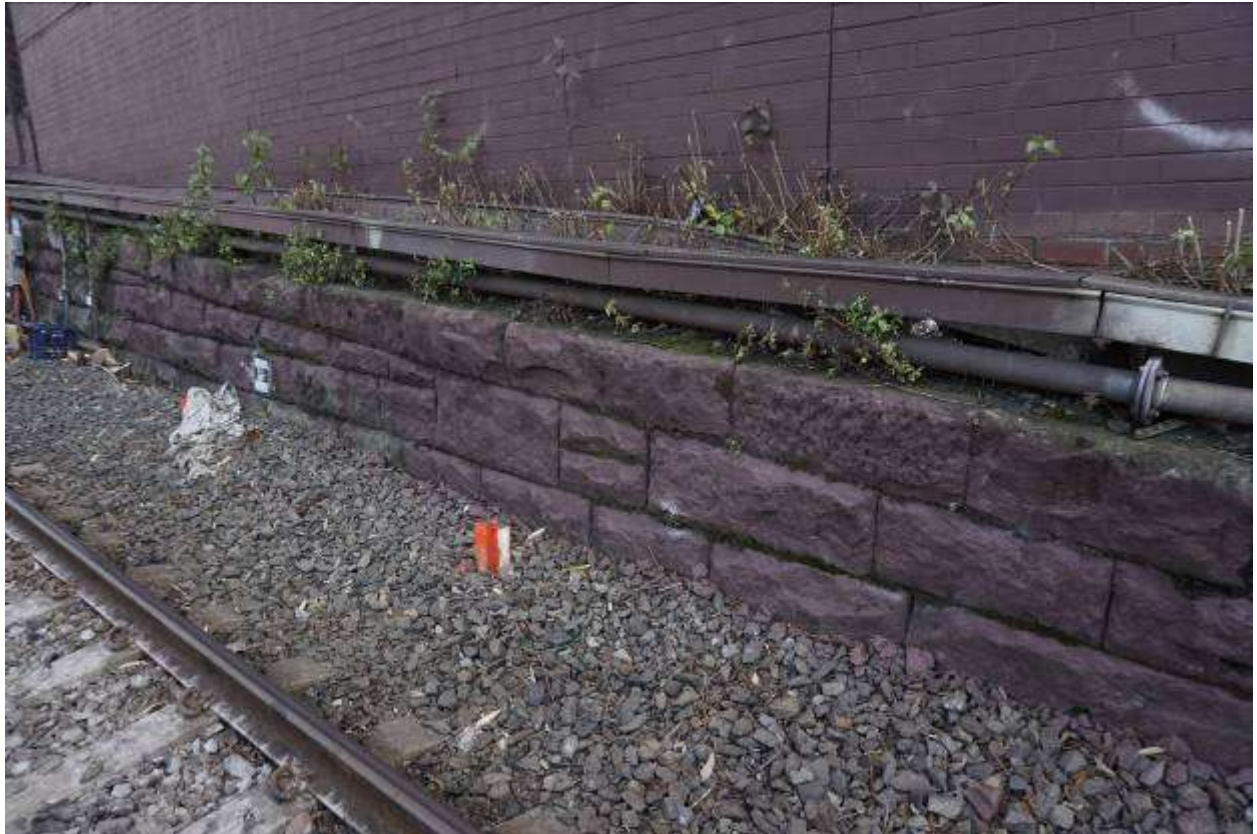
Figure 245 – General condition of RailCorp signal troughing observed from Railway Corridor

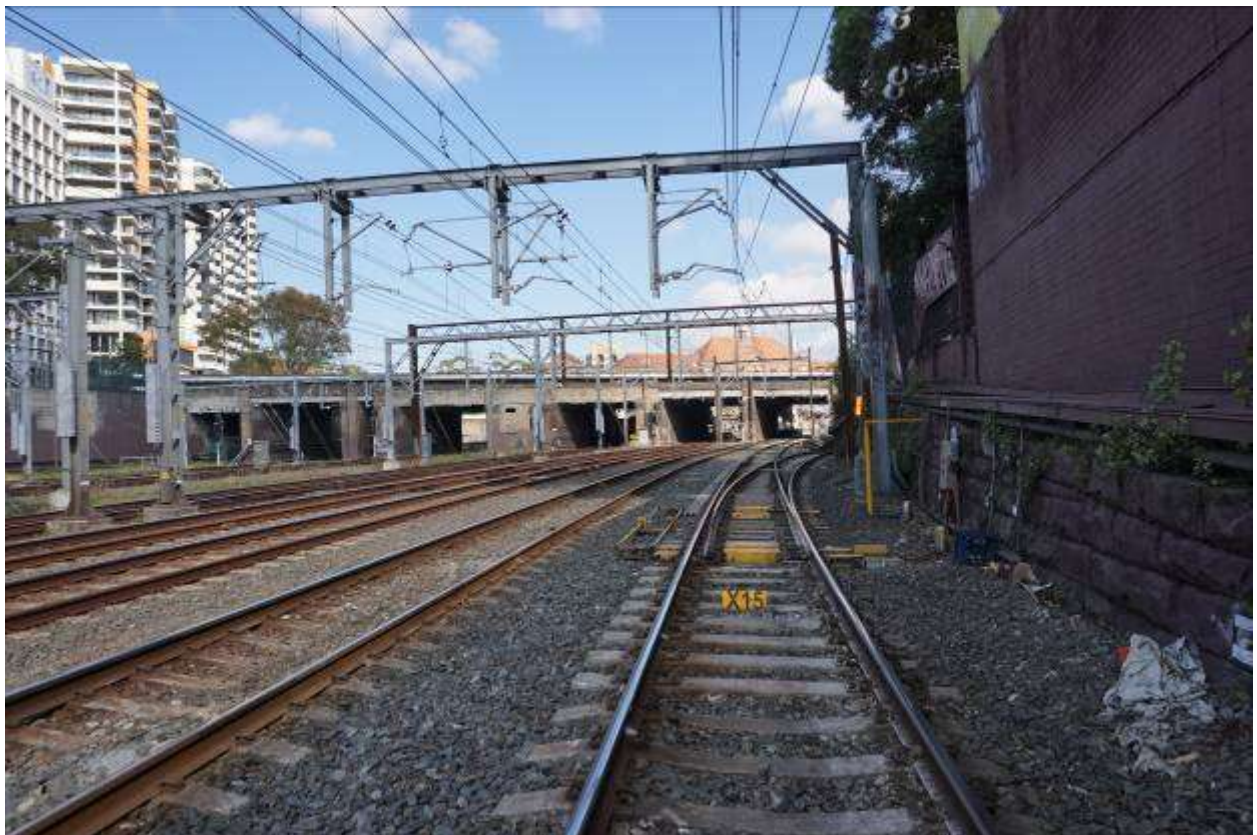
Figure 246 – General condition of railway corridor observed from Railway Corridor

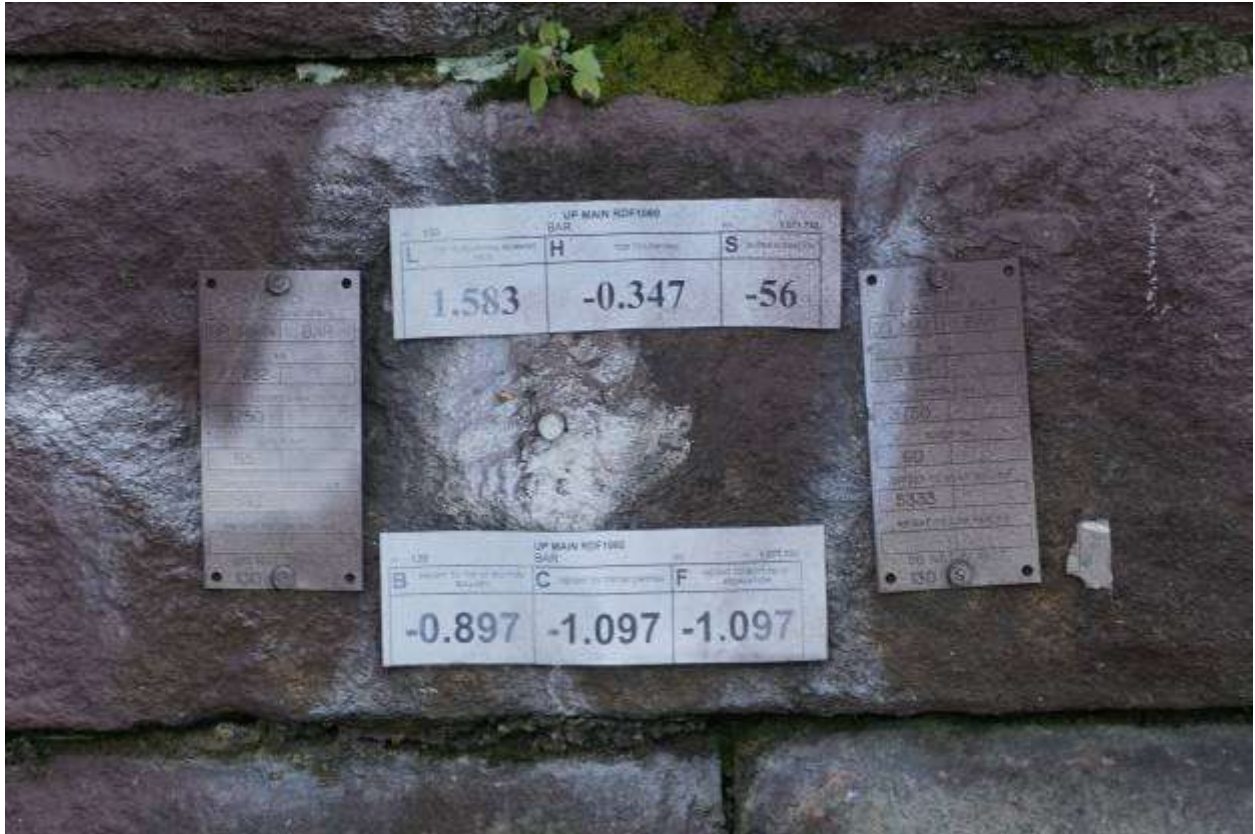
Figure 247 – General condition of Survey Track Control Mark observed from Railway Corridor

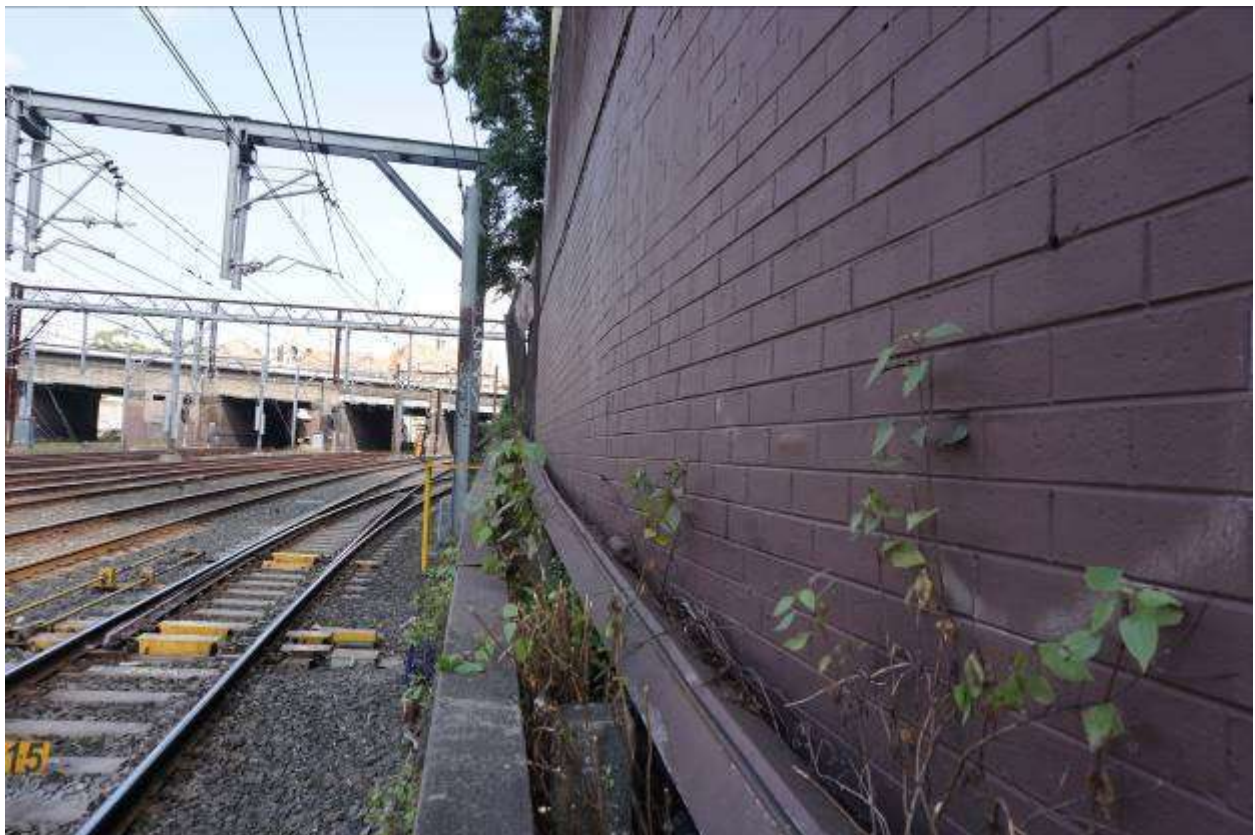
Figure 248 – General condition of RailCorp boundary wall observed from Railway Corridor

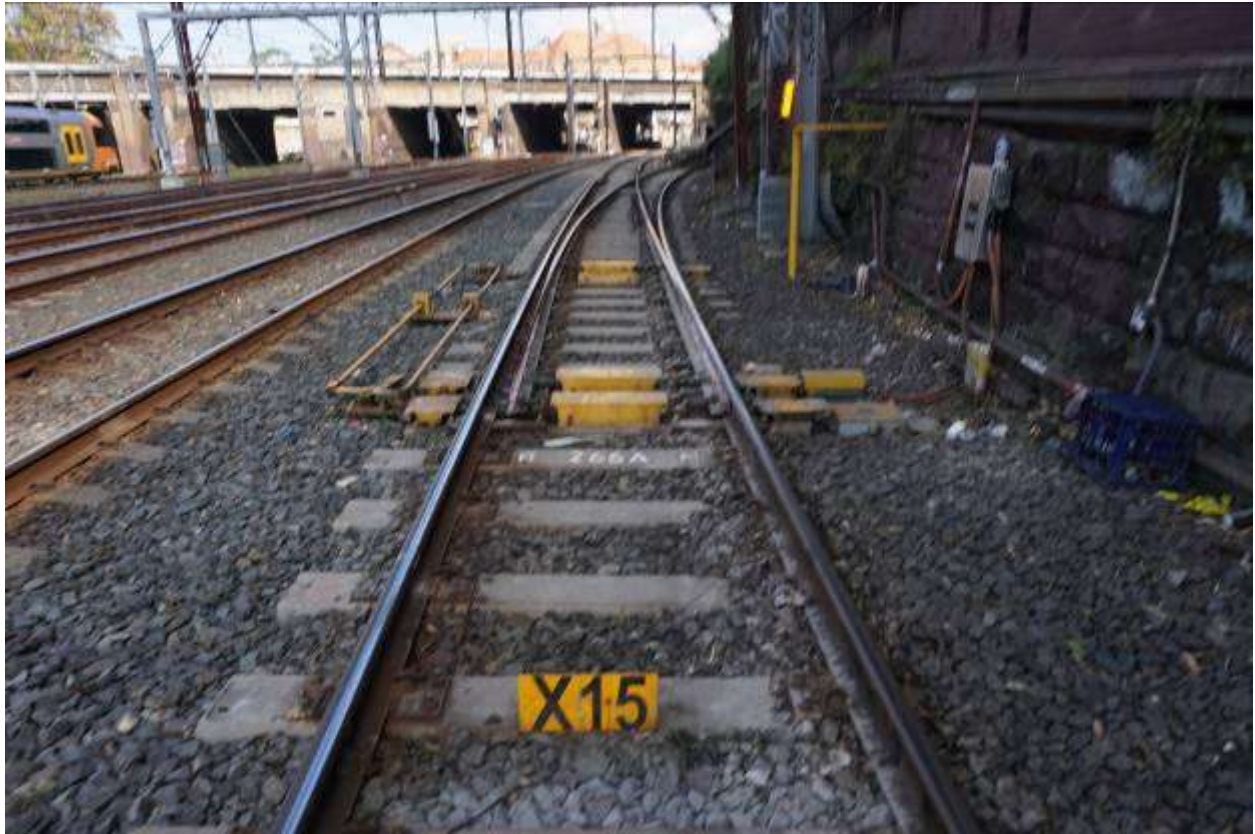
Figure 249 – General condition of RailCorp tracks observed from Railway Corridor
